2019년 하반기 지방하천 배수문 정밀점검 요약

임겨 박스 외관조사만도

2019. 11. 19 ~ 2020. 01. 26

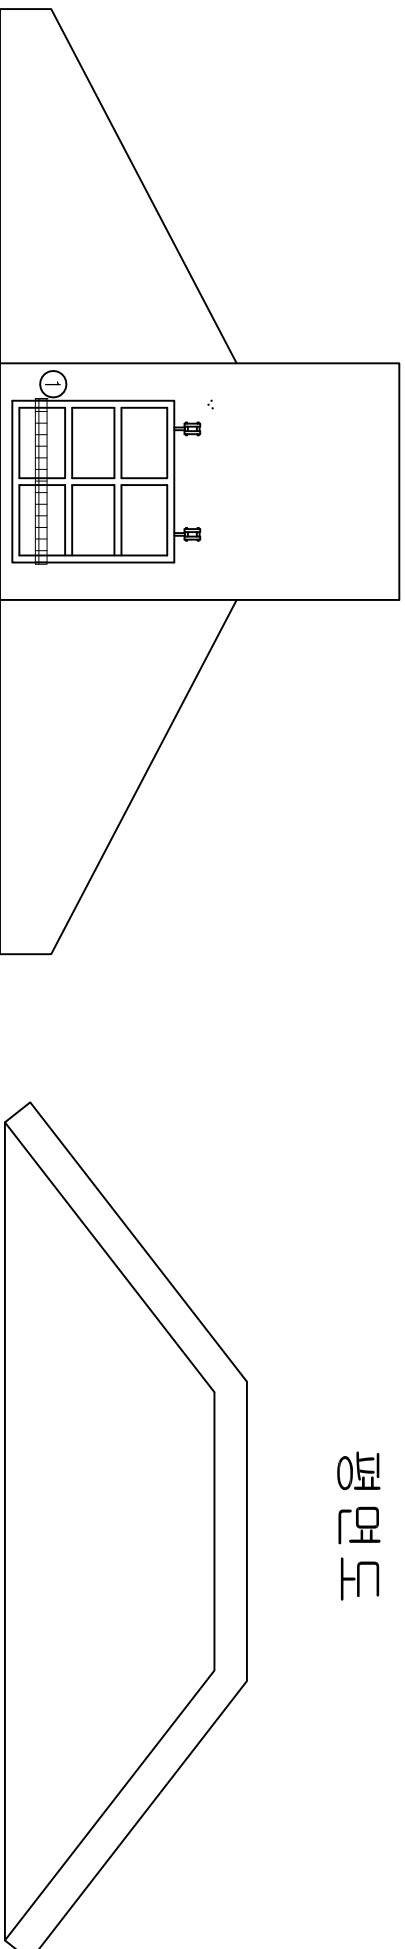
전면부

| 손상물량 집계표 | | 손상현황 | | | | | |
|---|---|---|---|---|---|---|---|
| 1 | 수평재 파손 | - | 1.6 | - | 1.0 | 1.6 | m b |
