수문 본체 외관조사망도

| 발주처 | 화성시청 | 공역 | 주식회사성본 | 공역명 | 2019년 하반기 지방하천 배수문 정밀점검 공역 | | | | | | | | | 도면명 | | 수문 본체 외관조사망도 | | 도면번호 | | 34 | |

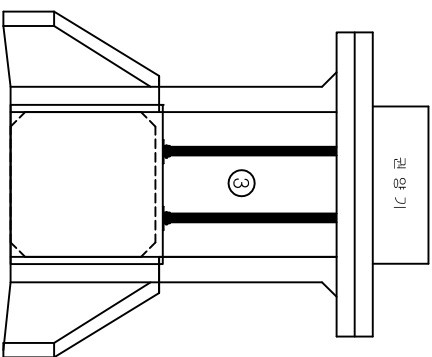
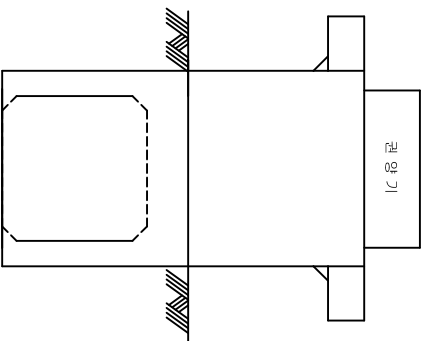
손상 위치

| 손상물량 집계표 | | | | | | | | | |
|---|---|---|---|---|---|---|---|---|---|
| 1 | 헨드브레이크파손 | - | - | - | 1.0 | 1.0 | | | |
| 2 | 표면부식 | 2.0 | 3.0 | - | 1.0 | 6.0 | m <sup>2</sup> | b | |
| 3 | 표면부식 | 0.5 | 2.0 | - | 2.0 | 2.0 | m <sup>2</sup> | c | |

※배면과 손상부를 제외한 부재 표면보수 할 것. 평면도
