## **6. 현황조사 및 외관조사 사진첩**

## 01. 남전천교

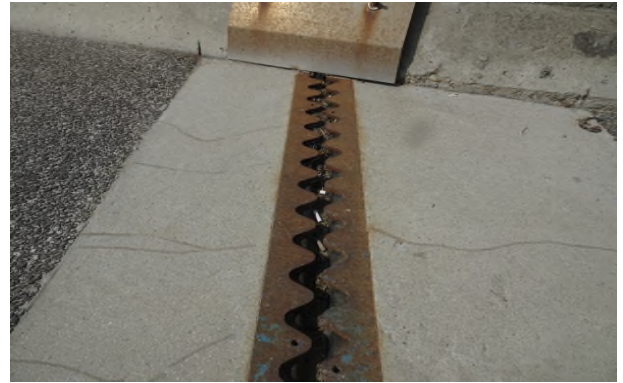
④ 부식 0.2m x 0.5m

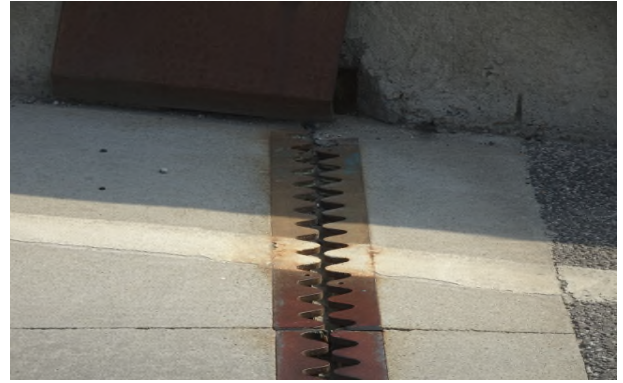
③ 부식 0.1m x 0.5m

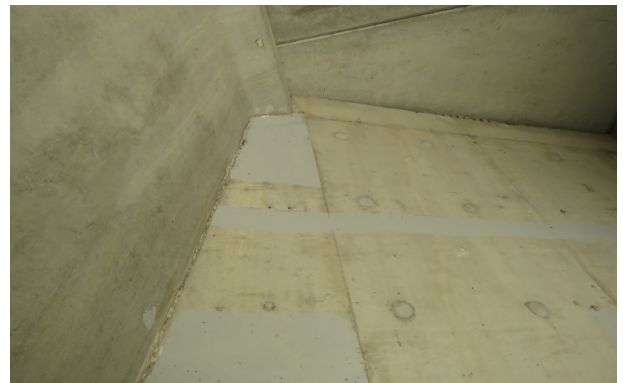
③ 가로보 균열 (0.3mm미만) cw=0.1mm / 2.0 m (보수완료)

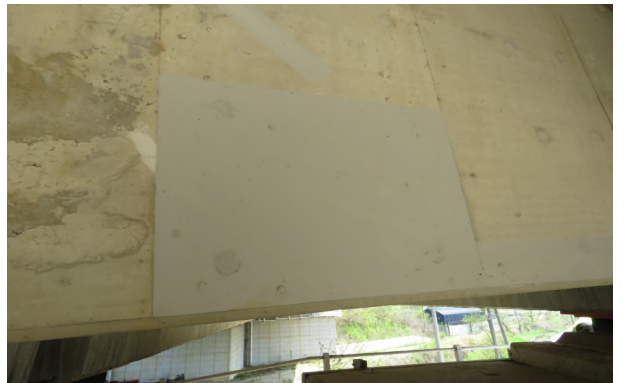
⑤ 가로보 재료분리 1.0m x 0.5m (보수완료)

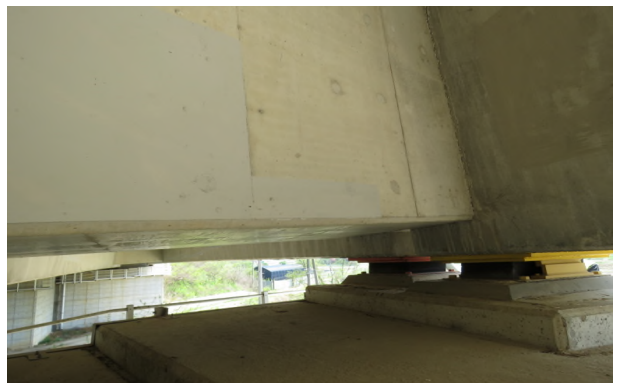
⑦ 가로보 망상균열 (0.3mm미만) cw=0.2mm / 1.0m x 1.0m (보수완료)

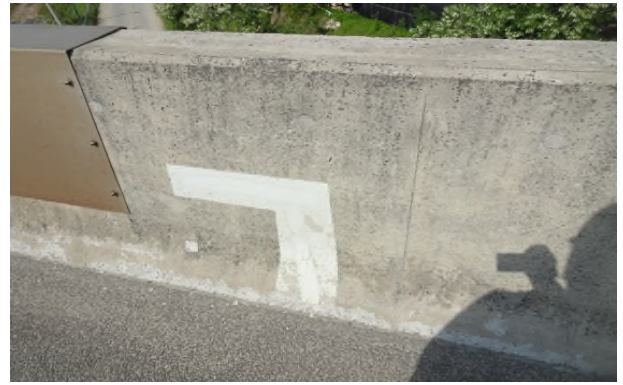
① 망상균열 (0.3mm미만) cw=0.2mm / 1.2m x 0.4m  
(보수완료)

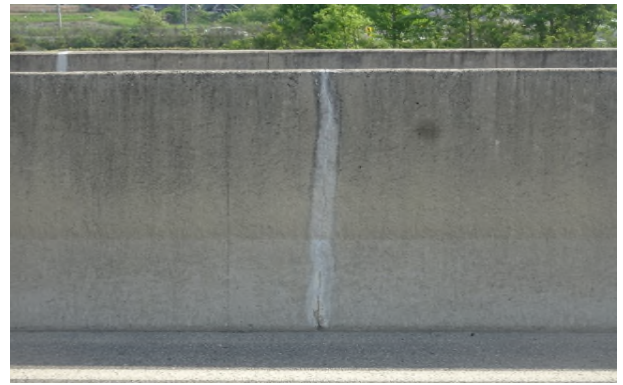
③ 균열 (0.3mm미만) cw=0.1mm / 0.5m (2EA)  
(보수완료)

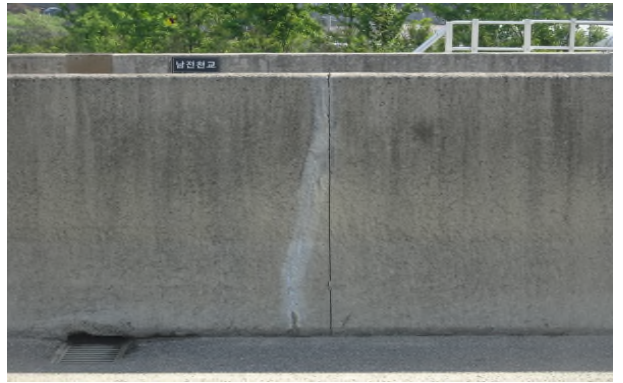
⑤ 균열 (0.3mm미만) cw=0.1mm / 0.8m(보수완료)

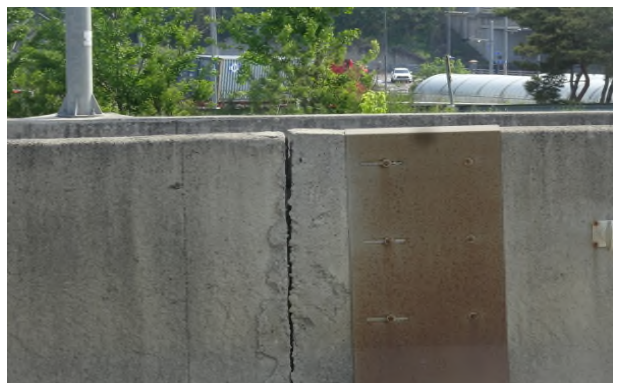
⑦ 균열(0.3mm미만) cw=0.2mm / 0.8m(보수완료)

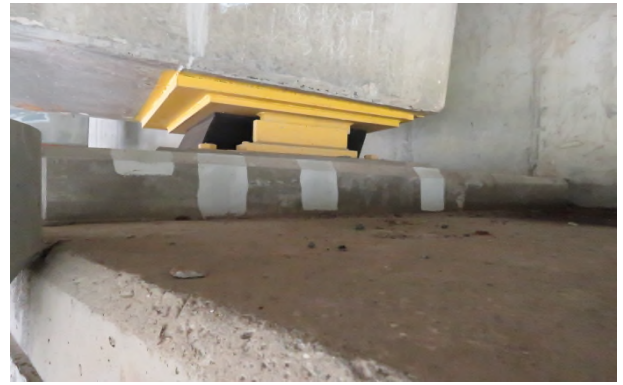
⑩ 받침콘크리트 균열 (0.3mm미만)  $cw=0.2mm$  / 0.3m (2EA) (보수완료)

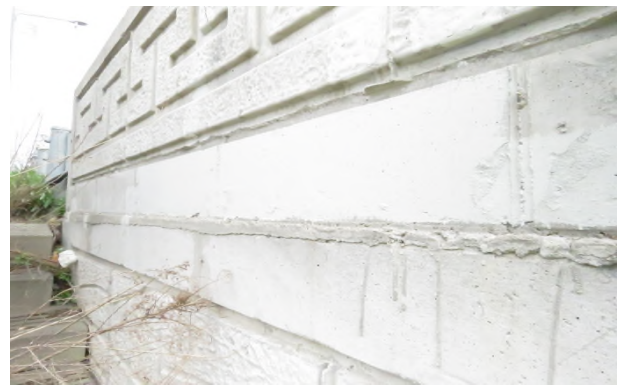
⑭ 파손 0.1m x 0.1m (보수완료)

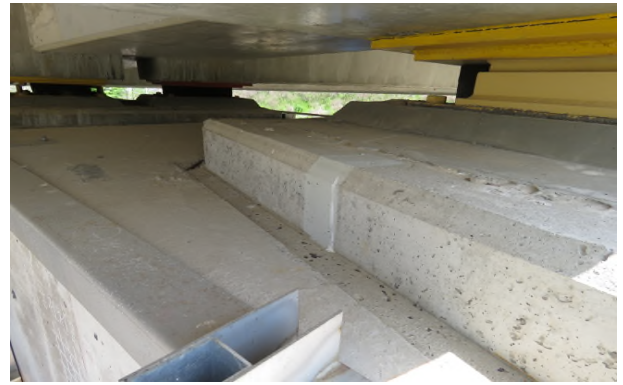
③ 받침콘크리트 균열  $cw=0.3\text{mm}$  /  $0.3\text{m}$  (보수완료)

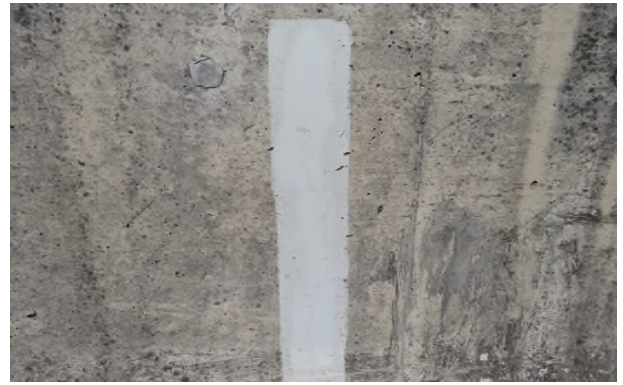
⑨ 균열 (0.3mm미만) cw=0.1mm / 0.5m (보수완료)

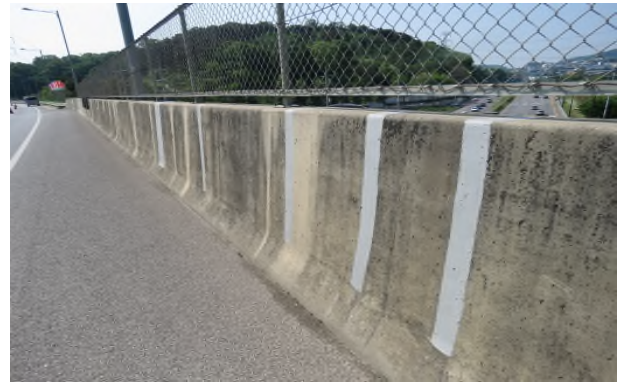
⑰ 균열 (0.3mm미만)  $cw=0.2mm$  / 1.3m (보수완료)

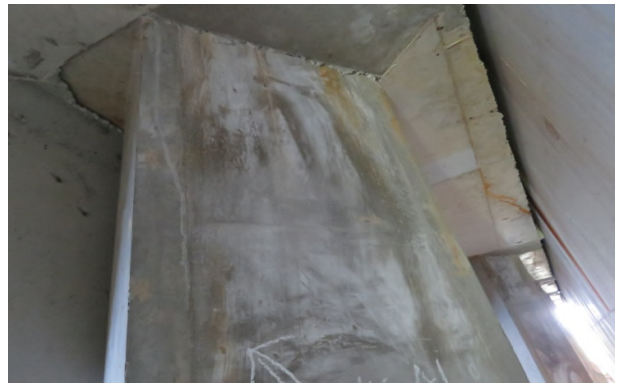
⑥ 균열 0.8m x 0.1m (2EA) (보수완료)

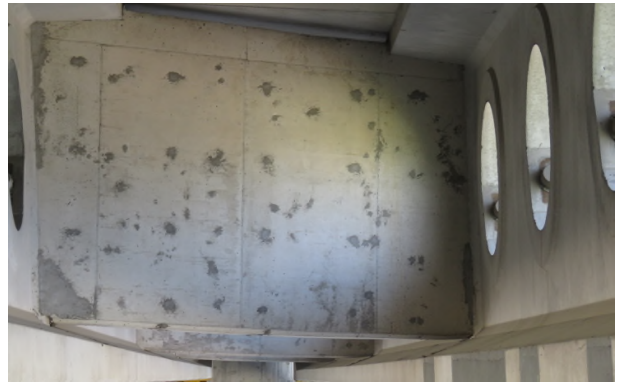
① 균열 (0.3mm미만)  $cw=0.1mm / 0.1m$  (3EA)

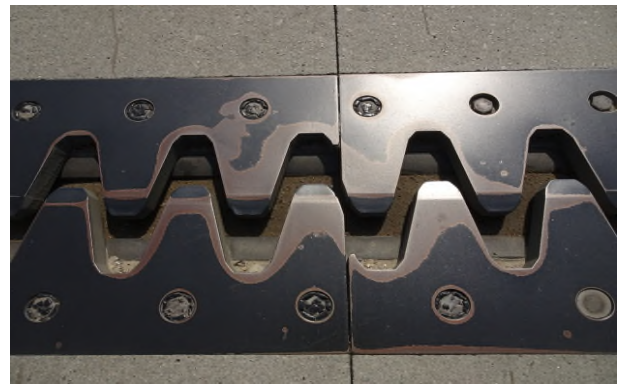
④ 신축이음 토사퇴적 2.0m

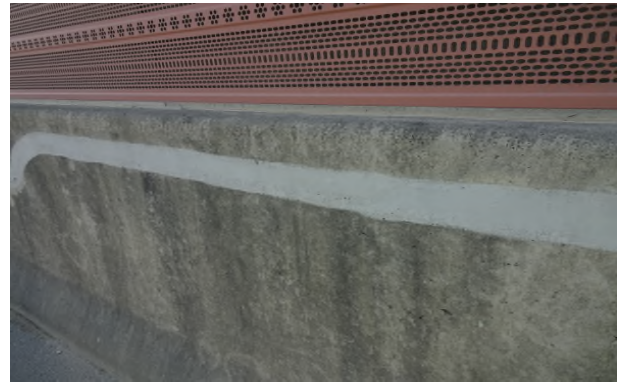
⑱ 균열 (0.3mm미만)  $cw=0.1mm$  / 0.3m (보수완료)

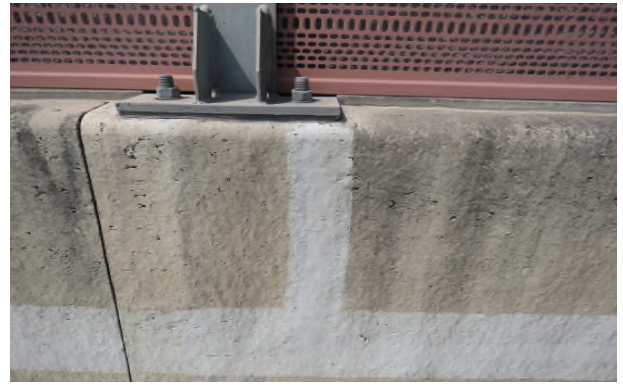
① 균열 (0.3mm미만)  $cw=0.2mm$  / 2.0m (4EA)  
(보수완료)

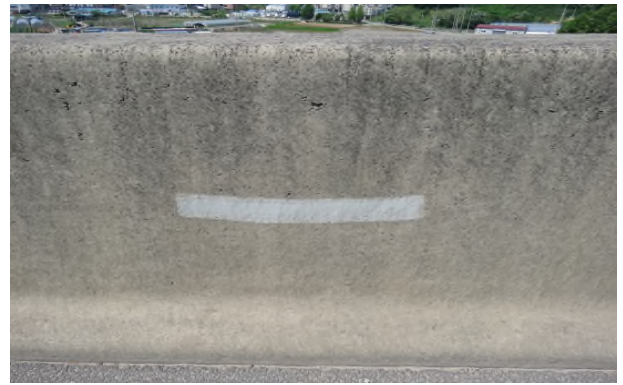
③ 균열 (0.3mm미만)  $cw=0.2mm$  / 22.0m (보수완료)

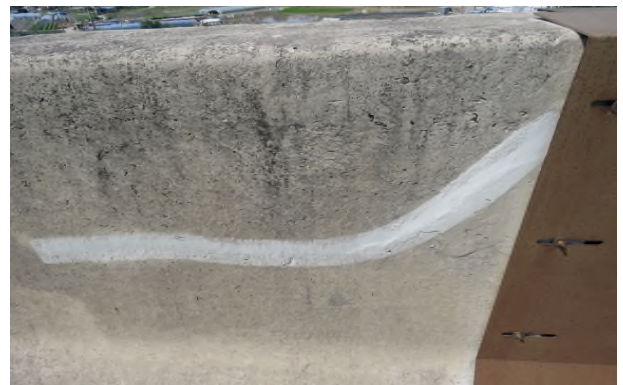
⑤ 균열 (0.3mm미만)  $cw=0.1mm$  / 0.5m (5EA)  
(보수완료)

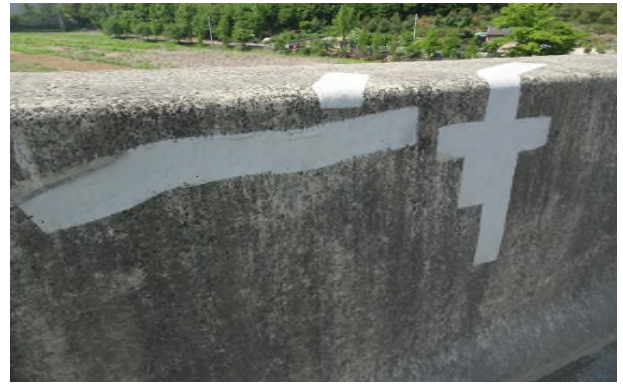
⑨ 균열 (0.3mm미만)  $cw=0.1mm$  / 0.4m (보수완료)

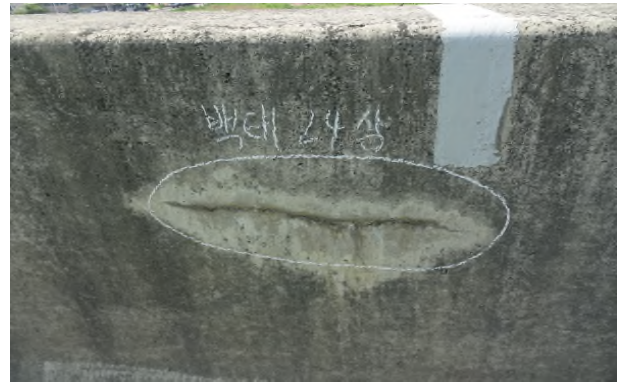
⑱ 균열부 백태 (0.3mm미만) cw=0.1mm /0.7m (2EA)

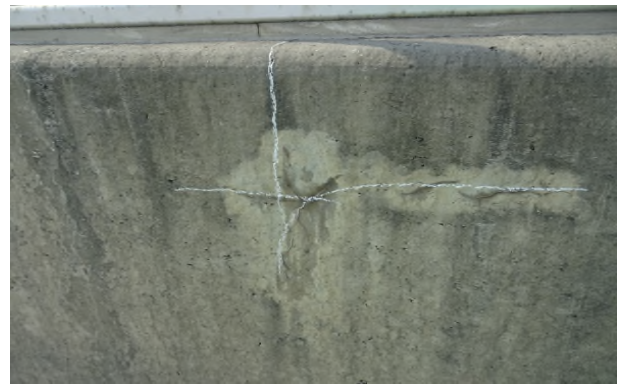
㉔ 균열 (0.3mm미만) cw=0.2mm / 0.6m

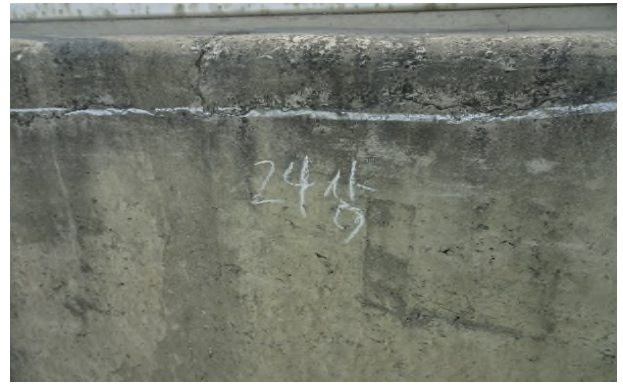
⑰ 접속부 방호벽 이격단차 (1EA) (5.1cm)

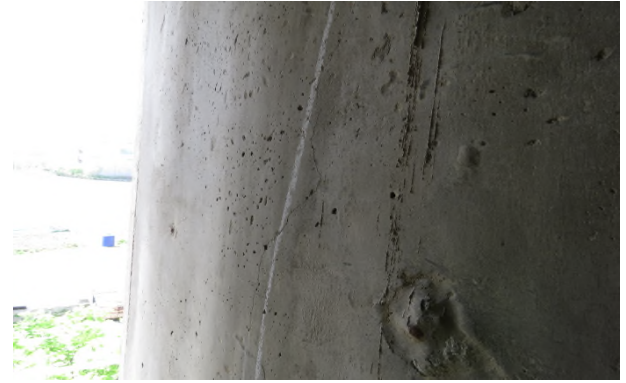
㉔ 거더 단부 균열 (0.3mm미만) cw=0.2mm / 1.2m

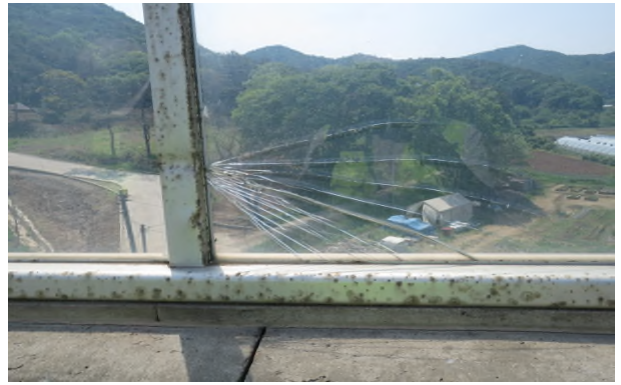
⑦ 균열 0.2mm / 1.4m

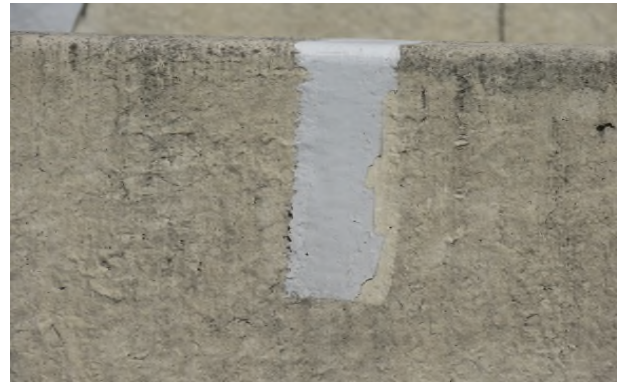
② 균열 0.2mm / 0.3m (보수완료)

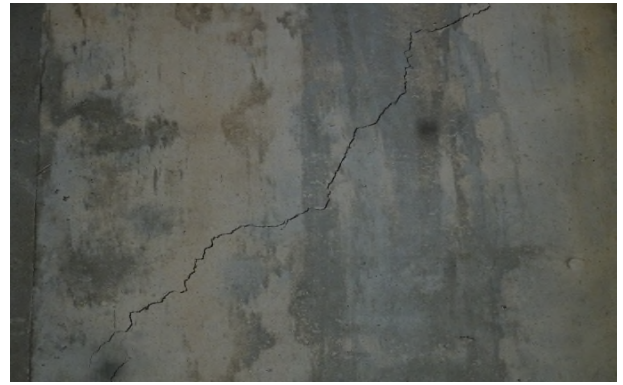
⑨ 균열 0.1mm / 0.5m

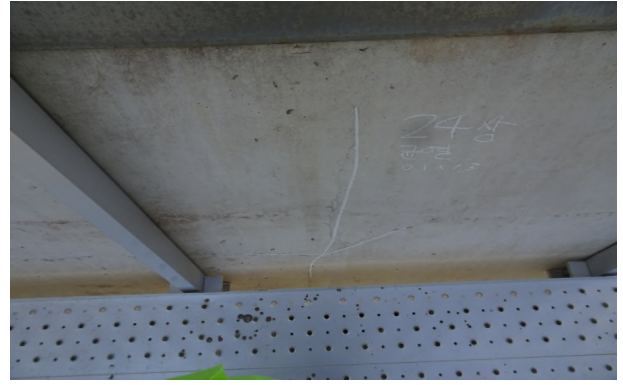
㉔ 균열 0.1mm / 0.7m

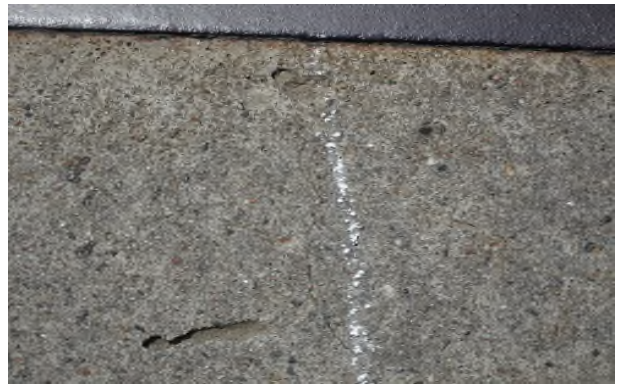
⑦ 후타재균열 0.1mm / 0.4m (3EA)

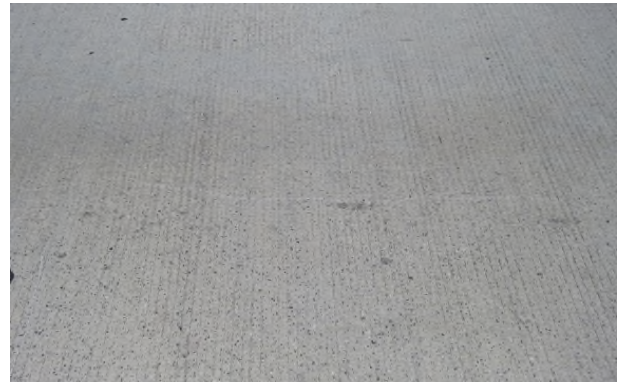
③ 배수구 이물질퇴적 (1EA)

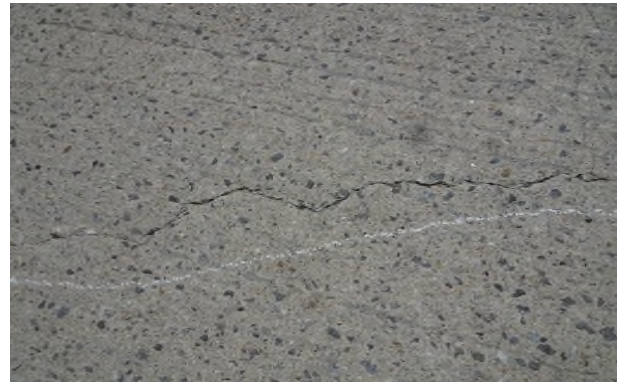
⑥ 균열 0.2mm / 2.5m

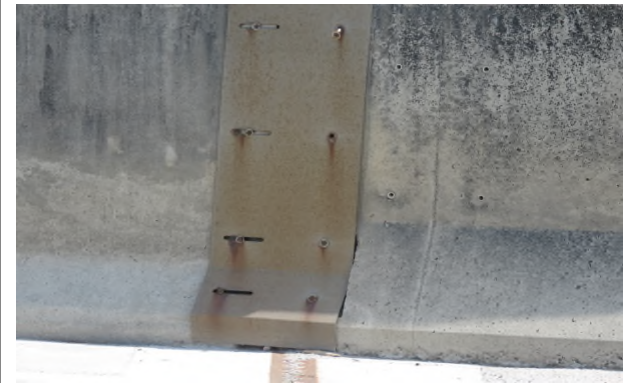
| ㉕ 균열 0.2mm / 1.0m (3EA) | ㉖ 차수판 볼트탈락 (3EA) |

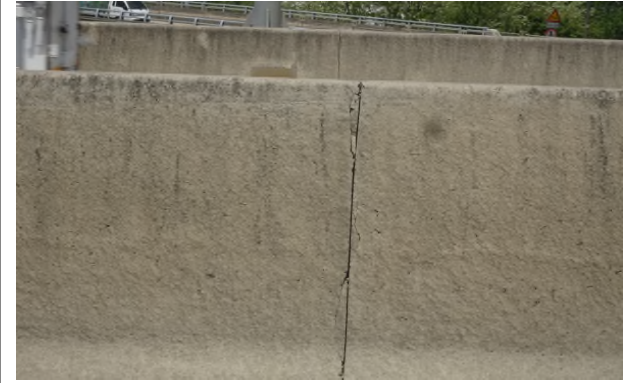
| <p>㉕ 균열 0.2mm / 1.5m</p> | <p>㉖ 균열 0.3mm / 1.5m</p> |

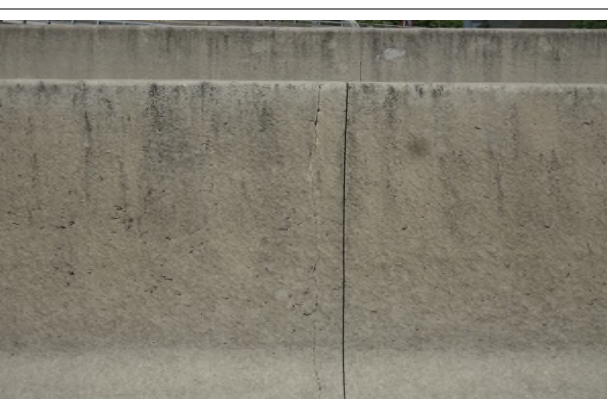
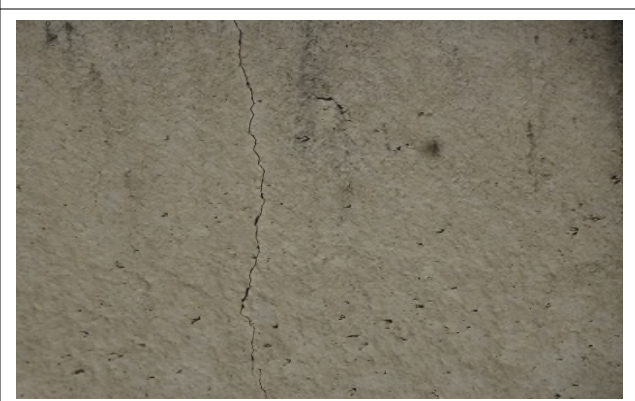
| <p>㉗ 균열 0.3mm / 1.5m</p> | <p>㉘ 균열 0.3mm / 1.5m (4EA)</p> |

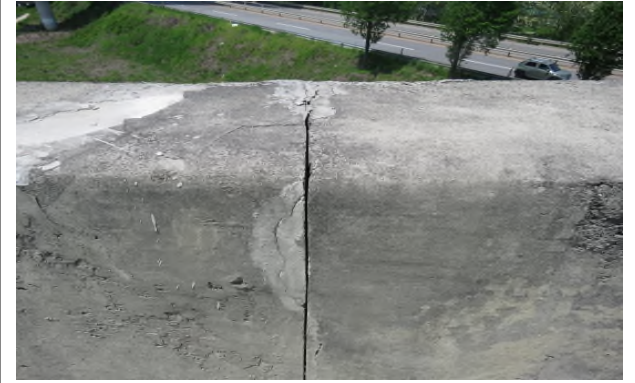
| ① 파손 0.1m x 0.3m (3EA) | ② 파손 0.1m x 0.1m |

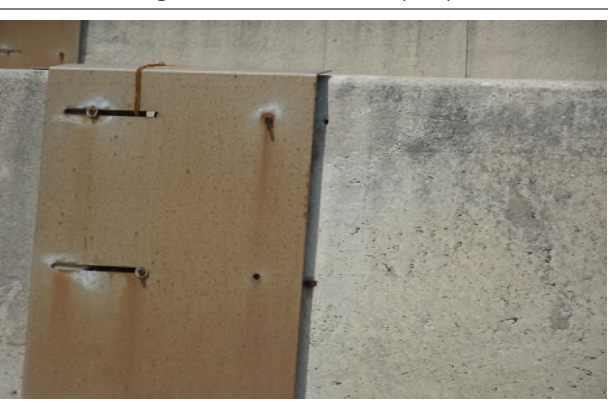
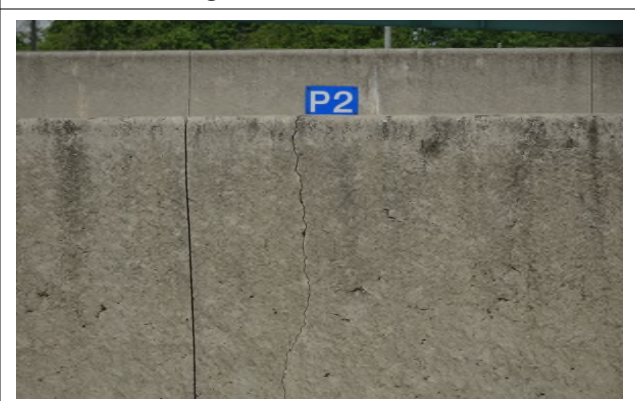
| ③ 차수판 볼트 고정불량 (1EA) | ㉟ 균열 0.3mm / 1.2m (2EA) |

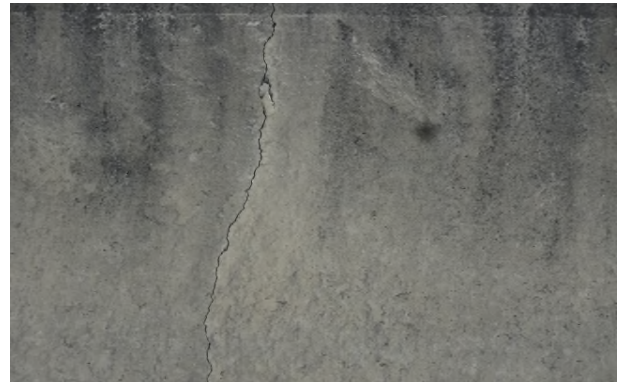
② 균열 0.3mm / 0.1m

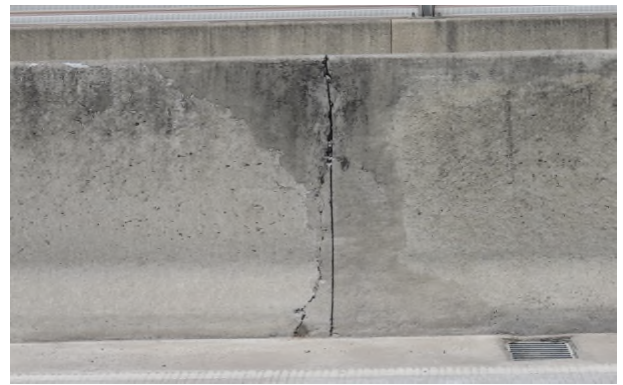
⑤ 균열 0.2mm / 1.5m

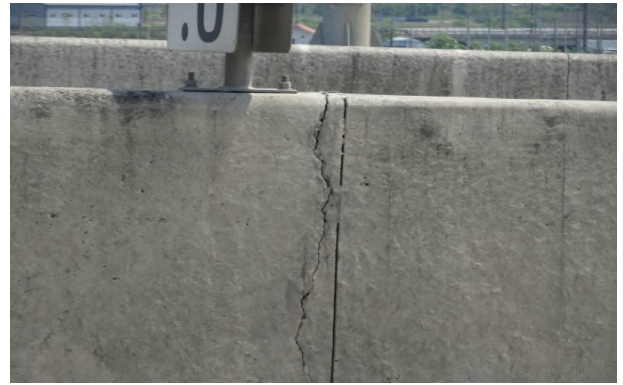
⑦ 균열 0.3mm / 0.5m

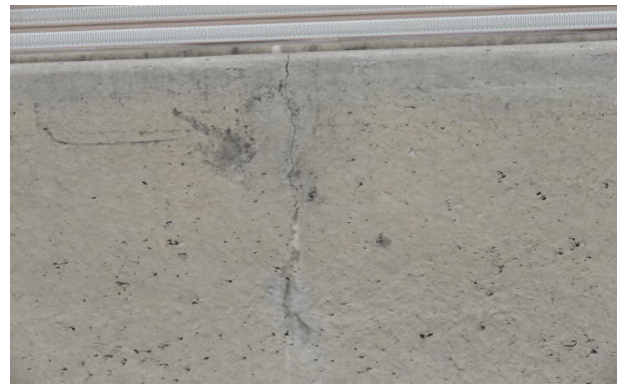
⑳ 균열 0.3mm / 1.5m

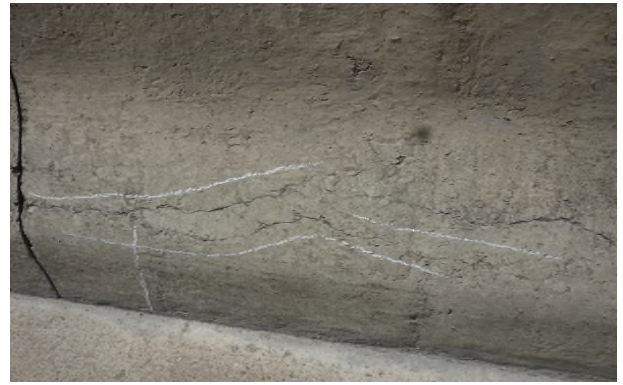
㉒ 균열 0.2mm / 1.0m

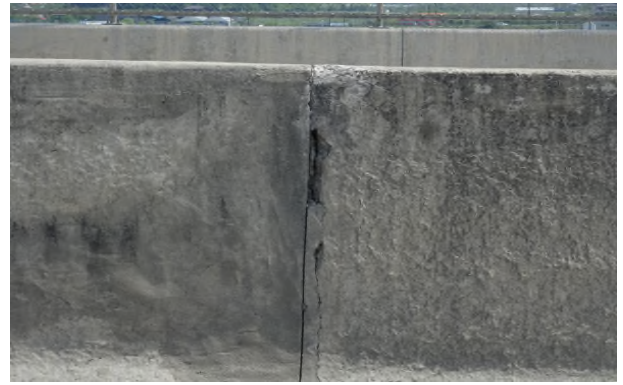
① 균열 0.2mm / 1.0m

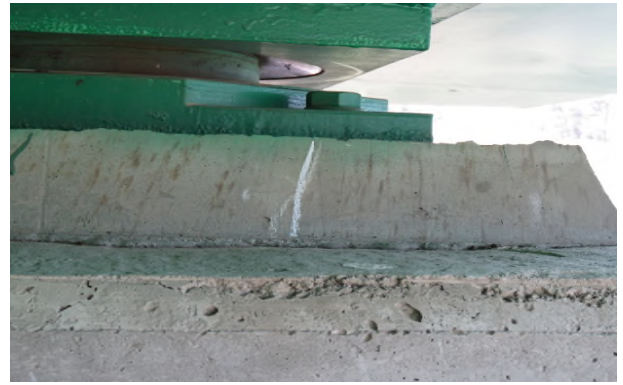
⑬ 받침콘크리트 재료분리 0.1m x 0.1m

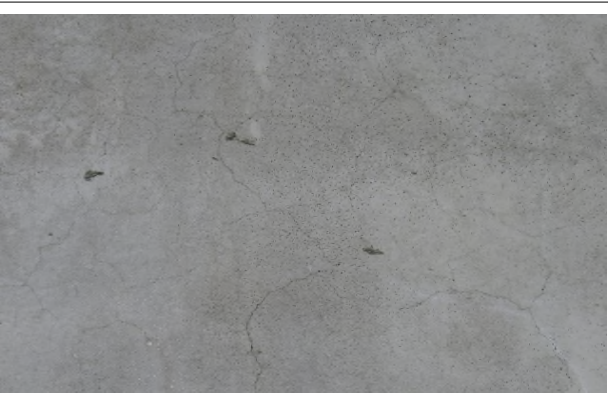
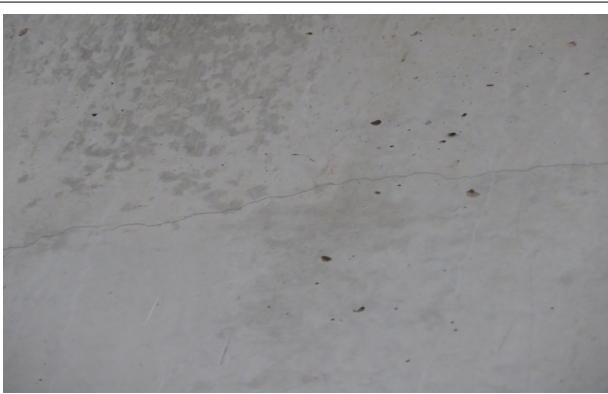
| ㉓ 망상균열 0.1mm / 1.5m x 1.0m | ㉔ 균열 0.2mm / 22.0m |

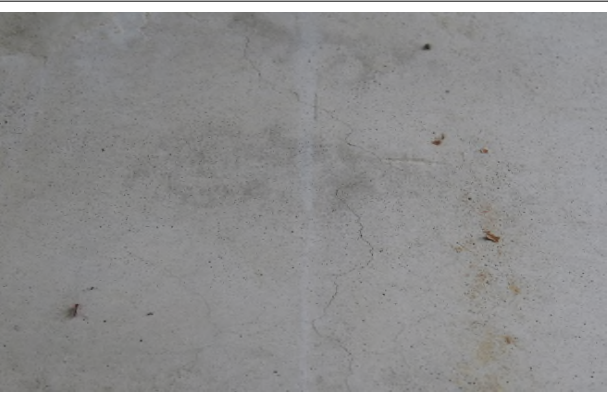
| ㉕ 균열 0.2mm / 1.0m (4EA) | |

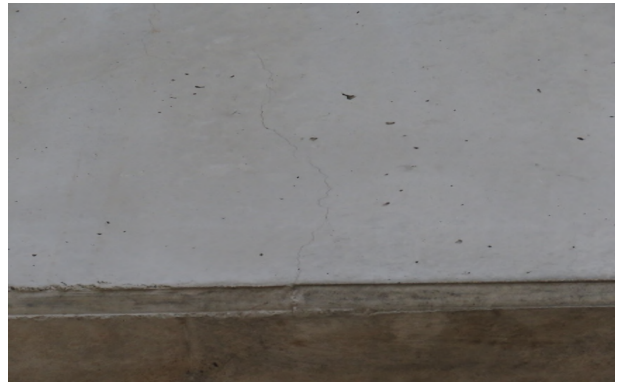
㉓ 균열 0.1mm / 1.0m

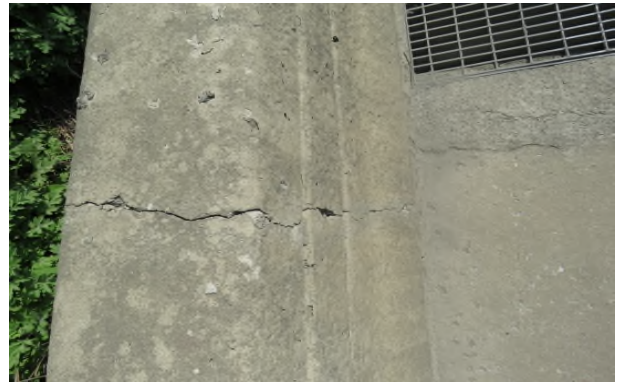
③ L형측구 균열 cw=0.5mm / 1.5m

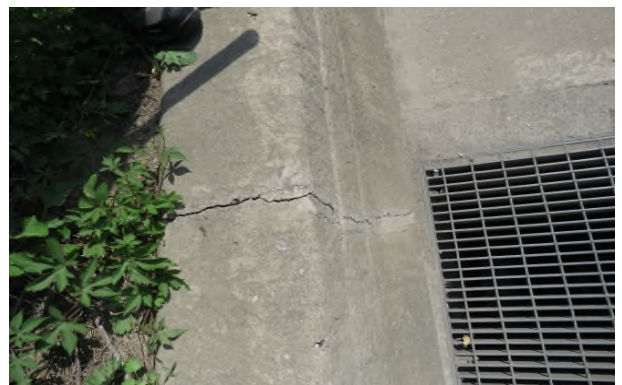
⑤ L형측구 균열 cw=0.5mm / 1.5m

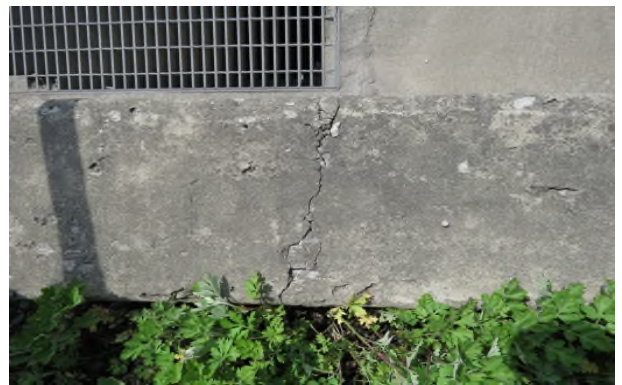
⑨ L형측구 균열 cw=0.5mm / 1.5m

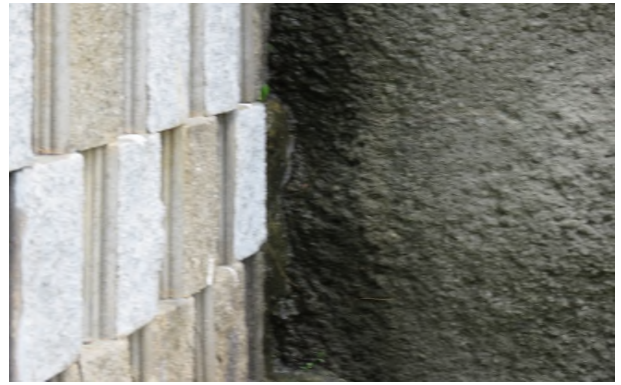
⑪ 침하균열  $cw=4.0\text{mm}$  /  $4.0\text{m}$
