신파주-송포인출 외관조사망도

| CW 0.2 균열 | 망상균열 | 재료분리 | 편칭, 공명 | 동 역 영<br>2023년 경기북부 송전전력구,<br>맨홀 철밀안전점검 구역 |
| 박리, 박락<br>파손 | 시공이음분리,<br>층분리, 이격 | 누수,<br>습윤부 | 백태 | 용 역 사<br>케이아이엠(주) |

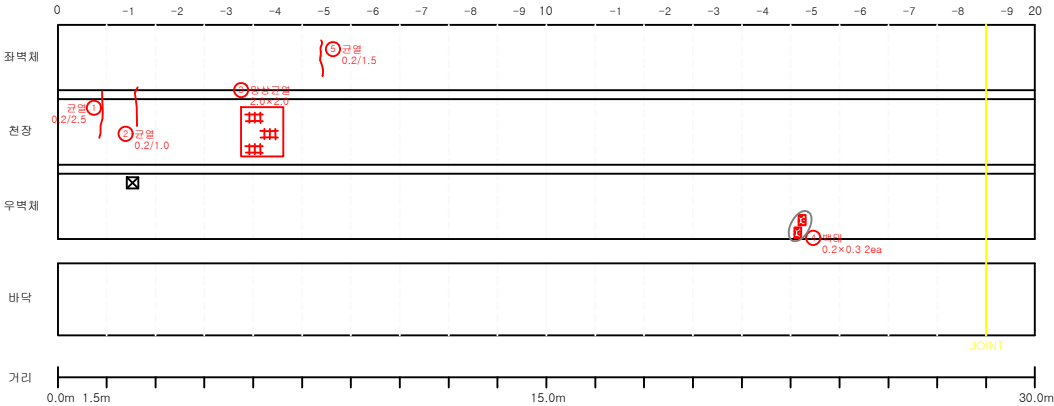
| 번호 | 손상내용 | 손상현황 | | | 단위 | 손상<br>물량 | 비 고 |
|---|---|---|---|---|---|---|---|
| 1 | 균열 | 0.2 | 2.5 | 1 | m | 2.50 | |
| 2 | 균열 | 0.2 | 1.0 | 1 | m | 1.00 | |
| 3 | 망상균열 | 2.0 | 2.0 | 1 | m <sup>2</sup> | 4.00 | |
| 4 | 백태 | 0.2 | 0.3 | 2 | m <sup>2</sup> | 0.12 | |
| 5 | 균열 | 0.2 | 1.5 | 1 | m | 1.50 | |

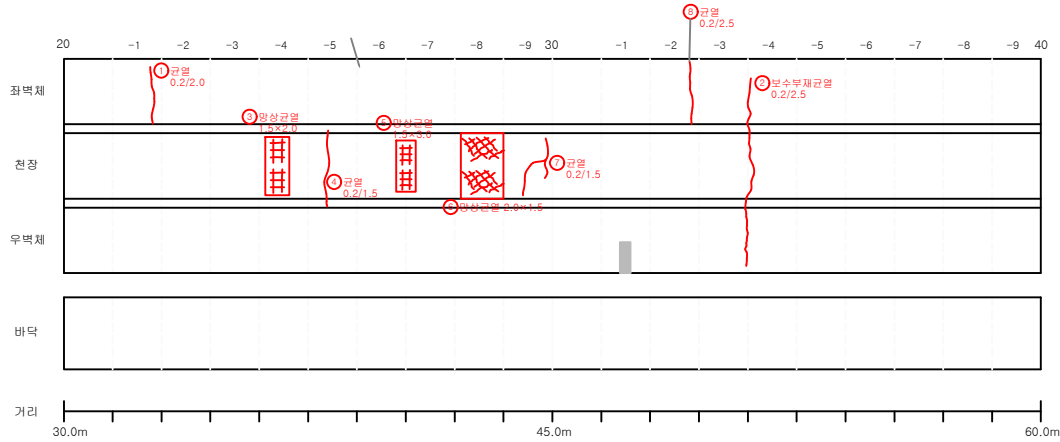
# 신파주-송포인출 외관조사망도

| 번호 | 손상내용 | 손상현황 | | | 단위 | 손상<br>수량 | 비 고 |
|---|---|---|---|---|---|---|---|
| 1 | 균열 | 0.2 | 2.0 | 1 | m | 2.00 | |
| 2 | 보수부재균열 | 0.2 | 2.5 | 1 | m | 2.50 | |
| 3 | 망상균열 | 1.5 | 2.0 | 1 | m | 3.00 | |
| 4 | 균열 | 0.2 | 1.5 | 1 | m | 1.50 | |
| 5 | 망상균열 | 1.5 | 3.0 | 1 | m | 4.50 | |
| 6 | 망상균열 | 2.0 | 1.5 | 1 | m | 3.00 | |
| 7 | 균열 | 0.2 | 1.5 | 1 | m | 1.50 | |
| 8 | 균열 | 0.2 | 2.5 | 1 | m | 2.50 | |

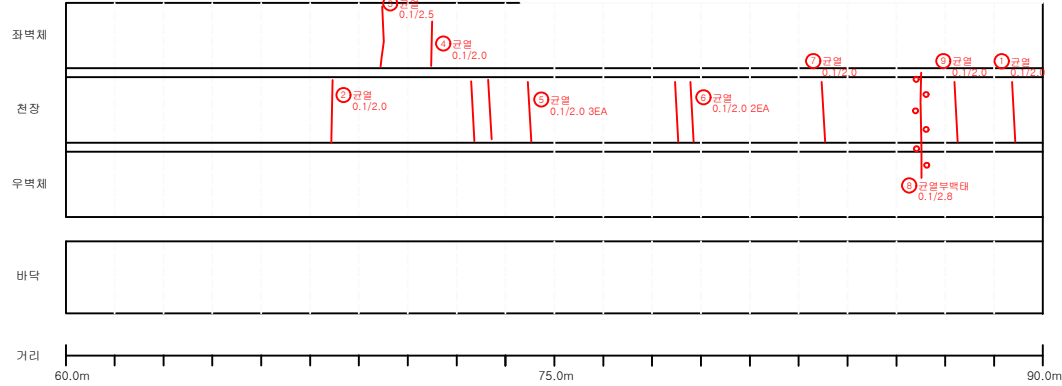
## 신파주-송포인출 외관조사망도

| 번호 | 손상내용 | 손상현황 | | | 단위 | 손상<br>수량 | 비 고 |
|---|---|---|---|---|---|---|---|
| 1 | 균열 | 0.1 | 2.0 | 1 | m | 2.00 | |
| 2 | 균열 | 0.1 | 2.0 | 1 | m | 2.00 | |
| 3 | 균열 | 0.1 | 2.5 | 1 | m | 2.50 | |
| 4 | 균열 | 0.1 | 2.0 | 1 | m | 2.00 | |
| 5 | 균열 | 0.1 | 2.0 | 3 | m | 6.00 | |
| 6 | 균열 | 0.1 | 2.0 | 2 | m | 4.00 | |
| 7 | 균열 | 0.1 | 2.0 | 1 | m | 2.00 | |
| 8 | 균열부백태 | 0.1 | 2.8 | 1 | m | 2.80 | |
| 9 | 균열 | 0.1 | 2.0 | 1 | m | 2.00 | |

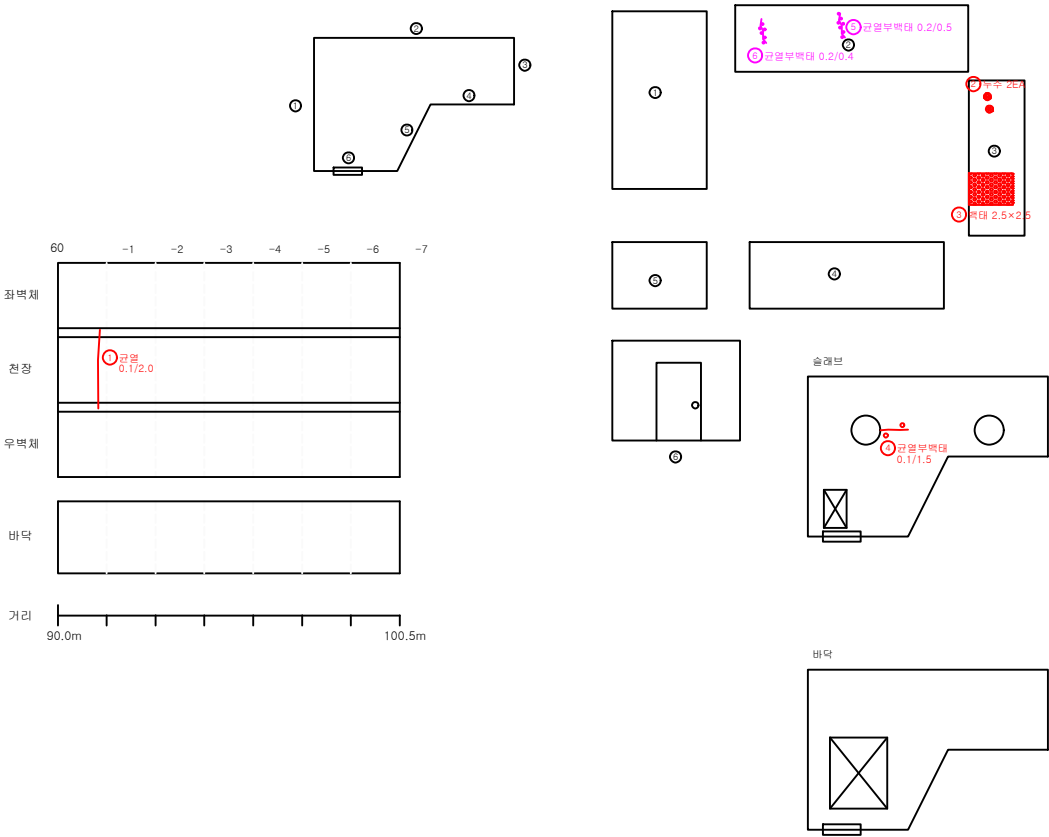
| 번호 | 손상내용 | 손상현황 | | | 단위 | 손상<br>물량 | 비 고 |
|---|---|---|---|---|---|---|---|
| 1 | 균열 | 0.1 | 2.0 | 1 | m | 2.00 | |
| 2 | 누수 | | | 2 | EA | 2.00 | |
| 3 | 백태 | 2.5 | 2.5 | 1 | ㎡ | 6.25 | |
| 4 | 균열부백태 | 0.1 | 1.5 | 1 | m | 1.50 | |
| 5 | 균열부백태 | 0.2 | 0.5 | 1 | m | 0.50 | |
| 6 | 균열부백태 | 0.2 | 0.4 | 1 | m | 0.40 | |
