용소천교(울산) 교면포장 S1

용역명 2023년 부산울산고속도로 정밀안전점검 및 성능평가용역

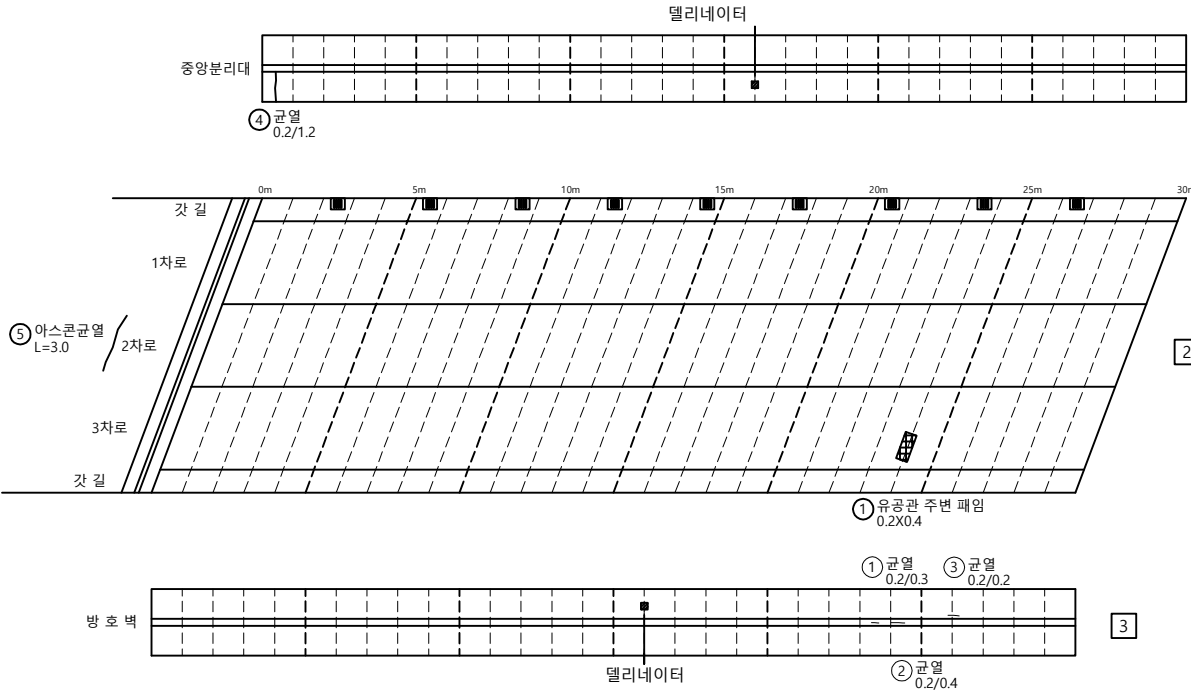
S1

| 번호 | 신/구 | 부재명 | 손 상 현 황 | 손 상 규 모 | | | | | 비고 |
|---|---|---|---|---|---|---|---|---|---|
| 1 | 구 | 방호벽 | 균열 | 0.2 | 0.3 | | 1 | m | 0.30 |
| 2 | 구 | 방호벽 | 균열 | 0.2 | 0.4 | | 1 | m | 0.40 |
| 3 | 구 | 방호벽 | 균열 | 0.2 | 0.2 | | 1 | m | 0.20 |
| 4 | 구 | 방호벽 | 균열 | 0.2 | 1.2 | | 1 | m | 1.20 |
| 5 | 구 | 교면포장 | 모장균열 | 0.5 | 3.0 | | 1 | m | 3.00 |
| 6 | 신 | 교면포장 | 유공관 주변 패임 | | 0.2 | 0.4 | 1 | m | 0.08 |

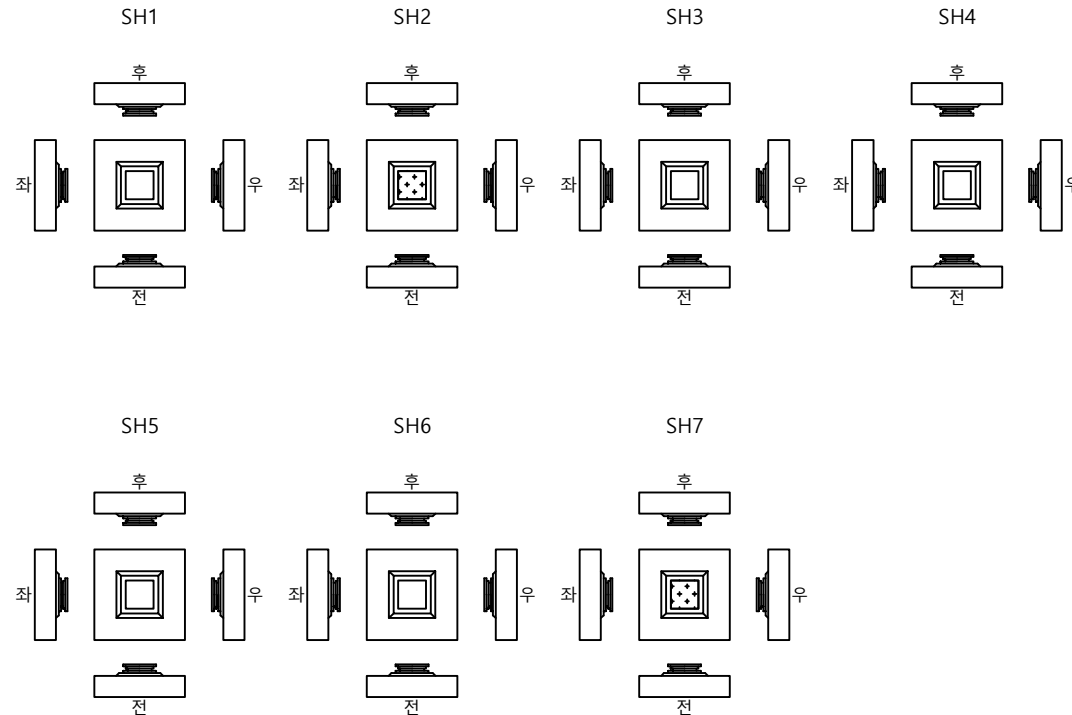
용소천교(울산) 받침장치 A1

① 받침부식  
2EA

| 번호 | 신/구 | 부재명 | 손 상 현 상 | 손 상 규 모 | | | | | | 비고 |
|---|---|---|---|---|---|---|---|---|---|---|
| 1 | 구 | 교량받침 | 플레이트 부식 | | | | 2 | EA | 2.00 | |

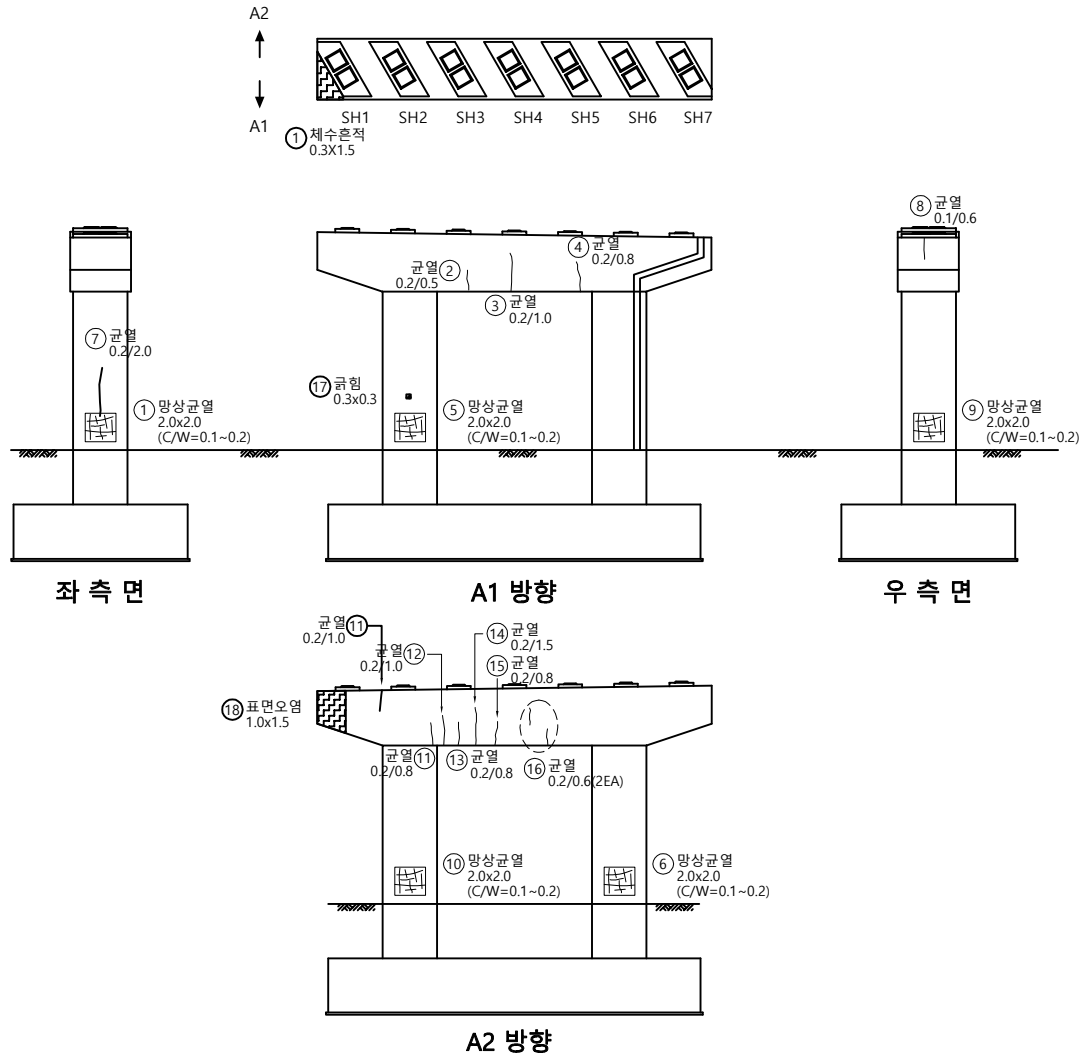
# 용소천교(울산) 교각 P1

| 교각 | | | | | | | | | |
|---|---|---|---|---|---|---|---|---|---|
| 1 | 구 | 교각 | 망상균열 | 0.1 | 2.0 | 2.0 | 1 | m <sup>2</sup> | 4.00 |
| 2 | 구 | 교각 | 균열 | 0.2 | 0.5 | | 1 | m | 0.50 |
| 3 | 구 | 교각 | 균열 | 0.2 | 1.0 | | 1 | m | 1.00 |
| 5 | 구 | 교각 | 망상균열 | | 2.0 | 2.0 | 1 | m <sup>2</sup> | 4.00 |

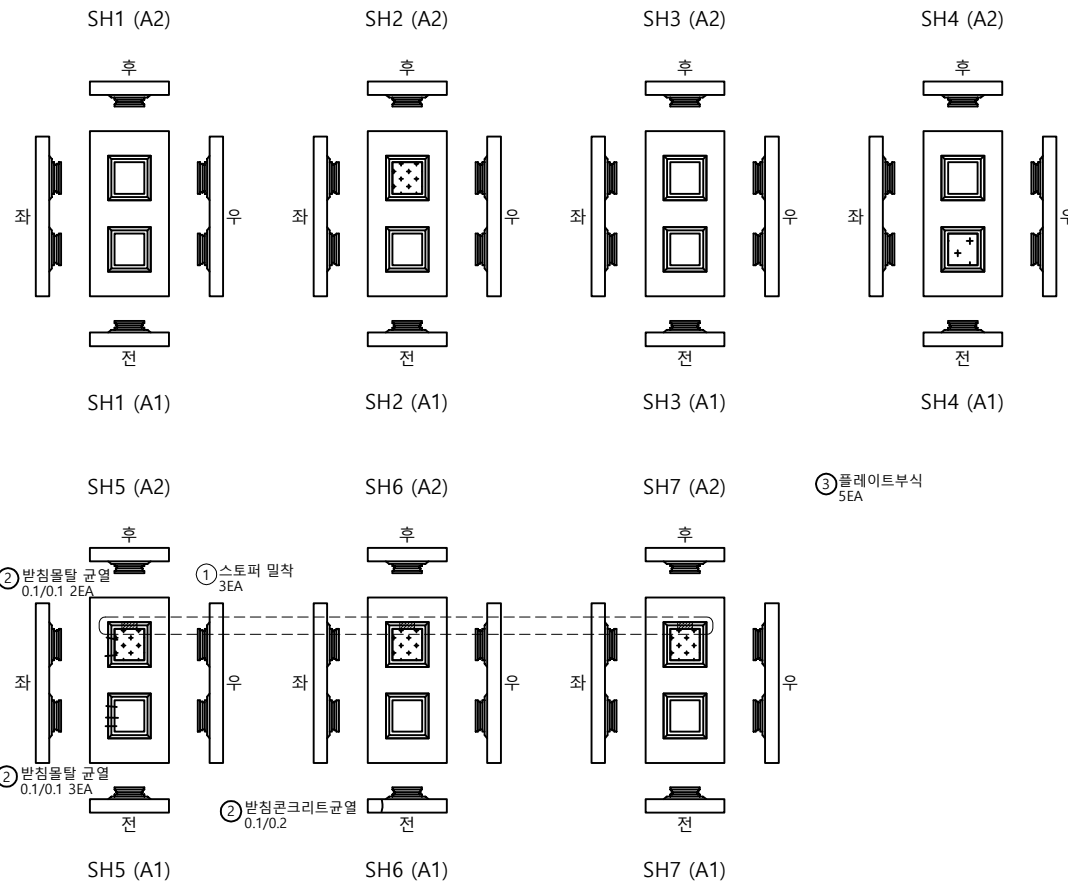
용소천교(울산) 받침장치 P1

| 받침장치 | | | | | | | | | |
|---|---|---|---|---|---|---|---|---|---|
| 2 | 구 | 교량받침 | 받침콘크리트 균열 | 0.1 | 0.2 | | 1 | m | 0.20 |
| 3 | 신 | 교량받침 | 플레이트 부식 | | | | 5 | EA | 5.00 |
| 4 | 신 | 교량받침 | 받침물탈 균열 | 0.1 | 0.1 | | 2 | m | 0.20 |
| 5 | 신 | 교량받침 | 받침물탈 균열 | 0.1 | 0.1 | | 3 | m | 0.30 |

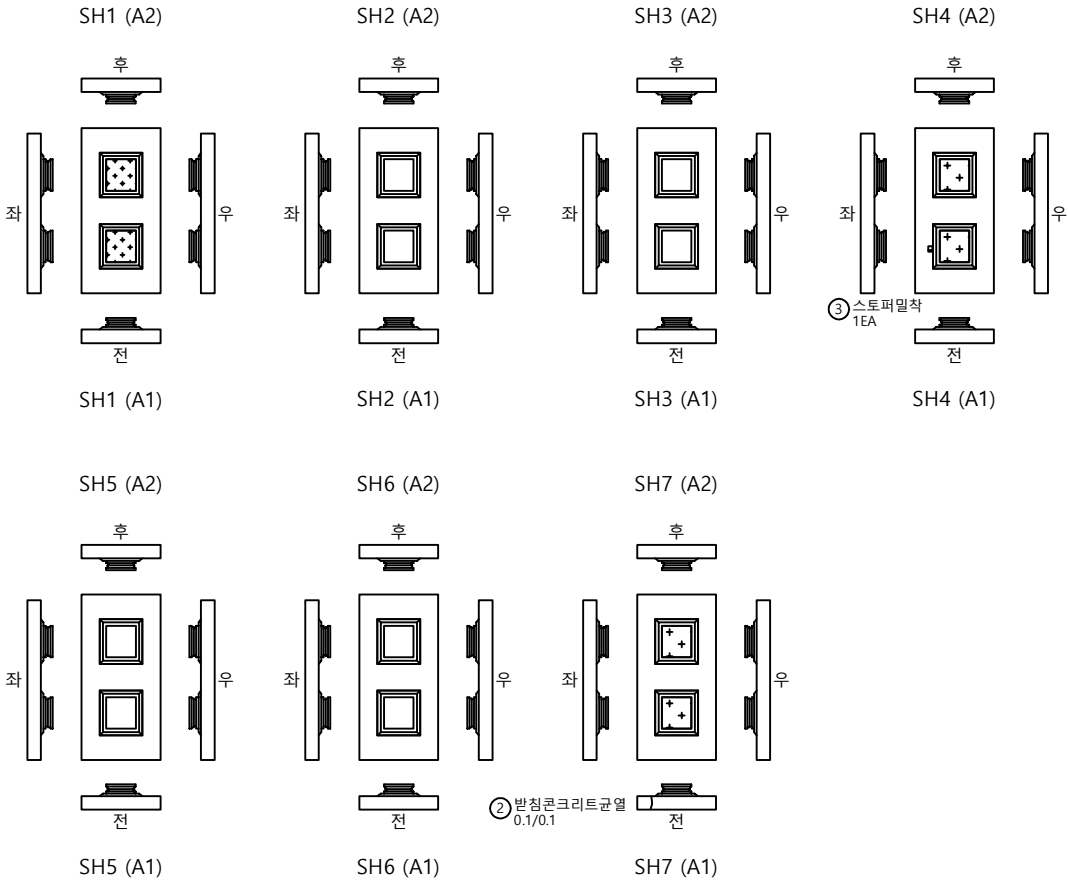
| 번호 | 선/구 | 부재명 | 손 상 현 황 | 손 상 규 모 | | | | | 비고 |
|---|---|---|---|---|---|---|---|---|---|
| 1 | 신 | 교량받침 | 플레이트 부식 | | | | 6 | EA | 6.00 |
| 2 | 구 | 교량받침 | 받침콘크리트 균열 | 0.1 | 0.1 | | 1 | m | 0.10 |

① 플레이트 부식  
6EA

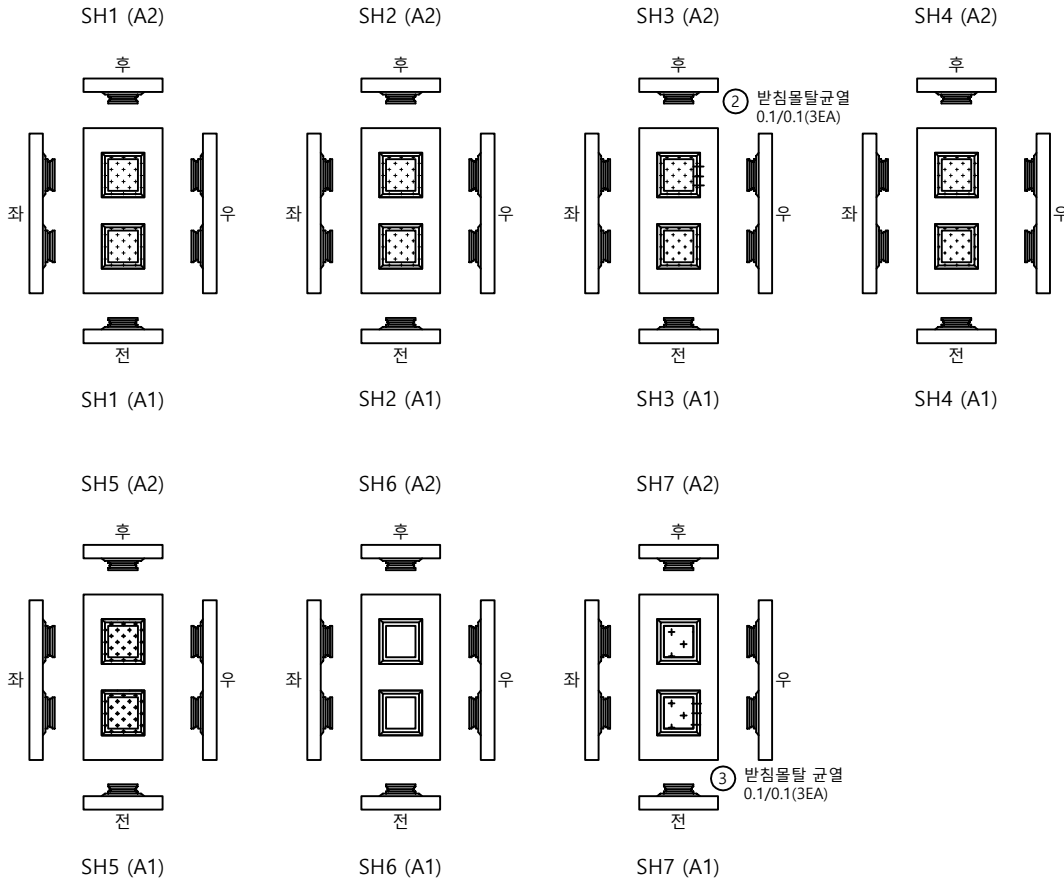
용소천교(울산) 받침장치 P5

① 플레이트 부식  
12EA

| 번호 | 신/구 | 부재명 | 손 상 현 황 | 손 상 규 모 | | | | | | 비고 |
|---|---|---|---|---|---|---|---|---|---|---|
| 1 | 신 | 교량받침 | 플레이트 부식 | | | | 12 | EA | 12.00 | |
| 2 | 구 | 교량받침 | 받침물탈 균열 | 0.1 | 0.1 | | 3 | m | 0.30 | |
| 3 | 신 | 교량받침 | 받침물탈 균열 | 0.1 | 0.1 | | 3 | m | 0.30 | |

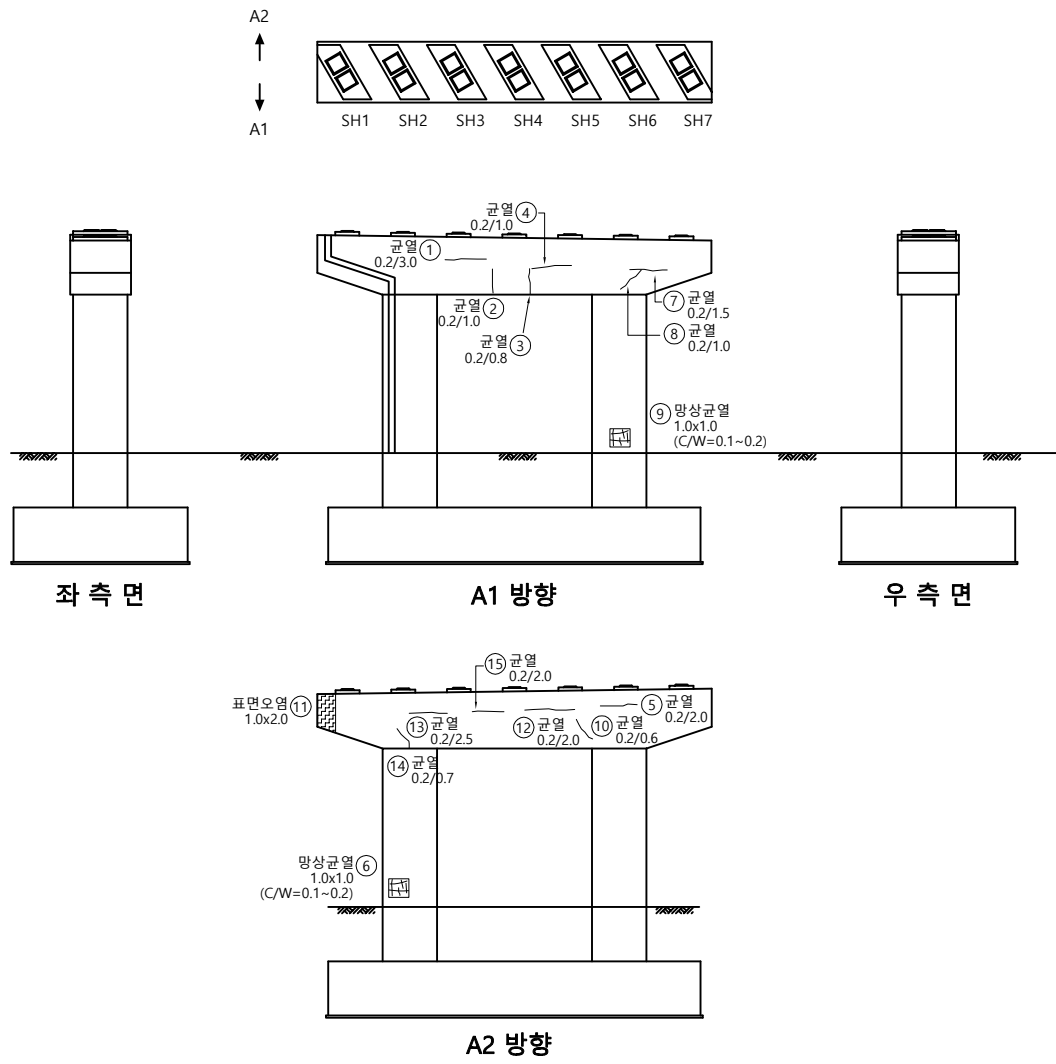
용소천교(울산) 교각 P7

| 교각 | | | | | | | | | | |
|---|---|---|---|---|---|---|---|---|---|---|
| 1 | 구 | 교각 | 균열 | 0.2 | 3.0 | | 1 | m | 3.00 | |
| 2 | 구 | 교각 | 균열 | 0.2 | 1.0 | | 1 | m | 1.00 | |
| 6 | 구 | 교각 | 망상균열 | 0.2 | 1.0 | 1.0 | 1 | m <sup>2</sup> | 1.00 | |
| 9 | 구 | 교각 | 망상균열 | 0.2 | 1.0 | 1.0 | 1 | m <sup>2</sup> | 1.00 | |

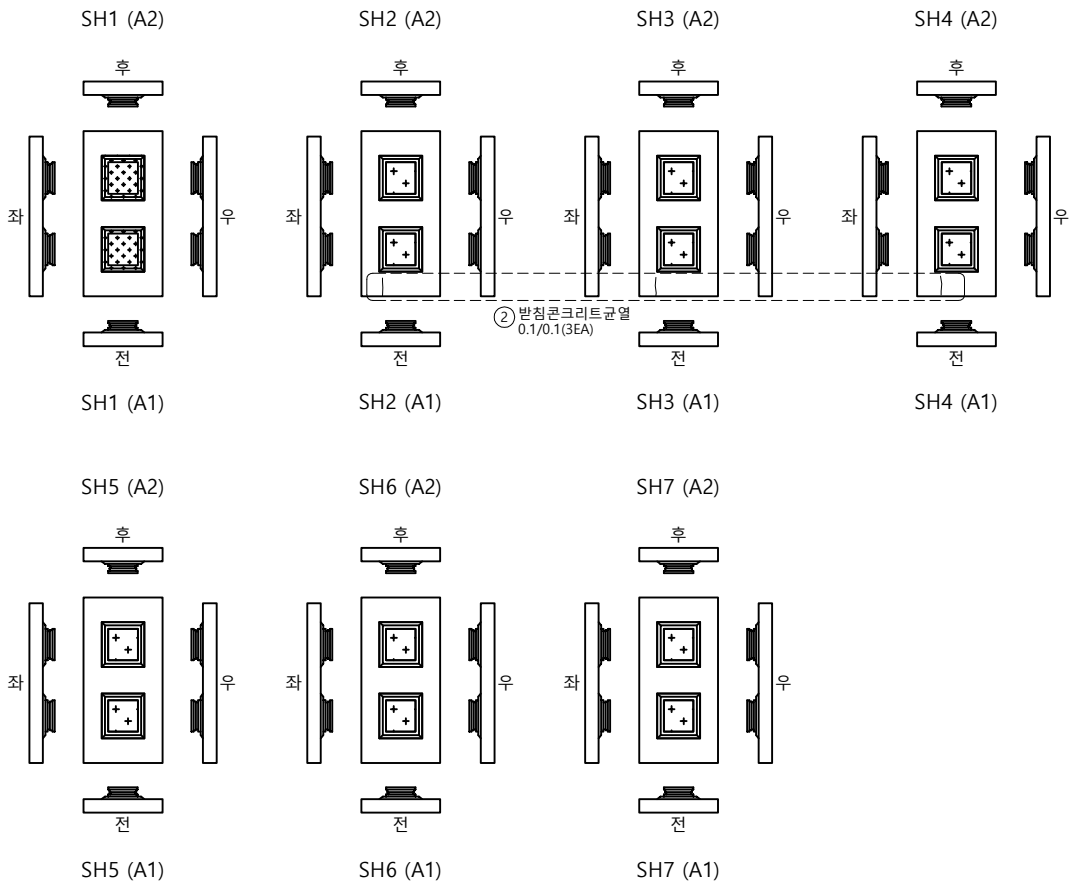
받침장치

① 받침부식  
14EA
