상주영천고속도로 2024~2025년 시설물 안전점검 용역  
(2025년 상반기 정기안전점검)

# 외 관 조 사 망 도

양지교

(주)명성엔지니어링

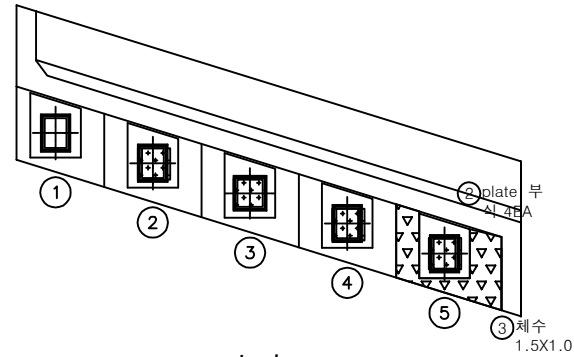
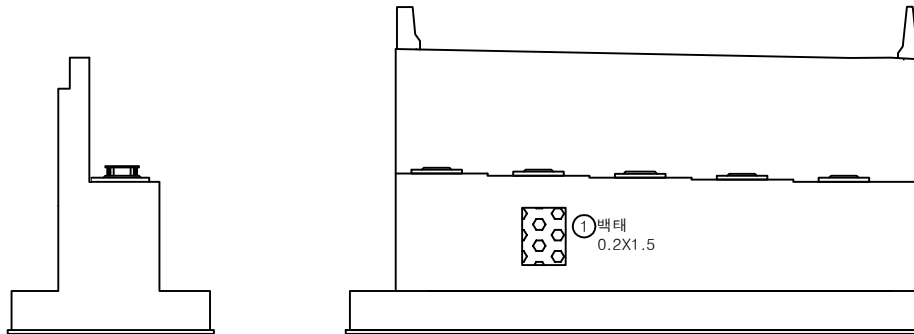
| 번호 | 구분 | 부재 | 손상내용 | 손상현황 | | | | | | 비 고 |
|---|---|---|---|---|---|---|---|---|---|---|
| 1 | 19하 | 교대 | 백태 | | 0.2 | 1.5 | 0.30 | m <sup>2</sup> | 1 | 20'하 보수 |
| 2 | 19하 | 교량방침 | plate 부식 | | | | 4.00 | EA | 4 | |
| 3 | 19하 | 교대 | 채수 | | 1.5 | 1.0 | 1.50 | m <sup>2</sup> | 1 | |

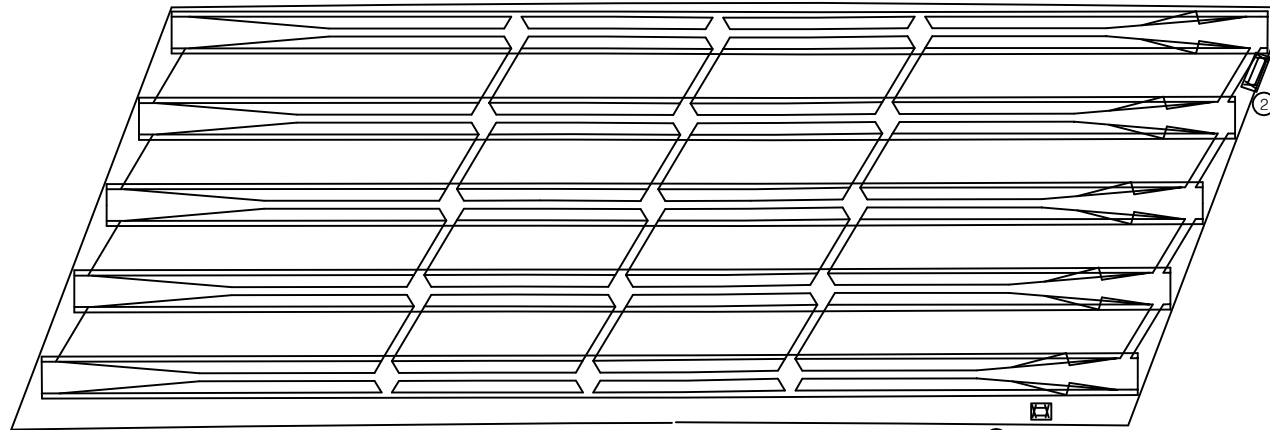
| 번호 | 구분 | 부재 | 손상내용 | 손상현황 | | | | | | 비고 |
|---|---|---|---|---|---|---|---|---|---|---|
| 1 | 19하 | 바닥판 | 철근노출 | | 0.3 | 0.2 | 0.06 | m <sup>2</sup> | 1 | |
| 2 | 24상 | 바닥판 | 철근노출 | | 0.2 | 1.5 | 0.30 | m <sup>2</sup> | 1 | |

① 철근노출  
0.3X0.2② 철근노출  
0.2X1.5

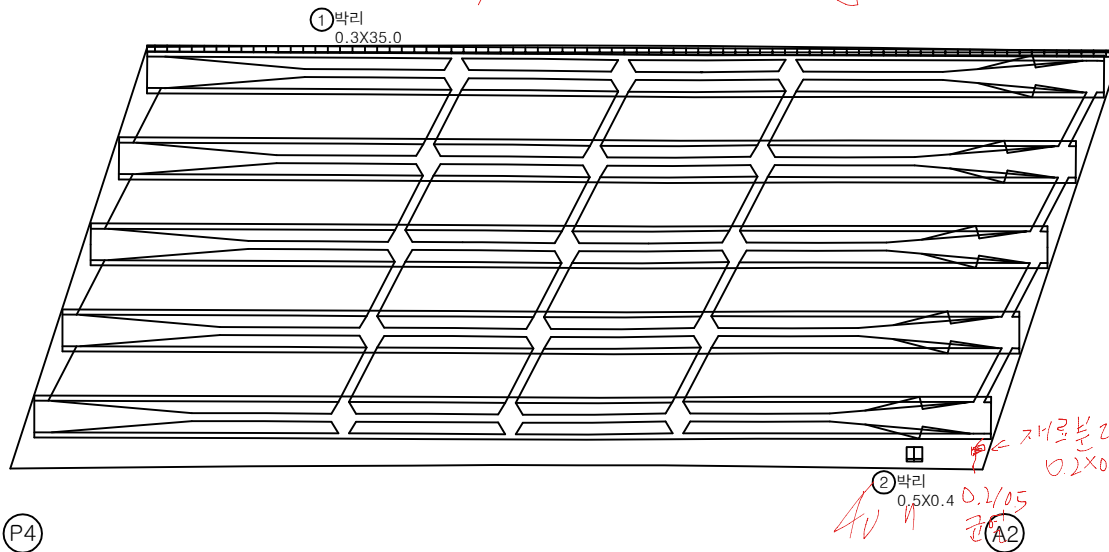
| 번호 | 구분 | 부재 | 손상내용 | 손상현황 | | | | | | 비고 |
|---|---|---|---|---|---|---|---|---|---|---|
| 1 | 23하 | 바닥판 | 박리 | | 0.3 | 35.0 | 10.50 | m <sup>2</sup> | 1 | |
| 2 | 23하 | 바닥판 | 박리 | | 0.5 | 0.4 | 0.20 | m <sup>2</sup> | 1 | |

재료분리  
0.2X0.2  
4v n 0.2/0.5  
A2

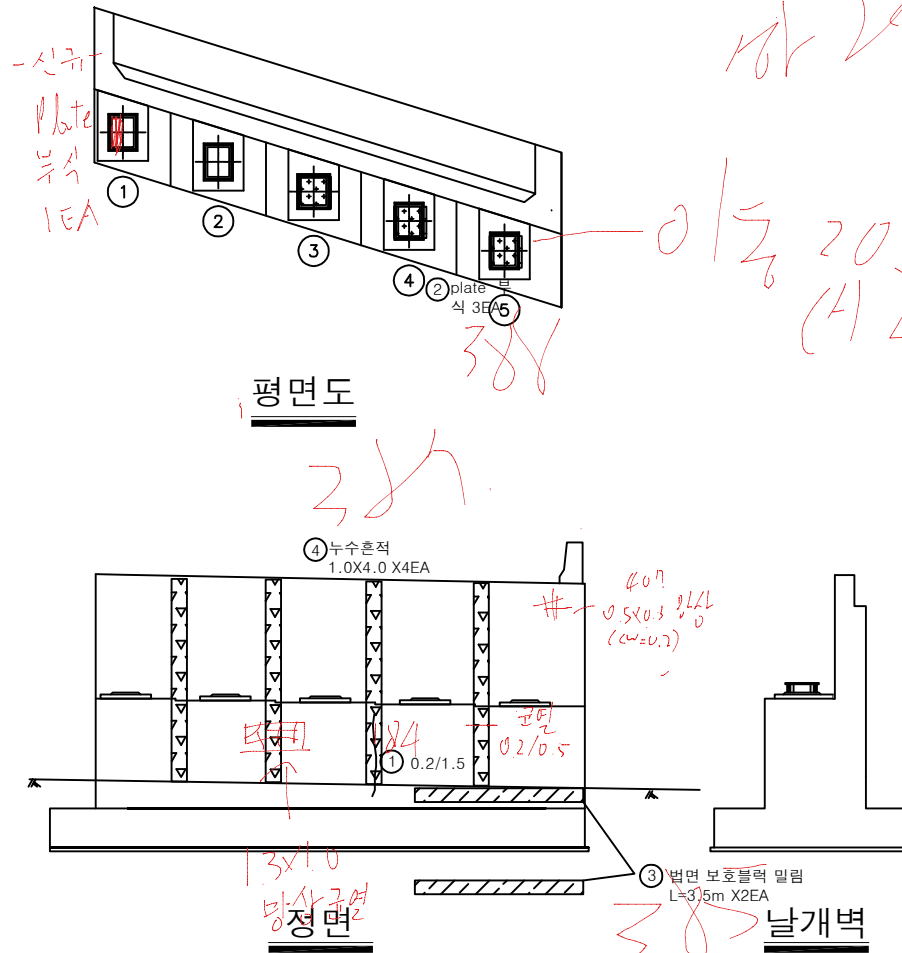
| | | | 05 |

| 번호 | 구분 | 부재 | 손상내용 | 손상현황 | | | | | | 비고 |
|---|---|---|---|---|---|---|---|---|---|---|
| 1 | 21하 | 교대 | 균열(0.3mm미만) | 0.2 | 1.5 | | 1.50 | m | 1 | |
| 2 | 21하 | 교량방청 | plate 부식 | | | | 3.00 | EA | 3 | |
| 3 | 23하 | 교대 | 범면 보호블럭 밀림 | | 3.5 | | 7.00 | m | 2 | |
| 4 | 24상 | 교대 | 누수흔적 | | 1.0 | 4.0 | 16.00 | m² | 4 | |

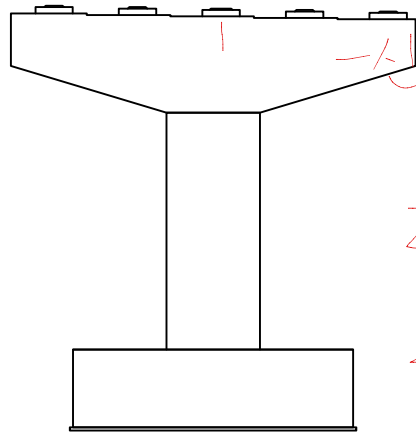
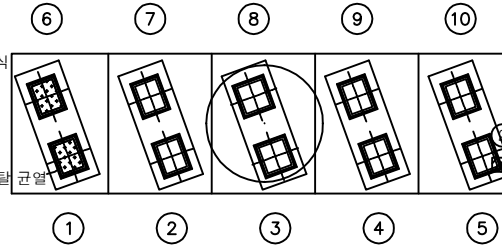
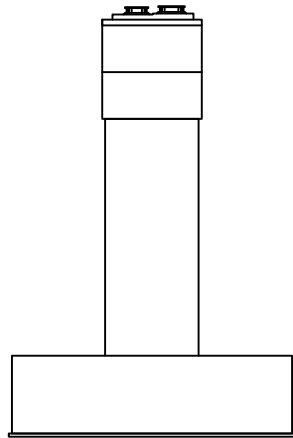
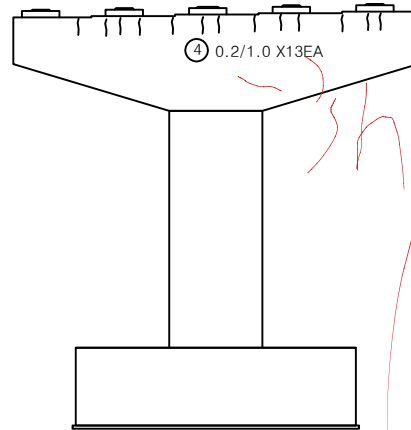
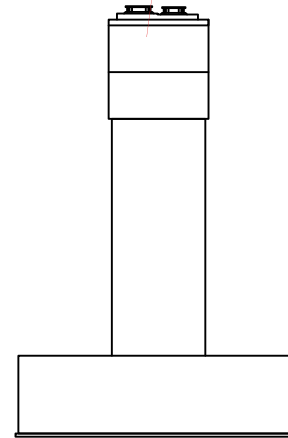
| 번호 | 구분 | 부재 | 손상내용 | 손상현황 | | | | | | 비고 |
|---|---|---|---|---|---|---|---|---|---|---|
| 1 | 19하 | 교량받침 | 무수축물탈 균열 | 0.2 | 0.2 | | 0.20 | m | 1 | 20'하 보수 |
| 2 | 19하 | 교량받침 | 무수축물탈 층분리 | | 0.1 | 0.5 | 0.05 | m' | 1 | 20'하 보수 |
| 3 | 23하 | 교량받침 | plate 부식 | | | | 2.00 | EA | 2 | |
| 4 | 23하 | 교각 | 균열(0.3mm미만) | 0.2 | 1.0 | | 13.00 | m | 13 | |
