## 08 전곡장외배수지

2023년 화성시 상수도시설물 안전점검용역

전곡장외배수지 - 2지 하부슬래브

전곡장외배수지 - 1지 기둥

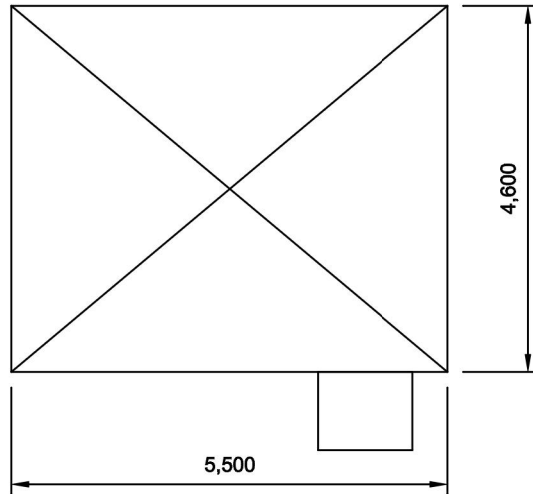
바닥 기초

| 번호 | 손상내용 | 손상물량 | | | | | 비고 |
|---|---|---|---|---|---|---|---|
| 1 | 균열 | 0.2 | 0.2 | 0.20 | m | 1 | 신규 |
