# 화성1송수관로 [2구간]

## 1. 관로 매설환경조사

## 2. 밸브.밸브실 조사

### 3. 관로 부식환경조사

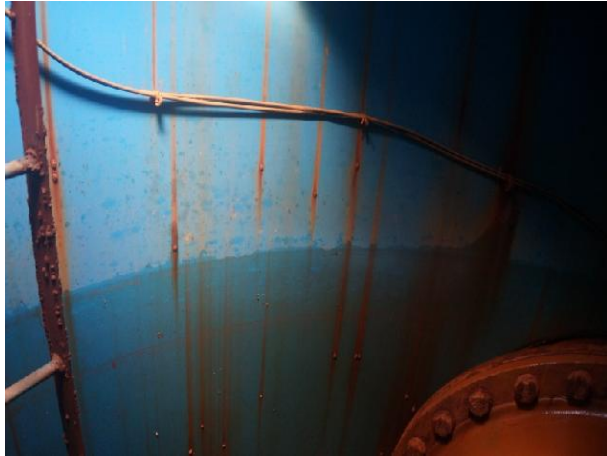
송수계통, 02구간, Sta. No. 1+22.0[A]  
강제구조물 표면부식

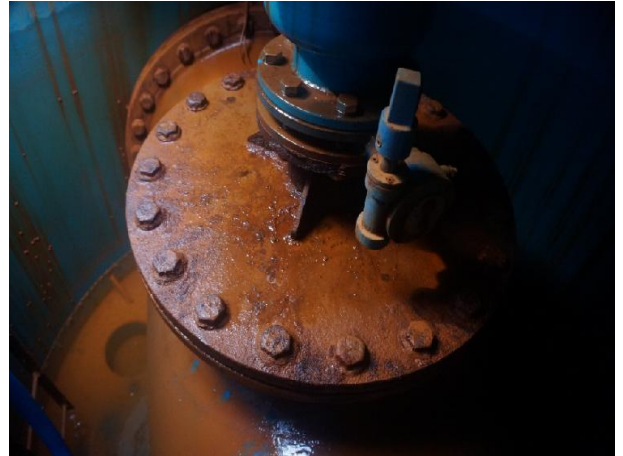
송수계통, 02구간, Sta. No. 1+22.0[A]  
마개F 부식

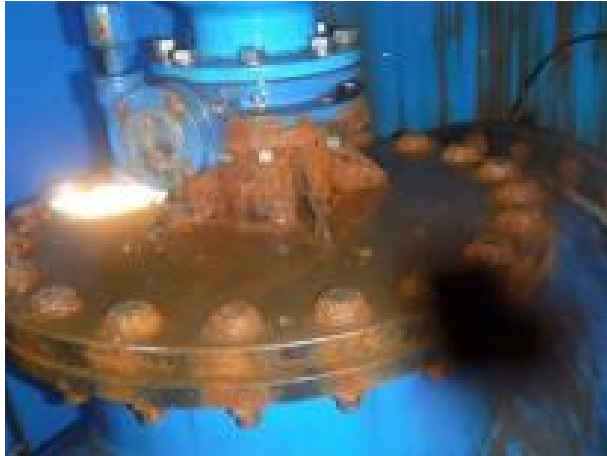
송수계통, 02구간, Sta. No. 15+3.7[A]  
마개F 부식

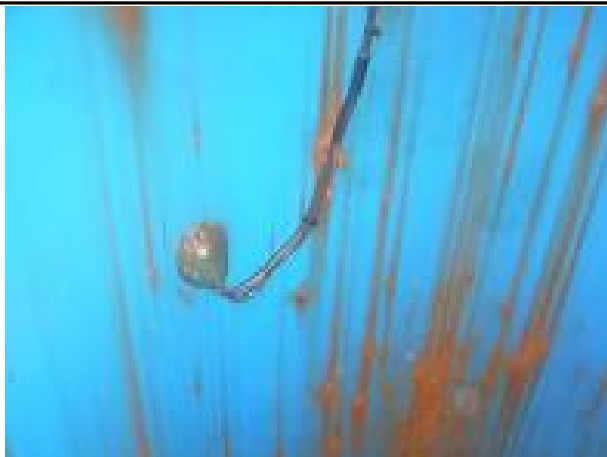
송수계통, 02구간, Sta. No. 15+3.7[A]  
강재구조물 국부적 표면부식

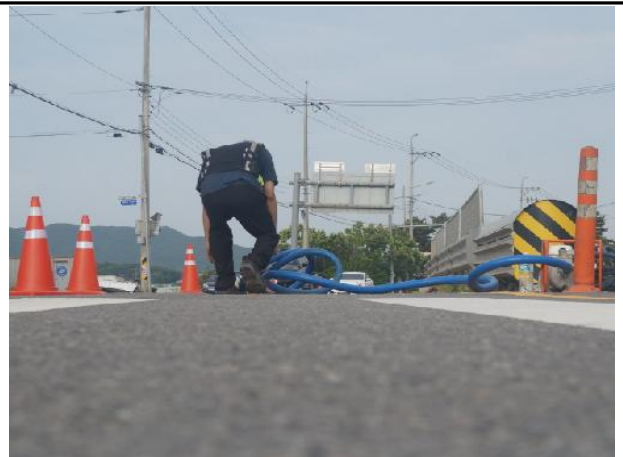
송수계통, 02구간, Sta. No. 15+3.7[A]  
밸브실 양수(h=2.6m)

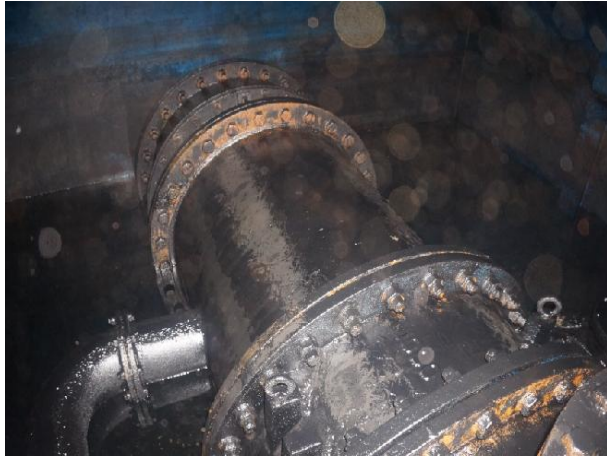
송수계통, 02구간, Sta. No. 34+0.0[M]  
빠관 및 밸브 볼트체결부 부식

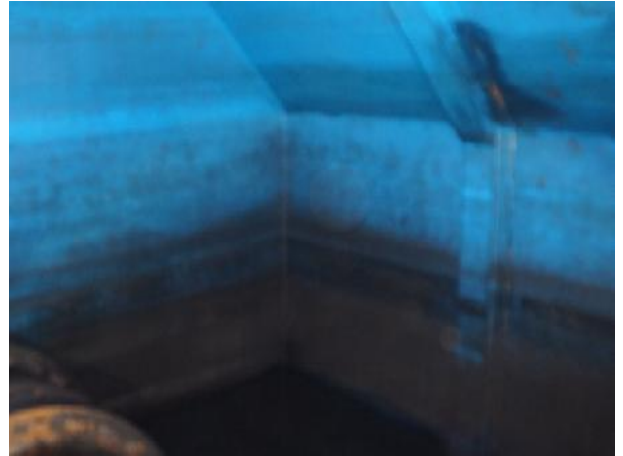
송수계통, 02구간, Sta. No. 34+0.0[M]  
강재구조물 국부적 표면부식

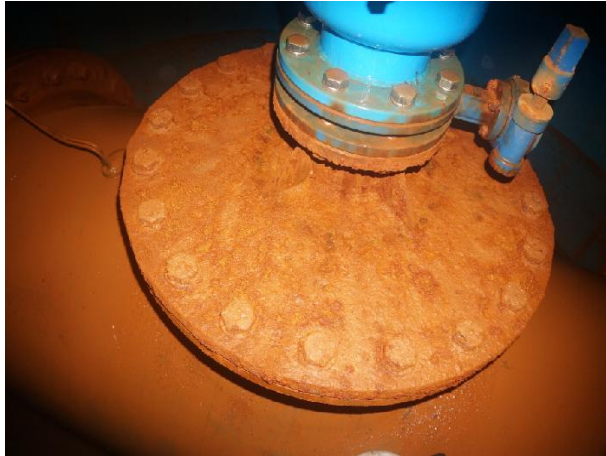
송수계통, 02구간, Sta. No. 45+8.3[A]  
마개F 부식

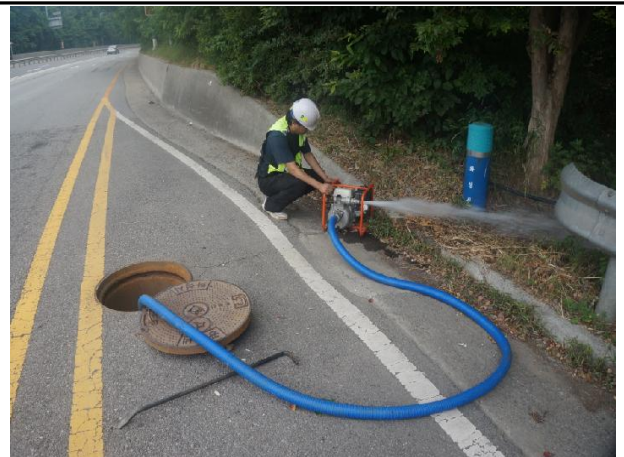
송수계통, 02구간, Sta. No. 45+8.3[A]  
밸브실 양수(h=2.0m)

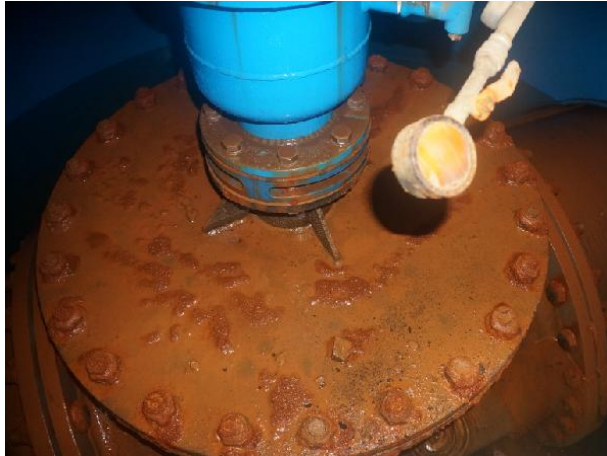
송수계통, 02구간, Sta. No. 84+17.5[A]  
마개F 부식

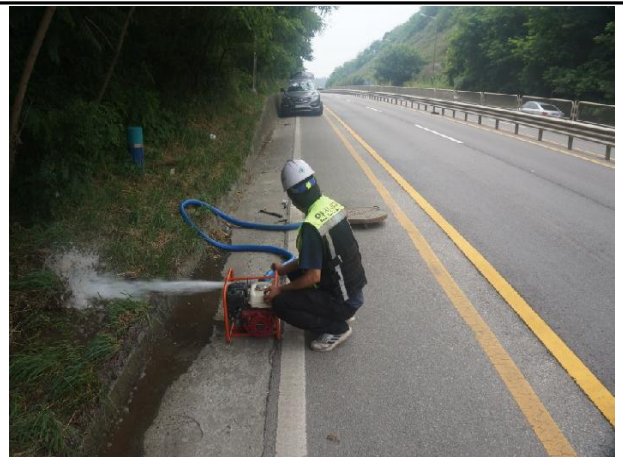
송수계통, 02구간, Sta. No. 84+17.5[A]  
밸브실 양수(h=2.7m)

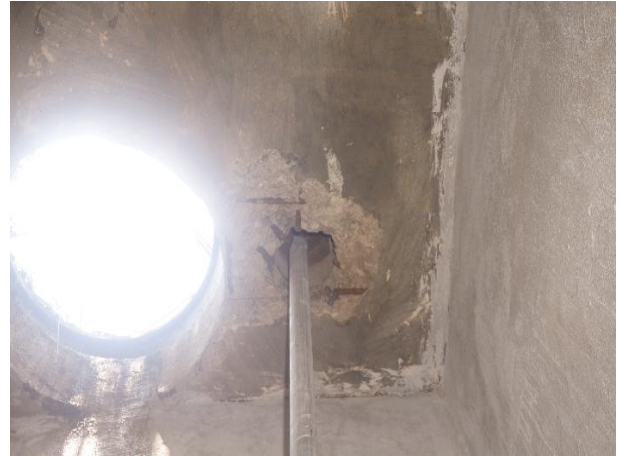
송수계통, 02구간, Sta. No. 108+4.0[D]  
상부슬래브 철근노출

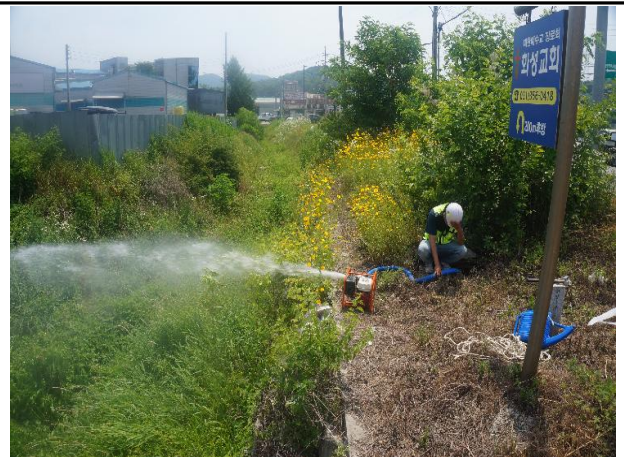
송수계통, 02구간, Sta. No. 108+4.0[D]  
밸브실 양수(h=2.0m)
