2022년 국도 38호선 3종 시설물 행죽교 등 6개소  
내진 성능평가 및 정기안전점검용역

외관조사망도  
( 마정2보도육교 )

수원국토관리사무소

(주)명성엔지니어링

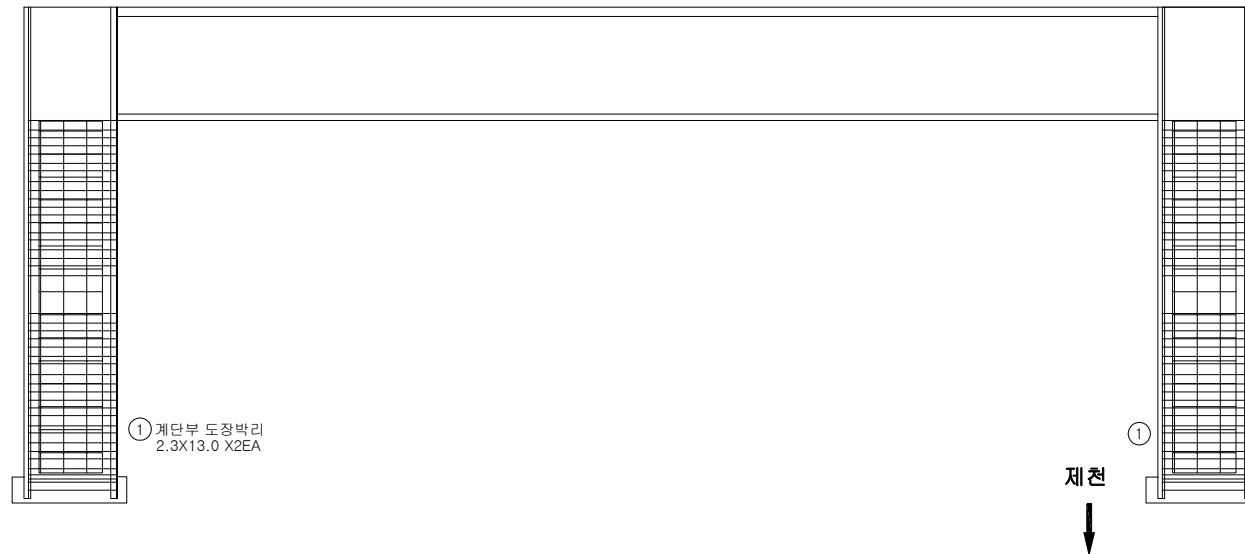
| | | | 마정2보도육교 바닥판상면 S1 |

| 번호 | 발생<br>년도 | 부재 | 손상내용 | 손상현황 | | | | | | | 비 고 |
|---|---|---|---|---|---|---|---|---|---|---|---|
| 1 | 22년 | 계단부 | 계단부 도장박리 | | 2.3 | 13.0 | 29.90 | m <sup>2</sup> | 2 | 59.80 | |

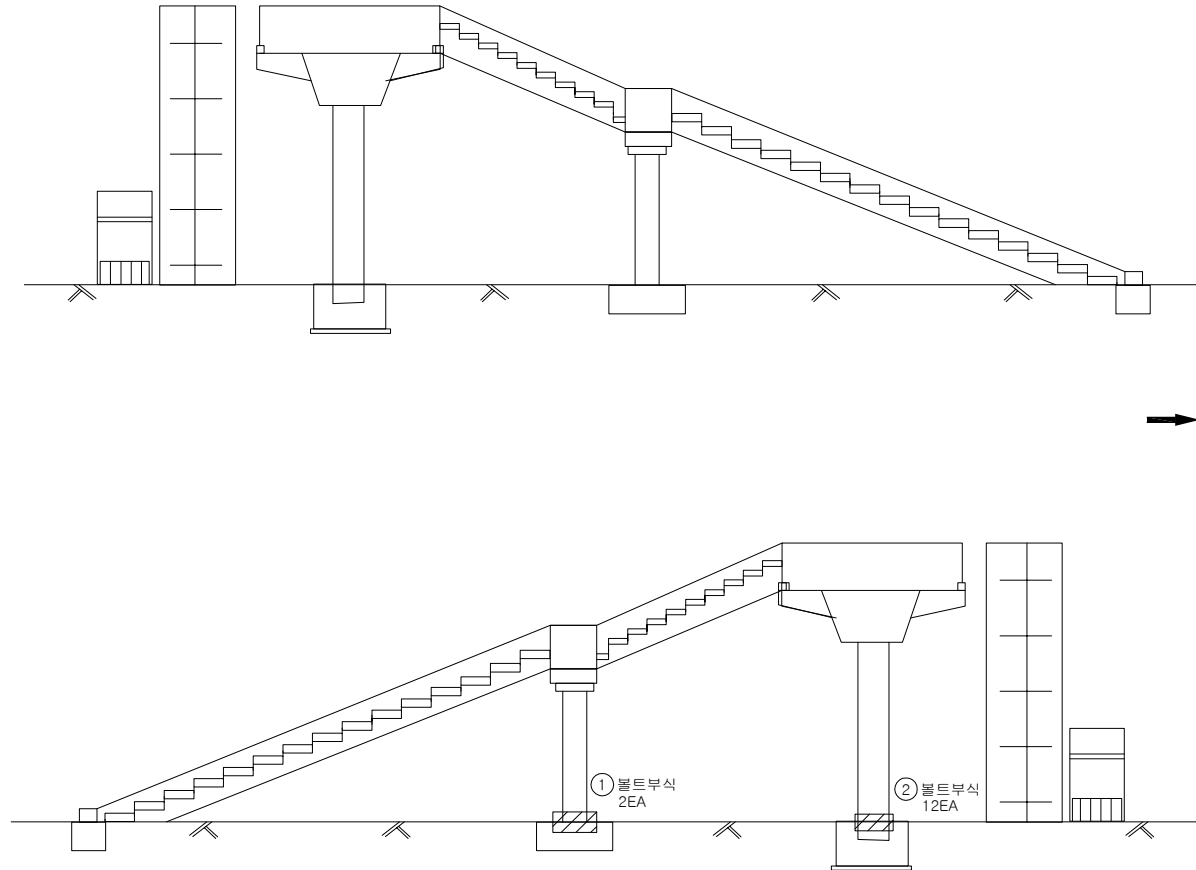
| | | | 마정2보도육교 측면2 |

| 번호 | 발생<br>년도 | 부재 | 손상내용 | 손상현황 | | | | | | | 비고 |
|---|---|---|---|---|---|---|---|---|---|---|---|
| 1 | 22년 | 기둥부 | 기둥부 볼트부식 | | | | 1.00 | EA | 2 | 2.00 | |
| 2 | 22년 | 기둥부 | 기둥부 볼트부식 | | | | 1.00 | EA | 12 | 12.00 | |
