상주영천고속도로 시설물 안전·하자점검 및 성능평가 용역  
(2023년 상반기 정기안전점검)

# 외 관 조 사 망 도

패널식 옹벽 10

2023.04

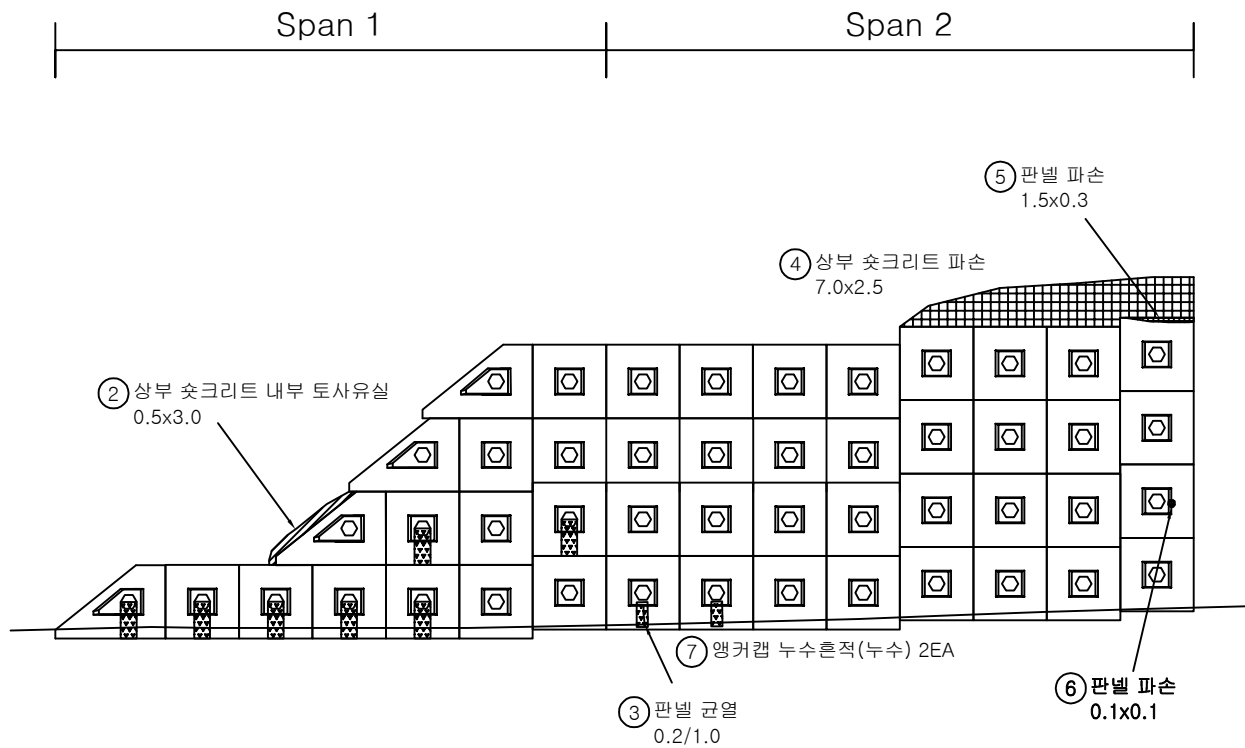
① 앵커캡 누수흔적(누수) 7EA

| 번호 | 손상내용 | 손상현황 | | | | | | 비고 |
|---|---|---|---|---|---|---|---|---|
| 1 | 앵커캡 누수흔적(누수) | | | | 7.00 | EA | 7 | |
| 2 | 스프트 내부 토사유실 | | 0.5 | 3.0 | 1.50 | m <sup>3</sup> | 1 | |
| 3 | 판넬 균열 | 0.2 | 1.0 | | 1.00 | m | 1 | |
| 4 | 스프트 파손 | | 7.0 | 2.5 | 17.50 | m <sup>3</sup> | 1 | |
| 5 | 판넬 파손 | | 1.5 | 0.3 | 0.45 | m <sup>3</sup> | 1 | |
| 6 | 판넬 파손 | | 0.1 | 0.1 | 0.01 | m <sup>3</sup> | 1 | |
| 7 | 앵커캡 누수흔적(누수) | | | | 2.00 | EA | 2 | |

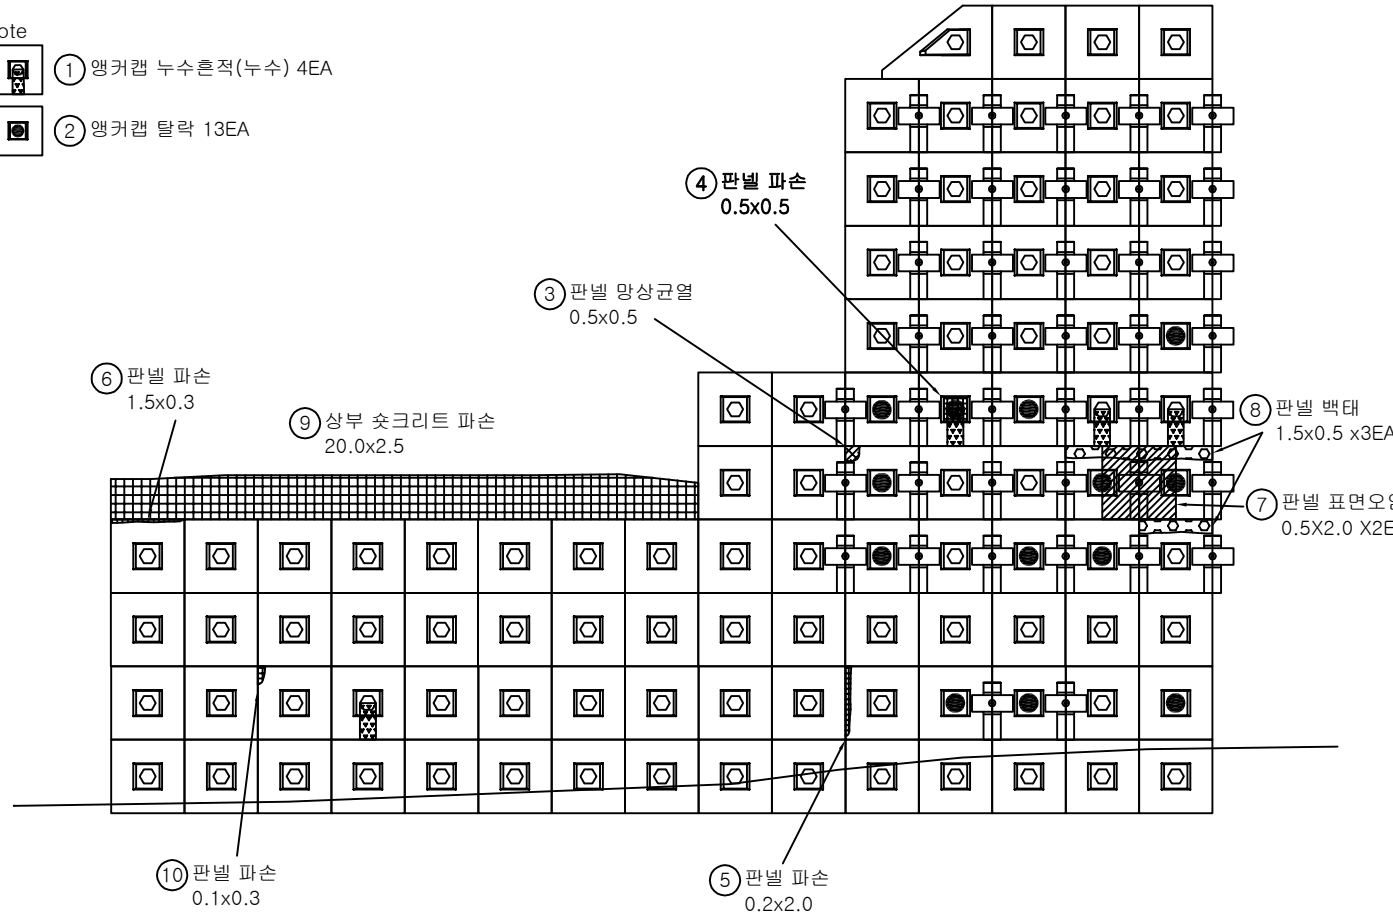
① 앵커캡 누수흔적(누수) 4EA

② 앵커캡 탈락 13EA

| 번호 | 손상내용 | 손상현황 | | | | | | 비고 |
|---|---|---|---|---|---|---|---|---|
| 1 | 앵커캡 누수흔적(누수) | | | | 4.00 | EA | 4 | 손상증가 |
| 2 | 앵커캡 탈락 | | | | 13.00 | EA | 13 | |
| 3 | 판넬 망상균열 | | 0.5 | 0.5 | 0.25 | m <sup>2</sup> | 1 | |
| 4 | 판넬 파손 | | 0.5 | 0.5 | 0.25 | m <sup>2</sup> | 1 | |
| 5 | 판넬 파손 | | 0.2 | 2.0 | 0.40 | m | 1 | |
| 6 | 판넬 파손 | | 1.5 | 0.3 | 0.45 | m <sup>2</sup> | 1 | |
| 7 | 판넬 표면오염 | | 0.5 | 2.0 | 2.00 | m <sup>2</sup> | 2 | |
| 8 | 판넬 백태 | | 1.5 | 0.5 | 2.25 | m <sup>2</sup> | 3 | |
| 9 | 상부 슛크리트 파손 | | 20.0 | 2.5 | 50.00 | m <sup>2</sup> | 1 | |
| 10 | 판넬 파손 | | 0.1 | 0.3 | 0.03 | m <sup>2</sup> | 1 | |

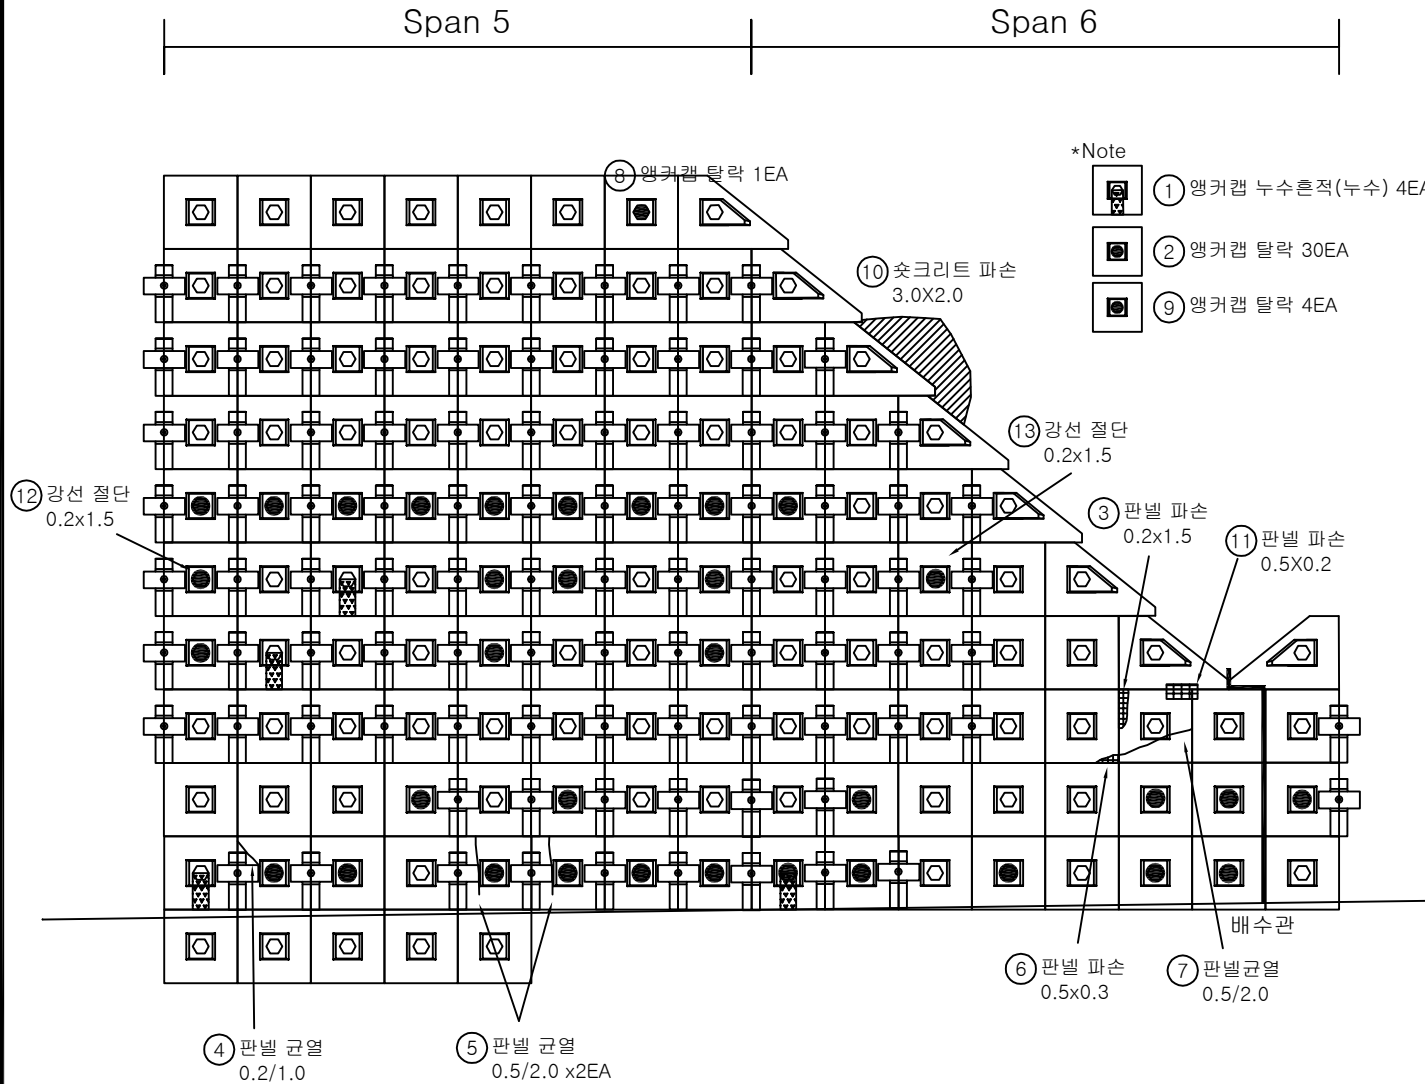
| 번호 | 손상내용 | 손상현황 | | | | | | 비고 |
|---|---|---|---|---|---|---|---|---|
| 1 | 앵커캡 누수흔적(누수) | | | | 4.00 | EA | 4 | |
| 2 | 앵커캡 탈락 | | | | 30.00 | EA | 30 | |
| 3 | 판넬 파손 | | 0.2 | 1.5 | 0.30 | m | 1 | |
| 4 | 판넬 균열 | 0.2 | 1.0 | | 1.00 | m | 1 | |
| 5 | 판넬 균열 | 0.5 | 2.0 | | 4.00 | m | 2 | |
| 6 | 판넬 파손 | | 0.5 | 0.3 | 0.15 | m | 1 | |
| 7 | 판넬 균열 | 0.5 | 2.0 | | 2.00 | m | 1 | |
| 8 | 앵커캡 탈락 | | | | 1.00 | EA | 1 | |
| 9 | 앵커캡 탈락 | | | | 4.00 | EA | 4 | |
| 10 | 스icc리트 파손 | | 3.0 | 2.0 | 6.00 | m | 1 | |
| 11 | 판넬 파손 | | 0.5 | 0.2 | 0.10 | m | 1 | |
| 12 | 강선 절단 | | | | 1.00 | EA | 1 | |
| 13 | 강선 절단 | | | | 1.00 | EA | 1 | |

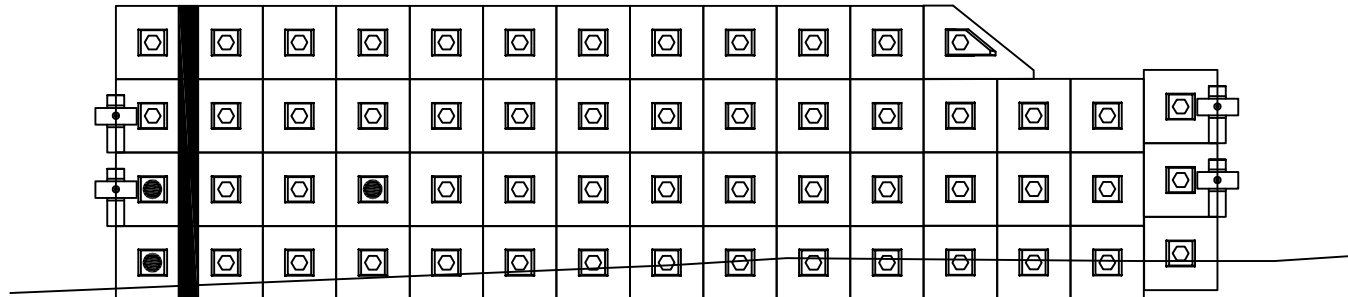
① 앵커캡 탈락 3EA

| 번호 | 손상내용 | 손상현황 | | | | | | 비고 |
|---|---|---|---|---|---|---|---|---|
| 1 | 앵커캡 탈락 | | | | 3.00 | EA | 3 | |

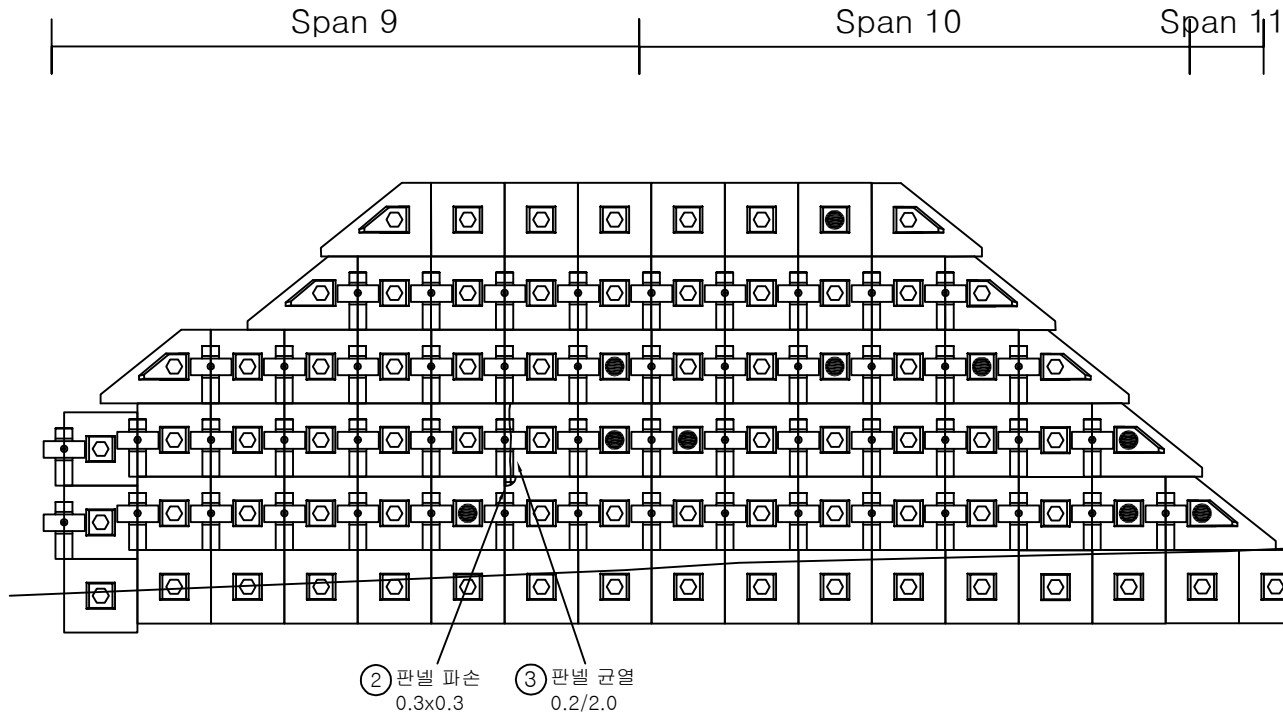
① 앵커캡 탈락 10EA

| 번호 | 손상내용 | 손상현황 | | | | | | 비고 |
|---|---|---|---|---|---|---|---|---|
| 1 | 앵커캡 탈락 | | | | 10.00 | EA | 10 | |
| 2 | 패널 파손 | | 0.3 | 0.3 | 0.09 | m <sup>2</sup> | 1 | |
| 3 | 패널 균열 | 0.2 | 2.0 | | 2.00 | m | 1 | |
