# No.6(2) 영인면 아산로 1233번길 12

명성엔지니어링

서해선(홍선~송산) 복선전철 제5공구 건설공사 사후현황 용역[공사후]

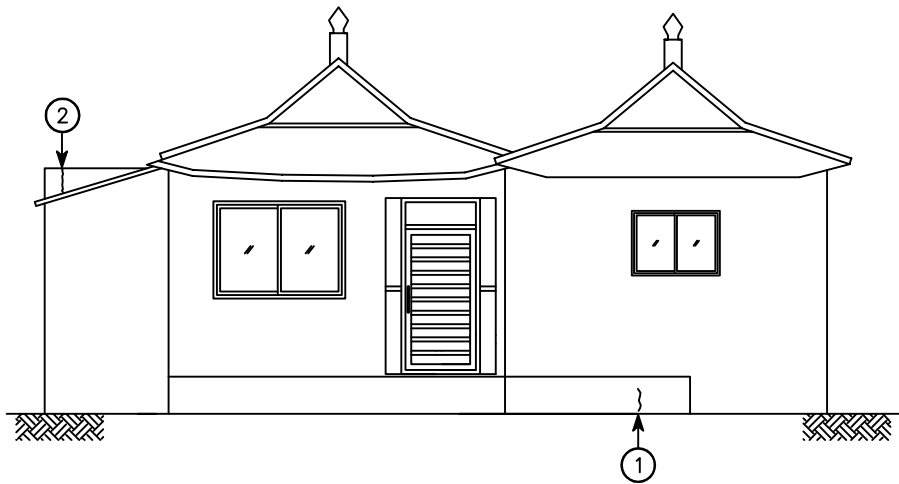
정면

| No | 손상내용 | 결함규모 | | | | 사진<br>번호 | 비고 |
|---|---|---|---|---|---|---|---|
| 1 | 수직균열 | 0.3 | 0.50 | m | 1 | 1 | |
| 2 | 수직균열 | 1.0 | 1.00 | m | 1 | 2 | |

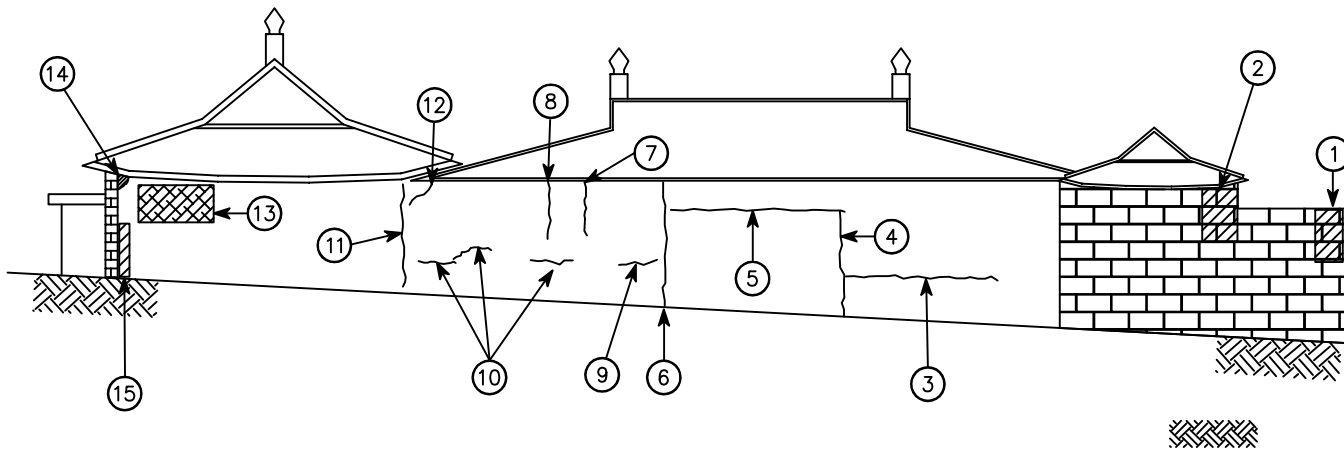
좌측면

| No | 손상내용 | 결함규모 | | | | 사진<br>번호 | 비고 |
|---|---|---|---|---|---|---|---|
| 1 | 파손 | 1.00 | 1.00 | m² | 1 | 3 | |
| 2 | 파손 | 1.00 | 1.00 | m² | 1 | 4 | |
| 3 | 수평균열 | 0.2 | 3.00 | m | 1 | 5 | |
| 4 | 수직균열 | 0.3 | 3.00 | m | 1 | 6 | |
| 5 | 수평균열 | 0.3 | 3.00 | m | 1 | 7 | |
| 6 | 이격 | - | 2.50 | m | 1 | 8 | T=1.0cm |
| 7 | 수직균열 | 0.1 | 1.00 | m | 1 | 9 | |
| 8 | 수직균열 | 0.2 | 1.00 | m | 1 | 10 | |
| 9 | 수평균열 | 0.3 | 0.50 | m | 1 | 11 | |
| 10 | 수평균열 | 0.2 | 0.50 | m | 3 | 12 | |
| 11 | 수직균열 | 0.3 | 2.50 | m | 1 | 13 | |
| 12 | 경사균열 | 0.1 | 0.50 | m | 1 | 14 | |
| 13 | 망상균열 | 1.00 | 1.00 | m² | 1 | 15 | |
| 14 | 들뜸 | 0.20 | 0.40 | m² | 1 | 16 | |
| 15 | 들뜸 | 0.20 | 2.00 | m² | 1 | 17 | |

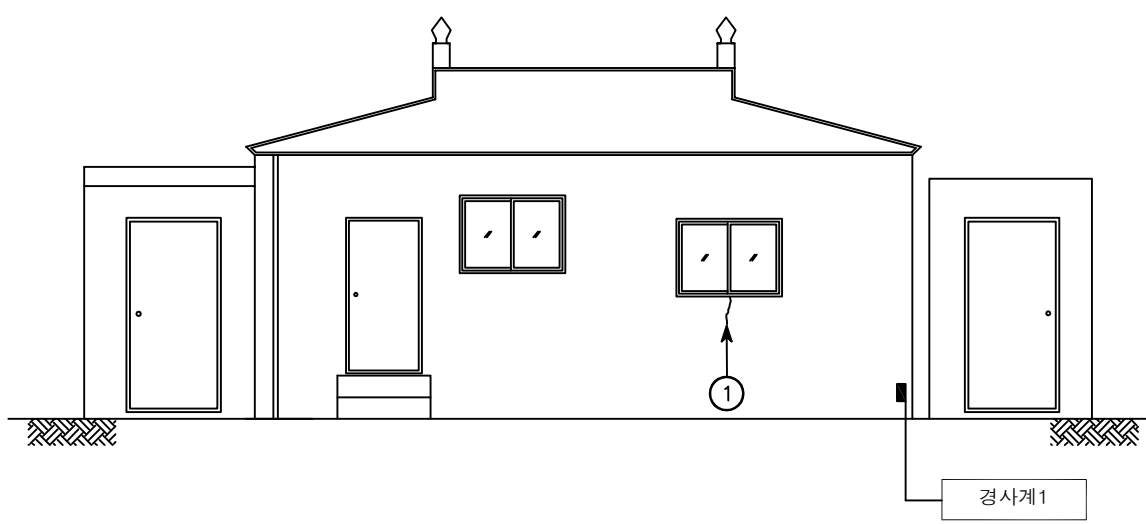
| No | 손상내용 | 결함규모 | | | | 사진<br>번호 | 비고 |
|---|---|---|---|---|---|---|---|
| 1 | 수직균열 | 0.3 | 0.30 | m | 1 | 18 | |

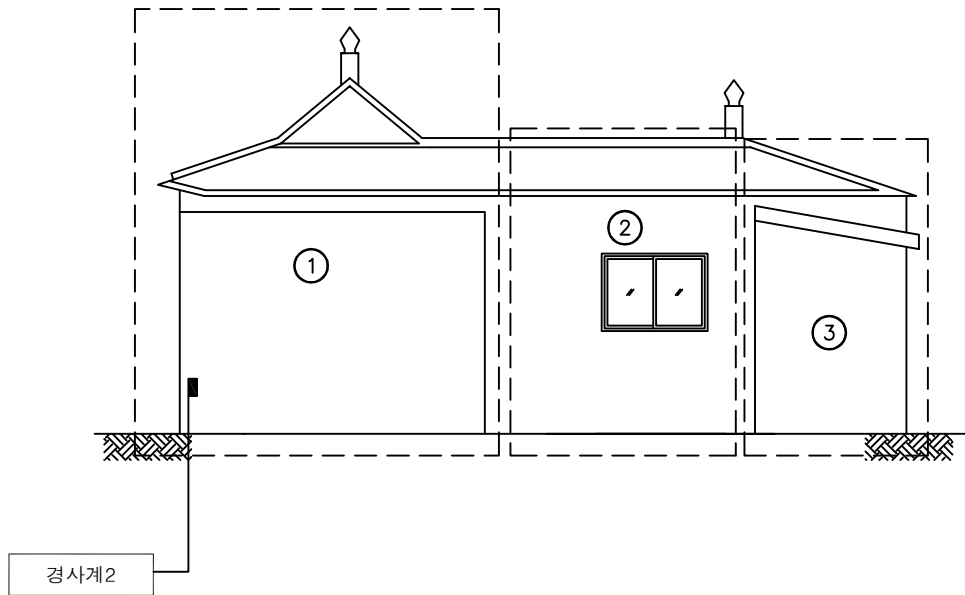
| No | 손상내용 | 결함규모 | | | | 사진<br>번호 | 비고 |
|---|---|---|---|---|---|---|---|
| 1 | 상태현황 | - | - | - | - | 19 | |
| 2 | 상태현황 | - | - | - | - | 20 | |
| 3 | 상태현황 | - | - | - | - | 21 | |
