## 1. 강매교

## 손상현황 사진

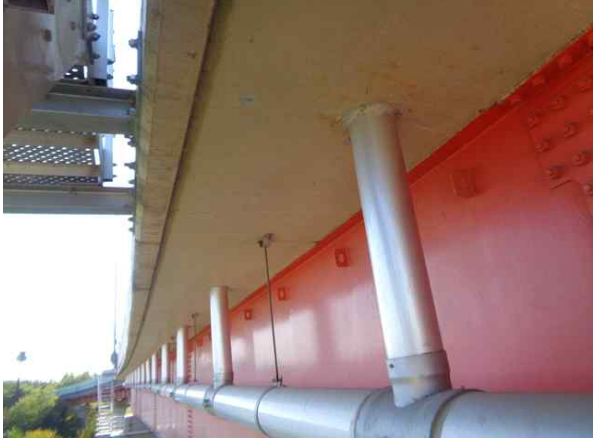
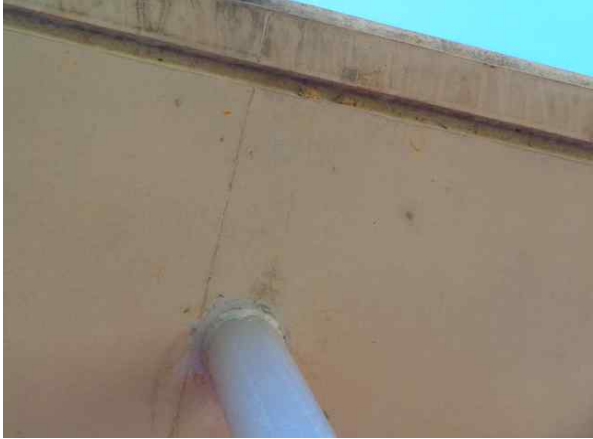
| S1 캔틸레버부 균열 (0.2mm/1.0m×2EA) | S1 캔틸레버부 균열 (0.2mm/1.0m×2EA) |

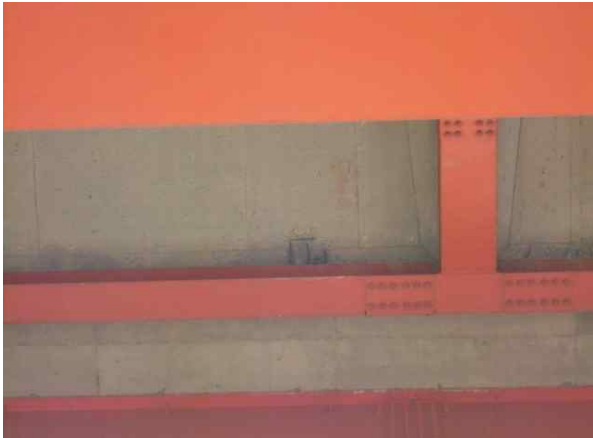
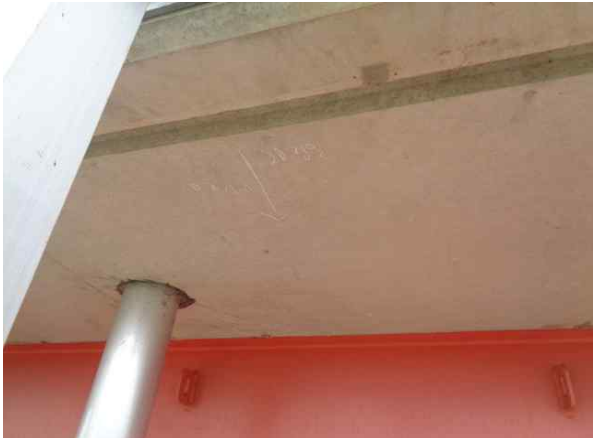
| S2 박리 (0.5m×2.0m×3EA) | S1 캔틸레버부 균열 (0.2mm/1.0m) |

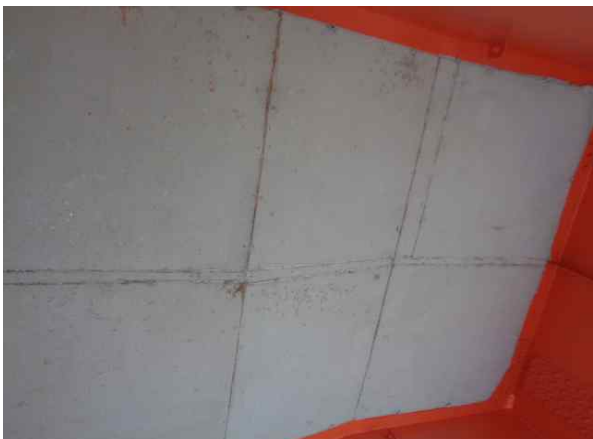
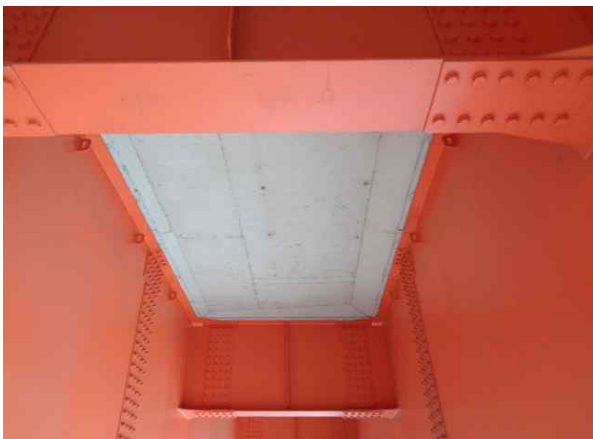
| S3 망상균열 (2.0m×5.0m×10EA) | S3 망상균열 (2.0m×5.0m×10EA) |

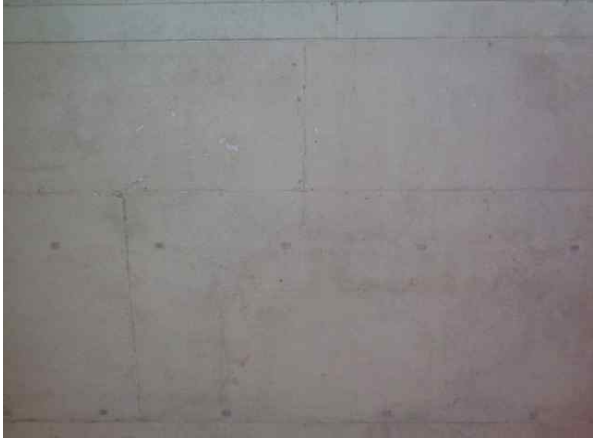
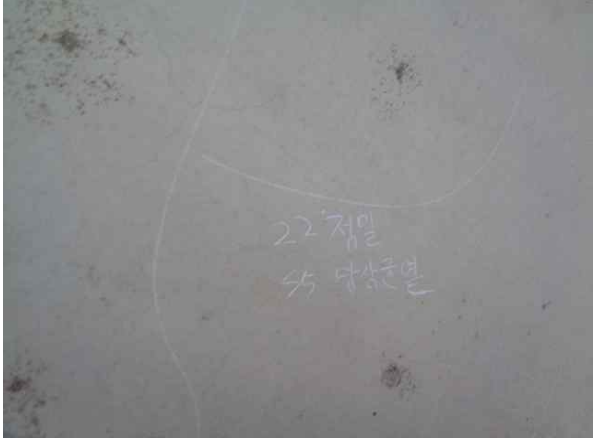
| S4 망상균열 (2.0m×5.0m×10EA) | S5 망상균열 (2.0m×5.0m×10EA) |

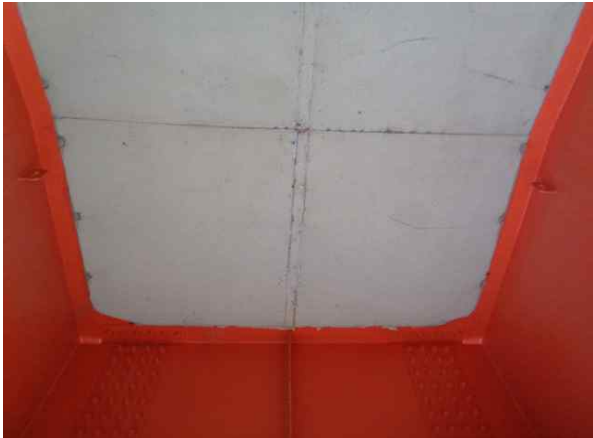
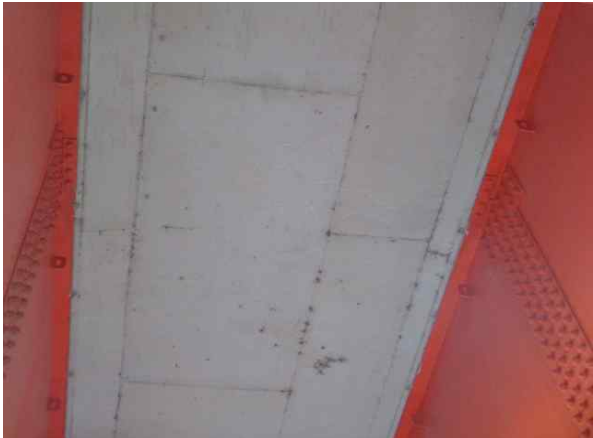
| S6 균열 (0.2mm/2.0m) | S6 망상균열 (2.0m×5.0m×5EA) |

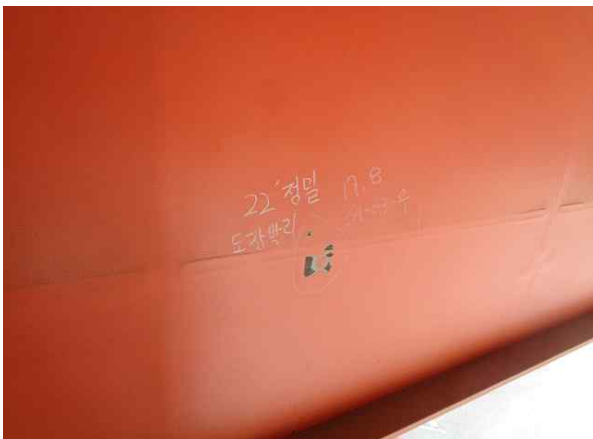
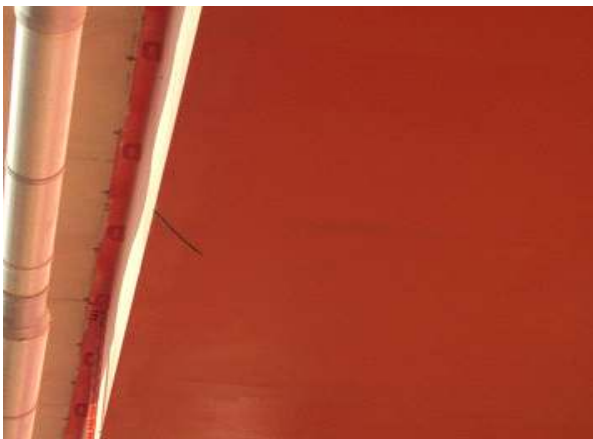
| S4-G3 도장손상 (0.1m×0.2m) | S6-G4 도장손상 (0.1m×0.3m) |

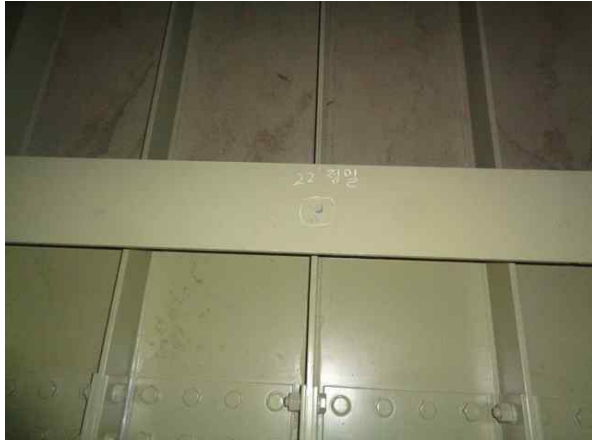
S2-G4 도장손상(0.1m×0.1m)

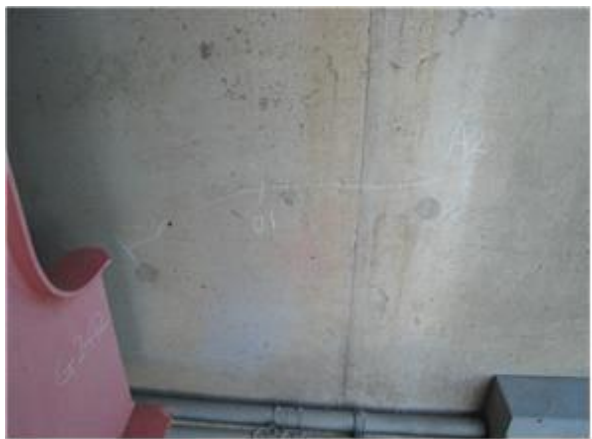
A2 균열(폭 0.2mm/1.0m)

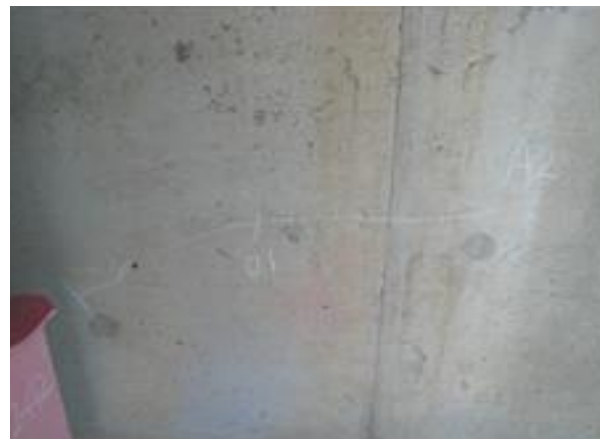
A2 균열(폭 0.2mm/1.0m)

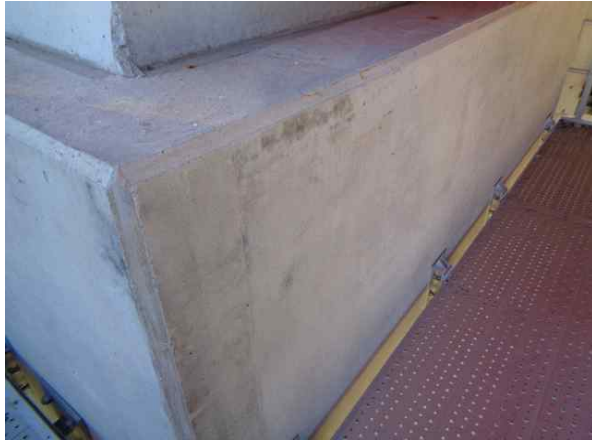
P1 코핑부 망상균열 (5.0m×1.0m)

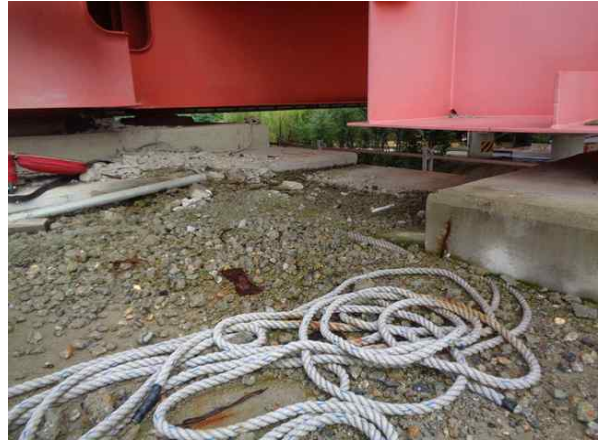
P2 코핑부 상면 폐코크리트 적치

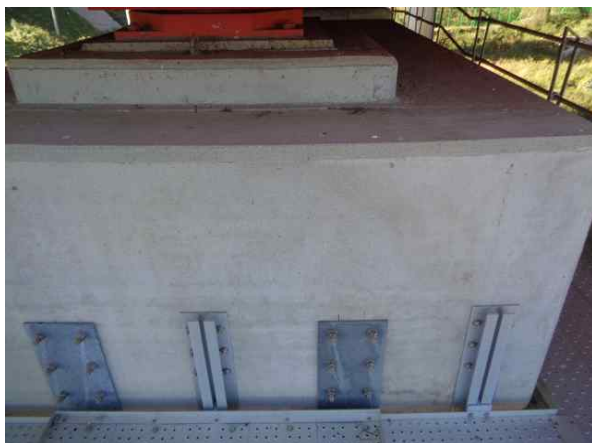
P5 코핑부 망상균열 (5.0m×1.0m)

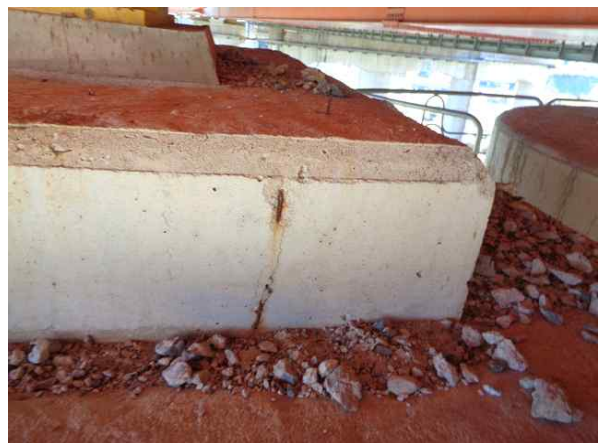
P1-Sh1 받침콘크리트 파손 (0.1m×0.3m)

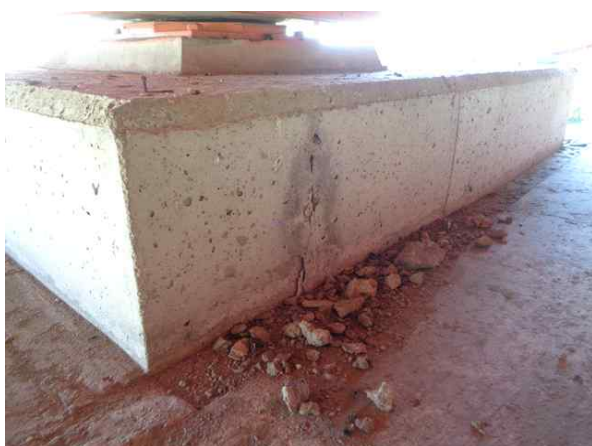
P35-Sh1 받침콘크리트 파손 (0.1m×0.3m×2EA)

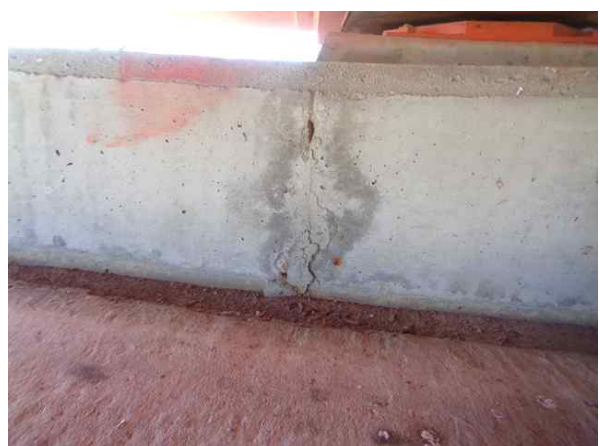
P35-Sh1 받침콘크리트 파손 (0.1m×0.3m×2EA)

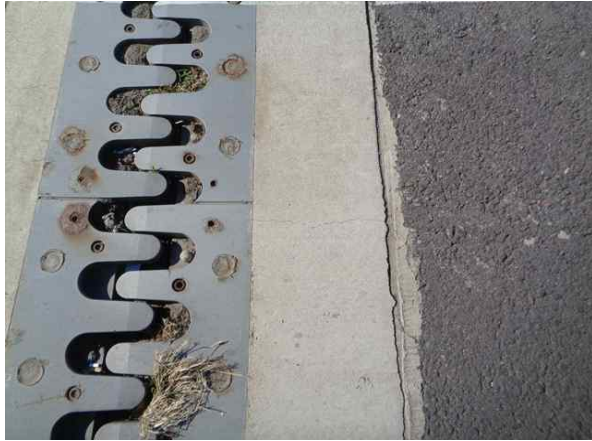
A2 후타재 균열 (0.2mm/0.3m×10EA)

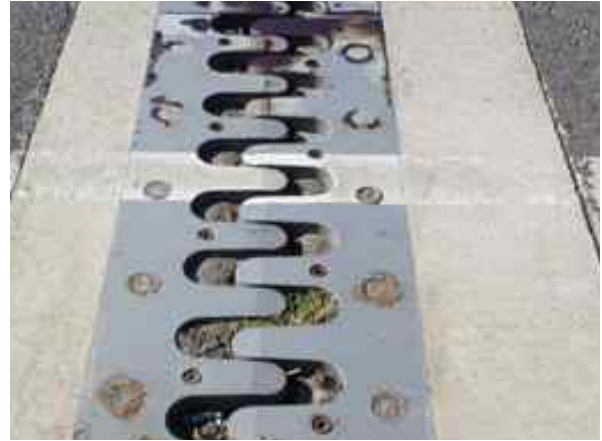
A2 본체 이물질퇴적

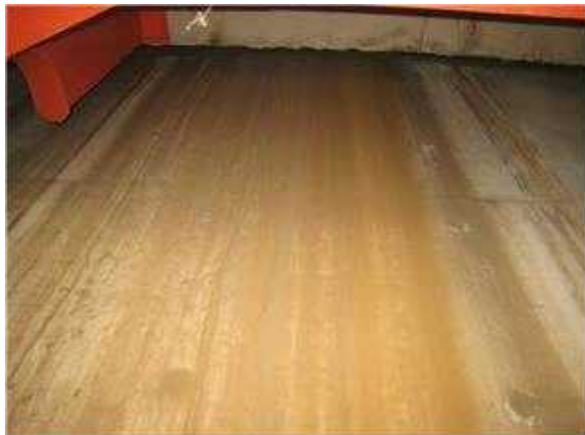
A2 하부 누수

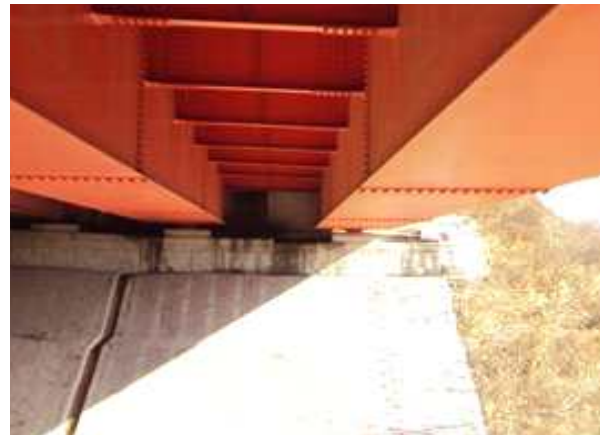
A2 하부 누수

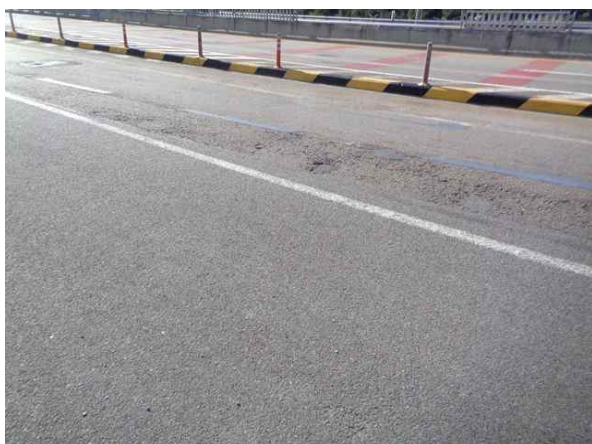
S1 라벨링(1.0m×45.0m)

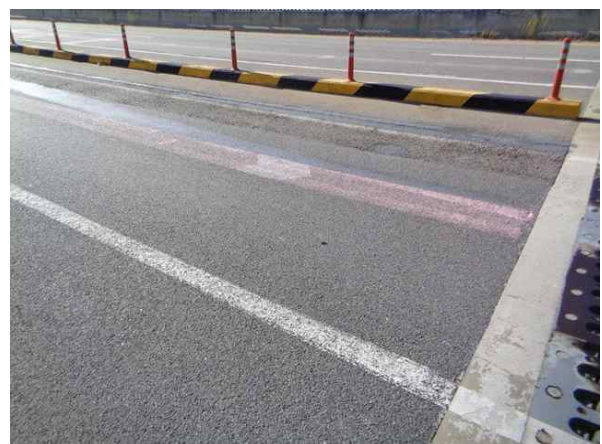
S1 라벨링(1.0m×50.0m)

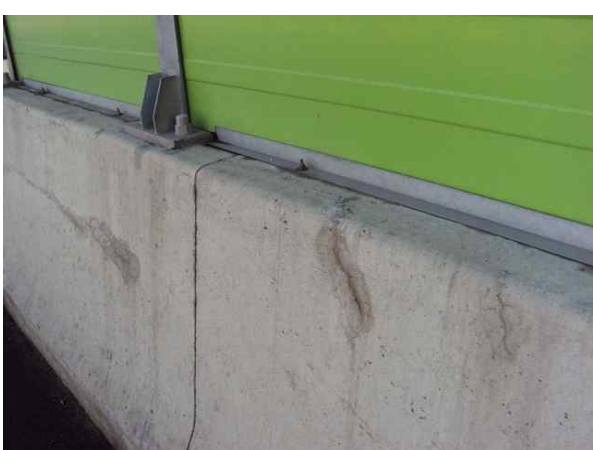
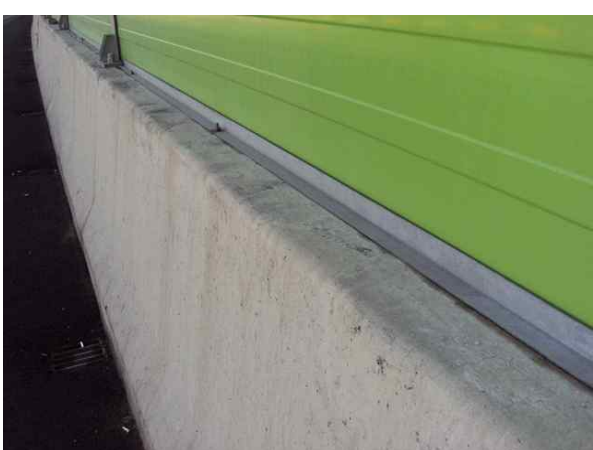
| S1 방호벽 균열 (0.2mm/0.4m×5EA) | S1 방호벽 균열 (0.2mm/0.8m) |

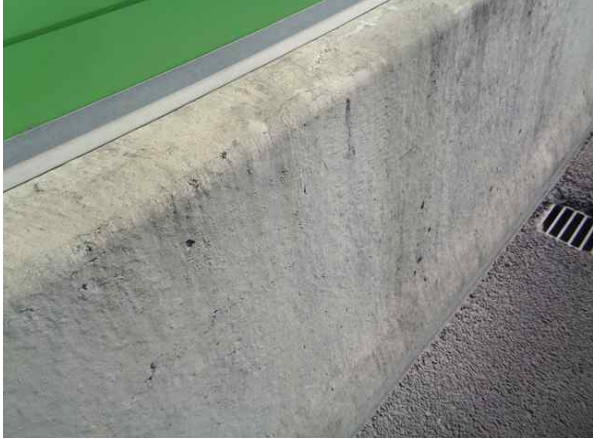
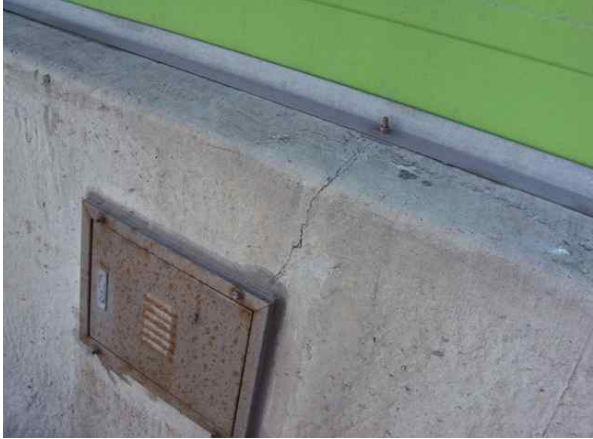
| S2 방호벽 균열부 (0.2mm/7.0m) | S2 방호벽 균열부 (0.3mm/0.5m) |

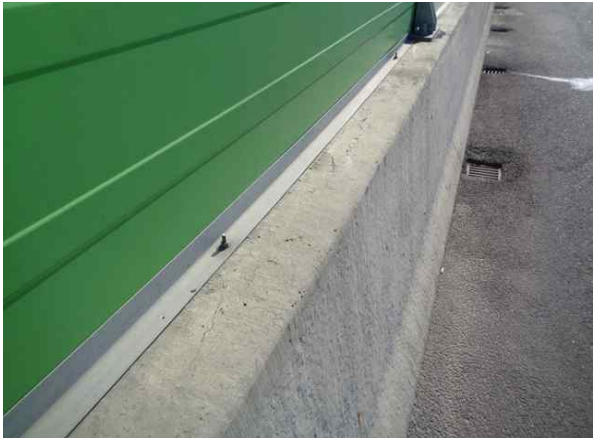
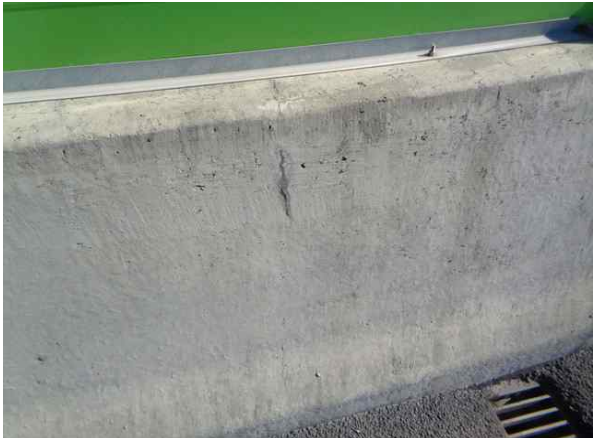
| S3 방호벽 균열부 (0.2mm/2.5m) | S3 방호벽 균열부 (0.3mm/1.1m) |

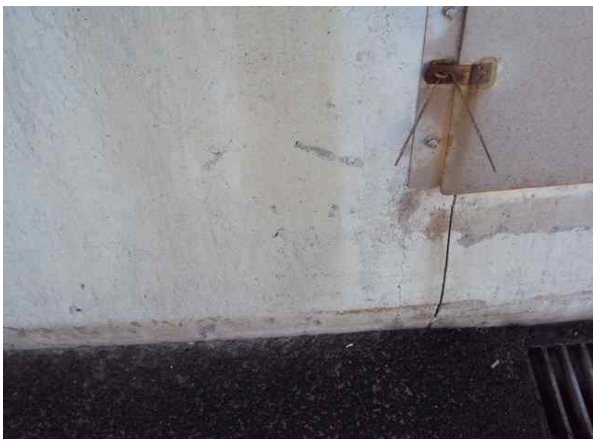
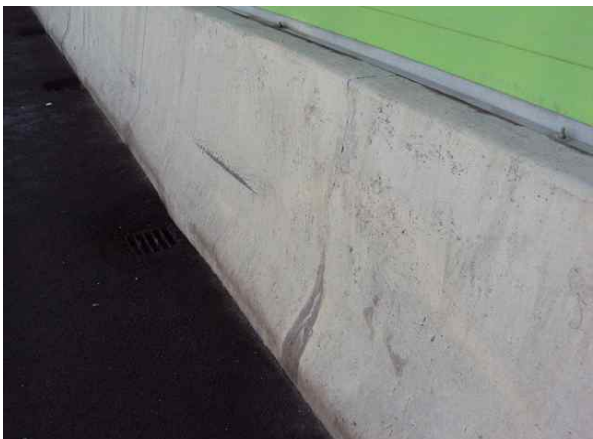
| S4 방호벽 균열 (0.2mm/0.5m) | S5 방호벽 균열 (0.2mm/1.2m) |

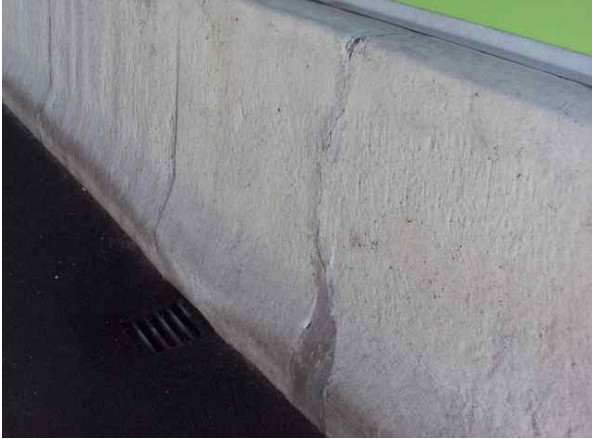
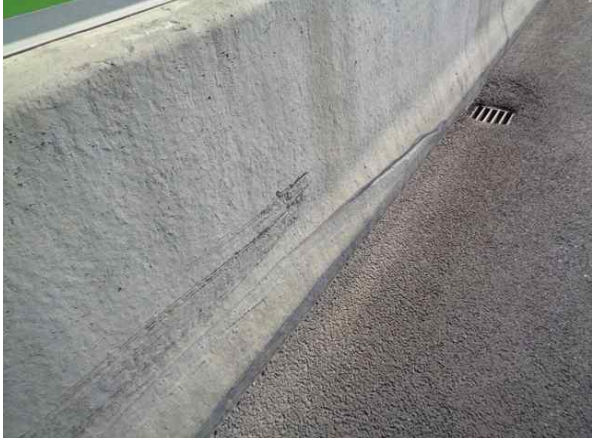
| S6 방호벽 균열(0.3mm/1.2m) | S4 파손(1.0m×0.3m) |

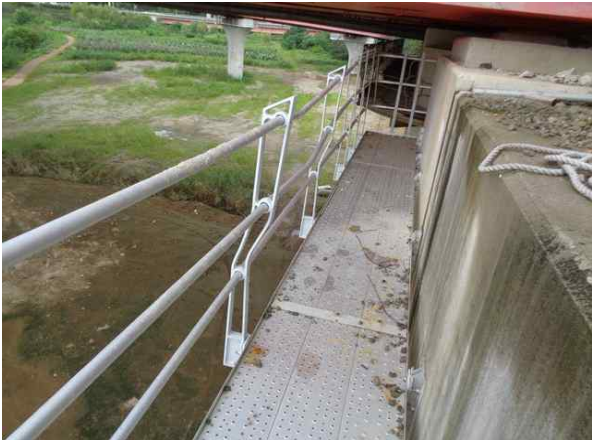
| P4 점검로 파손(1EA) | — |
