## 8. 서문5교(문산방향)

## 손상현황 사진

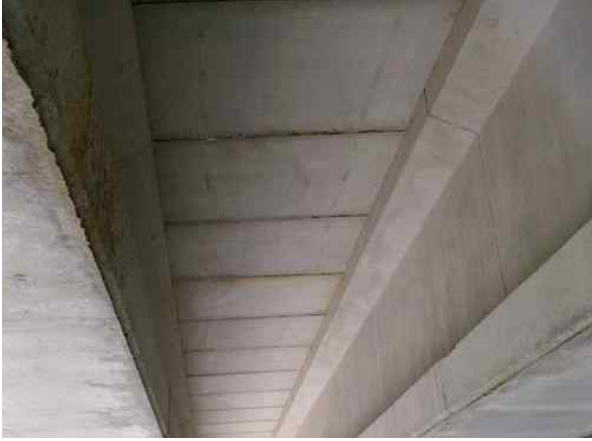
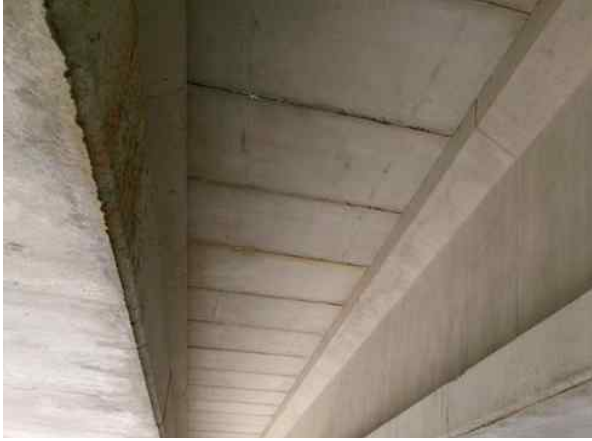
| 바닥판 하면 상태양호 | 바닥판 하면 상태양호 |

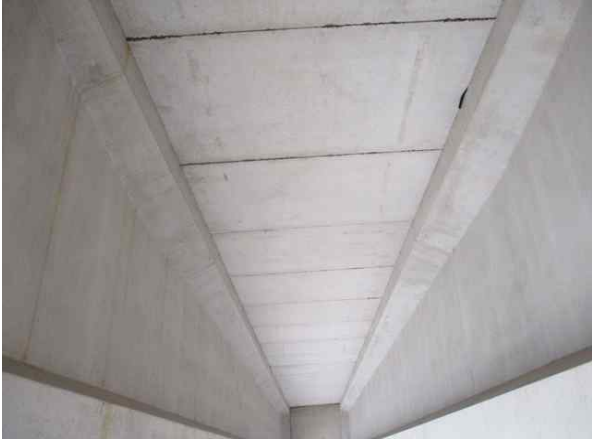
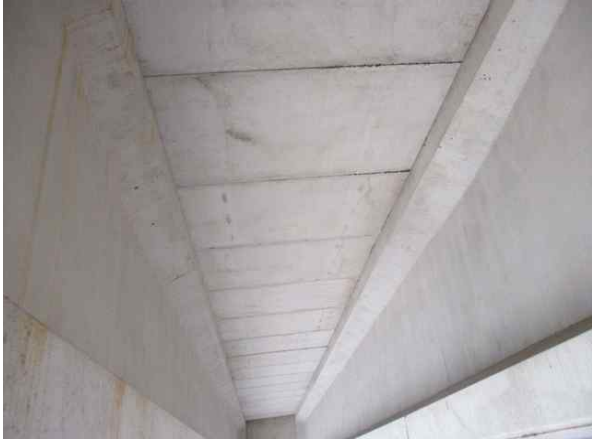
| 바닥판 하면 상태양호 | 바닥판 하면 상태양호 |

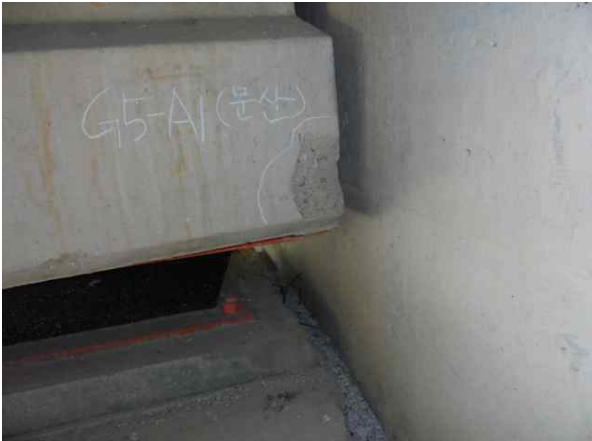
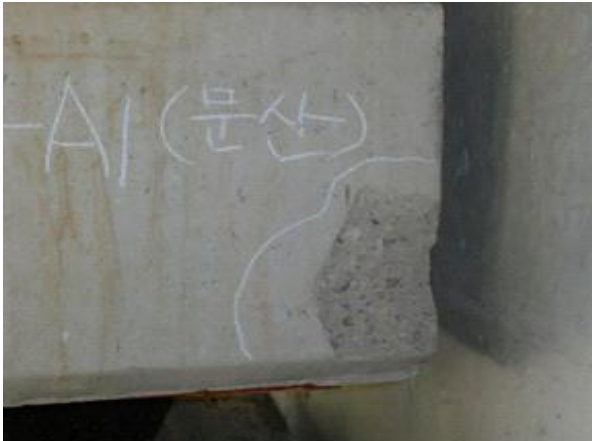
| S1-G5 파손 (0.3m×0.3m) | S1-G5 파손 (0.3m×0.3m) |

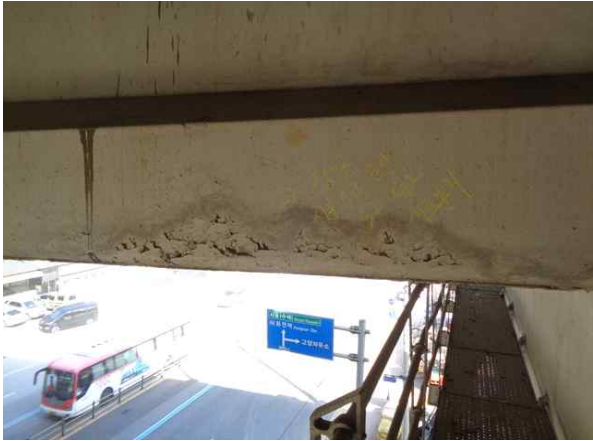
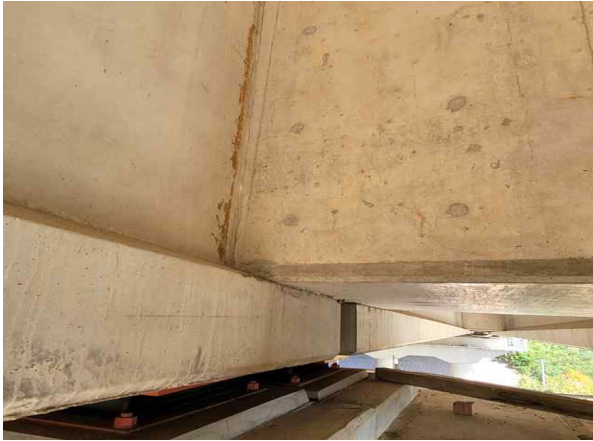
| S2-G2 파손 (1.0m×0.2m) | S1 G5~6 박리 (0.4m×0.4m) |

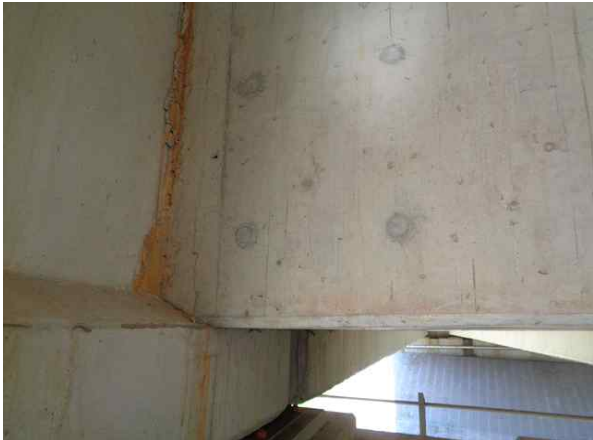
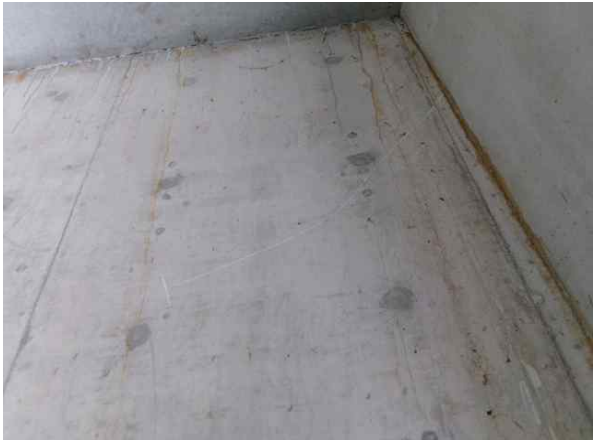
| S1 G2~3 균열 (0.2mm/1.2m) | S2 G2~3 균열 (0.2mm/1.2m) |

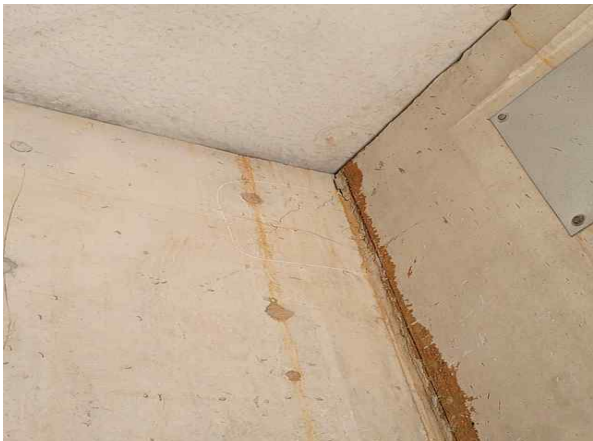
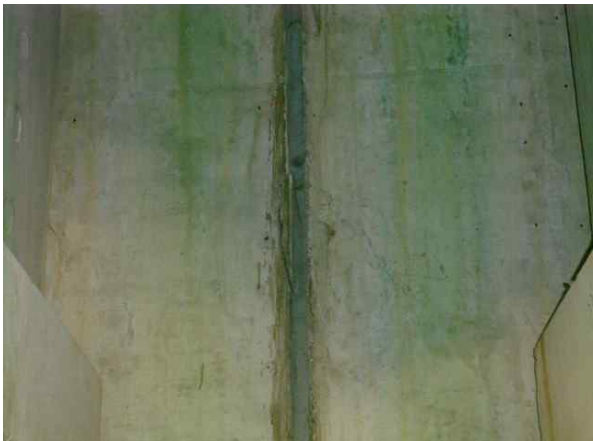
| S1 G5~6 박리 (0.4m×0.4m) | A1 콘크리트 박락 (0.1m×0.5m) |

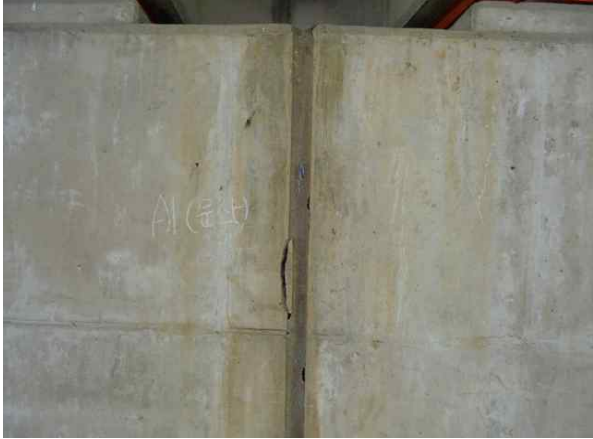
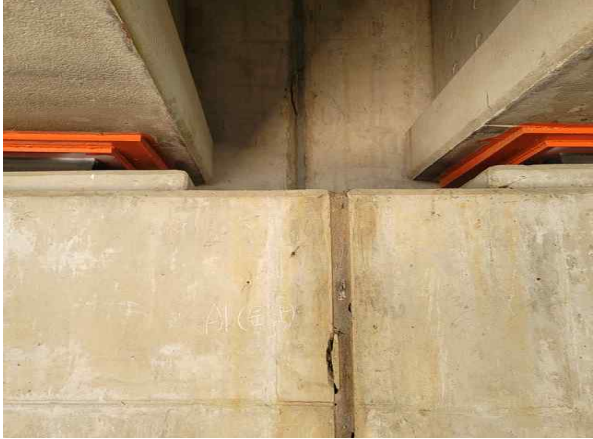
| <p>A1 콘크리트 박락(0.1m×0.3m)</p> | <p>A1 콘크리트 박락(0.1m×0.3m)</p> |

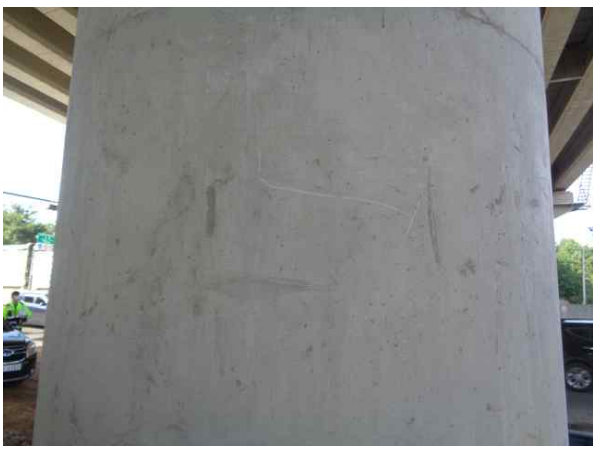
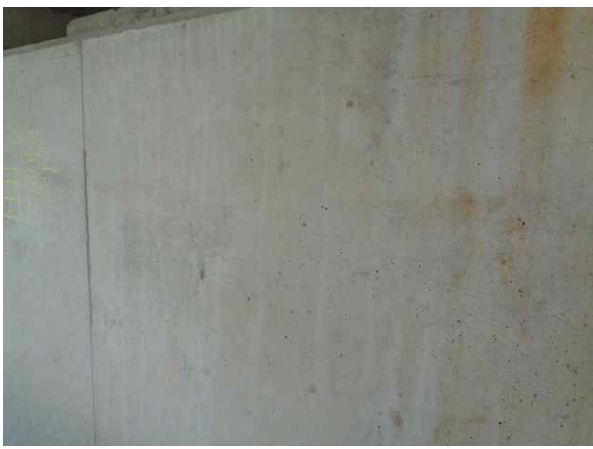
| <p>P1 기둥부 균열(0.2mm/0.7m)</p> | <p>P1 코핑부 망상균열(10.0m×1.0m)</p> |

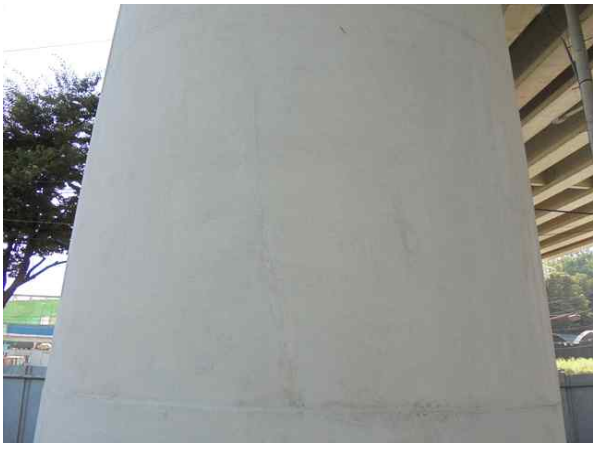
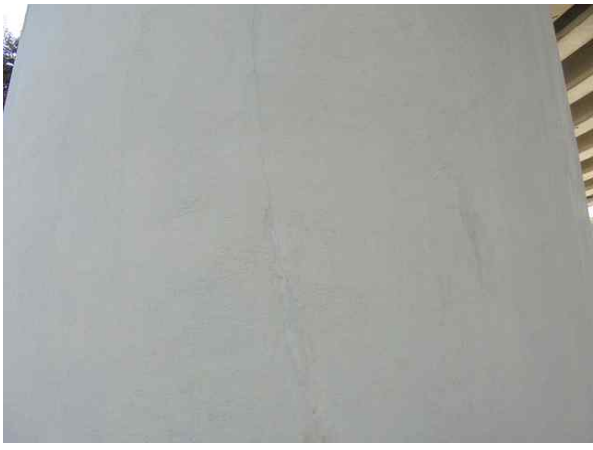
| <p>P2 기둥부 균열(0.2mm/1.0m)</p> | <p>P2 기둥부 균열(0.2mm/1.0m)</p> |

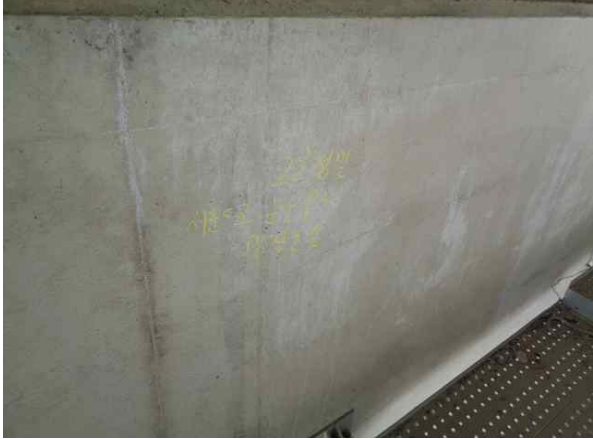
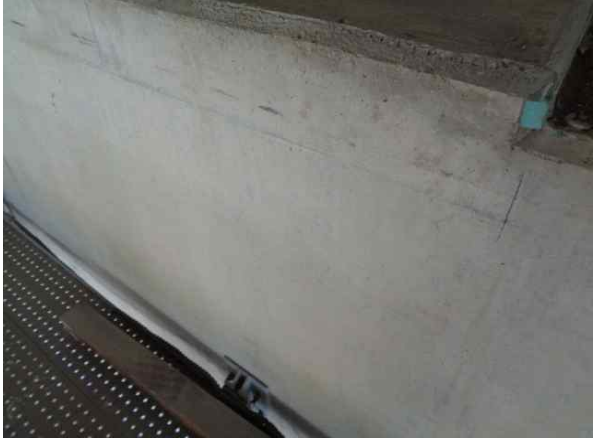
| P2 코핑부 망상균열 (6.0m×1.0m) | P2 코핑부 망상균열 (6.0m×1.0m) |

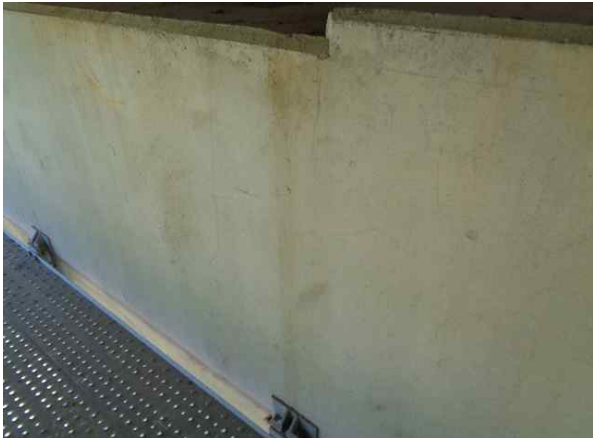
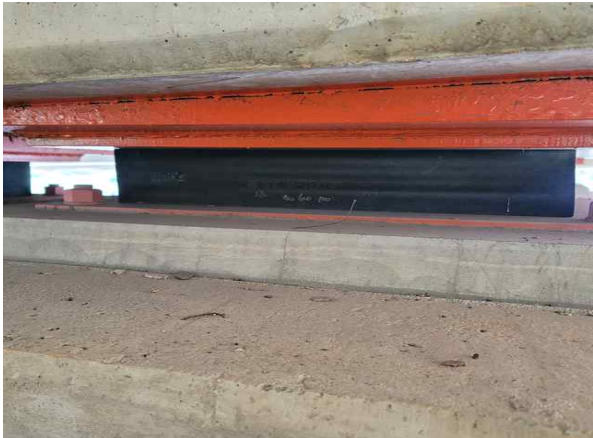
| P2 코핑부 망상균열 (8.0m×1.0m) | P1-Sh2 받침 몰탈균열 (0.2mm/0.3m) |

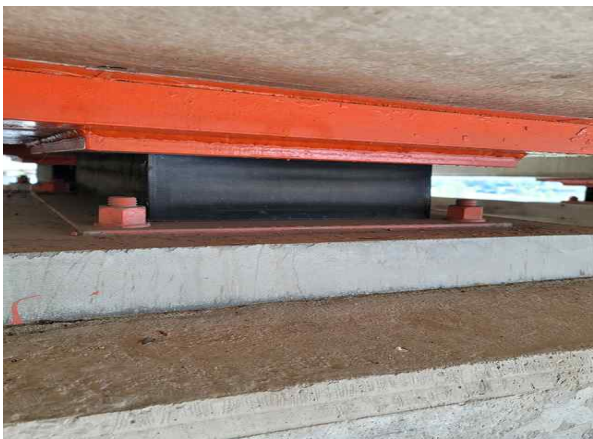
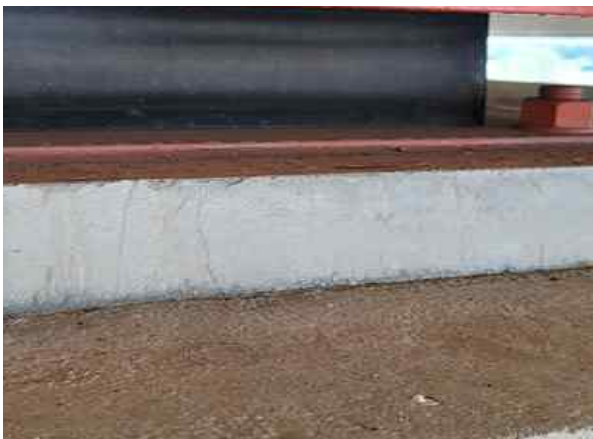
| P1-Sh5 받침 몰탈균열 (0.2mm/0.3m) | P1-Sh5 받침 몰탈균열 (0.2mm/0.3m) |

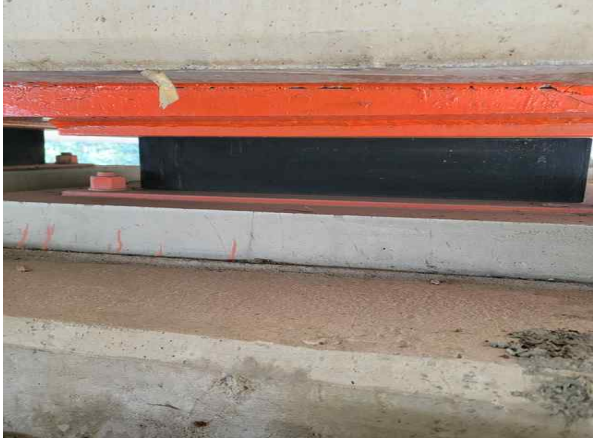
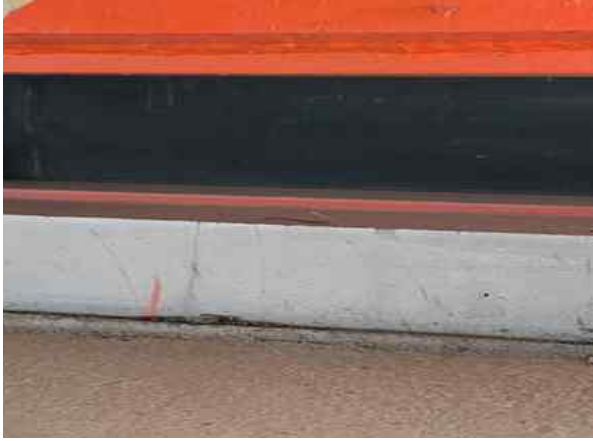
| P1-Sh8 받침 몰탈균열 (0.2mm/0.3m) | P1-Sh8 받침 몰탈균열 (0.2mm/0.3m) |

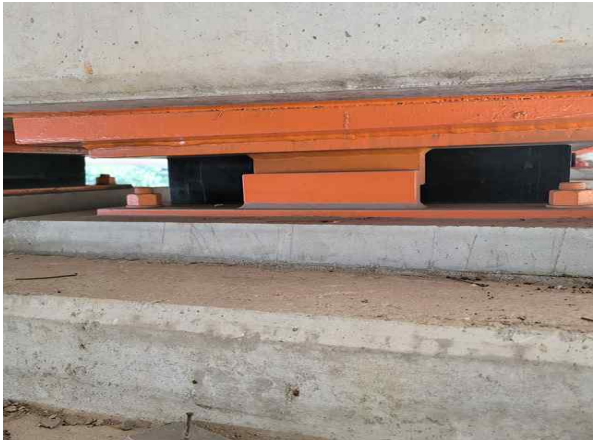
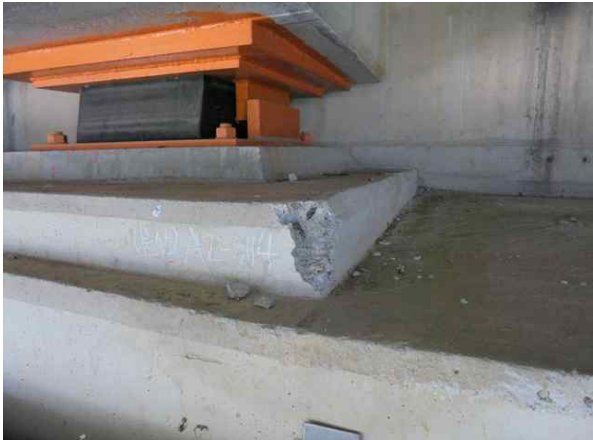
| P1-Sh10 받침 몰탈균열 (0.2mm/0.3m) | A2-Sh4 받침 콘크리트 파손 (0.2m×0.2m) |

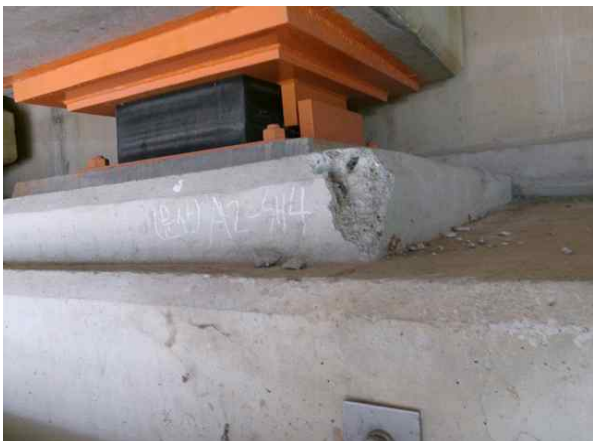
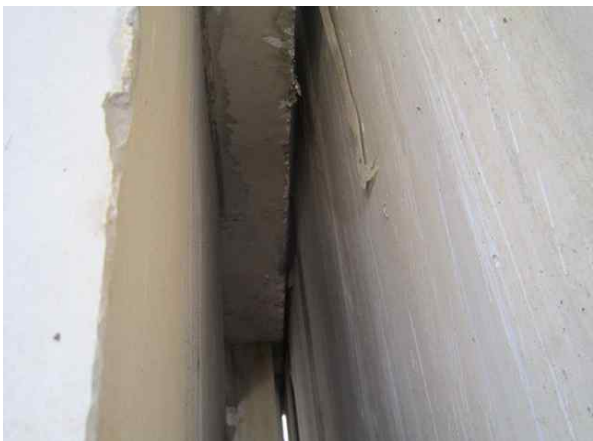
| A2-Sh4 받침 콘크리트 파손 (0.2m×0.2m) | A2 하부 누수 (0.5m/5EA) |

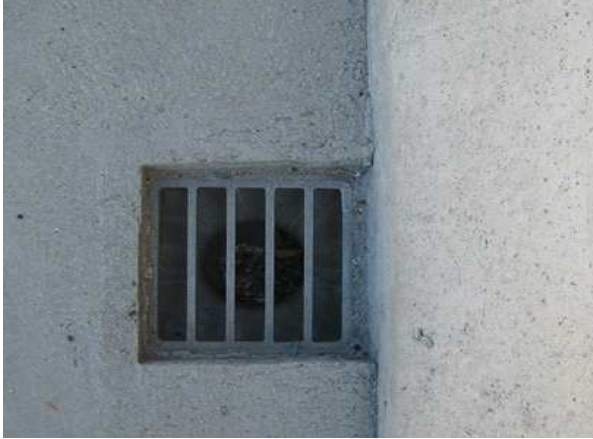
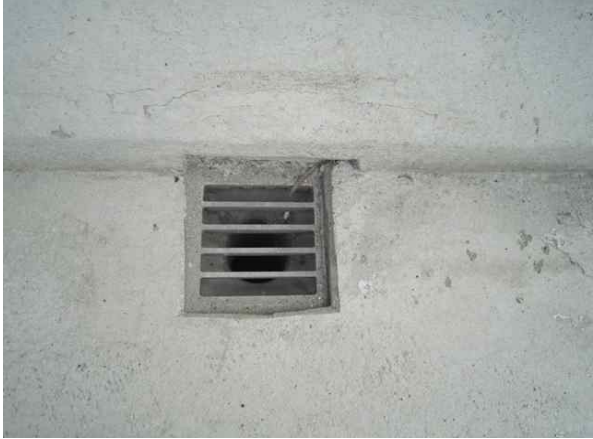
| 배수구 상태 양호 | 배수구 상태 양호 |

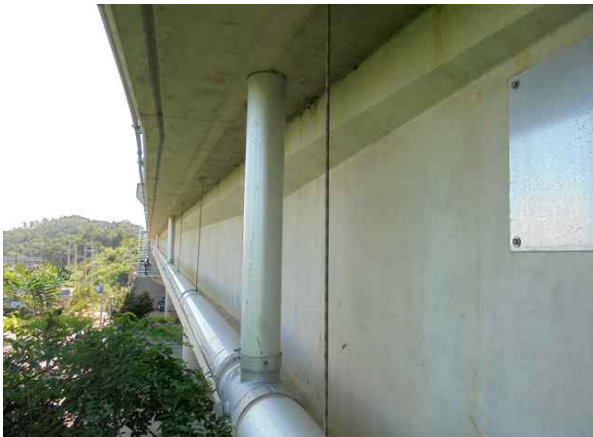
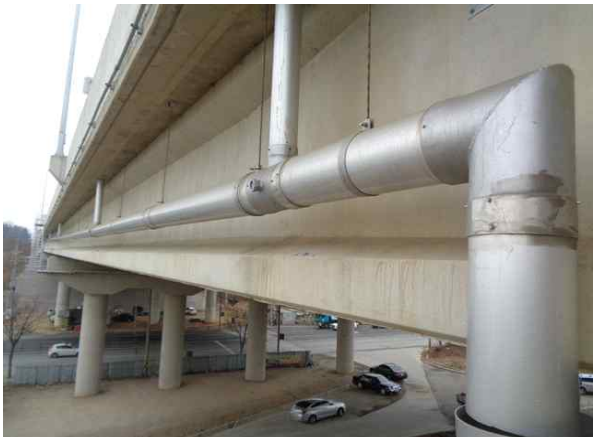
| 배수관 상태 양호 | 배수구 상태 양호 |

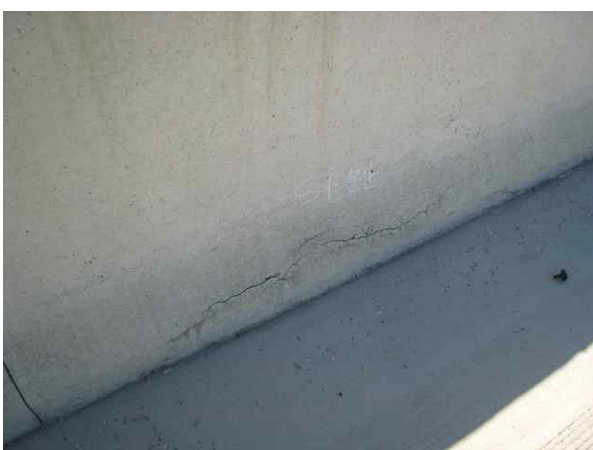
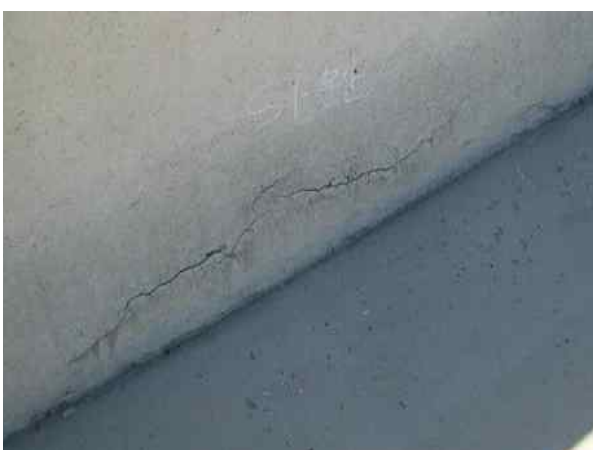
| S1 방호벽 균열(0.3mm/1.0m) | S1 방호벽 균열(0.3mm/1.0m) |

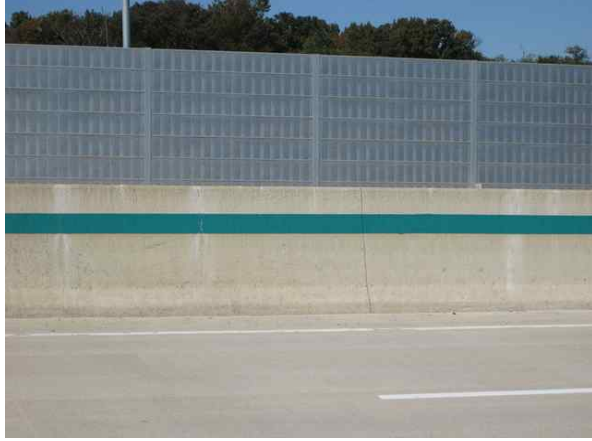
S3 방호벽 균열(0.2mm/1.5m)

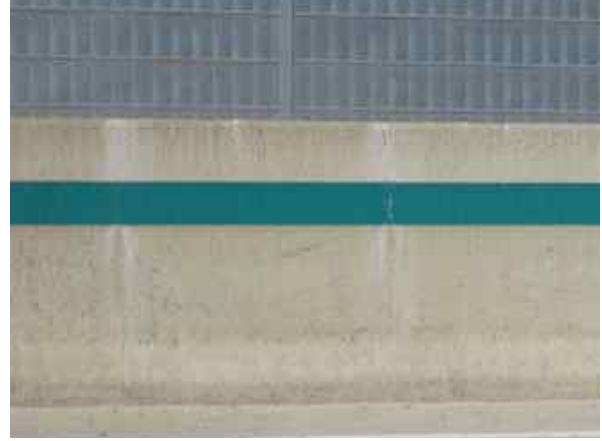
S3 방호벽 균열(0.2mm/1.5m)

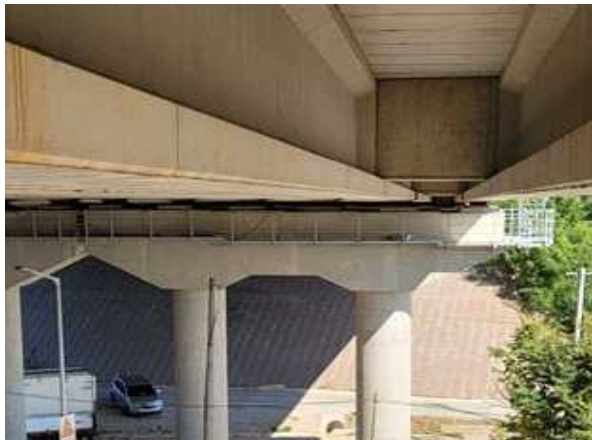
점검로 상태양호

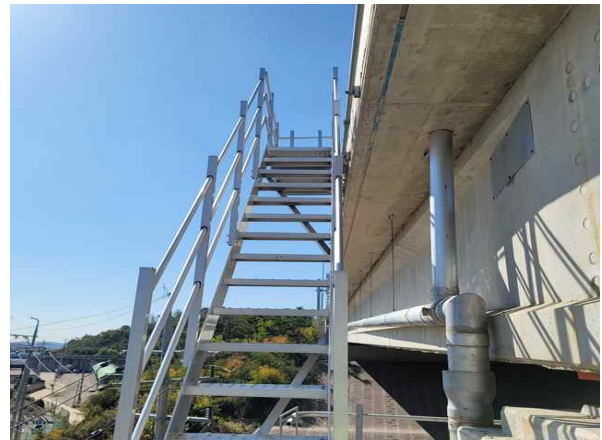
점검로 상태양호

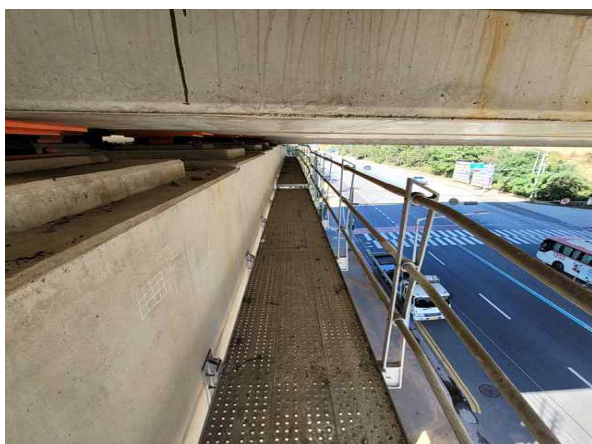
점검로 상태양호

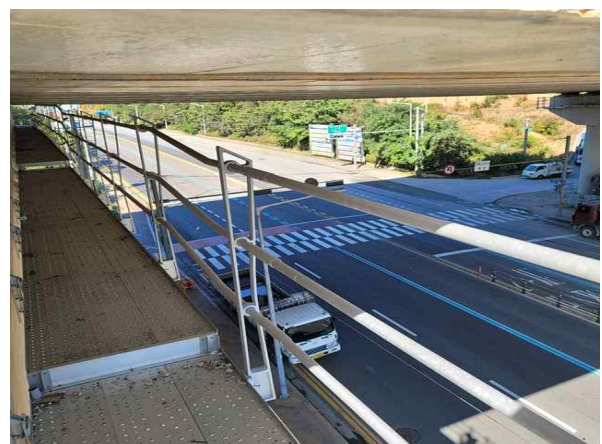
점검로 상태양호
