## 9. 서문9교(서울방향)

## 손상현황 사진

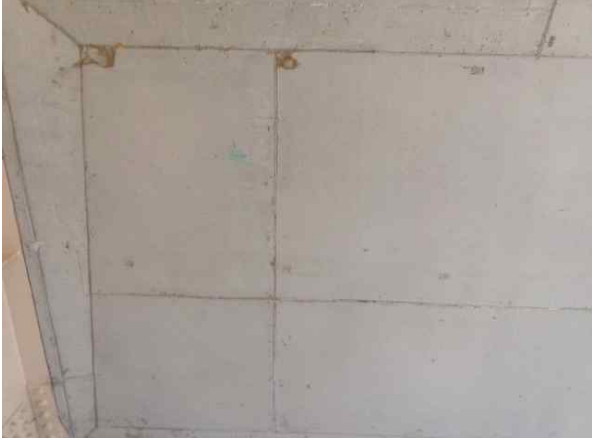
| S1 망상균열 (3.0m×10.0m×2EA) | S5 균열부백태 (0.2m×1.0m) |

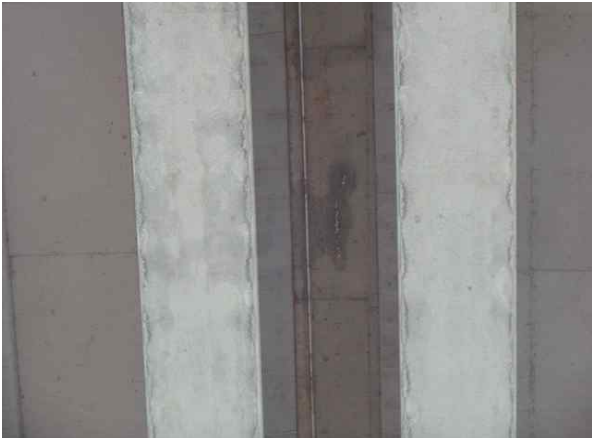
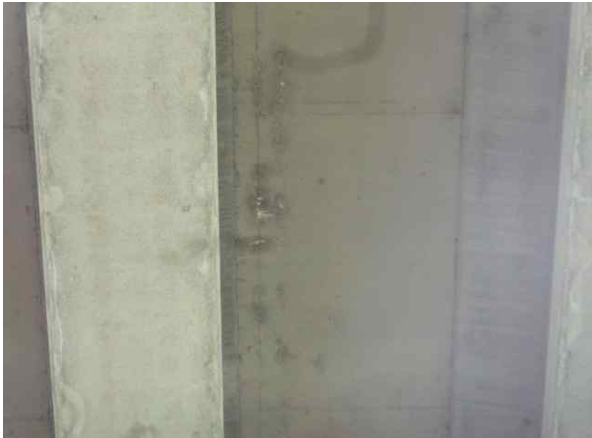
| S5 균열부백태 (0.2m×1.0m) | S5 균열부백태 (0.2m×1.5m) |

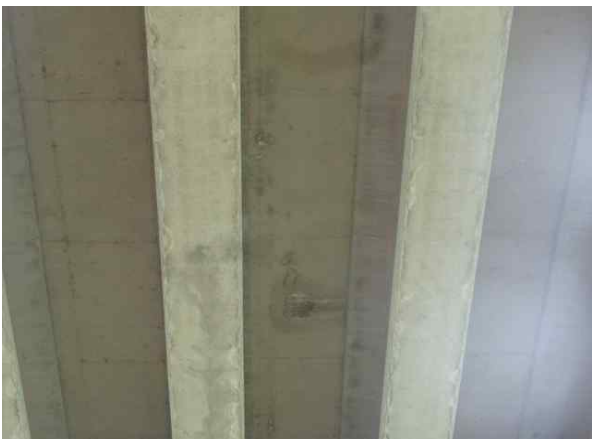
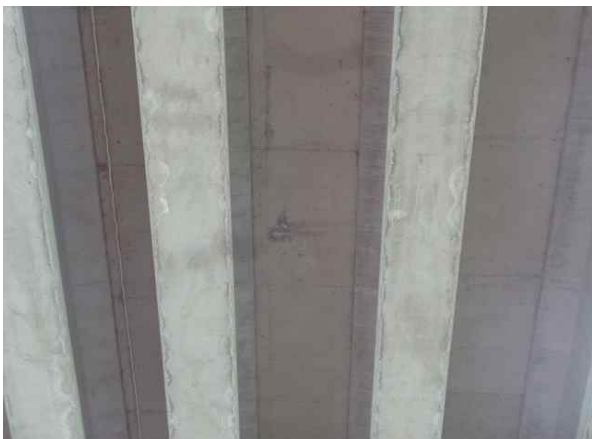
| S5 균열부백태 (0.2m×1.5m) | S5 백태 (0.3m×0.5m) |

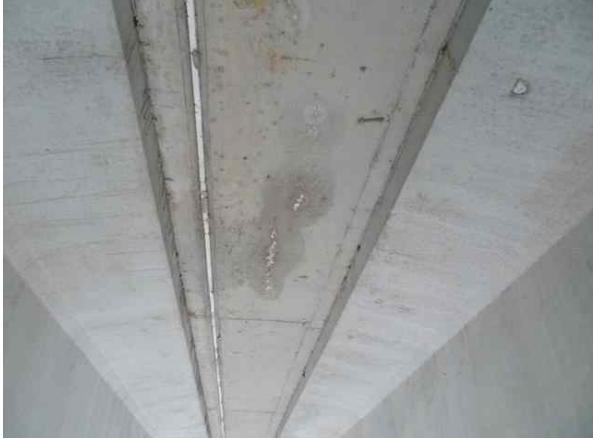
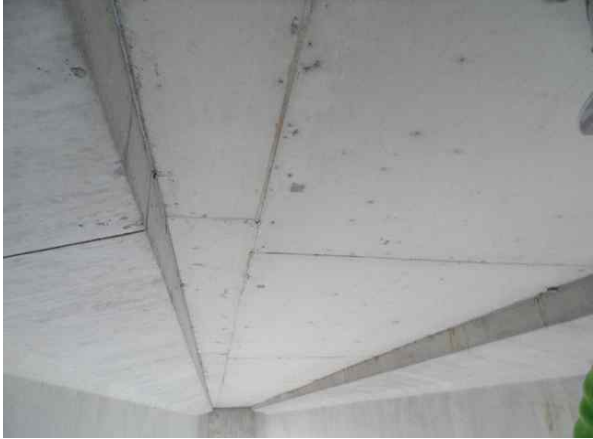
| S5 백태 (1.0m×1.0m) | S6 망상균열 (15.0m×10.0m×4EA) |

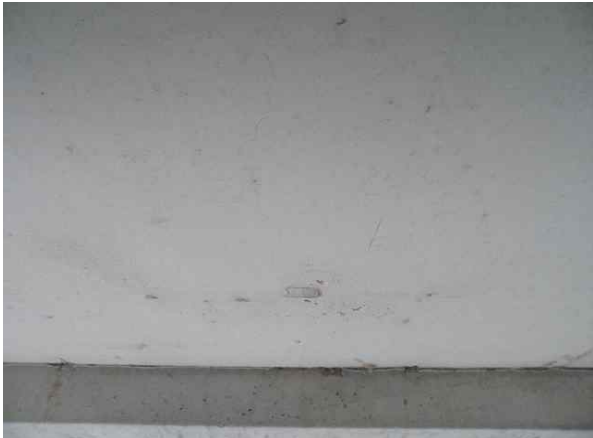
| S6 망상균열 (15.0m×10.0m×4EA) | 거더외부 상태양호 |

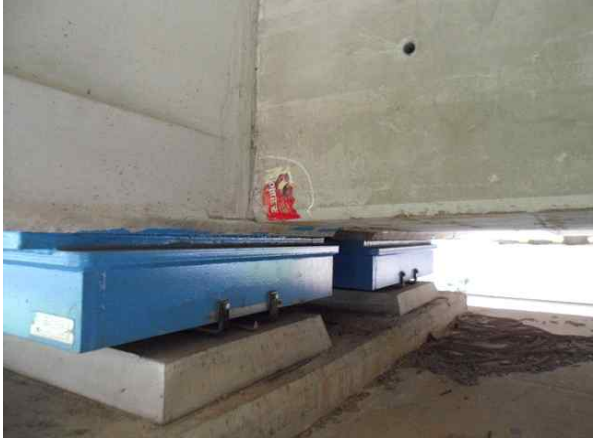
| 거더 상태양호 | S6 타설블량(0.2m×0.4m) |

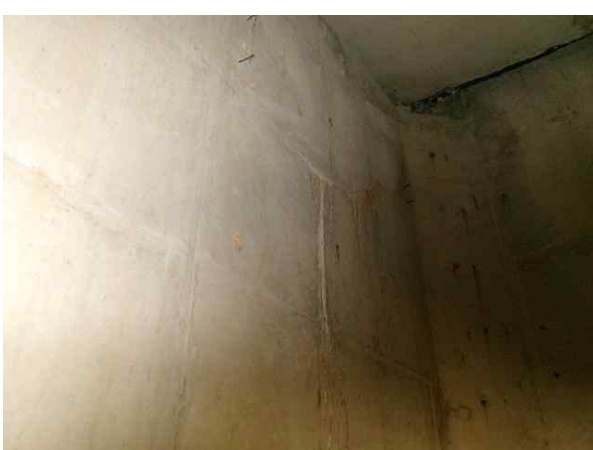
| 가로보 상태양호 | A1 균열부백태(0.2m×1.5m) |

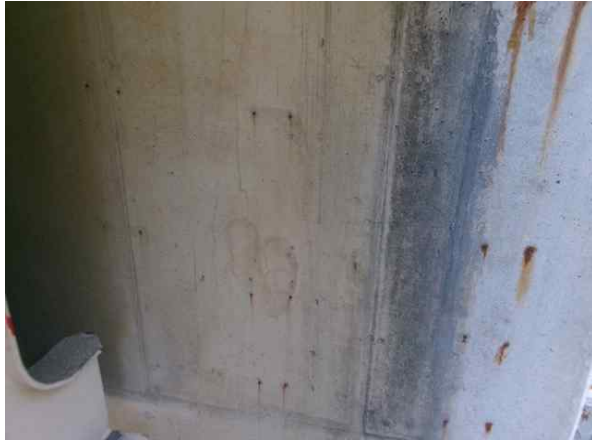
A1 망상균열 (1.0m x 2.0m)

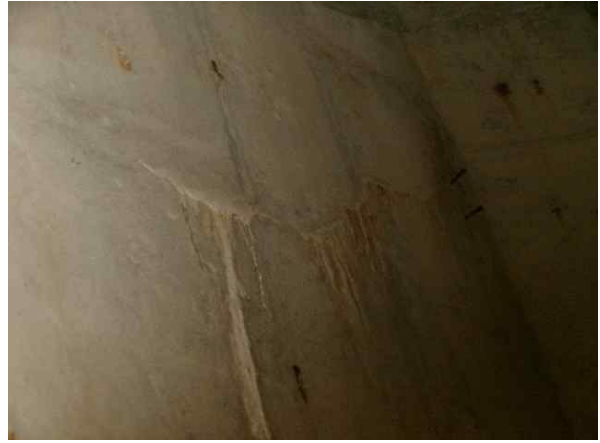
A1 균열부백태 (0.2m x 1.5m)

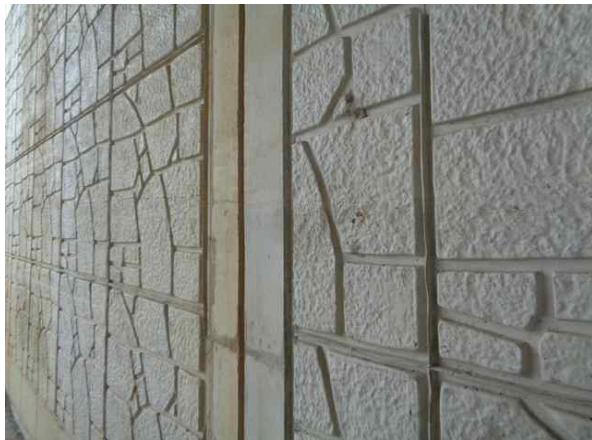
A2 균열 (0.2mm/3.0m)

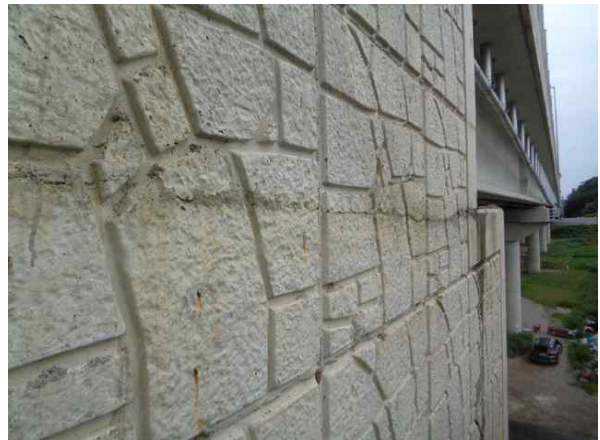
A2 균열 (0.2mm/3.0m)

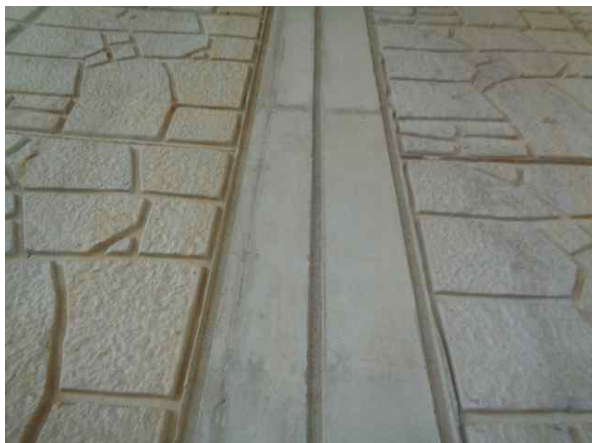
A2 균열 (0.2mm/5.5m)

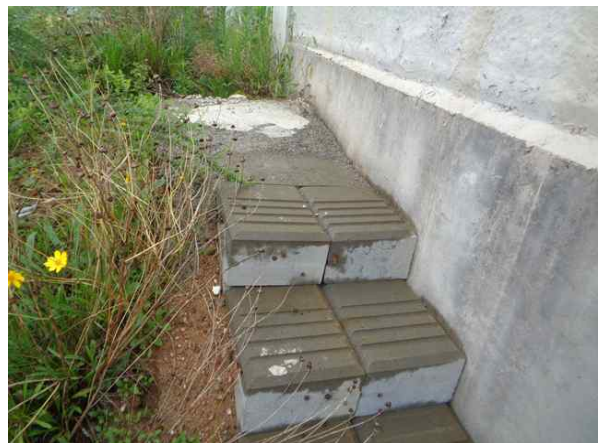
A2 날개벽 침하 (1.0m)

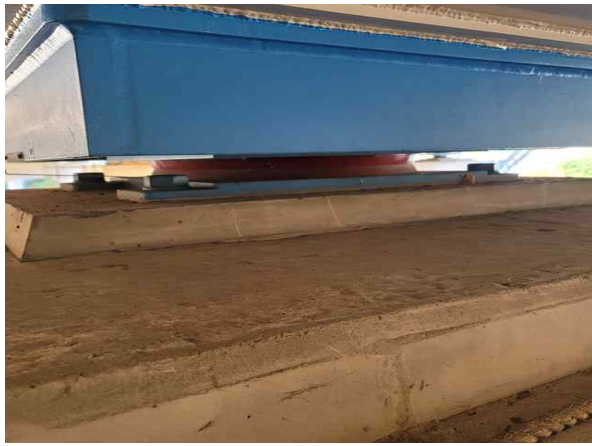
P1-Sh3 받침물탈 균열 (0.2mm/0.4m×4EA)

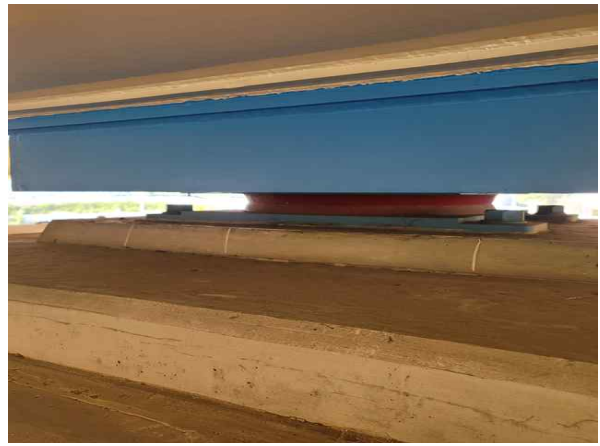
P1-Sh2 받침물탈 균열 (0.2mm/0.4m×3EA)

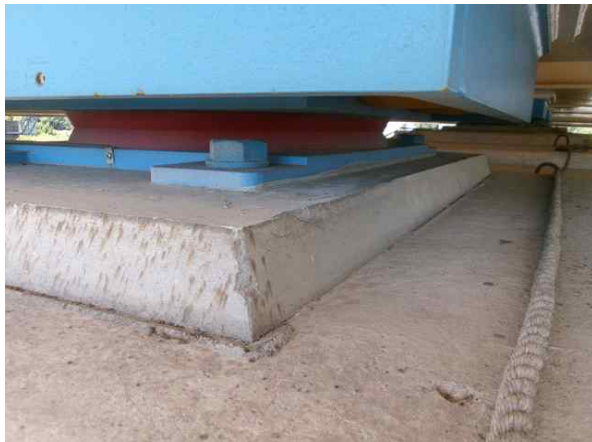
P2-Sh1 받침물탈 파손 (0.1m×0.1m)

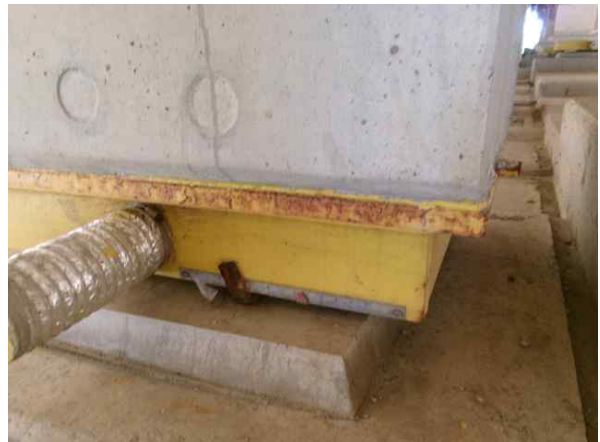
P3-Sh5 플레이트 부식 (1EA)

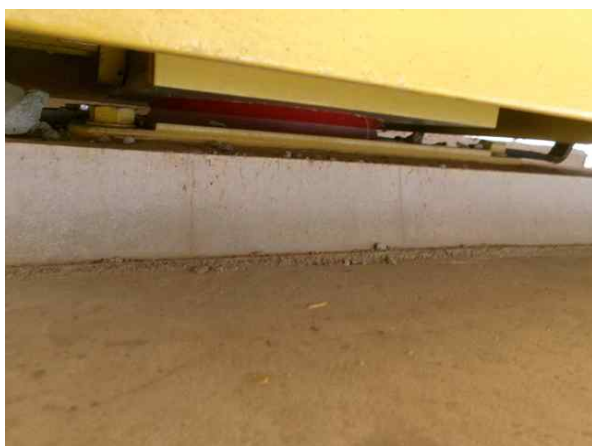
P3-Sh8 받침물탈 균열 (0.2mm/0.2m×2EA)

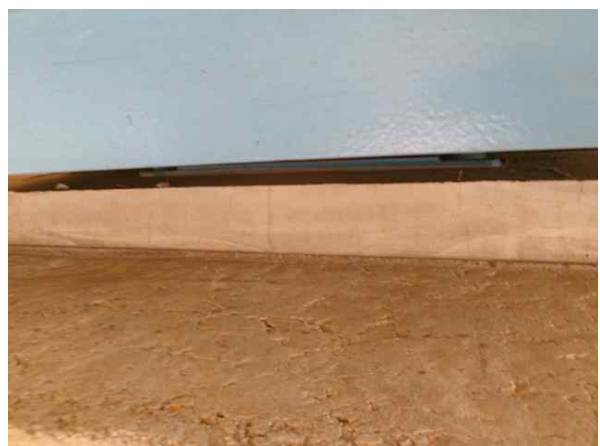
P4-Sh8 받침물탈 균열 (0.2mm/0.2m×2EA)

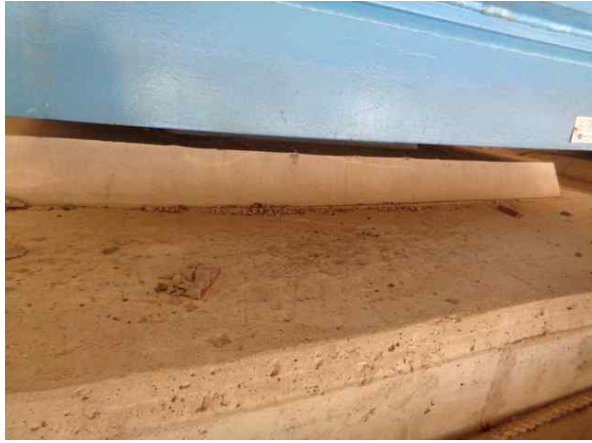
P5-Sh10 받침물탈 균열 (0.1mm/0.2m×2EA)

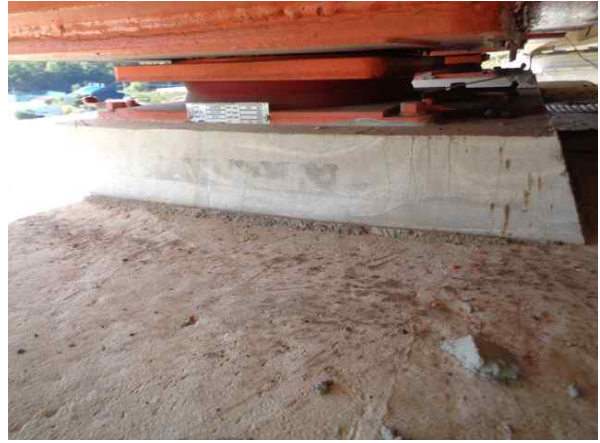
P5-Sh1 받침물탈 균열 (0.1mm/0.2m×2EA)

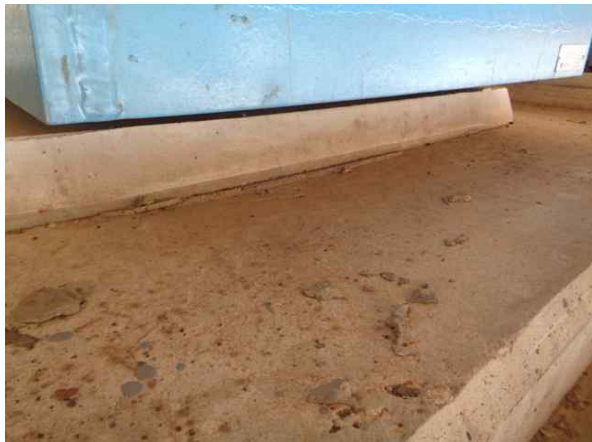
P5-Sh11 받침물탈 균열 (0.1mm/0.2m×2EA)

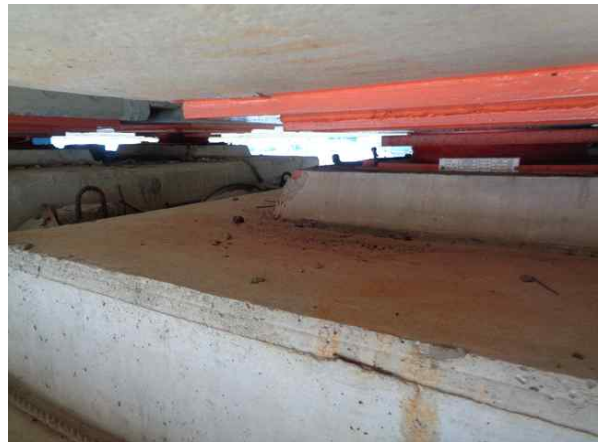
P5-Sh12 받침물탈 파손 (0.1m×0.1m)

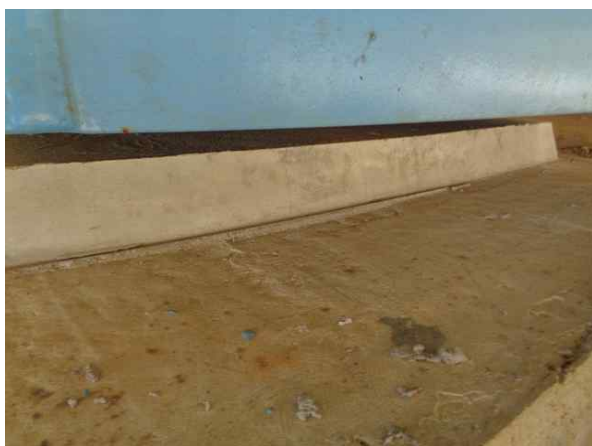
P5-Sh2 받침물탈 균열 (0.1mm/0.2m×2EA)

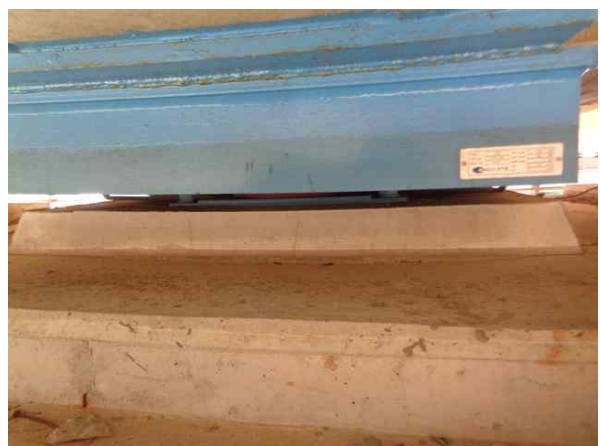
P5-Sh3 받침물탈 균열 (0.1mm/0.2m×2EA)

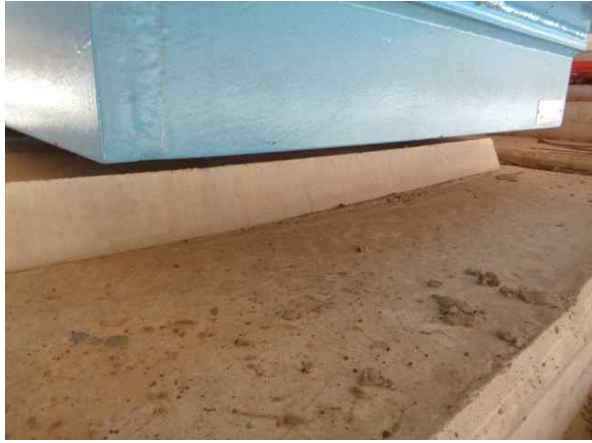
P5-Sh5 받침물탈 균열 (0.1mm/0.2m×2EA)

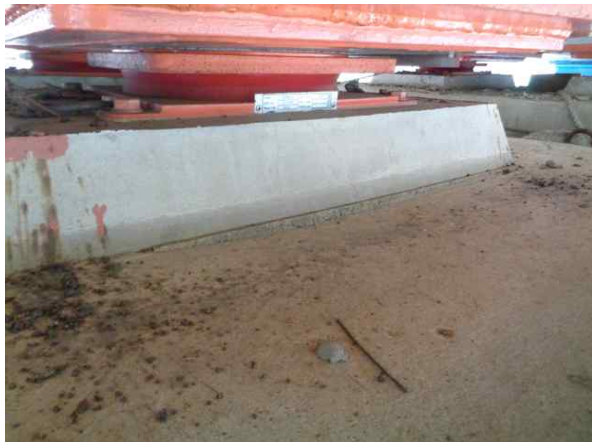
P5-Sh6 받침물탈 균열 (0.1mm/0.2m×2EA)

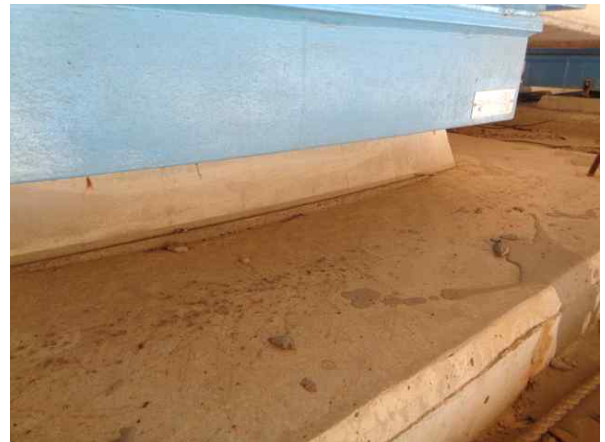
P5-Sh9 받침물탈 균열 (0.1mm/0.2m×2EA)

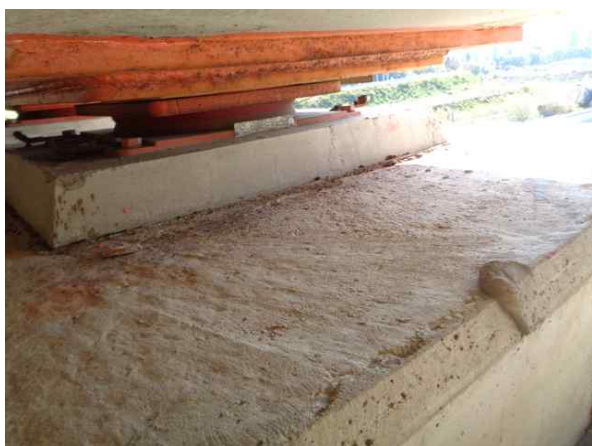
P5-Sh7 받침물탈 균열 (0.1mm/0.2m×2EA)

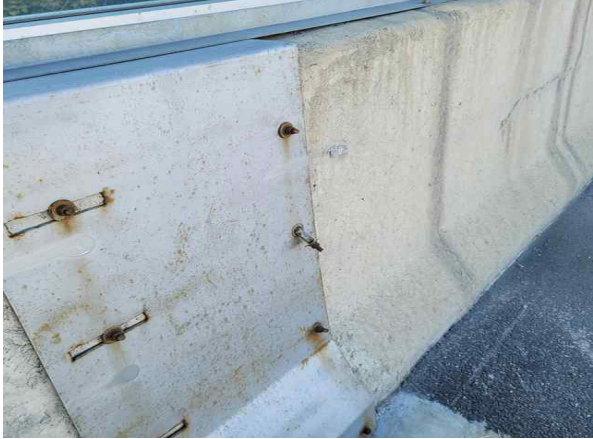
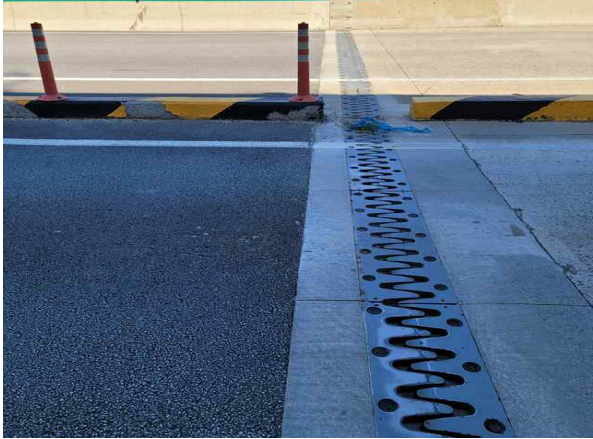
| A1 차수판 앵커탈락(1EA) | A1 후타재 균열 (0.2mm/0.3m×20EA) |

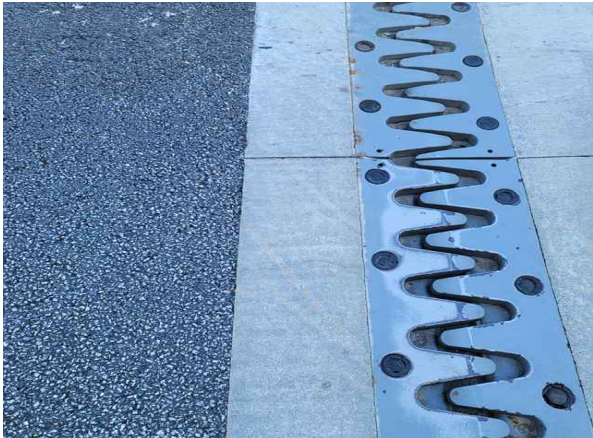
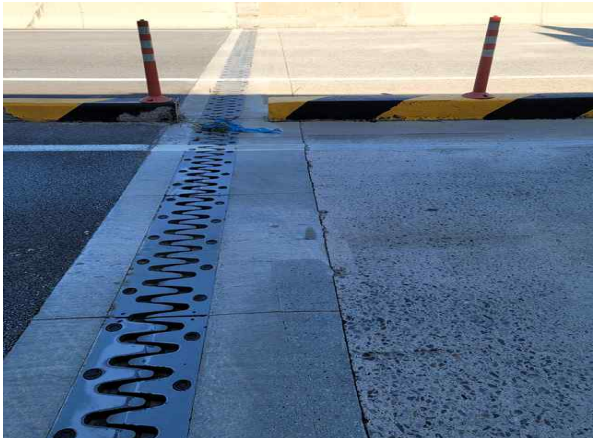
| A1 후타재 균열 (0.2mm/0.3m×20EA) | A1 후타재 균열 (0.2mm/0.5m×20EA) |

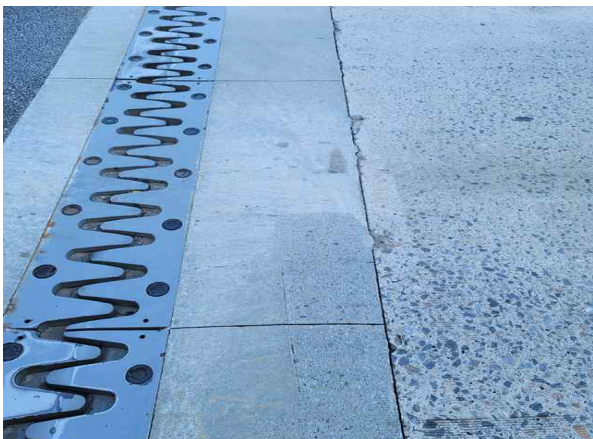
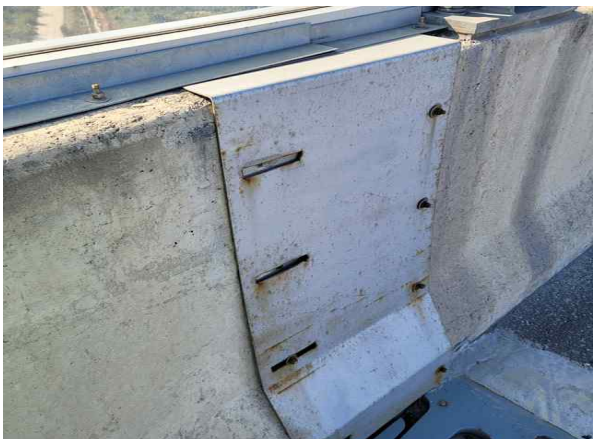
| A1 후타재 균열 (0.2mm/0.5m×20EA) | P3 차수판 앵커탈락(2EA) |

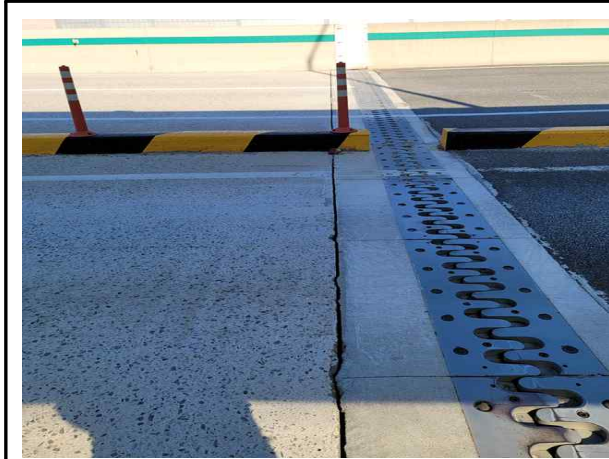
S7 접속부 이격(12.0m)

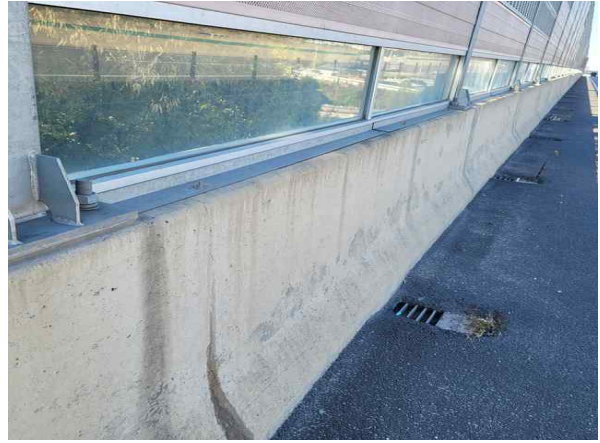
S1 균열 (0.2mm/1.5m×8EA)

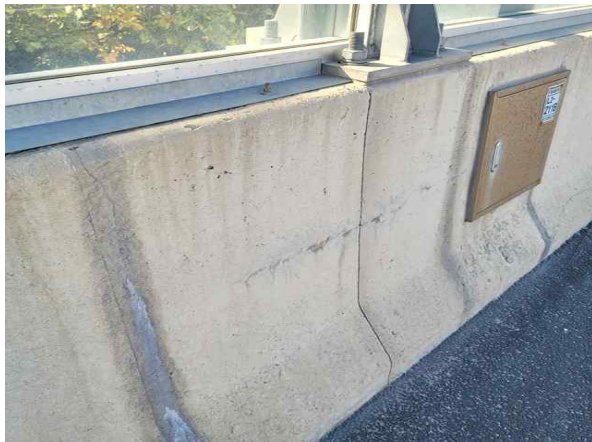
S1 균열 (0.2mm/1.0m)

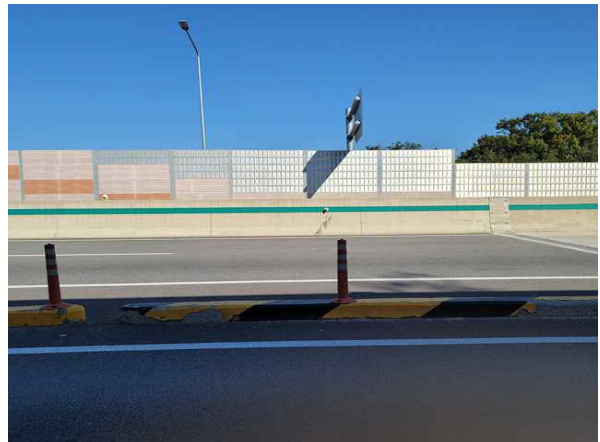
S1 균열 (0.2mm/1.5m)

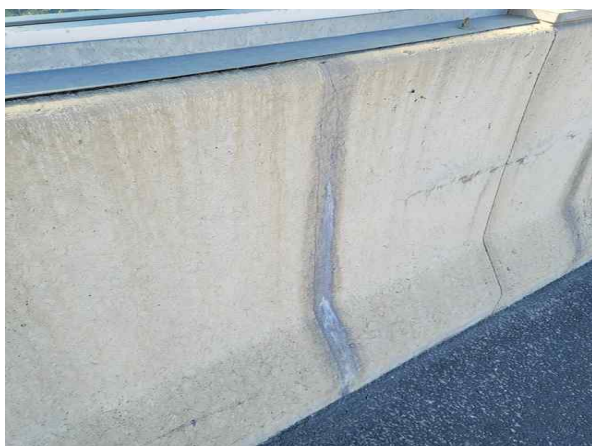
S1 균열부 백태 (0.1m×1.0m)

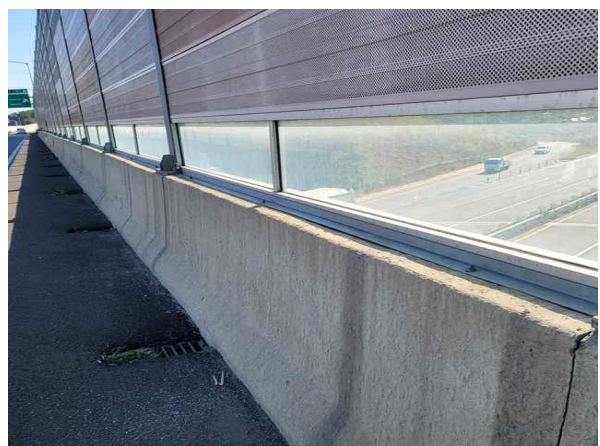
S2 균열 (0.2mm/1.5m×14EA)

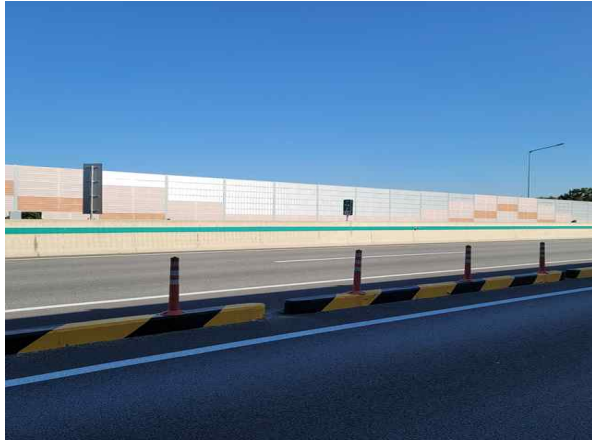
S2 균열 (0.2mm/1.5m×10EA)

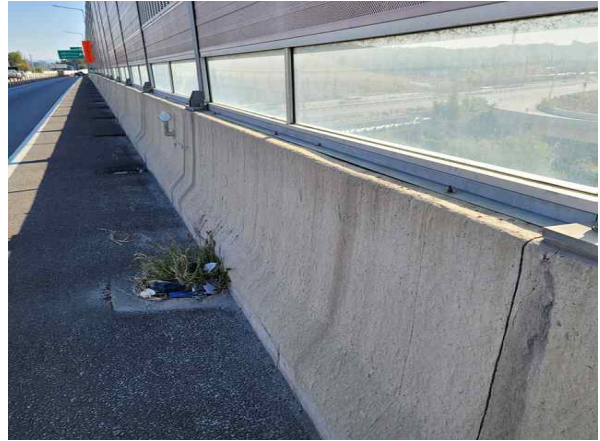
S3 균열 (0.2mm/1.5m×16EA)

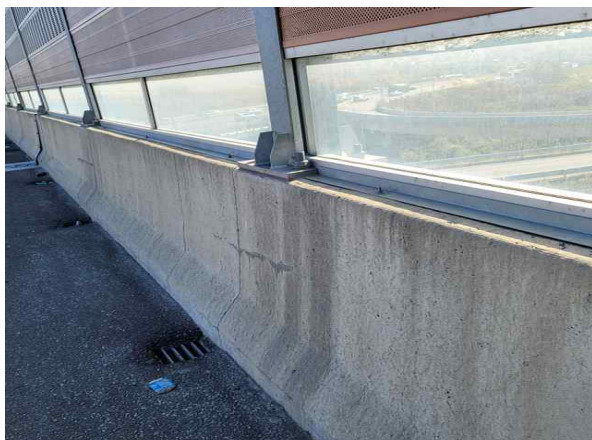
S4 균열 (0.2mm/1.5m×17EA)

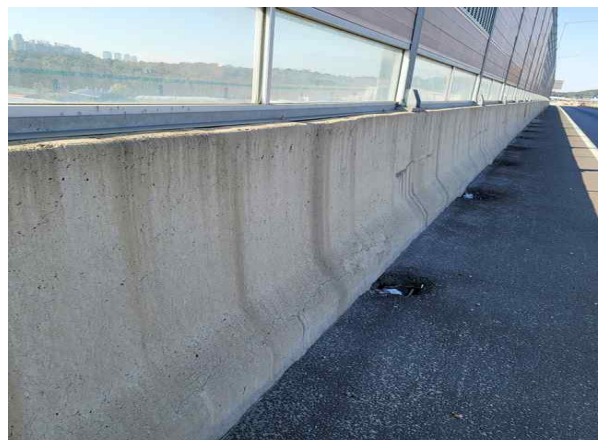
S5 균열 (0.2mm/1.5m×24EA)

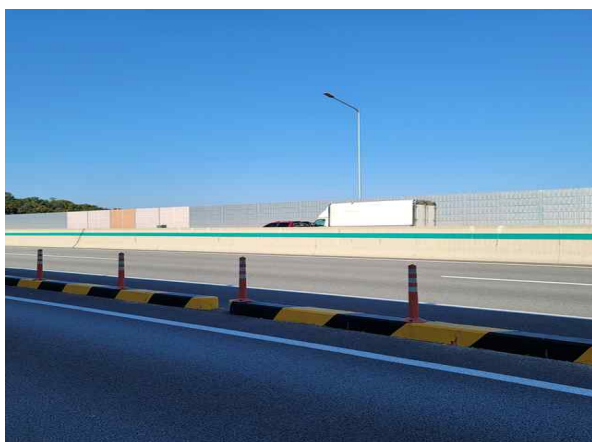
S5 균열 (0.2mm/1.5m×13EA)

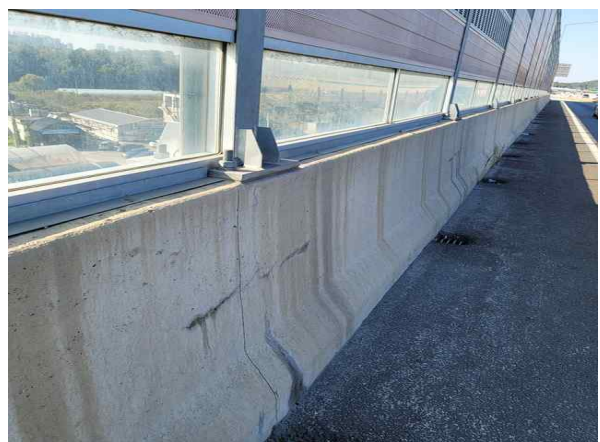
S6 균열 (0.2mm/1.5m×12EA)

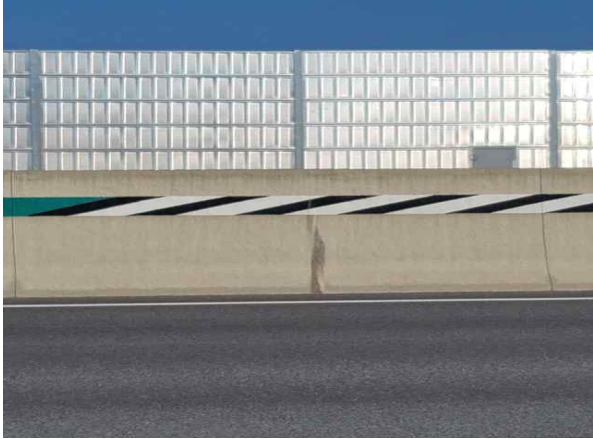
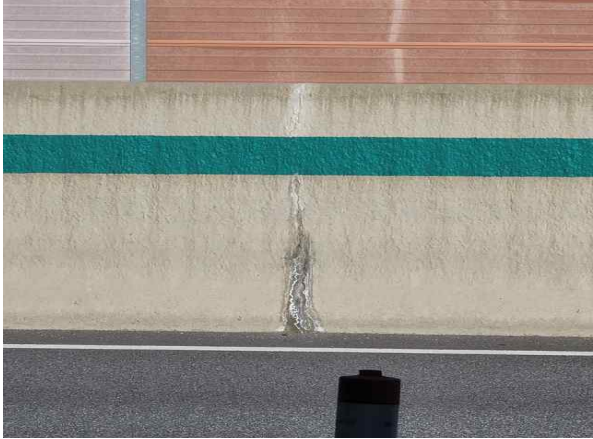
| S6 균열 (0.2mm/1.5m) | S6 균열부백태 (0.2m×1.5m) |

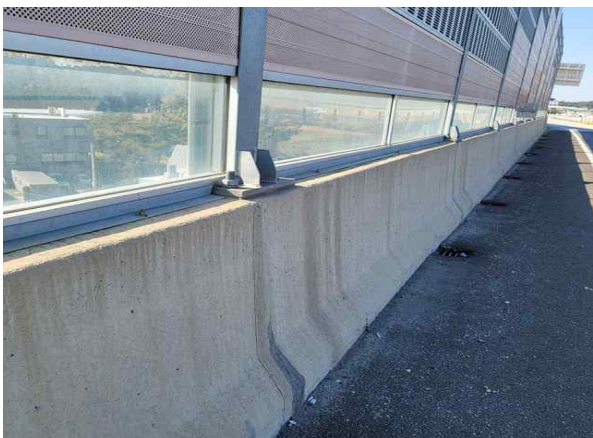
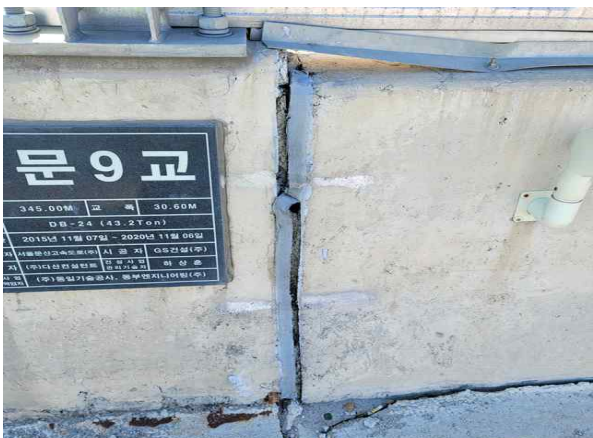
| S7 균열 (0.2mm/1.5m×6EA) | S7 접속부 단차 (1.5m) |

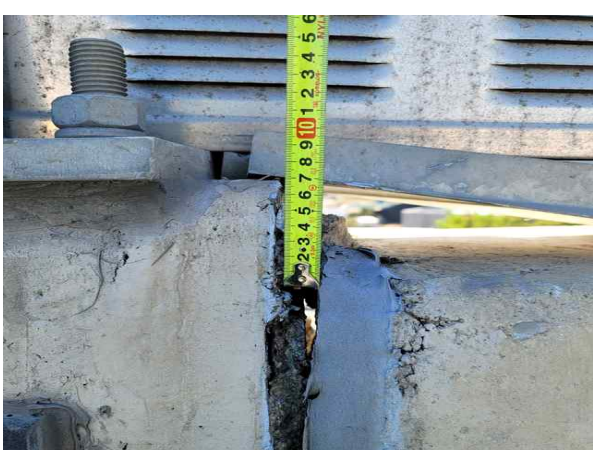
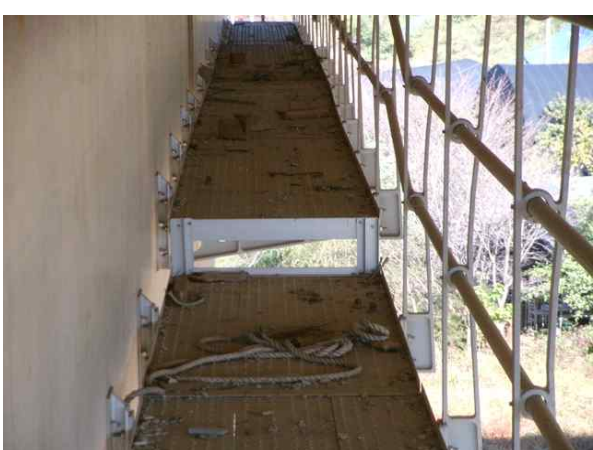
| S7 접속부 단차 (1.5m) | P4 점검로 폐자재 적치 (15.0m×1.0m) |

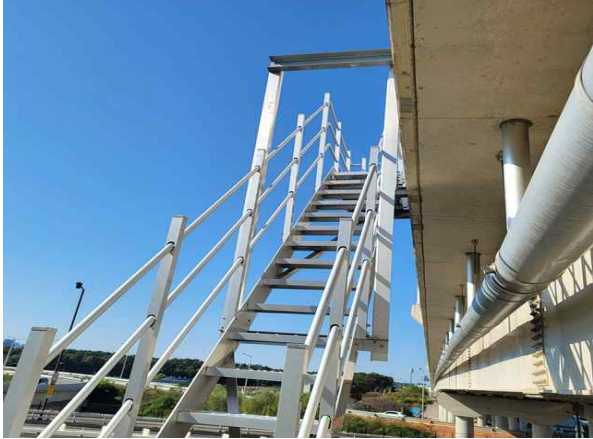
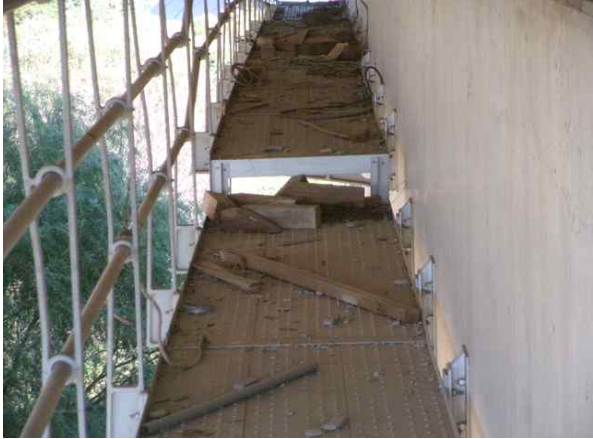
| P4 점검로 폐자재 적치 (15.0m×1.0m) | P4 점검로 폐자재 적치 (15.0m×1.0m) |
