# 2016년 상반기 시설물 정기점검 용역(7공구) 정 기 점 검 외 관 조 사 망 도

[ 기 타 종 시 설 물 / 교 량 ]

2016. 6.

# 7공구 시설물

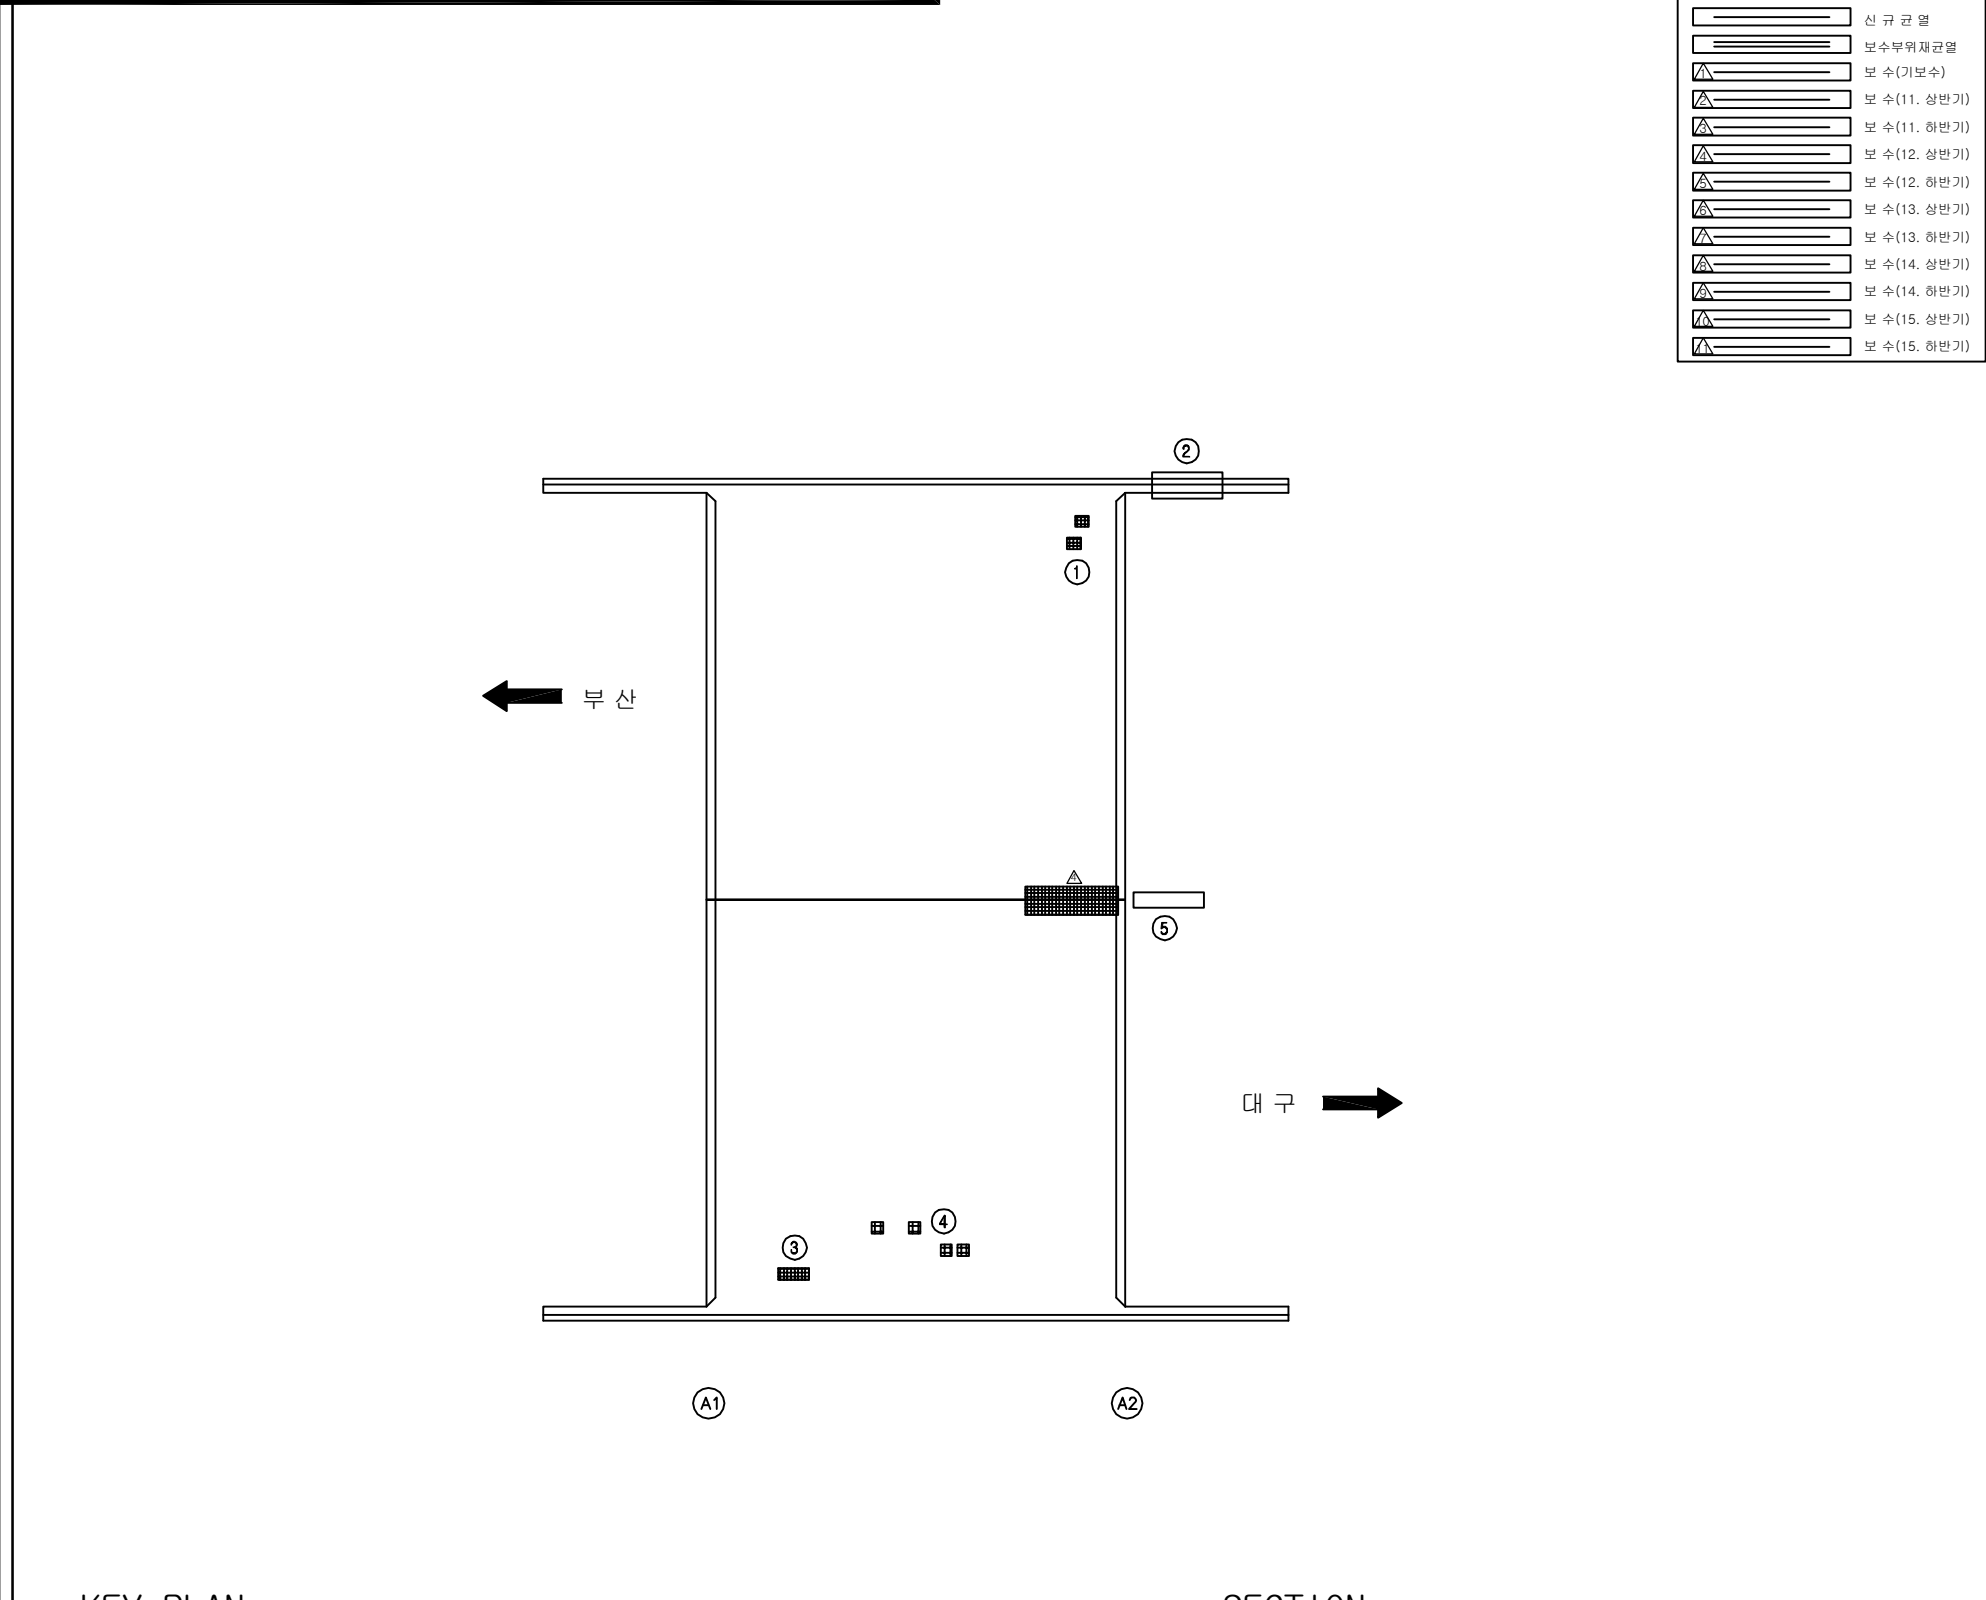
10:용평2교-교면포장

| 구 분 | | 손 상 현 황 | | 단 위 | 경 간 별 수 량 | | 합 계 | 비 고 |
|---|---|---|---|---|---|---|---|---|
| 기타 부재 | 교면포장 | 패임 | | m <sup>2</sup><br>(개소) | 0.06<br>(5) | | 0.06<br>(5) | |
| | 콘크리트 난간 | 차량충돌흔적 | | m<br>(개소) | 3.0<br>(1) | | 3<br>(1) | |

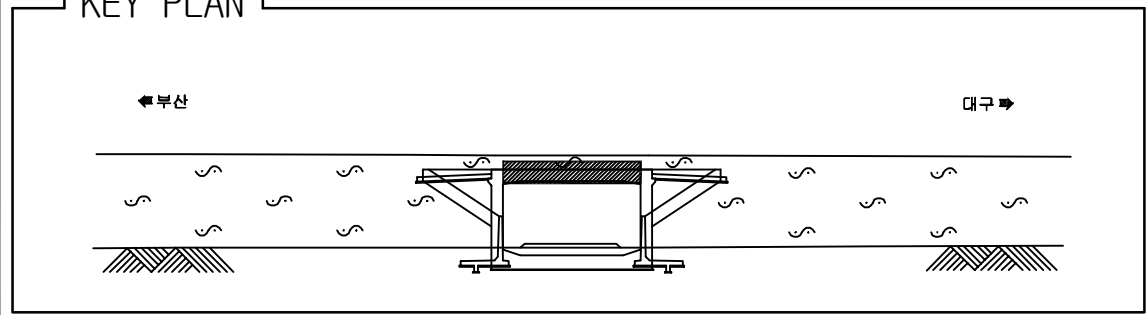
10:용평2교-바닥판하면

| 구 분 | | 손 상 현 황 | | 단 위 | 경 간 별 수 량 | | 합 계 | 비 고 |
|---|---|---|---|---|---|---|---|---|
| 상 부 구조 | 바닥판 하면 | 균열 | 0.3mm미만 | m<br>(개소) | 10.0<br>(3) | | 10<br>(3) | |
| | | 실란트 손상 | | m<br>(개소) | 14.0<br>(1) | | 14<br>(1) | |

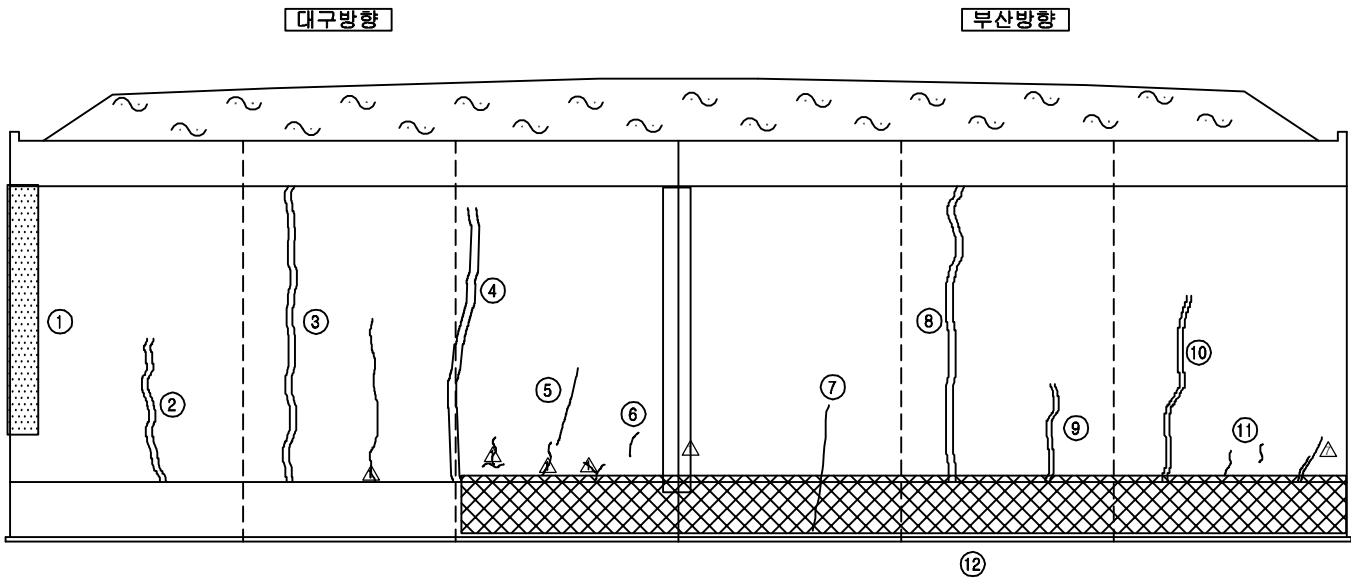
ID:용평2교-교대 A1

| 구 분 | | 손 상 현 황 | | 단 위 | 경 간 별 수 량 | | 합 계 | 비 고 |
|---|---|---|---|---|---|---|---|---|
| 하 부 구조 | 교대 | 균열 | 0.3mm미만 | m<br>(개소) | 4.2<br>(2) | 8.8<br>(4) | 13<br>(6) | |
| | | | 0.3mm이상 | m<br>(개소) | 15.7<br>(3) | 7.8<br>(2) | 23.5<br>(5) | |
| | | 누수흔적 | | m <sup>2</sup><br>(개소) | 2.0<br>(1) | -<br>(-) | 2<br>(1) | |

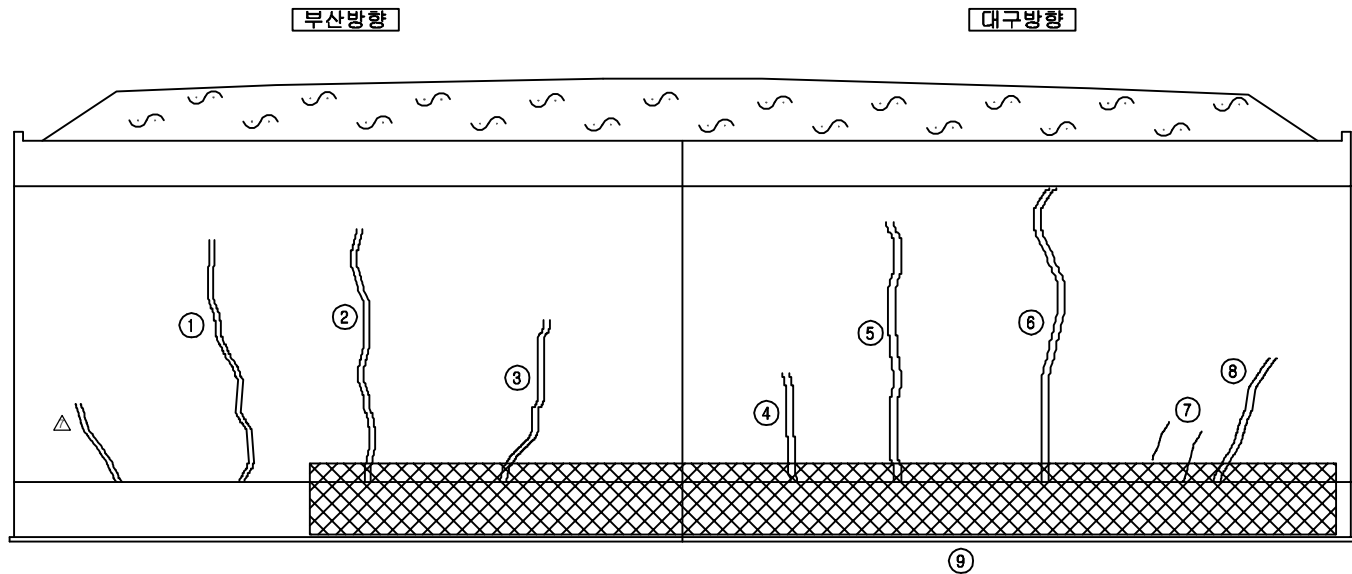
ID:용평2교-교대 A2

| 구 분 | | 손 상 현 황 | | 단 위 | 경 간 별 수 량 | | 합 계 | 비 고 |
|---|---|---|---|---|---|---|---|---|
| | | 이물질 적치 | | m <sup>2</sup><br>(개소) | -<br>(-) | 30.0<br>(1) | 30<br>(1) | |

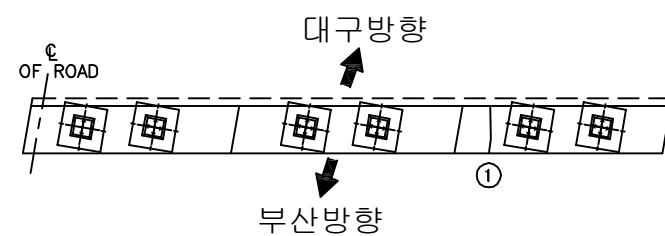
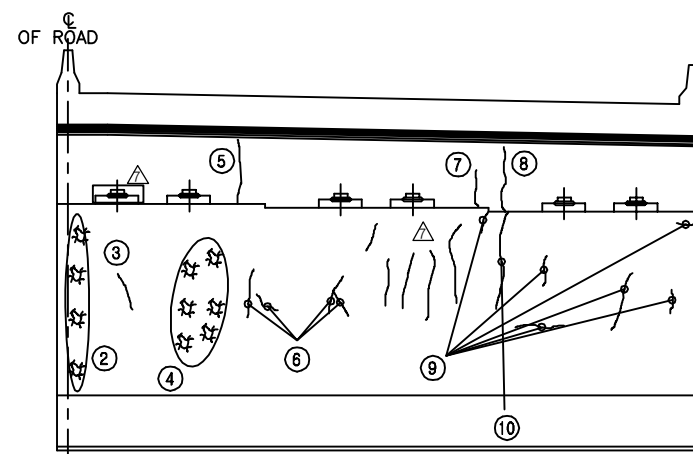
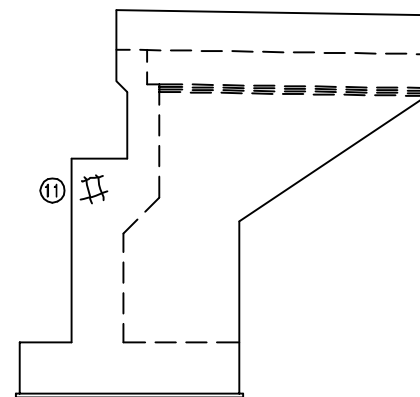
ID:밀양IC교(대구)-교대 A1

- ⑫ ※ 차수판 앵커 탈락(1EA)  
⑬ ※ 간격재 미 제거  
⑭ ※ 배수측구 손상

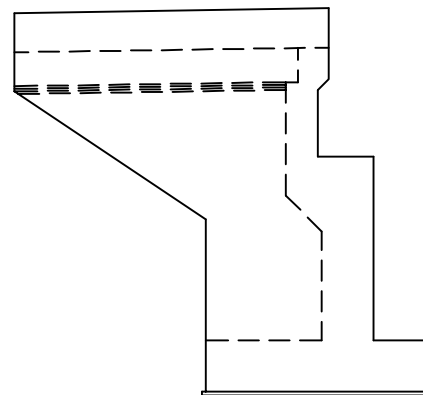
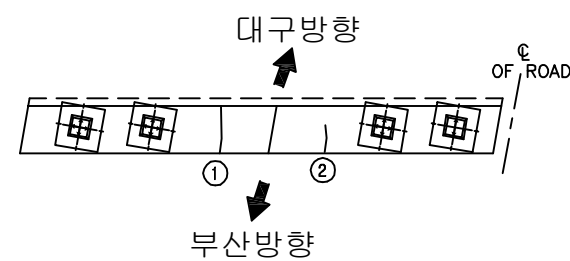
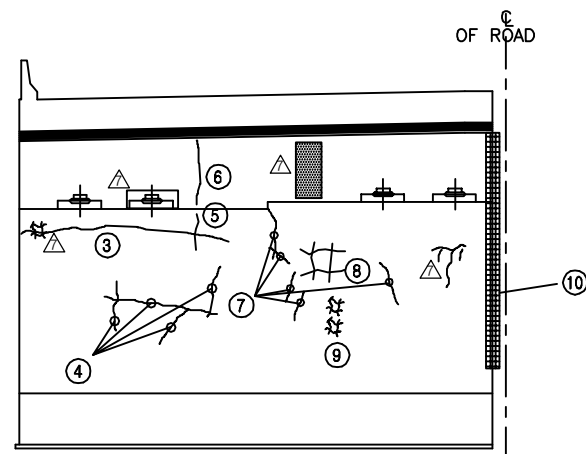
ID:밀양IC교(부산)-교대 A2

⑪ ※ 차수판 볼트 탈락
