범안대교

## 범안대교

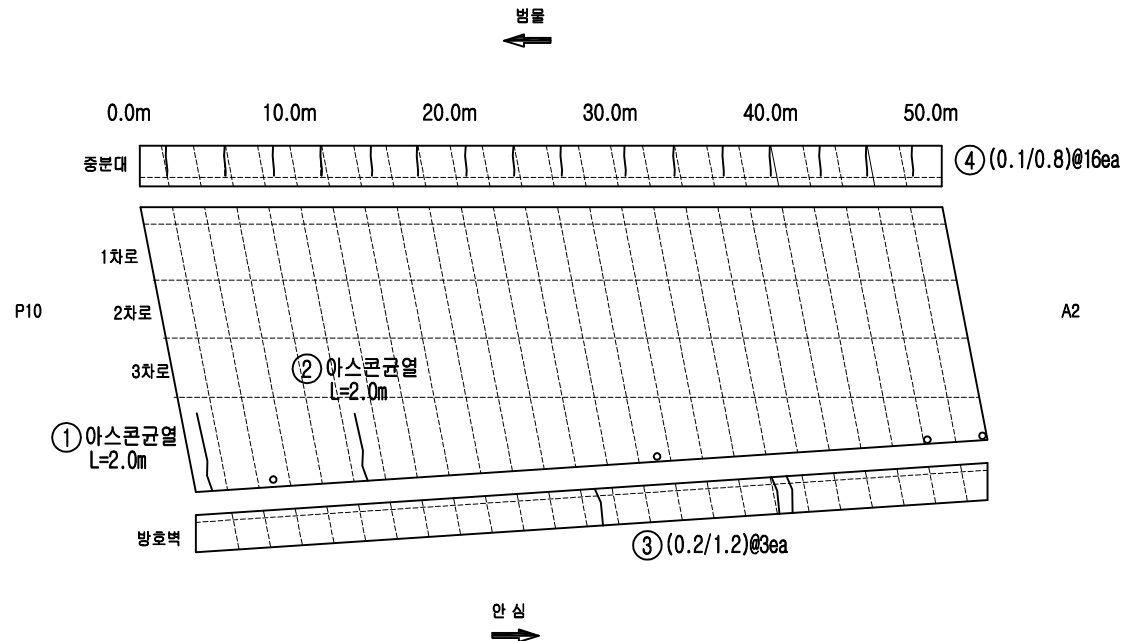
| 번호 | 위치 | 손상내용 | 손상물량 | | | | | 보수보강방안 |
|---|---|---|---|---|---|---|---|---|
| 1 | 포장부 | 아스콘 균열 | - | 2.0 | 1 | m | 2.0 | 아스팔트심당 |
| 2 | 포장부 | 아스콘 균열 | - | 2.0 | 1 | m | 2.0 | 아스팔트심당 |
| 3 | 방호벽 | 균열 | 0.2 | 1.2 | 3 | m | 3.6 | 주의관찰 |
| 4 | 중문대 | 균열 | 0.1 | 0.8 | 16 | m | 12.8 | 주의관찰 |

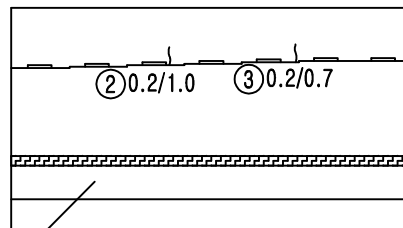
교 대(A1)

① 싼재 탈락  
6ea

④ 법면 침하  
0.3X0.3

⑤ 법면보호블럭 침하  
L=13.0m(T=0.16)
