## 02. 옹벽

| 용역명 | | 부산울산선 11.75k(부산) 등 12개소 비탈면·옹벽 정밀안전점검 및 성능평가용역 | | | | | | |

ID :부산울산선 용벽 29.483K(포항) STA.80.0 ~ STA.120.0

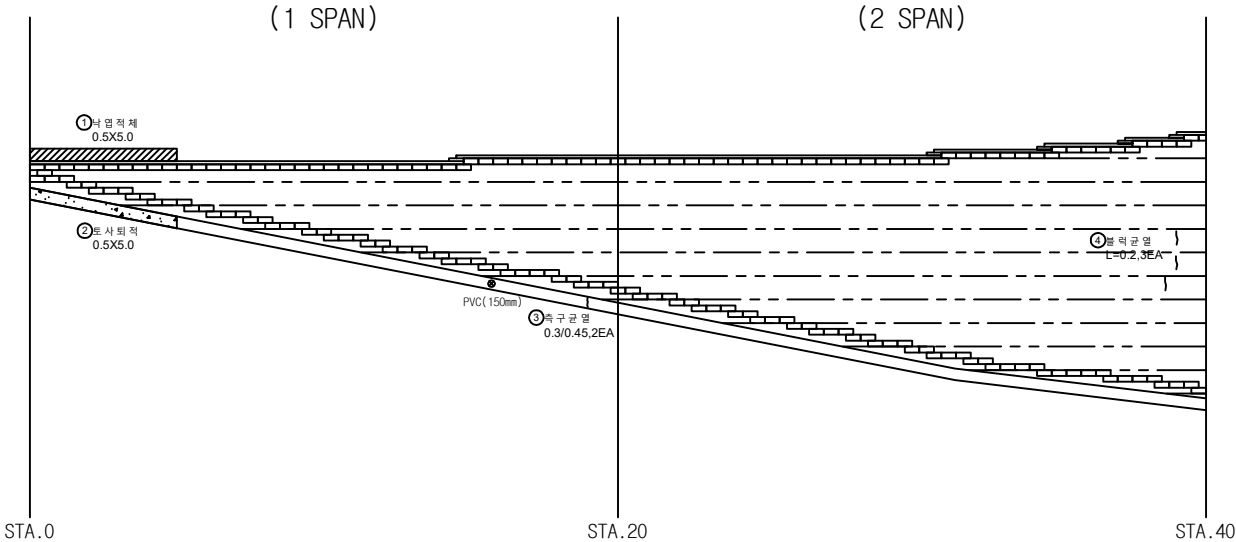
| 번호 | 손상내용 | 폭(mm) | 길이(m) | 너비(m) | 개소 | 손상물량 | | 비고 |
|---|---|---|---|---|---|---|---|---|
| 1 | 낙엽적체 | | 0.5 | 5.0 | 1 | 2.50 | m <sup>2</sup> | |
| 2 | 토사퇴적 | | 0.5 | 5.0 | 1 | 2.50 | m <sup>2</sup> | |
| 3 | 측구균열 | 0.3 | 0.45 | | 2 | 0.90 | m | |
| 4 | 블럭균열 | | 0.2 | | 3 | 0.60 | m | |

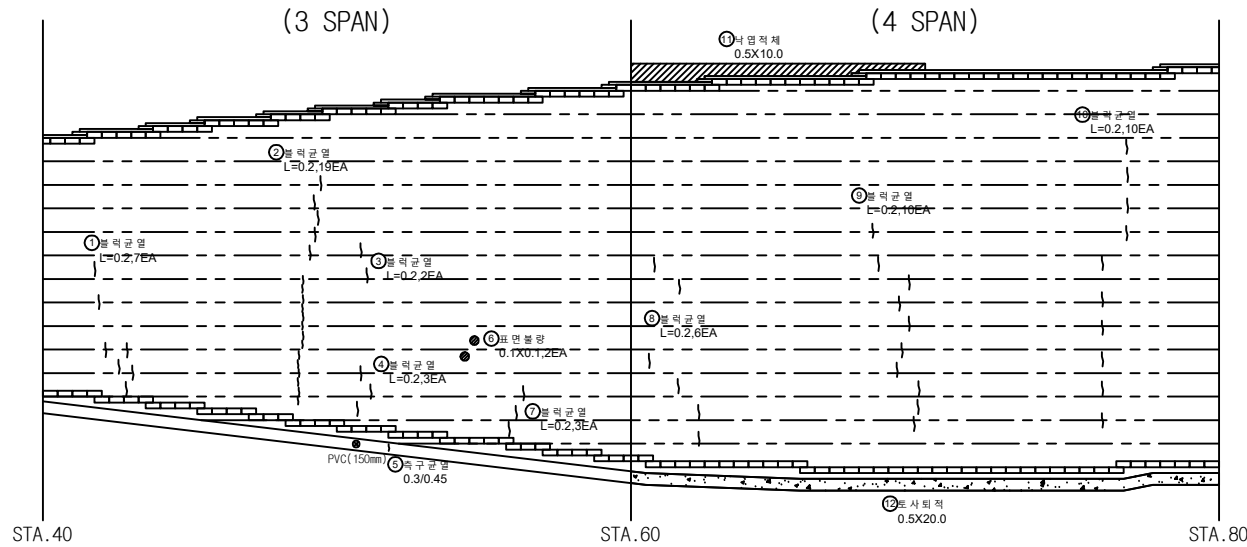
| 용역명 | | 부산울산선 11.75k(부산) 등 12개소 비탈면·옹벽 정밀안전점검 및 성능평가용역 | | | |
|---|---|---|---|---|--|
| | 철근노출 | 오염 | 배수구막힘 | No. 002 | |

| 번호 | 손상내용 | 폭(mm) | 길이(m) | 너비(m) | 개소 | 손상물량 | | 비고 |
|---|---|---|---|---|---|---|---|---|
| 1 | 불력균열 | | 0.2 | | 7 | 1.40 | m | |
| 2 | 불력균열 | | 0.2 | | 19 | 3.80 | m | |
| 5 | 측구균열 | 0.3 | 0.45 | | 1 | 0.45 | m | |
| 6 | 표면불량 | | 0.1 | 0.1 | 2 | 0.02 | m <sup>2</sup> | |
| 11 | 낙엽적체 | | 0.5 | 10.0 | 1 | 5.00 | m <sup>2</sup> | |
| 12 | 토사퇴적 | | 0.5 | 20.0 | 1 | 10.00 | m <sup>2</sup> | |

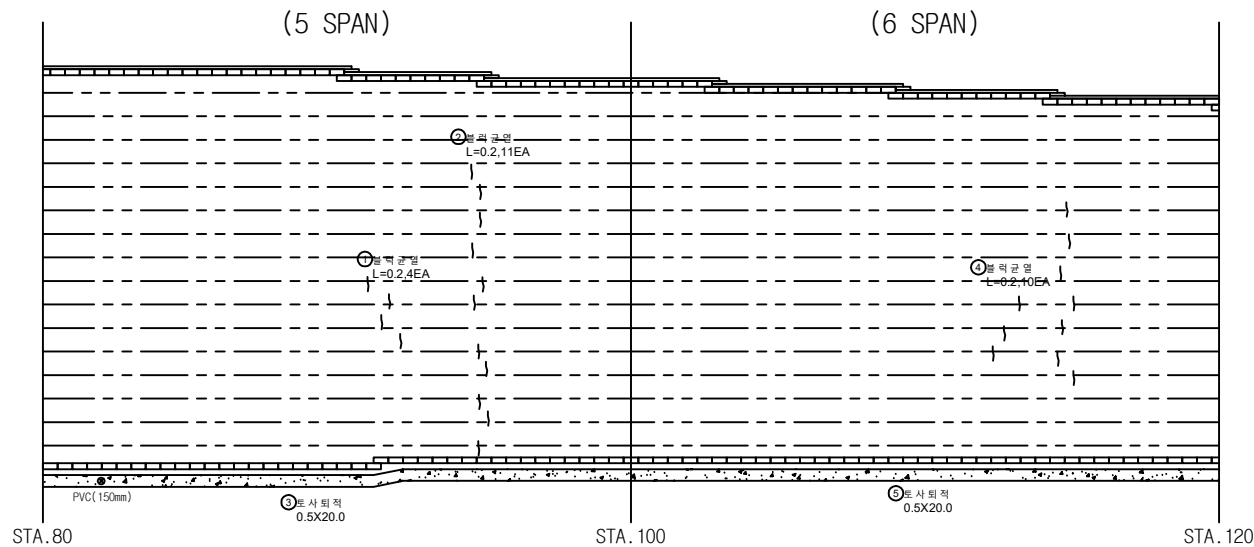
| 번호 | 손상내용 | 폭(mm) | 길이(m) | 너비(m) | 개소 | 손상물량 | | 비고 |
|---|---|---|---|---|---|---|---|---|
| 1 | 블럭균열 | | 0.2 | | 4 | 0.80 | m | |
| 2 | 블럭균열 | | 0.2 | | 11 | 2.20 | m | |
| 3 | 토사퇴적 | | 0.5 | 20.0 | 1 | 10.00 | m <sup>3</sup> | |
| 4 | 블럭균열 | | 0.2 | | 10 | 2.00 | m | |
| 5 | 토사퇴적 | | 0.5 | 20.0 | 1 | 10.00 | m <sup>3</sup> | |

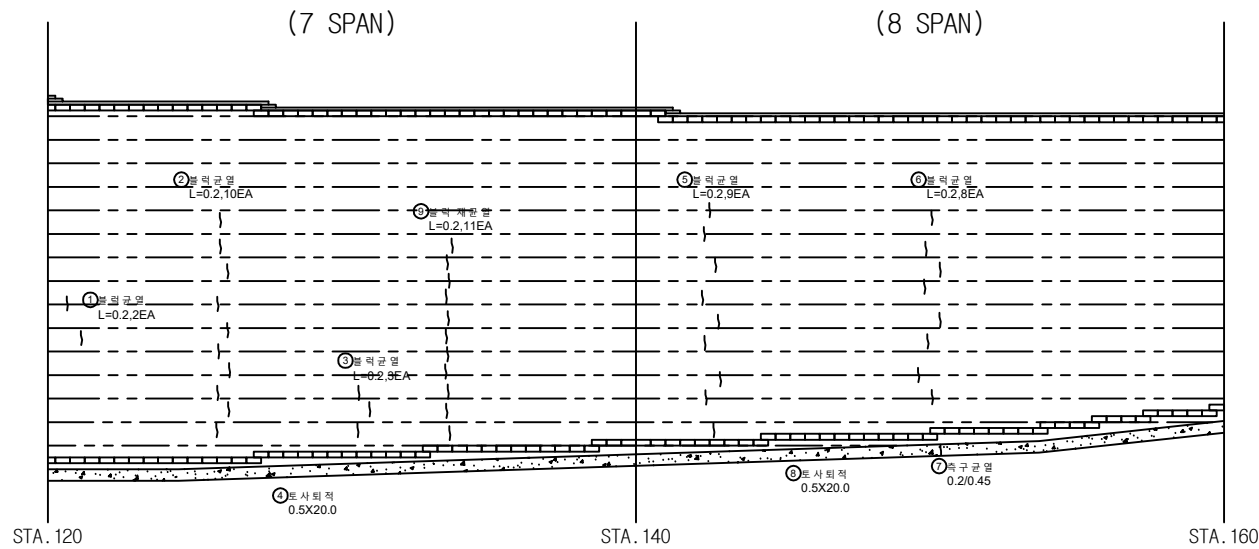
| 용역명 | | 부산울산선 11.75k(부산) 등 12개소 비탈면·옹벽 정밀안전점검 및 성능평가용역 | | | |
|---|---|---|---|---|--|
| | 철근노출 | 오염 | 배수구막힘 | No. 004 | |

| 번호 | 손상 내용 | 폭(mm) | 길이(m) | 너비(m) | 개소 | 손상물량 | | 비고 |
|---|---|---|---|---|---|---|---|---|
| 1 | 블럭균열 | | 0.2 | | 2 | 0.40 | m | |
| 2 | 블럭균열 | | 0.2 | | 10 | 2.00 | m | |
| 3 | 블럭균열 | | 0.2 | | 3 | 0.60 | m | |
| 4 | 토사 퇴적 | | 0.5 | 20.0 | 1 | 10.00 | m³ | |
| 5 | 블럭균열 | | 0.2 | | 9 | 1.80 | m | |
| 6 | 블럭균열 | | 0.2 | | 8 | 1.60 | m | |
| 7 | 측구 균열 | 0.2 | 0.45 | | 1 | 0.45 | m | |
| 8 | 토사 퇴적 | | 0.5 | 20.0 | 1 | 10.00 | m³ | |
| 9 | 블럭균열 | | 0.2 | | 11 | 2.20 | m | 신 |

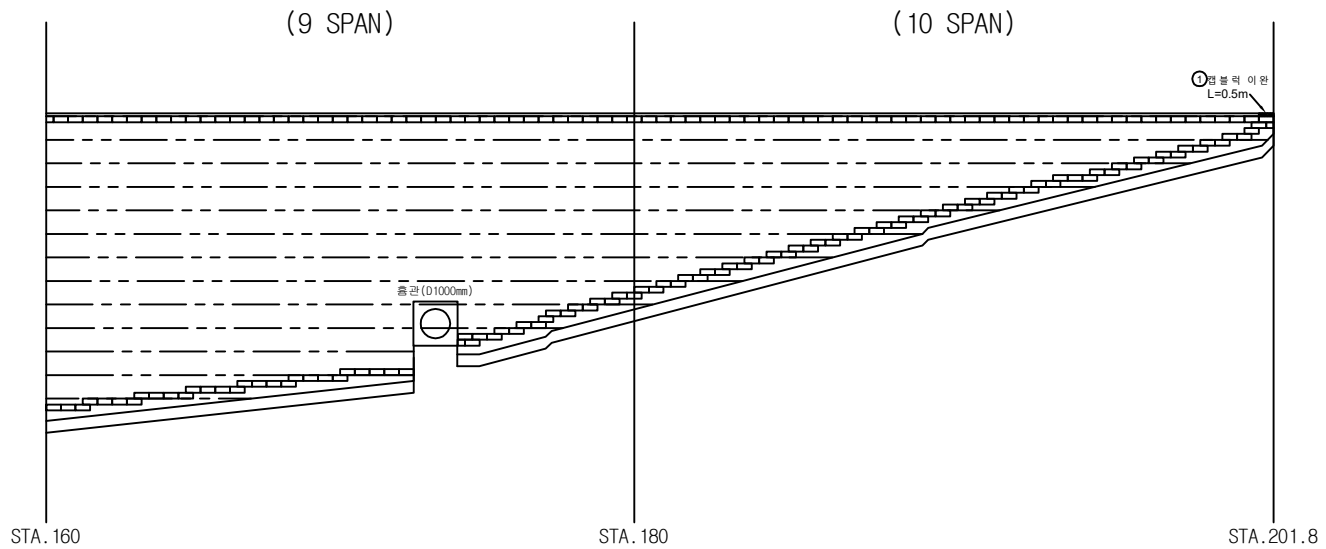
| 용역명 | | 부산울산선 11.75k(부산) 등 12개소 비탈면·옹벽 정밀안전점검 및 성능평가용역 | | | |
|---|---|---|---|---|--|
| | 철근노출 | 오염 | 배수구막힘 | No. 005 | |

| 번호 | 손상 내용 | 폭(mm) | 길이(m) | 너비(m) | 개소 | 손상물량 | | 비고 |
|---|---|---|---|---|---|---|---|---|
| 1 | 캡볼력 이완 | | 0.5 | | 1 | 0.50 | m | |

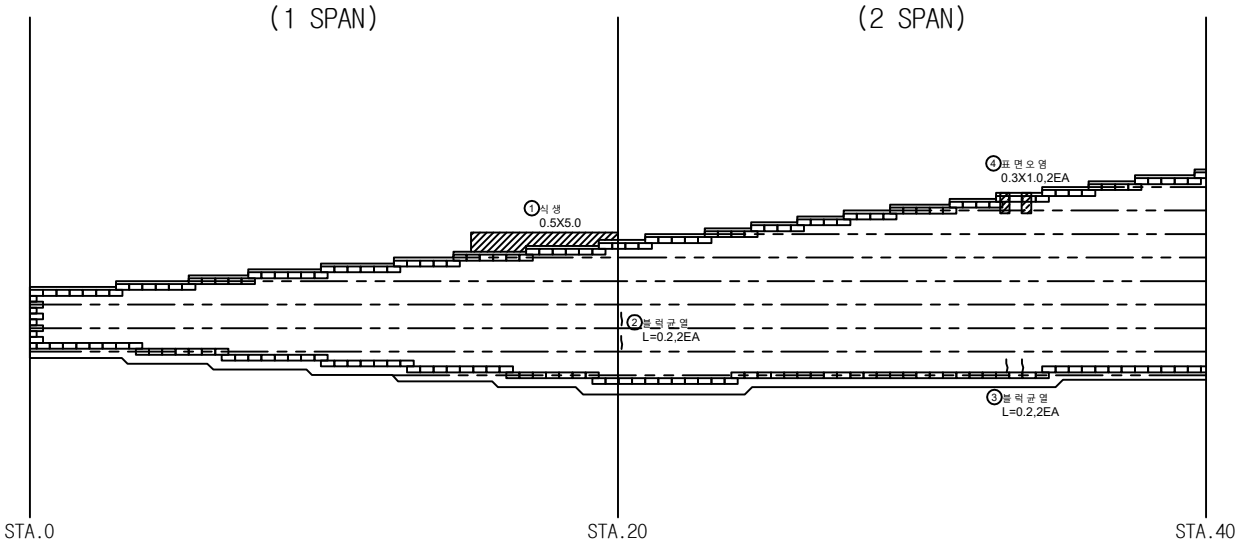
| 용역명 | | 부산울산선 11.75k(부산) 등 12개소 비탈면·옹벽 정밀안전점검 및 성능평가용역 | | | |
|---|---|---|---|---|--|
| | 철근노출 | 오염 | 배수구막힘 | No. 001 | |

| 번호 | 손상내용 | 폭(mm) | 길이(m) | 너비(m) | 개소 | 손상물량 | | 비고 |
|---|---|---|---|---|---|---|---|---|
| 1 | 식생 | | 0.5 | 5.0 | 1 | 2.50 | m <sup>2</sup> | |
| 2 | 불박균열 | | 0.2 | | 2 | 0.40 | m | |
| 3 | 불박균열 | | 0.2 | | 2 | 0.40 | m | |
| 4 | 표면오염 | | 0.3 | 1.0 | 2 | 0.60 | m <sup>2</sup> | |

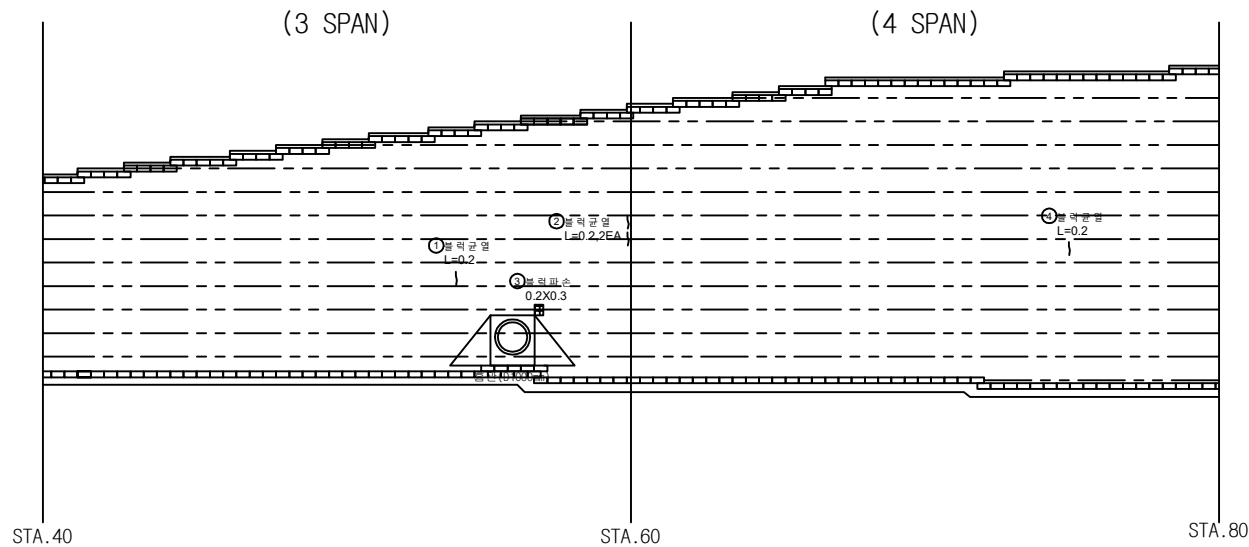
ID :부산울산선 옹벽 42.70K(포항) STA.80.0 ~ STA.120.0

| 번호 | 손상내용 | 폭(mm) | 길이(m) | 너비(m) | 개소 | 손상물량 | | 비고 |
|---|---|---|---|---|---|---|---|---|
| 1 | 블럭균열 | | 0.2 | | 1 | 0.20 | m | |
| 2 | 블럭균열 | | 0.2 | | 2 | 0.40 | m | |
| 3 | 블럭파손 | | 0.2 | 0.3 | 1 | 0.06 | m' | |
| 4 | 블럭균열 | | 0.2 | | 1 | 0.20 | m | 신 |

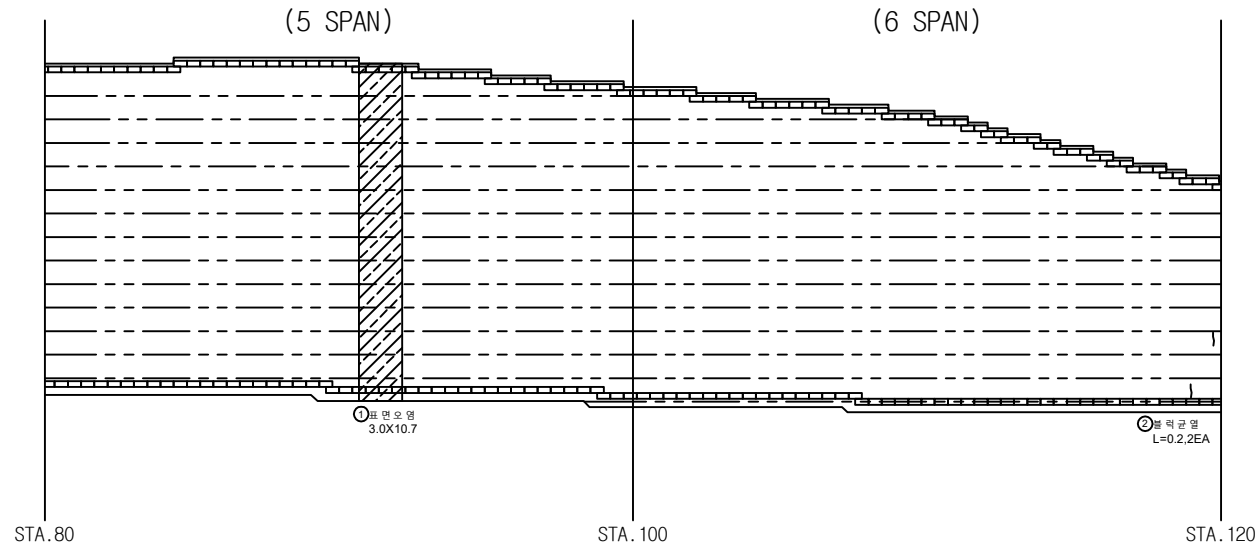
ID :부산울산선 옹벽 42.70K(포항) STA.120.0 ~ STA.160.0

| 번호 | 손상내용 | 폭(mm) | 길이(m) | 너비(m) | 개소 | 손상물량 | | 비고 |
|---|---|---|---|---|---|---|---|---|
| 1 | 표면오염 | | 3.0 | 10.7 | 1 | 32.10 | m² | |
| 2 | 블럭균열 | | 0.2 | | 2 | 0.40 | m | |

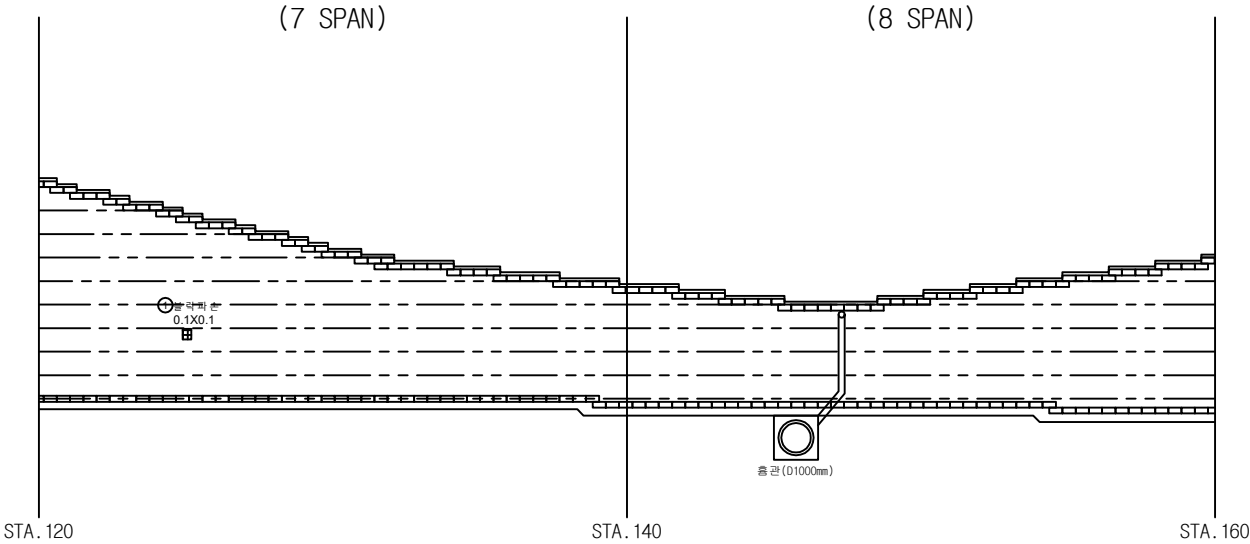
ID :부산울산선 옹벽 42.70K(포항) STA.160.0 ~ STA.200.0

| 번호 | 손상 내용 | 폭(mm) | 길이(m) | 너비(m) | 개소 | 손상물량 | | 비고 |
|---|---|---|---|---|---|---|---|---|
| 1 | 블럭파손 | | 0.1 | 0.1 | 1 | 0.01 | m <sup>2</sup> | |

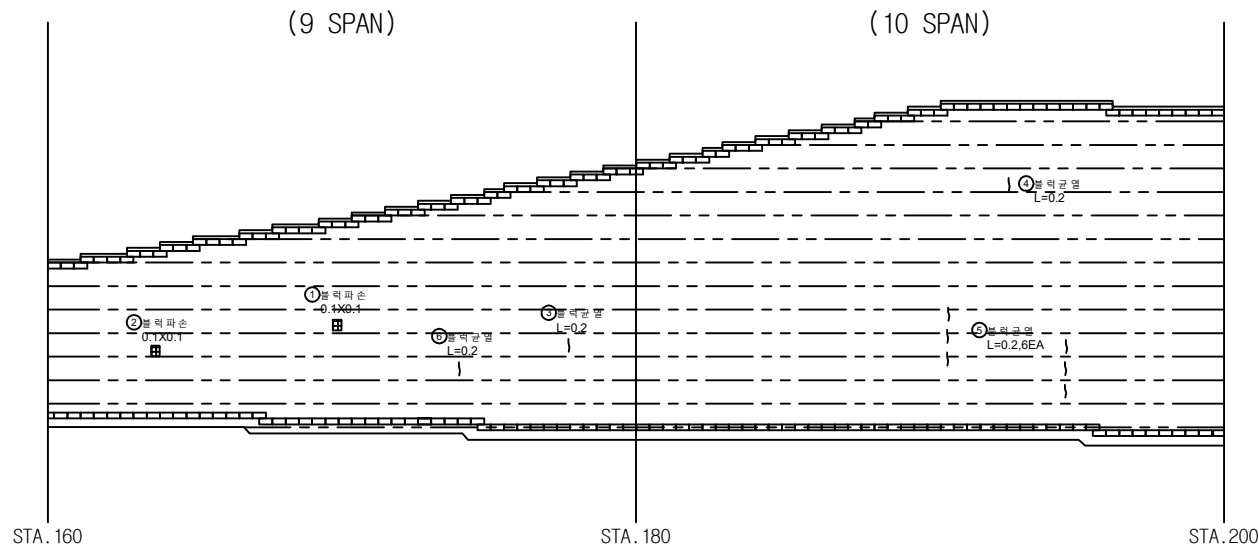
ID :부산울산선 용벽 42.70K(포항) STA.200.0 ~ STA.240.0

| 번호 | 손상내용 | 폭(mm) | 길이(m) | 너비(m) | 개소 | 손상물량 | | 비고 |
|---|---|---|---|---|---|---|---|---|
| 1 | 블럭파손 | | 0.1 | 0.1 | 1 | 0.01 | m <sup>2</sup> | |
| 2 | 블럭파손 | | 0.1 | 0.1 | 1 | 0.01 | m <sup>2</sup> | |
| 3 | 블럭균열 | | 0.2 | | 1 | 0.20 | m | |
| 4 | 블럭균열 | | 0.2 | | 1 | 0.20 | m | |
| 5 | 블럭균열 | | 0.2 | | 6 | 1.20 | m | |
| 6 | 블럭균열 | | 0.2 | | 1 | 0.20 | m | 신 |

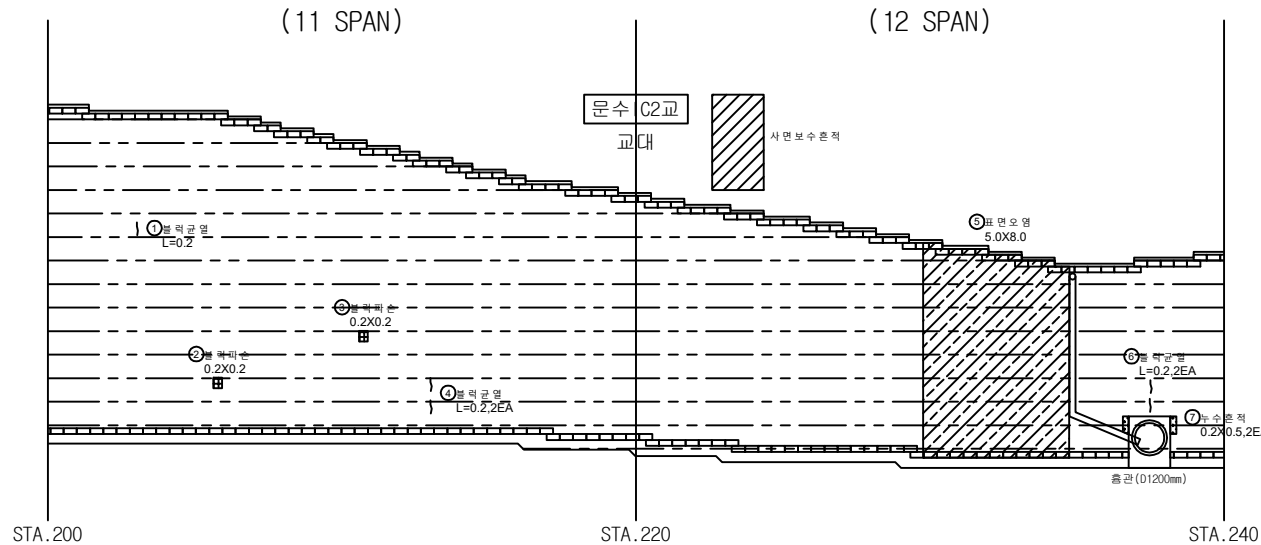
| 용역명 | | 부산울산선 11.75k(부산) 등 12개소 비탈면·옹벽 정밀안전점검 및 성능평가용역 | | | |
|---|---|---|---|---|--|
| | 철근노출 | 오염 | 배수구막힘 | No. 006 | |

| 번호 | 손상내용 | 폭(mm) | 길이(m) | 너비(m) | 개소 | 손상물량 | | 비고 |
|---|---|---|---|---|---|---|---|---|
| 1 | 블럭균열 | | 0.2 | | 1 | 0.20 | m | |
| 2 | 블럭파손 | | 0.2 | 0.2 | 1 | 0.04 | m <sup>2</sup> | |
| 3 | 블럭파손 | | 0.2 | 0.2 | 1 | 0.04 | m <sup>2</sup> | |
| 4 | 블럭균열 | | 0.2 | | 2 | 0.40 | m | |
| 5 | 표면오염 | | 5.0 | 8.0 | 1 | 40.00 | m <sup>2</sup> | |
| 6 | 블럭균열 | | 0.2 | | 2 | 0.40 | m | |
| 7 | 누수흔적 | | 0.2 | 0.5 | 2 | 0.20 | m <sup>2</sup> | |

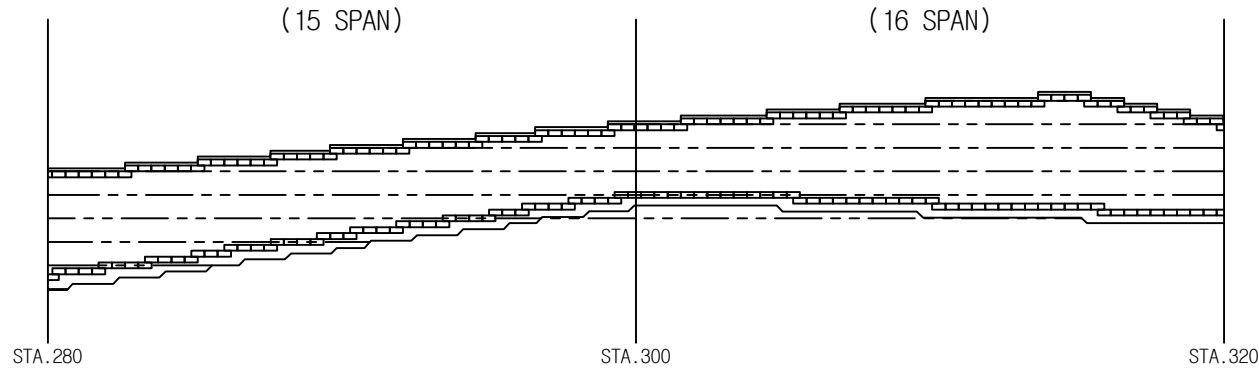
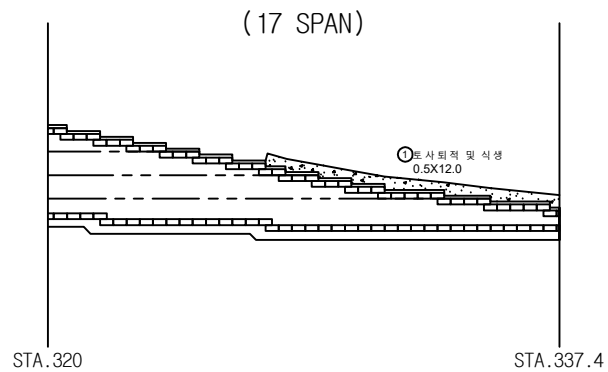
| 용역명 | | 부산울산선 11.75k(부산) 등 12개소 비탈면·옹벽 정밀안전점검 및 성능평가용역 | | | |
|---|---|---|---|---|---|
| | 철근노출 | 오염 | 배수구막힘 | No. 008 | |

| 번호 | 손상 내용 | 폭(mm) | 길이(m) | 너비(m) | 개소 | 손상물량 | | 비고 |
|---|---|---|---|---|---|---|---|---|
| 1 | 토사 퇴적 | | 0.5 | 12.0 | 1 | 6.00 | m³ | |

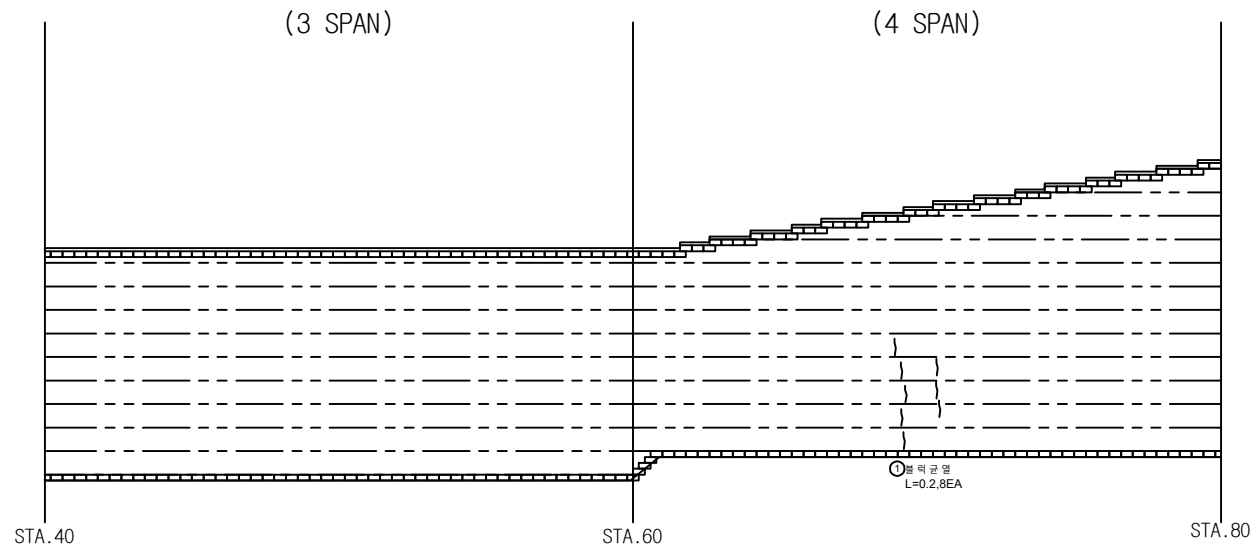
ID :부산울산선 옹벽 44.02K(부산) STA.40.0 ~ STA.80.0

| 번호 | 손상내용 | 폭(mm) | 길이(m) | 너비(m) | 개소 | 손상물량 | | 비고 |
|---|---|---|---|---|---|---|---|---|
| 1 | 블럭균열 | | 0.2 | | 8 | 1.60 | m | 추가 |

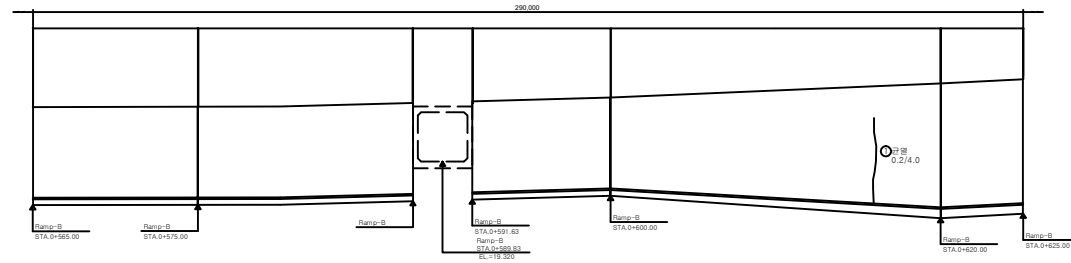
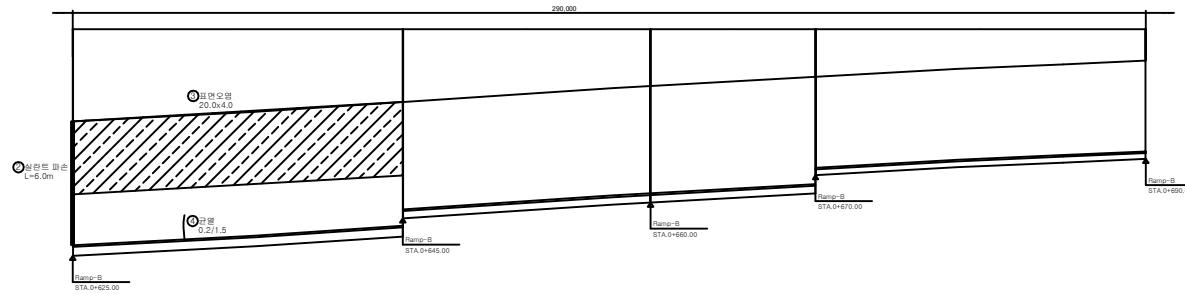
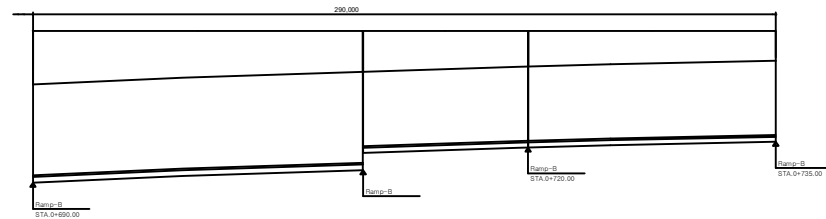
| 번호 | 손상내용 | 폭(mm) | 길이(m) | 너비(m) | 개소 | 손상물량 | | 비고 |
|---|---|---|---|---|---|---|---|---|
| 1 | 균열 | 0.2 | 4.0 | | 1 | 4.00 | m | 신 |
| 4 | 균열 | 0.2 | 1.5 | | 1 | 1.50 | m | 신 |
