# 여의도공동구 (의사당로A)

2019년 공동구 정밀점검용역 (여의도공동구)

의사당로 A 전력구 외관조사망도

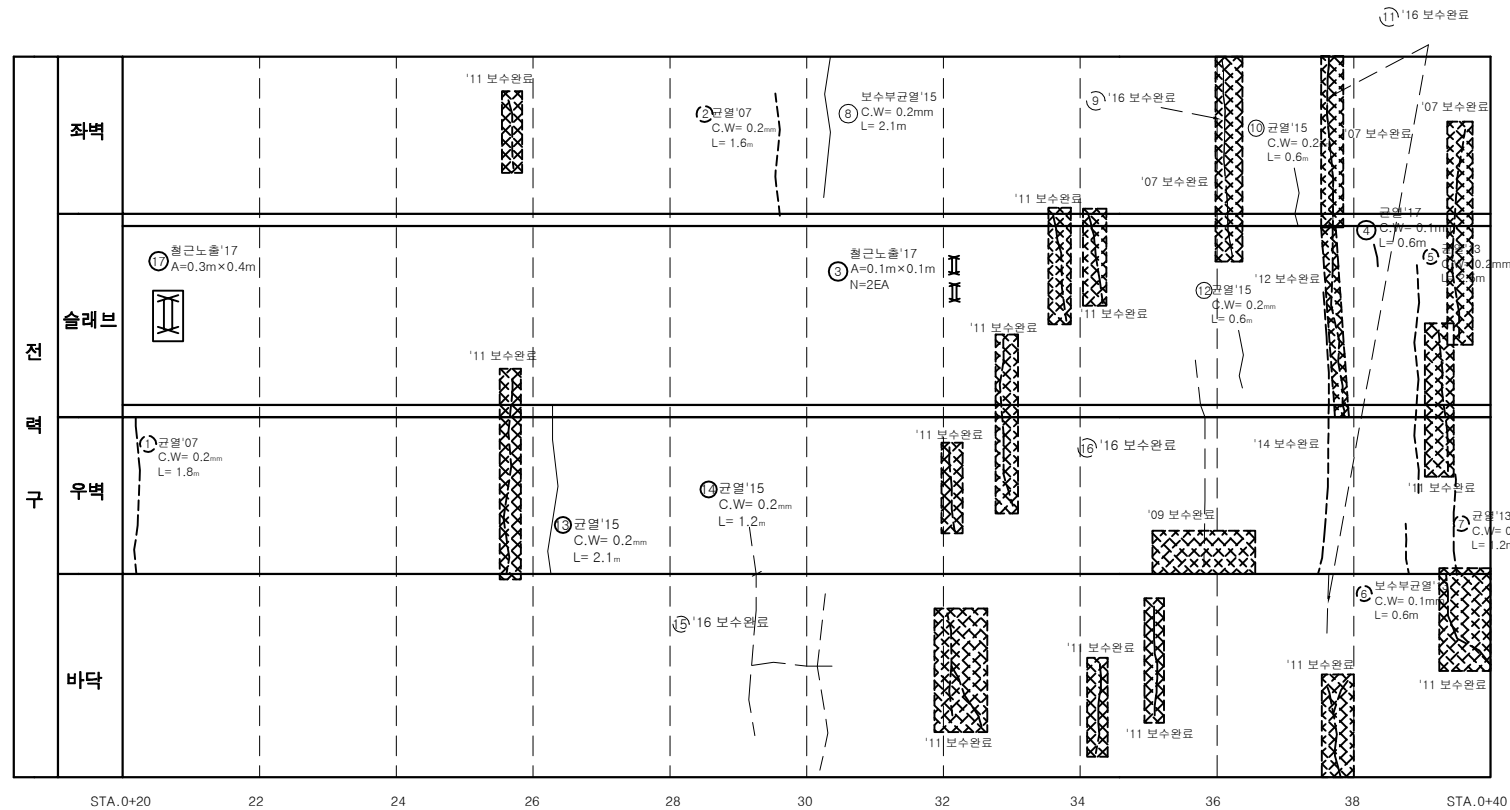
# 여의도 공동구 - 의사당로 A 전력구 (STA. 0+020 m ~ 0+040m)

| 연번 | 연도 | 행위내용 | 정밀검역 | | | | | 최종보수내역 | | 비고 |
|---|---|---|---|---|---|---|---|---|---|---|
| 1 | 2007 | 관설 | 0.2 | 1.80 | 1.80 | m | 1 | | - | |
| 2 | 2007 | 관설 | 0.2 | 1.80 | 1.80 | m | 1 | | - | |
| 3 | 2017 | 철근노출 | 0.1 | 0.10 | 0.02 | m | 2 | | - | 중요 |
| 4 | 2017 | 관설 | 0.1 | 0.80 | 0.80 | m | 1 | | - | |
| 5 | 2013 | 관설 | 0.2 | 2.50 | 2.50 | m | 1 | | - | |
| 6 | 2013 | 관설 | 0.1 | 0.80 | 0.80 | m | 1 | | - | |
| 7 | 2013 | 관설 | 0.2 | 1.20 | 1.20 | m | 1 | | - | |
| 8 | 2015 | 보수부 관설 | 0.2 | 2.10 | 2.10 | m | 1 | | - | 재결합 |
| 9 | 2015 | 보수부 관설 | 0.5 | 2.80 | 2.80 | m | 1 | 2016 주입보수공법 | 3.36 | |
| 10 | 2015 | 관설 | 0.2 | 0.80 | 0.80 | m | 1 | | - | |
| 11 | 2015 | 보수부 관설 | 0.4 | 3.20 | 3.20 | m | 1 | 2016 주입보수공법 | 3.84 | |
| 12 | 2015 | 관설 | 0.2 | 0.80 | 0.80 | m | 1 | | - | |
| 13 | 2015 | 관설 | 0.2 | 2.10 | 2.10 | m | 1 | | - | |
| 14 | 2015 | 관설 | 0.2 | 1.20 | 1.20 | m | 1 | | - | |
| 15 | 2015 | 관설 | 0.4 | 4.00 | 4.00 | m | 1 | 2016 주입보수공법 | 4.80 | |
| 16 | 2015 | 보수부 관설 | 0.5 | 3.10 | 3.10 | m | 1 | 2016 주입보수공법 | 3.72 | |
| 17 | 2017 | 철근노출 | 0.3 | 0.40 | 0.12 | m | 1 | | - | 중요 |

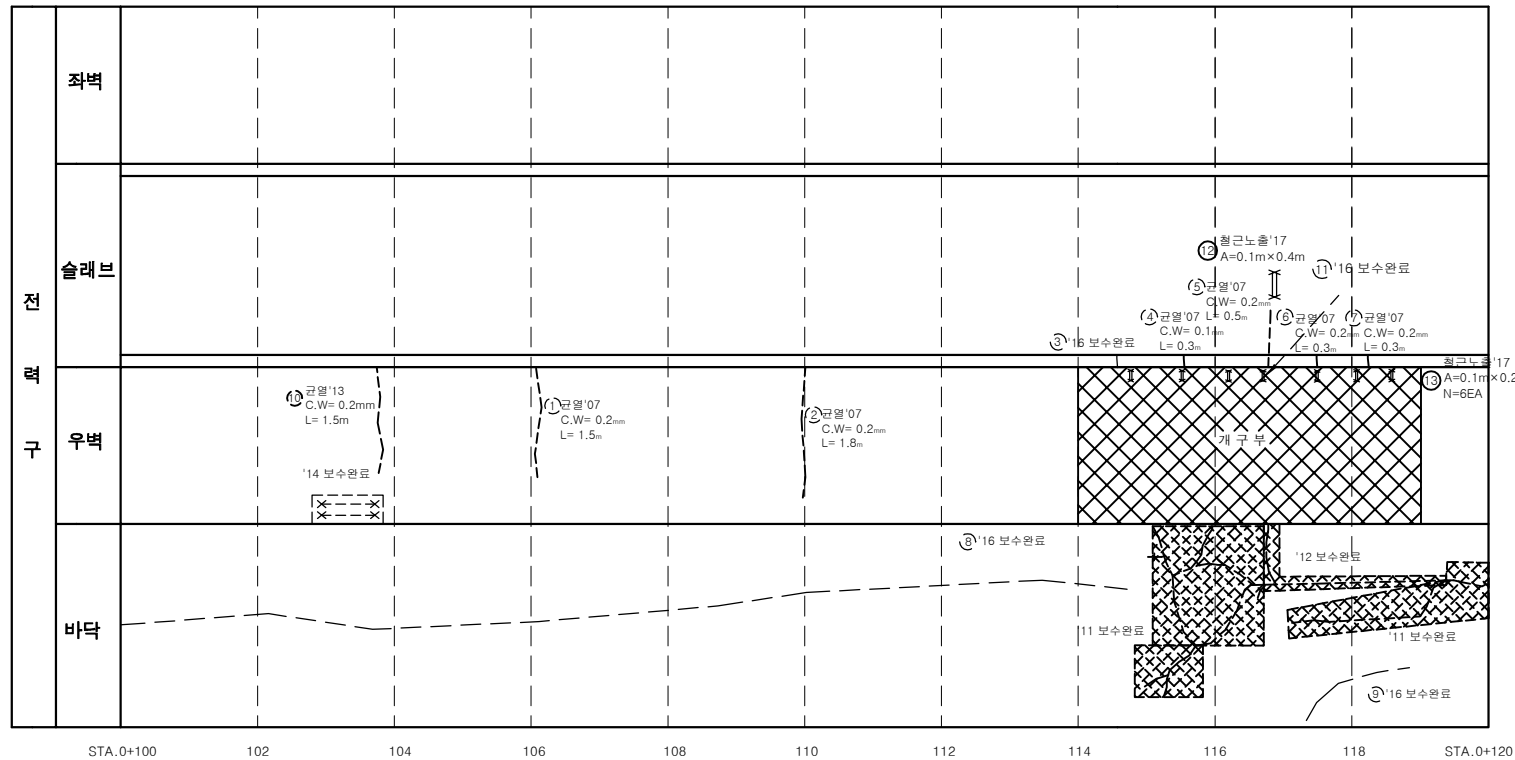
# 여의도 공동구 - 의사당로 A 전력구 (STA. 0+100 m ~ 0+120m)

| 연번 | 연도 | 행위내용 | 결함구도 | | | | 최종보수내역 | | 비고 |
|---|---|---|---|---|---|---|---|---|---|
| 1 | 2007 | 균열 | 0.2 | 1.50 | 1.50 | m | 1 | | - |
| 2 | 2007 | 균열 | 0.2 | 1.80 | 1.80 | m | 1 | | - |
| 3 | 2007 | 균열 | 0.2 | 0.30 | 0.30 | m | 1 | 표면치리공법 | 0.36 |
| 4 | 2007 | 균열 | 0.1 | 0.30 | 0.30 | m | 1 | | - |
| 5 | 2007 | 균열 | 0.2 | 0.50 | 0.50 | m | 1 | | - |
| 6 | 2007 | 균열 | 0.2 | 0.30 | 0.30 | m | 1 | | - |
| 7 | 2007 | 균열 | 0.2 | 0.30 | 0.30 | m | 1 | | - |
| 8 | 2015 | 균열 | 0.3 | 15.00 | 15.00 | m | 1 | 주입보수공법 | 18.00 |
| 9 | 2013 | 균열 | 0.3 | 2.00 | 2.00 | m | 1 | | 중요 |
| 10 | 2013 | 균열 | 0.2 | 1.50 | 1.50 | m | 1 | | - |
| 11 | 2015 | 철근노출 | 0.1 | 0.10 | 0.01 | m | 1 | 단면복귀방정 | 0.01 |
| 12 | 2017 | 철근노출 | 0.1 | 0.40 | 0.04 | m | 1 | | 중요 |
| 13 | 2017 | 철근노출 | 0.1 | 0.20 | 0.12 | m | 6 | | 중요 |

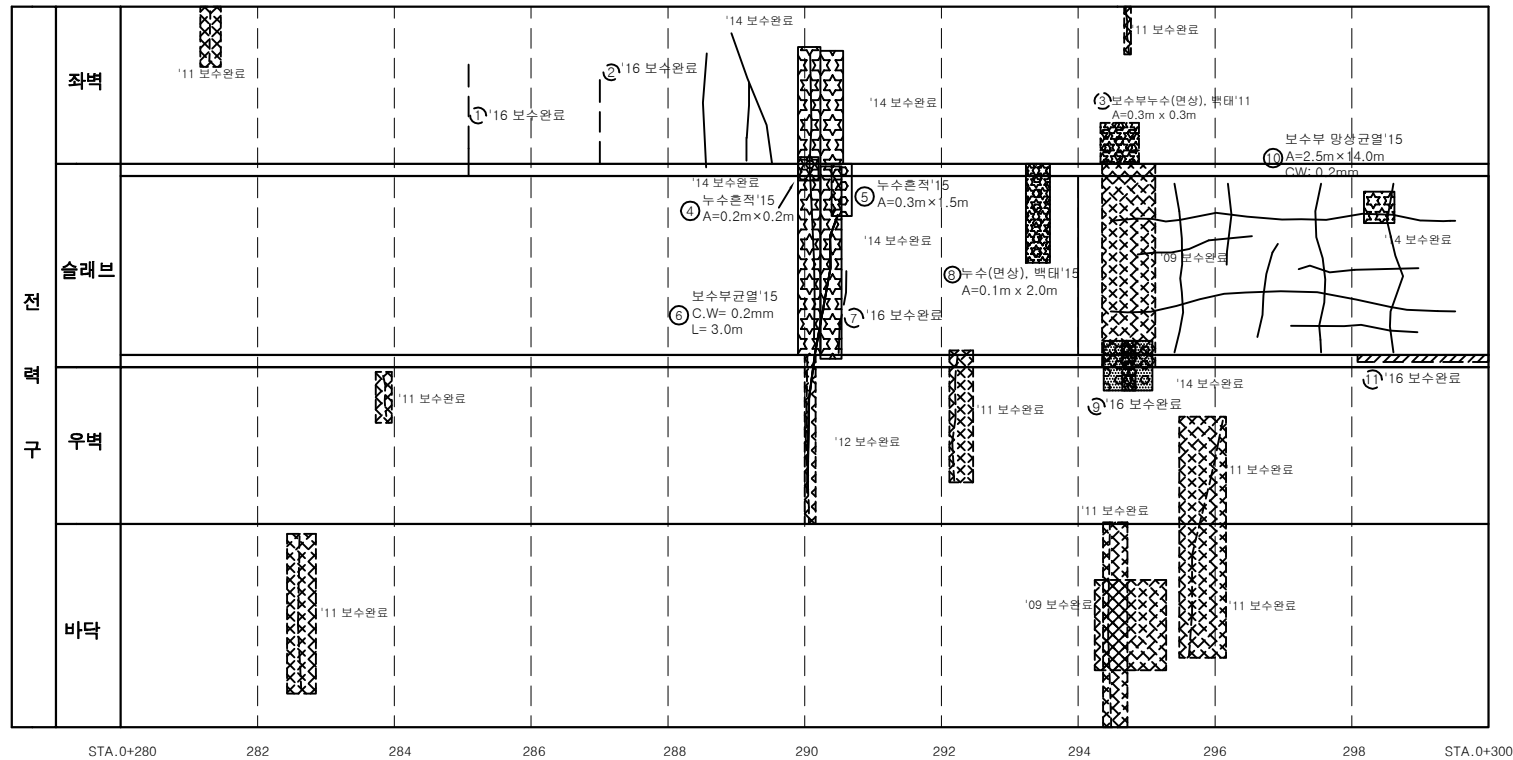
# 여의도 공동구 - 의사당로 A 전력구 (STA. 0+280 m ~ 0+300 m)

| 연번 | 연도 | 행위내용 | 정밀구분 | | | | 최종보수내역 | | | | 비고 |
|---|---|---|---|---|---|---|---|---|---|---|---|
| 1 | 2007 | 구분 | 0.1 | 1.50 | m | 1 | 2016 | 표면처리공법 | 1.80 | | |
| 2 | 2007 | 구분 | 0.1 | 0.80 | m | 1 | 2016 | 표면처리공법 | 0.72 | | |
| 3 | 2011 | 보수부(면상) 백태 | 0.3 | 0.30 | m | 1 | | | | - | 재결합 |
| 4 | 2015 | 누수흔적 | 0.2 | 0.20 | m | 1 | | | | - | |
| 5 | 2015 | 누수흔적 | 0.3 | 1.50 | m | 1 | | | | - | |
| 6 | 2015 | 보수부 구분 | 0.2 | 3.00 | m | 1 | | | | - | 재결합 |
| 7 | 2015 | 보수부 구분 | 0.3 | 0.70 | m | 1 | 2016 | 주입보수공법 | 0.84 | | |
| 8 | 2015 | 누수(면상) 백태 | 0.1 | 2.00 | m | 1 | | | | - | |
| 9 | 2015 | 보수부 누수 백태 | 0.1 | 1.00 | m | 1 | 2016 | 누수보수공법 | 0.12 | | |
| 10 | 2015 | 보수부 양상구분 | 2.5 | 14.00 | m | 1 | | | | - | 재결합 |
| 11 | 2015 | 재결합 | 0.5 | 2.00 | m | 1 | 2016 | 단면복구공법 | 1.20 | | |
