# 여의도공동구 (순환선)

2019년 공동구 정밀점검용역 (여의도공동구)

순환선 전력구 외관조사망도

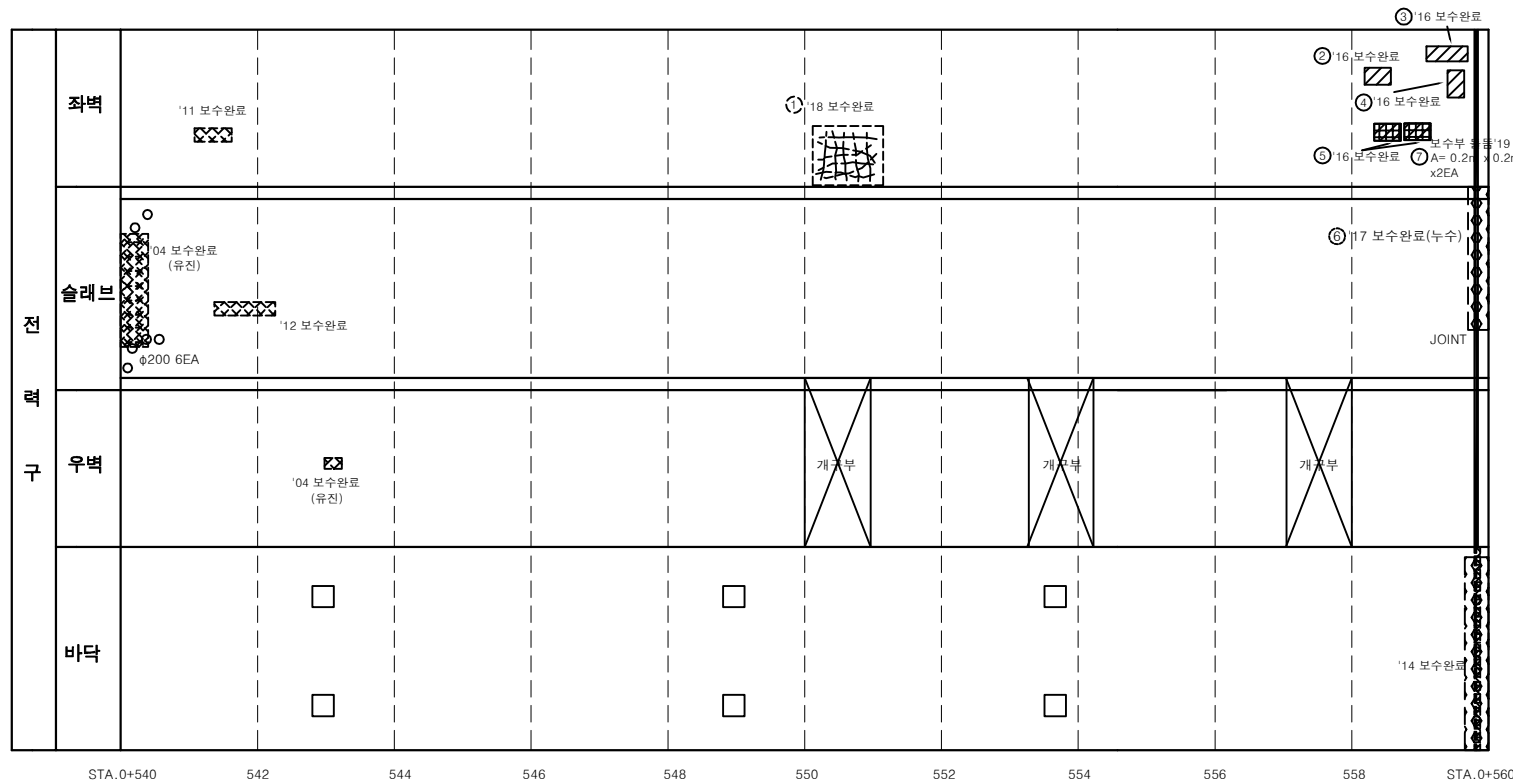
# 여의도 공동구 - 순환선 전력구 (STA.0+540m ~ 0+560m)

| 연번 | 연도 | 발생내용 | 발생구분 | | | | | 최종보수내역 | | 비고 |
|---|---|---|---|---|---|---|---|---|---|---|
| 1 | 2009 | 보수부 발생구분 | 1.5 | 1.50 | 2.25 | 1 | 1 | 2018 | 표면처리공법 | 2.70 |
| 2 | 2015 | 재발생 | 0.2 | 0.20 | 0.04 | 1 | 1 | 2016 | 단면복구공법 | 0.05 |
| 3 | 2015 | 재발생 | 0.2 | 0.80 | 0.16 | 1 | 1 | 2016 | 단면복구공법 | 0.19 |
| 4 | 2015 | 재발생 | 0.1 | 0.60 | 0.06 | 1 | 1 | 2016 | 단면복구공법 | 0.07 |
| 5 | 2015 | 재발생 | 0.2 | 0.20 | 0.08 | 2 | 2 | 2016 | 단면복구공법 | 0.10 |
| 6 | 2017 | 누수 | 2.40 | m | 1 | 1 | 2017 | 누수보수공법 | 2.88 | |
| 7 | 2019 | 보수부 발생 | 0.2 | 0.20 | 0.08 | 2 | 2 | 2016 | 단면복구공법 | 0.10 |

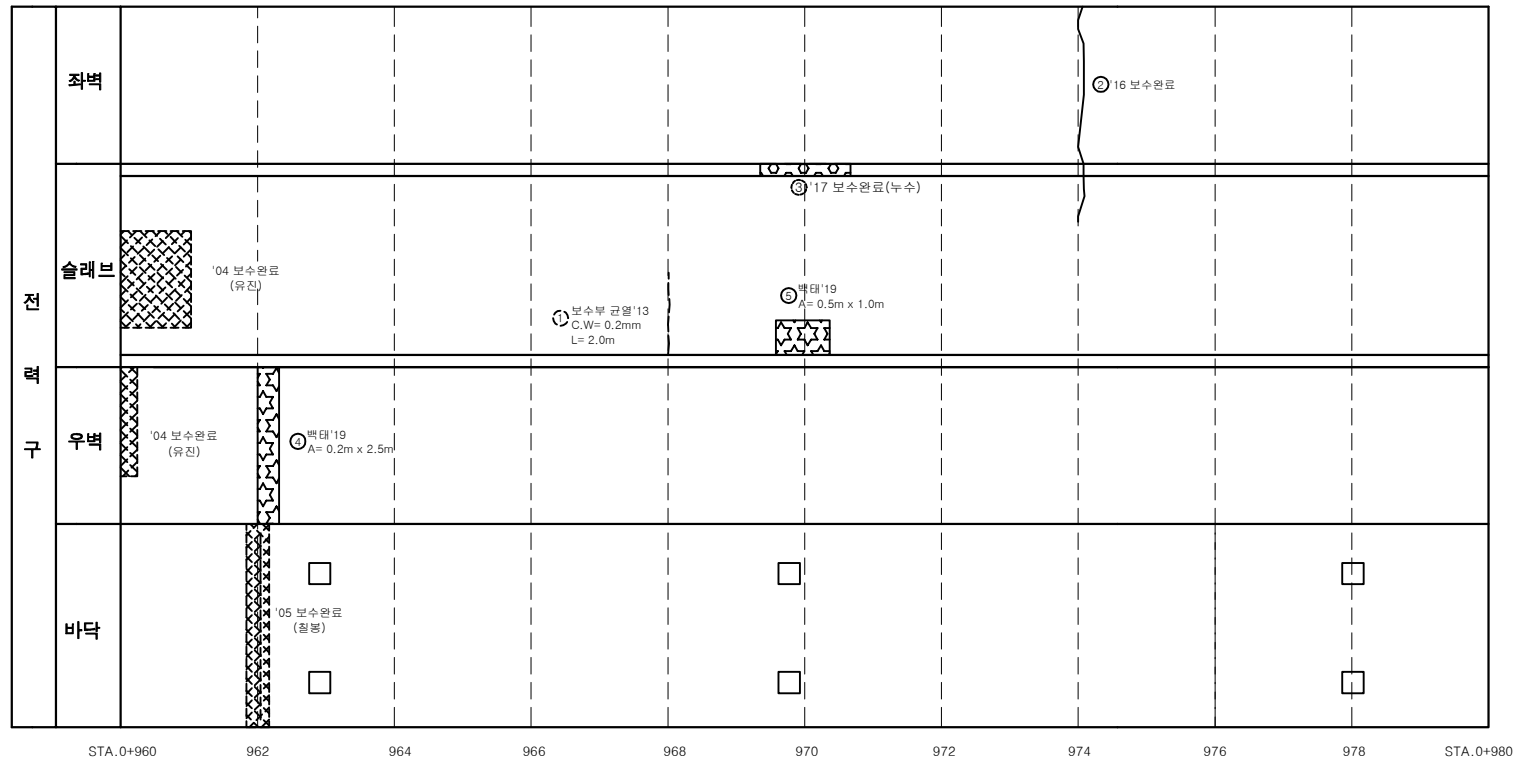
# 여의도 공동구 - 순환선 전력구 (STA. 0+960m ~ 0+980m)

| 연번 | 연도 | 발생내용 | 발생구분 | | | | | 최종보수내역 | | 비고 |
|---|---|---|---|---|---|---|---|---|---|---|
| 1 | 2013 | 보수부 균열 | 0.2 | 2.00 | 2.00 | m | 1 | 2016 주입보수공법 | - | 재검량 |
| 2 | 2015 | 균열 | 0.3 | 3.00 | 3.00 | m | 1 | 2017 누수보수공법 | 0.53 | |
| 3 | 2017 | 누수 | | | | | | 2017 누수보수공법 | 0.53 | |
| 4 | 2019 | 벽면 | 0.2 | 2.50 | 0.50 | m | 1 | | - | 신규 |
| 5 | 2019 | 벽면 | 0.5 | 1.00 | 0.50 | m | 1 | | - | 신규 |

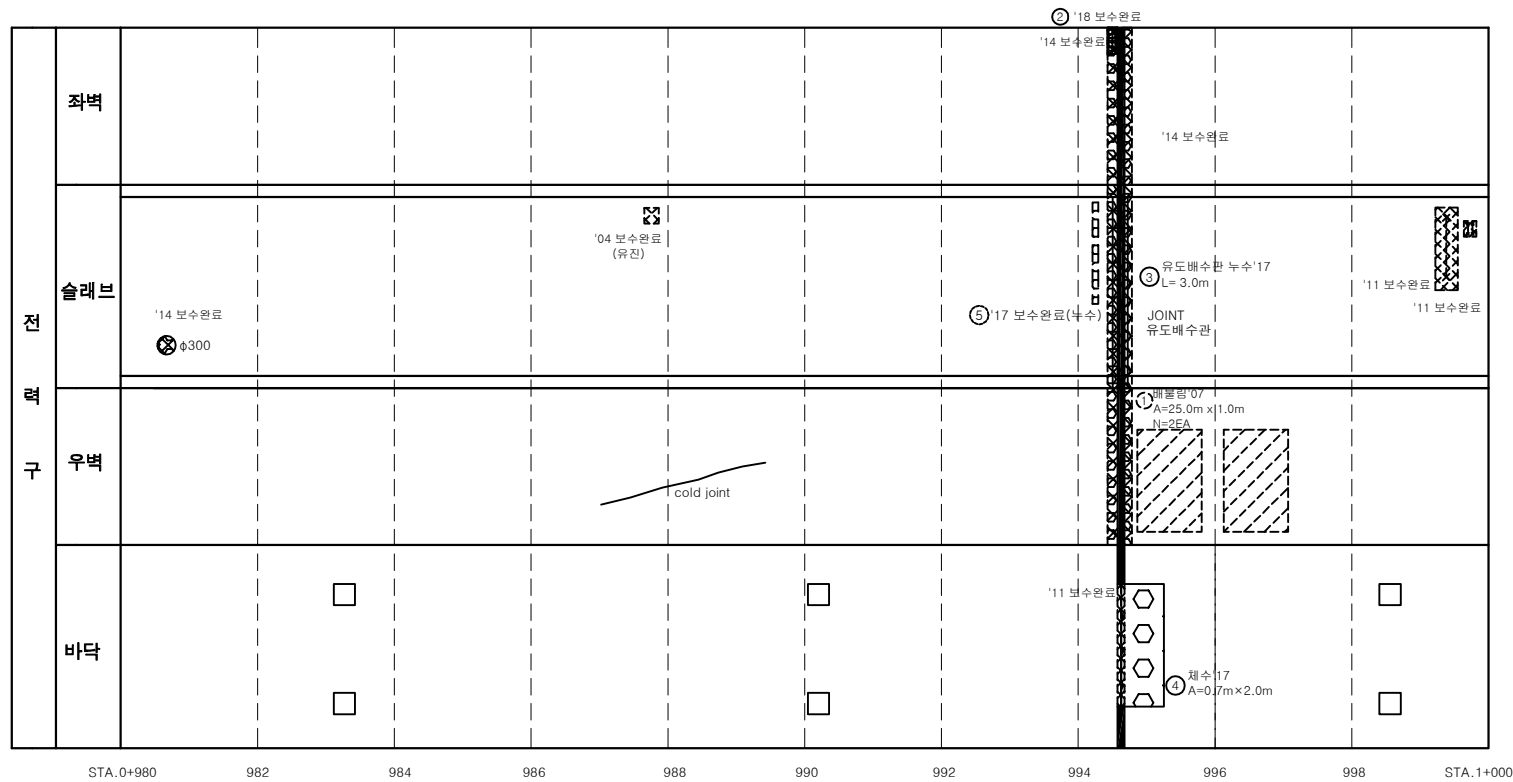
# 여의도 공동구 - 순환선 전력구 (STA. 0+980m ~ 1+000m)

| 연번 | 연도 | 발생내용 | 결함구분 | | | | | 최종보수내역 | | 비고 | |
|---|---|---|---|---|---|---|---|---|---|---|---|
| 1 | 2007 | 배출림 | 25.0 | 1.00 | | 50.00 | m | 2 | | - | |
| 2 | 2015 | 벽막 | 0.3 | 0.60 | | 0.18 | m | 1 | 2018 | 단면복구공법 | 0.22 |
| 3 | 2017 | 유도배수관 누수 | | 3.00 | | 3.00 | m | 1 | | - | |
| 4 | 2017 | 채수 | 0.7 | 2.00 | | 1.40 | m | 1 | | - | |
| 5 | 2017 | 누수 | | | | 1.40 | m | 1 | 2017 | 누수보수공법 | 1.68 |

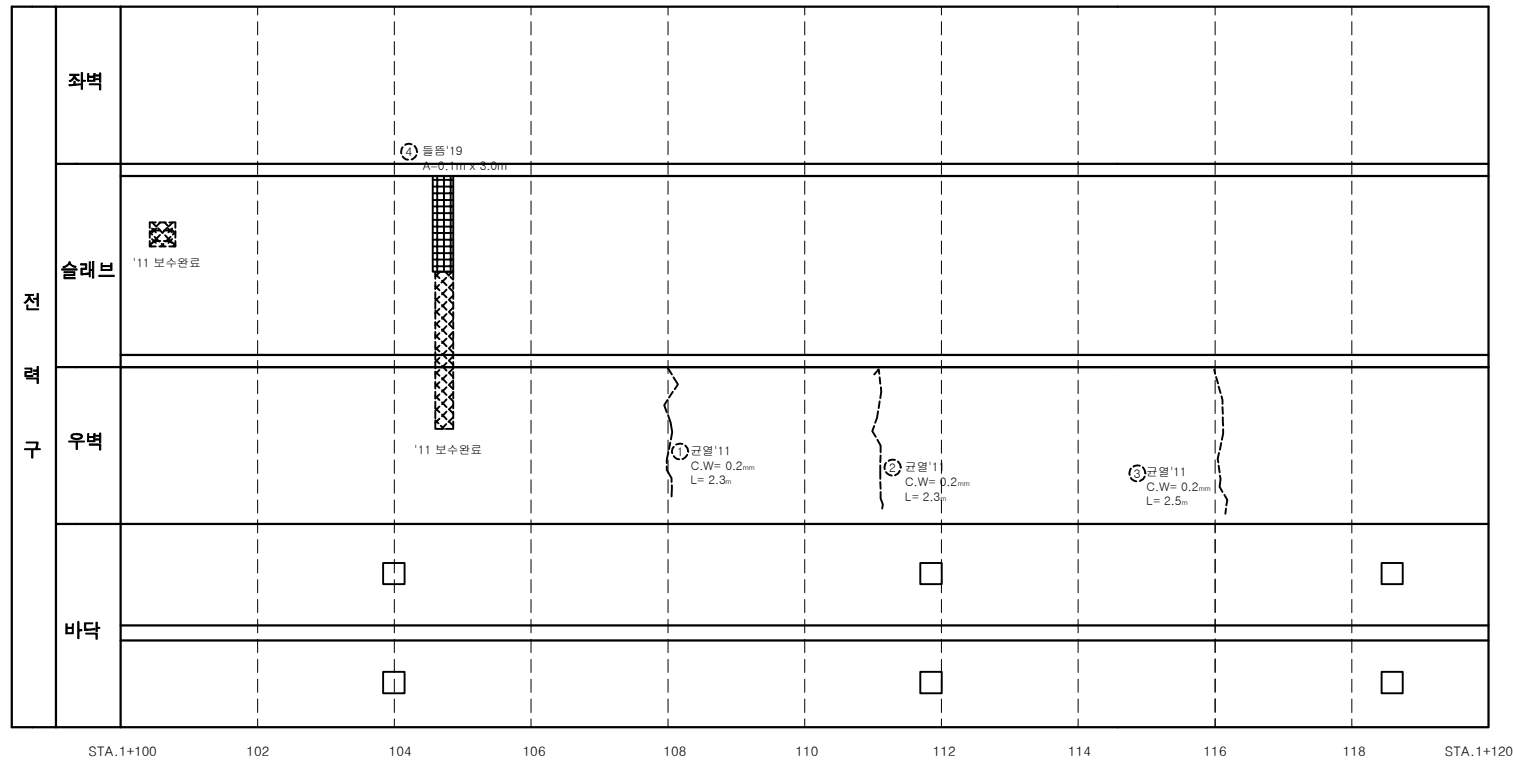
# 여의도 공동구 - 순환선 전력구 (STA. 1+100m ~ 1+120m)

| 연번 | 연도 | 발생내용 | 발생구분 | | | | | 최종보수내역 | | |
|---|---|---|---|---|---|---|---|---|---|---|
| 1 | 2011 | 균열 | 0.2 | 2.30 | 2.30 | m | 1 | | - | |
| 2 | 2011 | 균열 | 0.2 | 2.30 | 2.30 | m | 1 | | - | |
| 3 | 2011 | 균열 | 0.2 | 2.50 | 2.50 | m | 1 | | - | |
| 4 | 2019 | 침하 | 0.1 | 3.00 | 0.30 | m | 1 | | - | 신규 |

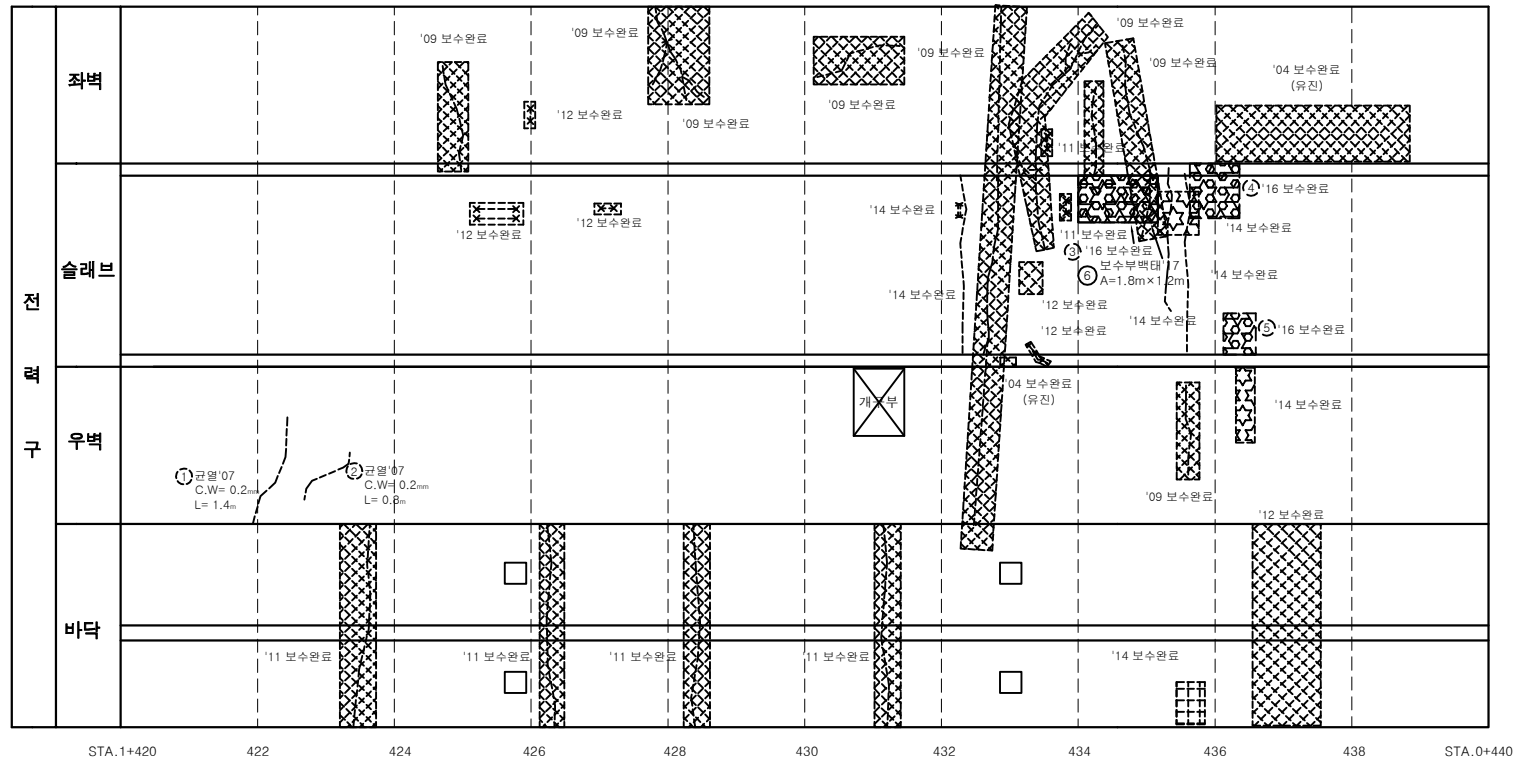
# 여의도 공동구 - 순환선 전력구 (STA. 1+420 m ~ 1+440 m)

| 연도 | 구분 | 구분 | 구분 | | | | 구분 | | 비고 |
|---|---|---|---|---|---|---|---|---|---|
| 1 | 2007 | 구분 | 0.2 | 1.40 | 1.40 | m | 1 | | - |
| 2 | 2007 | 구분 | 0.2 | 0.80 | 0.80 | m | 1 | | - |
| 3 | 2015 | 누수, 벽면 | 1.8 | 1.20 | 2.16 | m | 1 | 2016 | 누수보수공법 |
| 4 | 2015 | 누수, 벽면 | 0.8 | 0.70 | 0.42 | m | 1 | 2016 | 누수보수공법 |
| 5 | 2015 | 누수, 벽면 | 0.4 | 1.00 | 0.40 | m | 1 | 2016 | 누수보수공법 |
| 6 | 2017 | 보수부 벽면 | 1.8 | 1.20 | 2.16 | m | 1 | 2016 | 누수보수공법 |

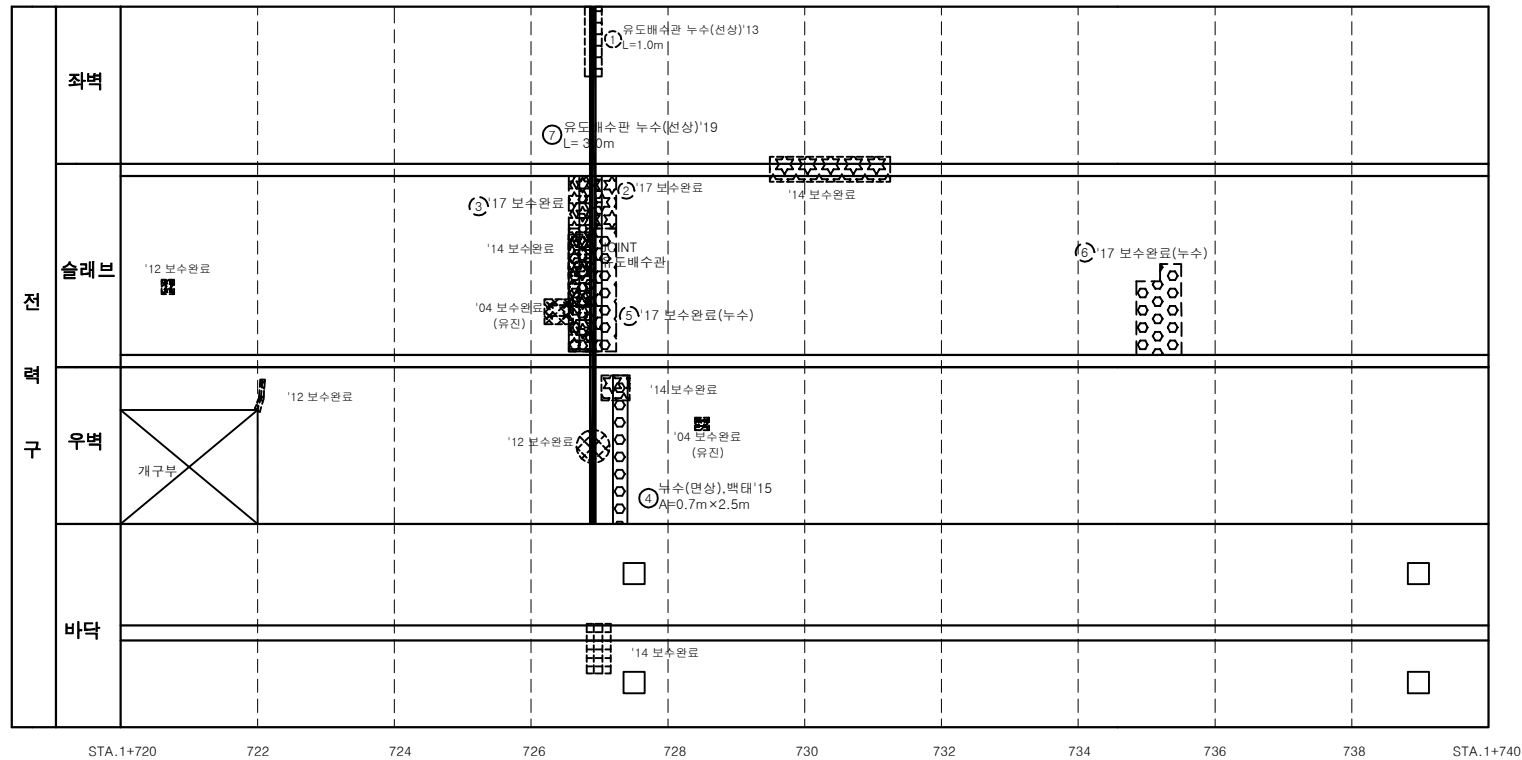
# 여의도 공동구 - 순환선 전력구 (STA. 1+720m ~ 1+740m)

| 연번 | 연도 | 발생내용 | 원인구분 | | | | 최종보수내역 | | 비고 |
|---|---|---|---|---|---|---|---|---|---|
| 1 | 2013 | 유도배수관 누수(선상) | 1.00 | 1.00 | m | 1 | 1 | 2017 | 누수보수공법 |
| 2 | 2013 | 누수, 백태 | 0.3 | 0.80 | | 1 | 1 | 2017 | 누수보수공법 |
| 3 | 2015 | 누수, 백태 | 0.3 | 2.50 | | 1 | 1 | 2017 | 누수보수공법 |
| 4 | 2015 | 누수(면상), 백태 | 0.7 | 2.50 | | 1 | 1 | 2017 | 누수보수공법 |
| 5 | 2017 | 누수 | | | | 2.01 | 1 | 2017 | 누수보수공법 |
| 6 | 2017 | 누수 | | 0.97 | | 1 | 1 | 2017 | 누수보수공법 |
| 7 | 2019 | 유도배수관 누수(선상) | 3.00 | 3.00 | m | 1 | 1 | 2017 | 누수보수공법 |

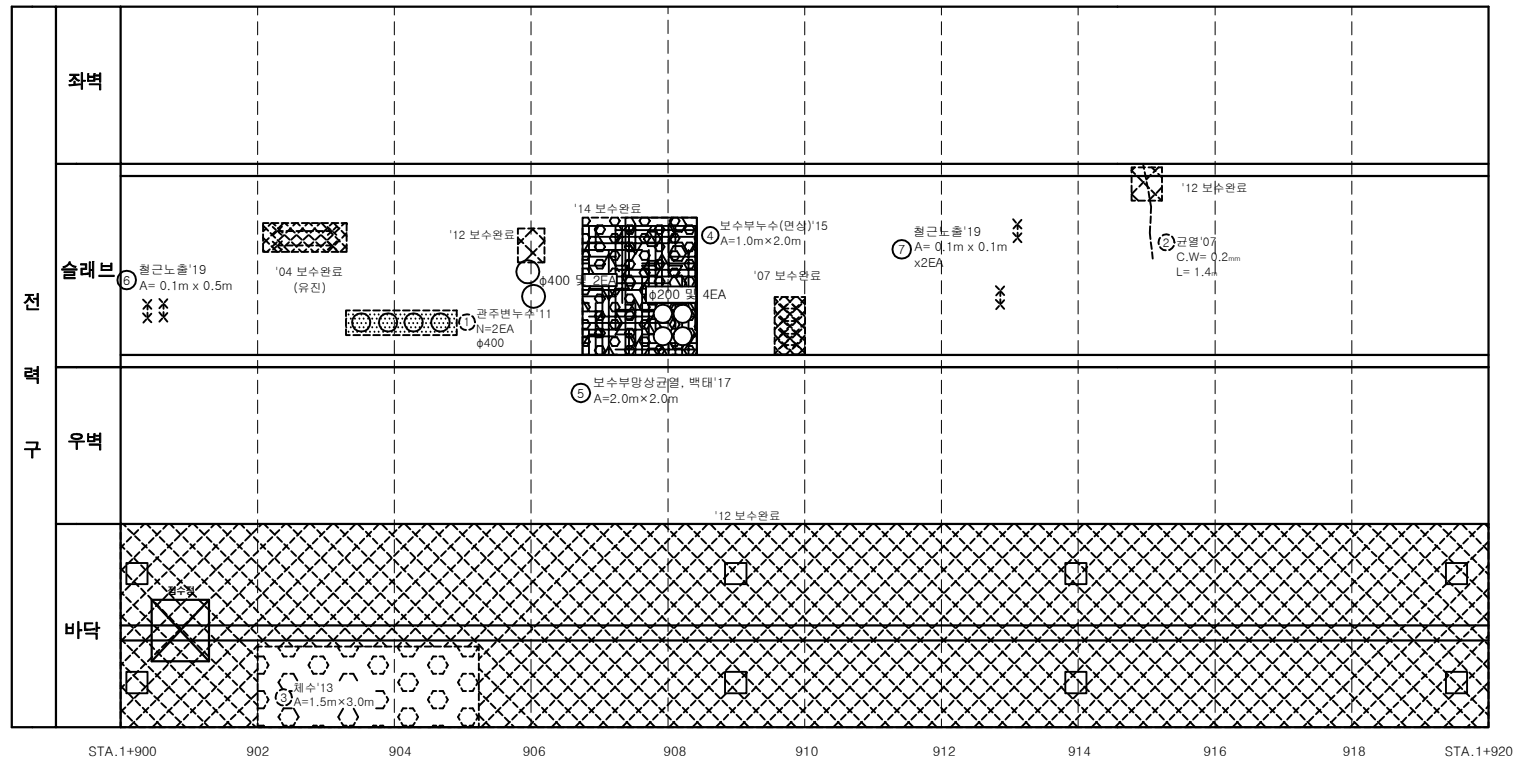
# 여의도 공동구 - 순환선 전력구 (STA. 1+900m ~ 1+920m)

| 연번 | 연도 | 발생내용 | 원형규모 | | | | 최종보수내역 | | 비고 |
|---|---|---|---|---|---|---|---|---|---|
| 1 | 2011 | 관주변누수 | 0.2 | 1.40 | 2.00 | EA | 2 | - | - |
| 2 | 2007 | 균열 | 0.2 | 1.40 | 1.40 | m | 1 | - | - |
| 3 | 2013 | 제수 | 1.5 | 3.00 | 4.50 | m | 1 | - | - |
| 4 | 2015 | 보수부 누수(연식) | 1.0 | 2.00 | 2.00 | m | 1 | - | 재결합 |
| 5 | 2017 | 보수부 누수(연식) | 2.0 | 2.00 | 4.00 | m | 1 | - | 재결합 |
| 6 | 2018 | 철근노출 | 0.1 | 0.50 | 0.05 | m | 1 | - | 신규 |
| 7 | 2019 | 철근노출 | 0.1 | 0.10 | 0.02 | m | 2 | - | 신규 |

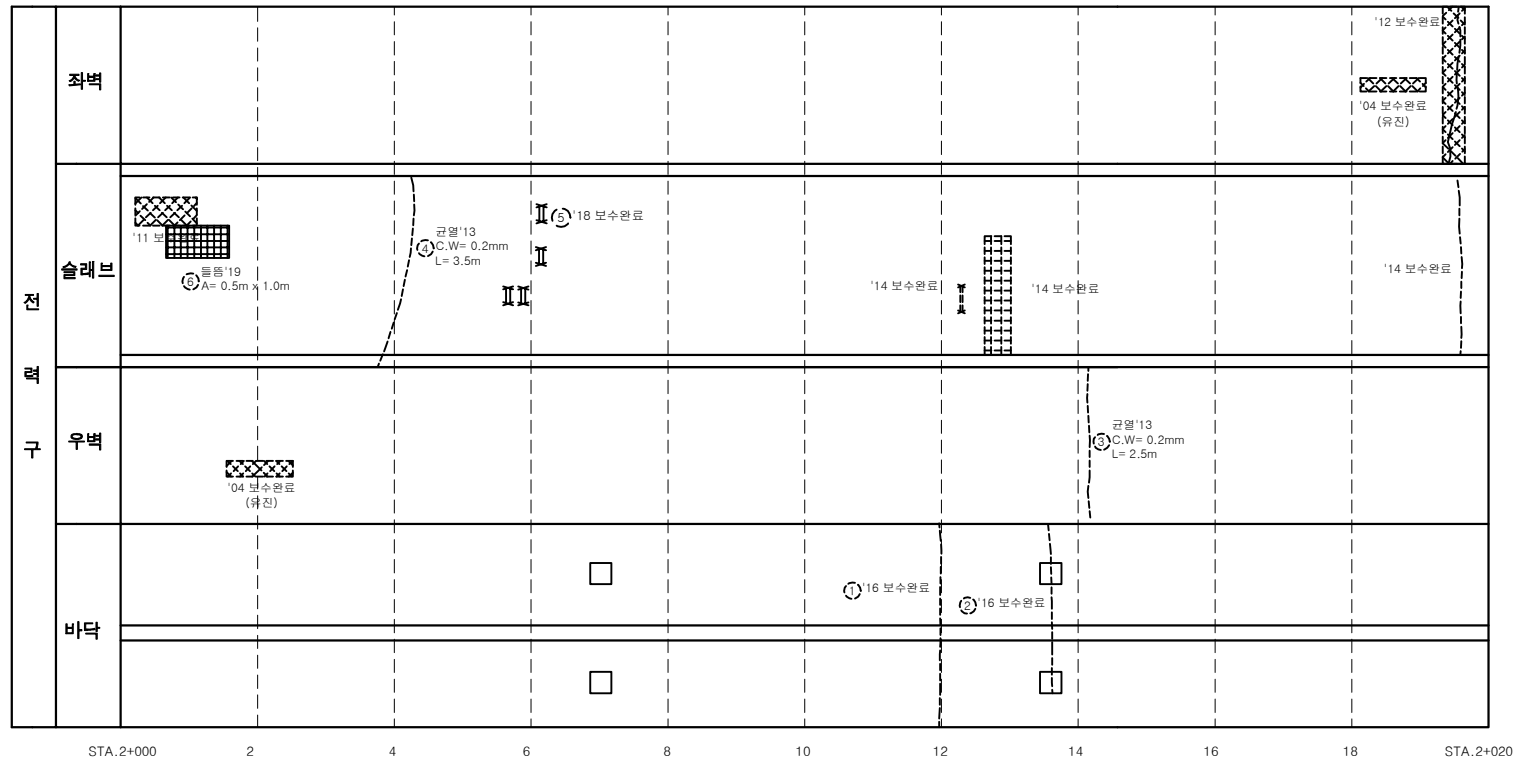
# 여의도 공동구 - 순환선 전력구 (STA. 2+000m ~ 2+020m)

| 연번 | 연도 | 발생내용 | 발생구분 | | | | 최종보수내역 | | 비고 |
|---|---|---|---|---|---|---|---|---|---|
| 1 | 2007 | 균열 | 1.0 | 3.00 | 3.00 | m | 1 | 주입보수공법 | 3.60 |
| 2 | 2013 | 균열 | 1.0 | 2.00 | 2.00 | m | 1 | 주입보수공법 | 2.40 |
| 3 | 2013 | 균열 | 0.2 | 2.50 | 2.50 | m | 1 | | - |
| 4 | 2013 | 균열 | 0.2 | 3.50 | 3.50 | m | 1 | | - |
| 5 | 2017 | 철근노출 | 0.1 | 0.20 | 0.08 | m | 4 | 단면복구(방청) | 0.10 |
| 6 | 2018 | 물품 | 0.5 | 1.00 | 0.50 | m | 1 | | - 신규 |

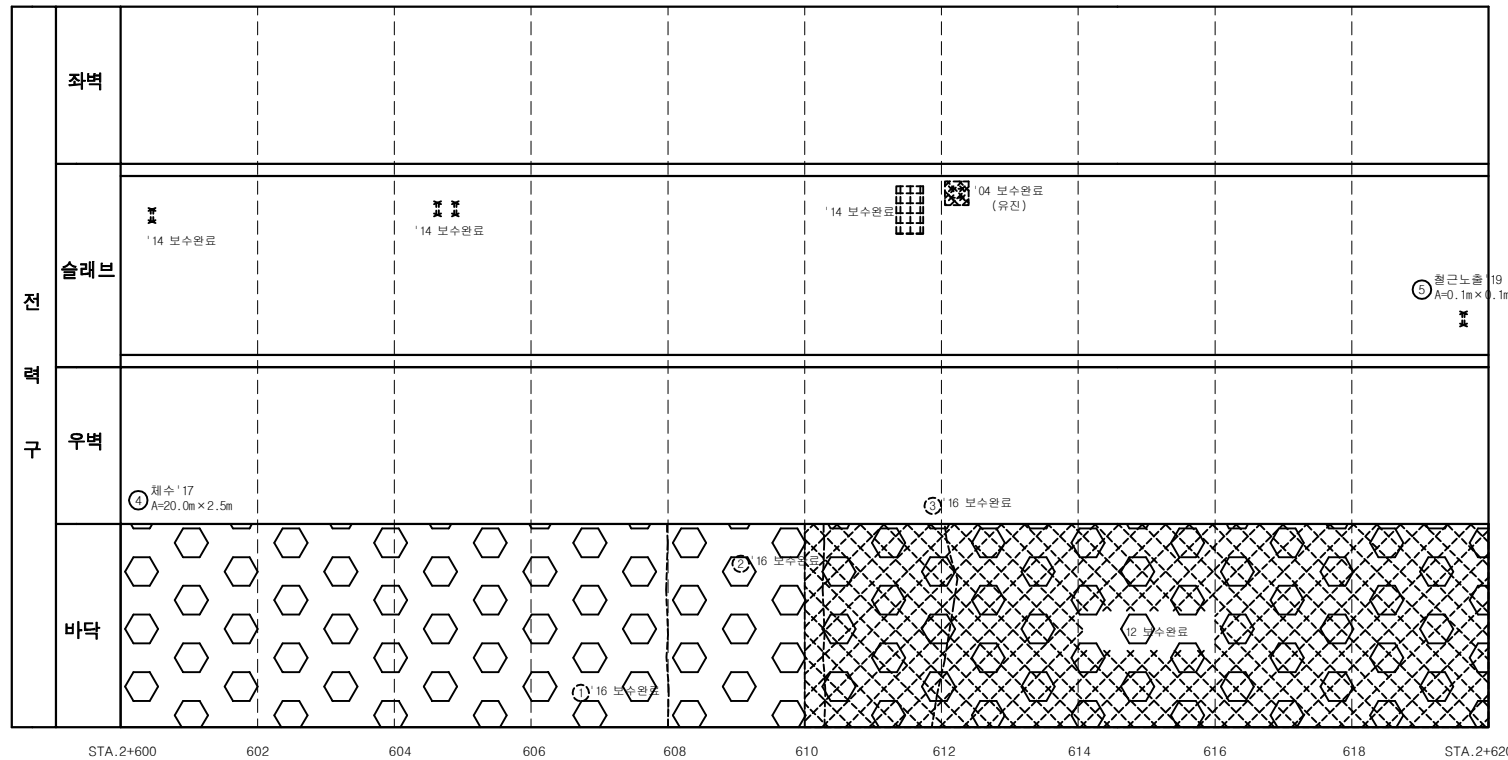
# 여의도 공동구 - 순환선 전력구 (STA. 2+600m ~ 2+620m)

| 연번 | 연도 | 발생내용 | 발생구분 | | | | | 최종보수내역 | | 비고 |
|---|---|---|---|---|---|---|---|---|---|---|
| 1 | 2013 | 균열 | 0.3 | 3.00 | 3.00 | m | 1 | 주입보수공법 | 3.00 | |
| 2 | 2013 | 균열 | 0.3 | 3.00 | 3.00 | m | 1 | 주입보수공법 | 3.00 | |
| 3 | 2013 | 균열 | 0.3 | 3.00 | 3.00 | m | 1 | 주입보수공법 | 3.00 | |

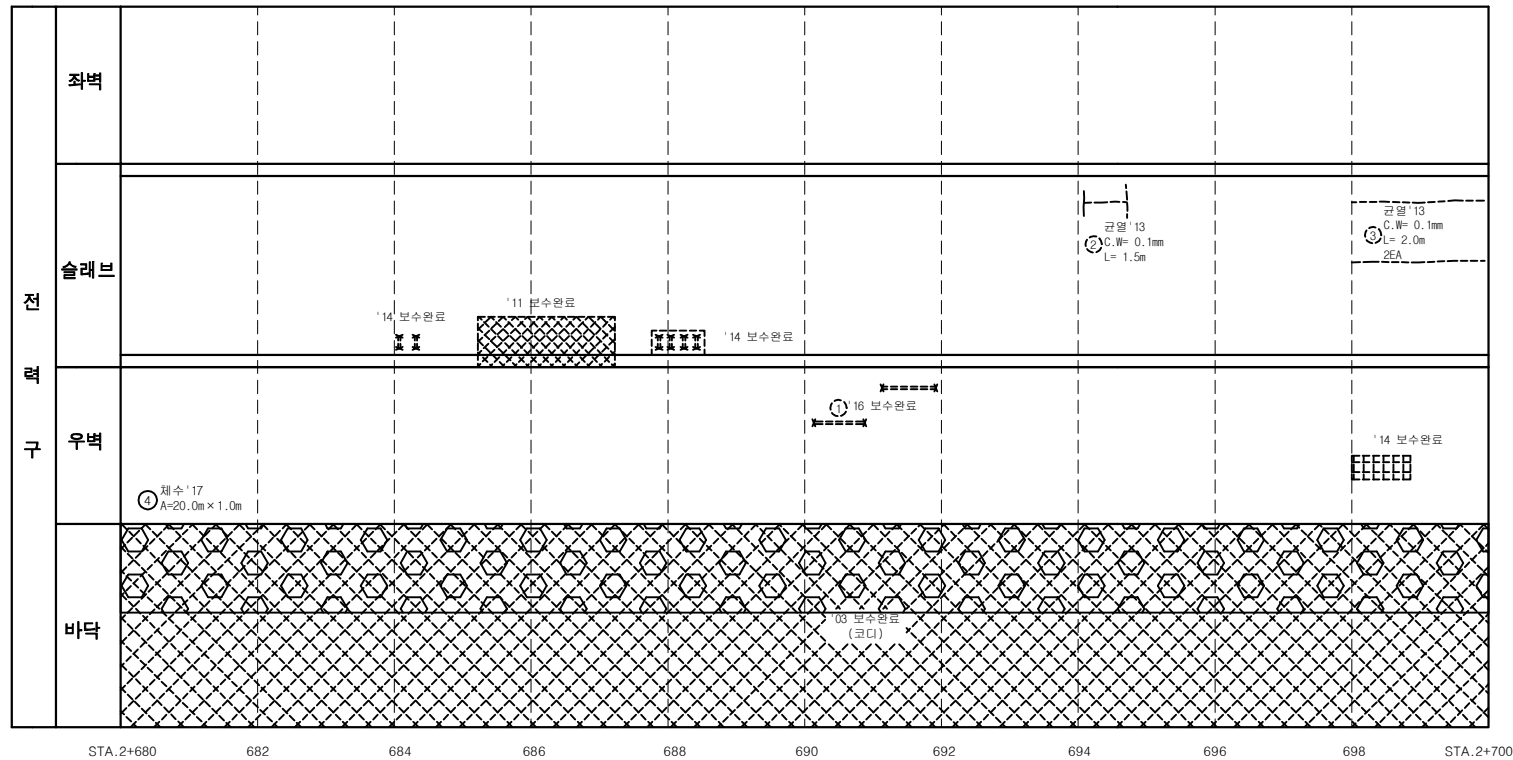
# 여의도 공동구 - 순환선 전력구 (STA. 2+680m ~ 2+700m)

| 연번 | 연도 | 발생내용 | 결함구분 | | | | | 최종보수내역 | | 비고 | |
|---|---|---|---|---|---|---|---|---|---|---|---|
| 2 | 2013 | 균열 | 0.1 | 1.50 | | 1.50 | m | 1 | | | - |
| 3 | 2013 | 균열 | 0.1 | 2.00 | | 4.00 | m | 2 | | | - |

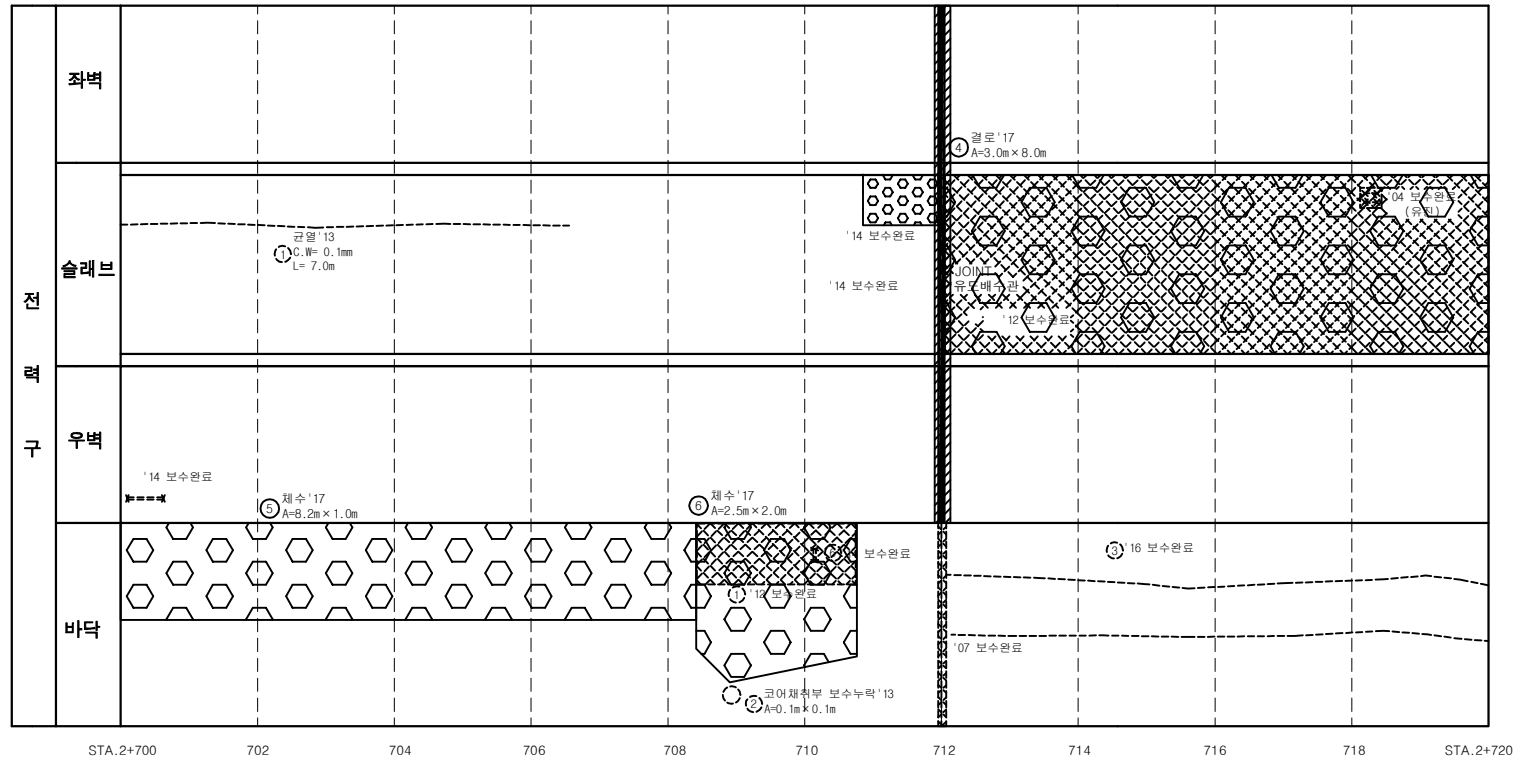
# 여의도 공동구 - 순환선 전력구 (STA. 2+700m ~ 2+720m)

⑦ 유도배수관 부식 '19  
L= 8.0m

| 연번 | 연도 | 발생내용 | 구분 | 길이 | 깊이 | 단위 | 개소 | 공사년도 | 공법명 | 수량 | 비고 |
|---|---|---|---|---|---|---|---|---|---|---|---|
| 1 | 2013 | 균열 | 구분 | 0.1 | 7.00 | m | 1 | | | - | |
| 2 | 2013 | 균열 | 구분 | 0.1 | 0.10 | m | 1 | | | - | |
| 3 | 2013 | 균열 | 구분 | 0.3 | 16.00 | m | 2 | 2016 | 주입보수공법 | 32.00 | |
| 4 | 2017 | 균열 | 구분 | 3.0 | 8.00 | m | 1 | | | - | |
| 7 | 2019 | 유도배수관 부식 | 구분 | 8.00 | 8.00 | m | 1 | | | - | 신규 |

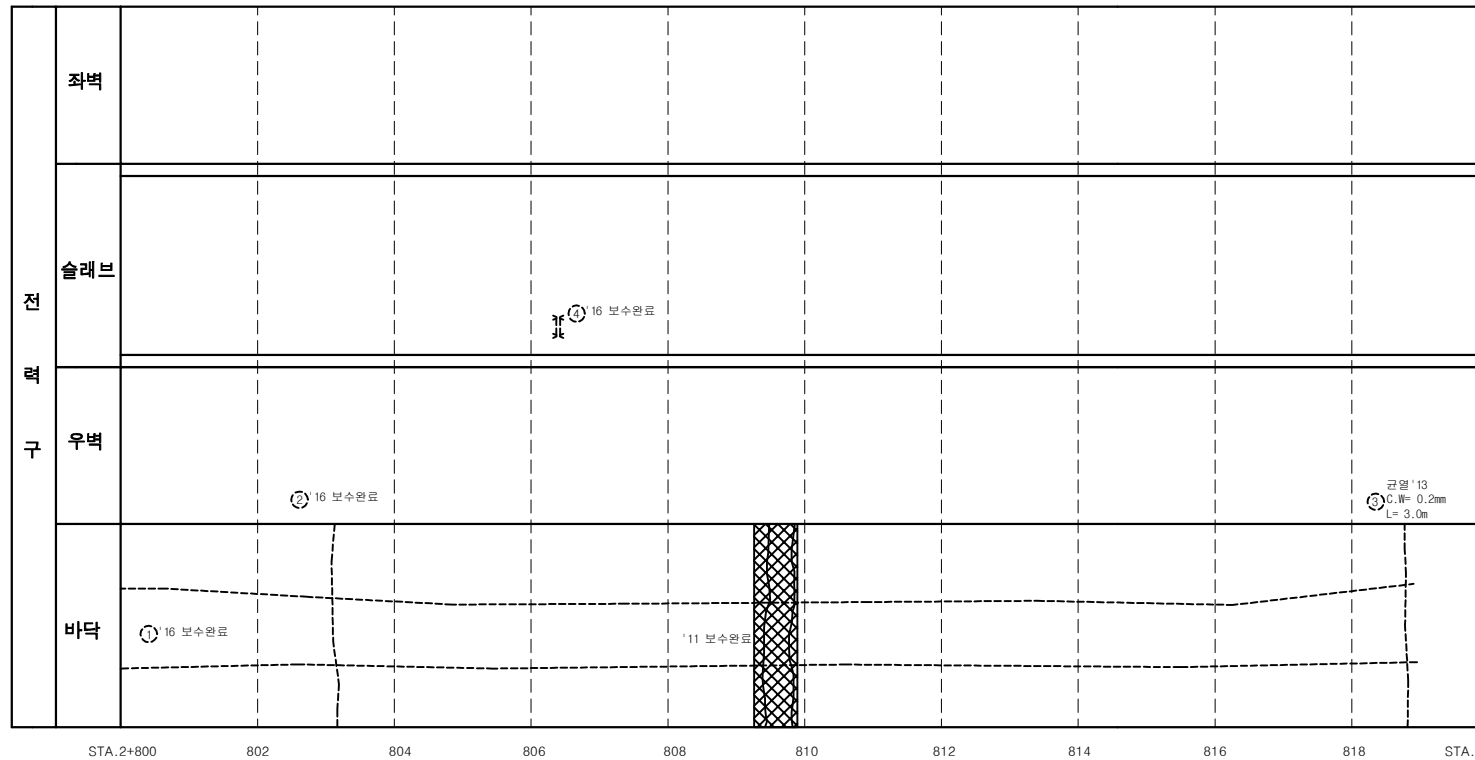
# 여의도 공동구 - 순환선 전력구 (STA. 2+800m ~ 2+820m)

| 연번 | 연도 | 발생내용 | 발생구분 | | | | | 최종보수내역 | | 비고 |
|---|---|---|---|---|---|---|---|---|---|---|
| 1 | 2013 | 균열 | 0.3 | 19.00 | 38.00 | m | 2 | 2016 | 주입보수공법 | 45.60 |
| 2 | 2013 | 균열 | 0.3 | 3.00 | 3.00 | m | 1 | 2016 | 주입보수공법 | 3.60 |
| 3 | 2013 | 균열 | 0.2 | 3.00 | 3.00 | m | 1 | | | - |

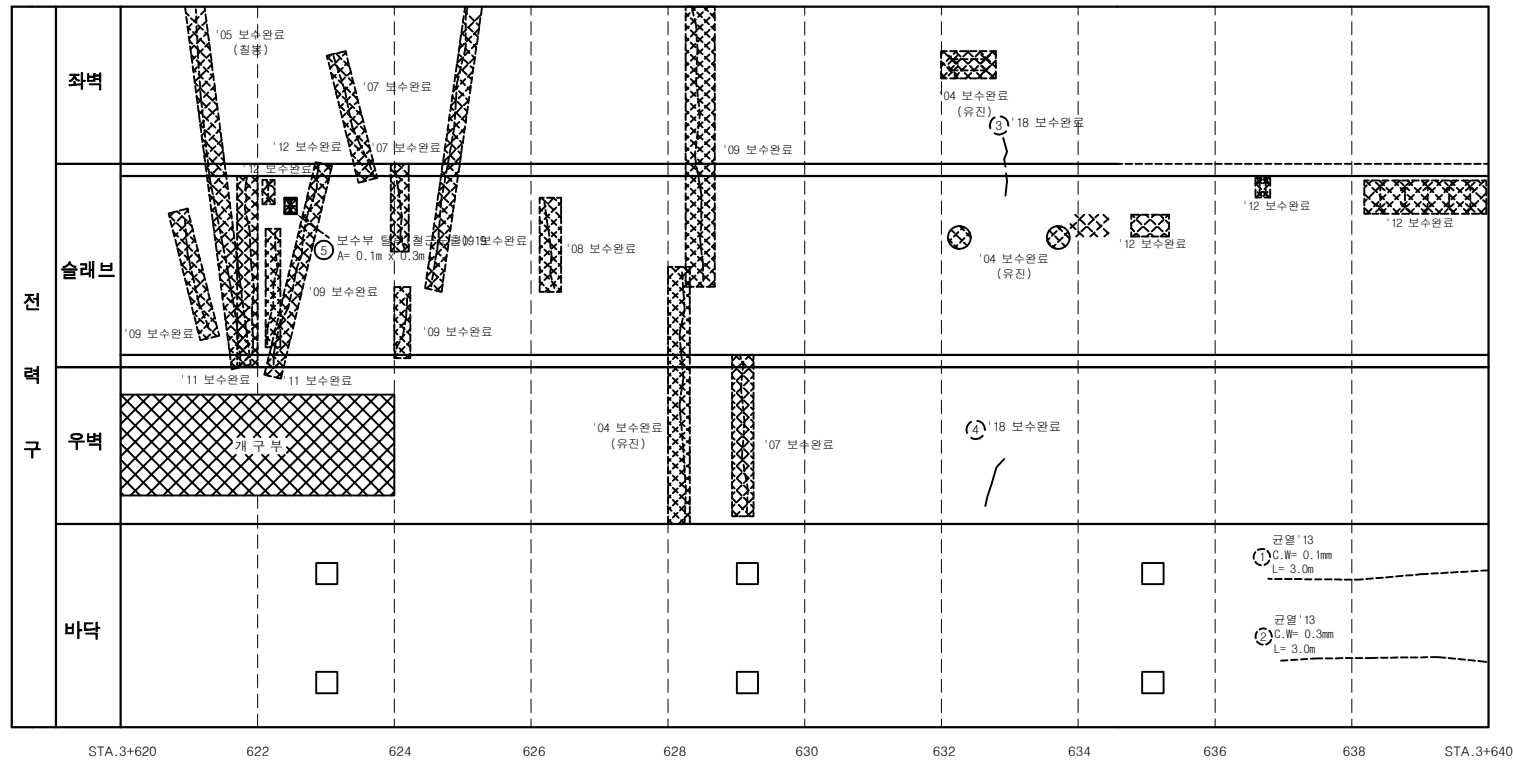
# 여의도 공동구 - 순환선 전력구 (STA. 3+620m ~ 3+640m)

| 연번 | 연도 | 발생내용 | 발생구분 | | | | 최종보수내역 | | 비고 |
|---|---|---|---|---|---|---|---|---|---|
| 1 | 2013 | 균열 | 0.1 | 3.00 | 3.00 | m | 1 | | - |
| 2 | 2013 | 균열 | 0.3 | 3.00 | 3.00 | m | 1 | | - |
| 3 | 2017 | 보수부 균열 | 0.2 | 2.00 | 2.00 | m | 1 | 표면치리공법 | - |
| 4 | 2017 | 균열 | 0.3 | 0.80 | 0.80 | m | 1 | 주입보수공법 | 0.98 |

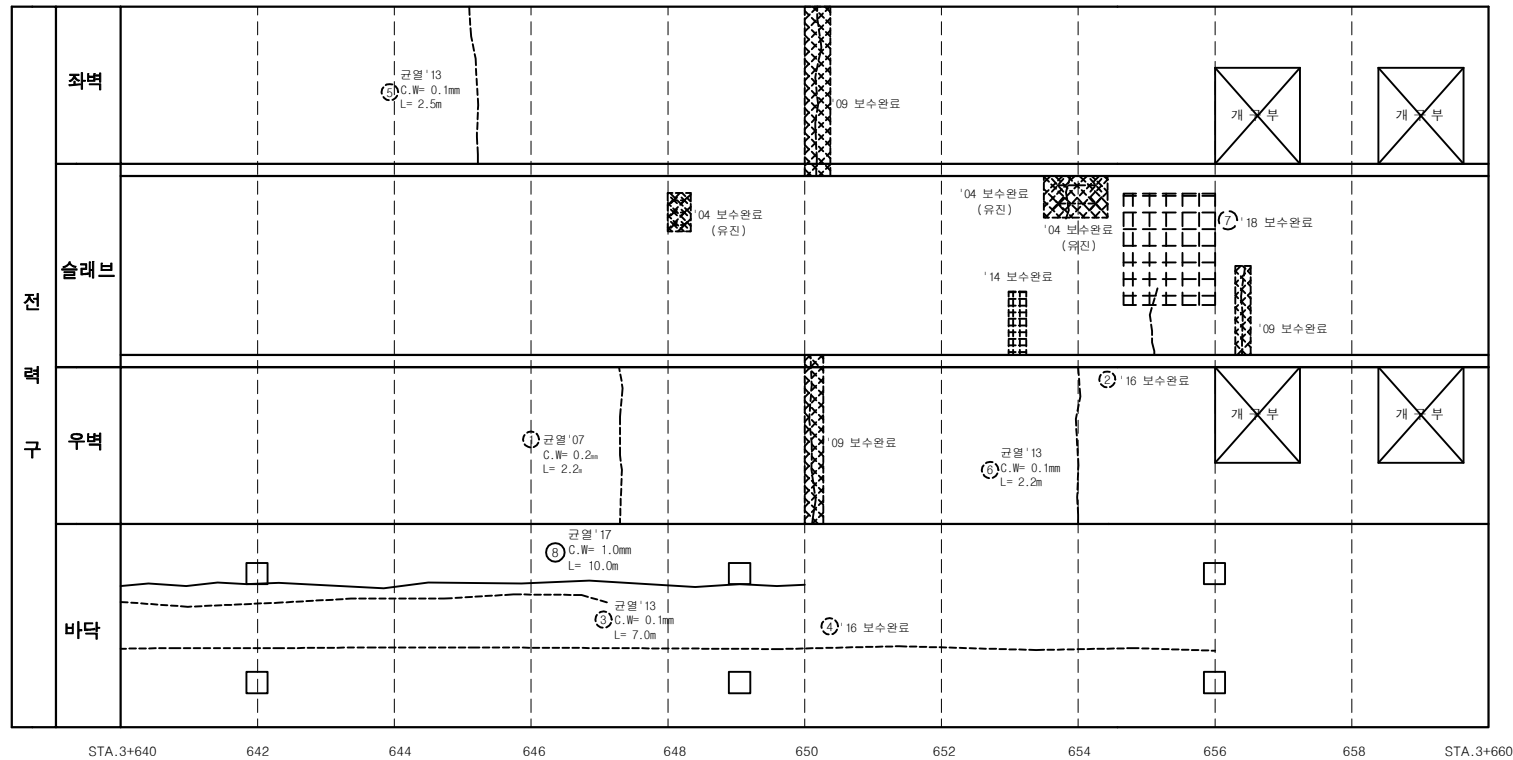
# 여의도 공동구 - 순환선 전력구 (STA. 3+640m ~ 3+660m)

| 연번 | 연도 | 발생내용 | 원형구도 | | | | 최종보수내역 | | 비고 |
|---|---|---|---|---|---|---|---|---|---|
| 1 | 2007 | 균열 | 0.2 | 2.20 | 2.20 | m | 1 | | - |
| 2 | 2011 | 균열 | 0.3 | 0.70 | 0.70 | m | 1 | 2016 주입보수공법 | 0.84 |
| 3 | 2013 | 균열 | 0.1 | 7.00 | 7.00 | m | 1 | | - |
| 4 | 2013 | 균열 | 0.3 | 16.00 | 16.00 | m | 1 | 2016 주입보수공법 | 16.00 |
| 5 | 2013 | 균열 | 0.1 | 2.50 | 2.50 | m | 1 | | - |
| 6 | 2013 | 균열 | 0.1 | 2.20 | 2.20 | m | 1 | | - |
| 8 | 2017 | 균열 | 1.0 | 10.00 | 10.00 | m | 1 | | - |
