# 외 관 조 사 망 도

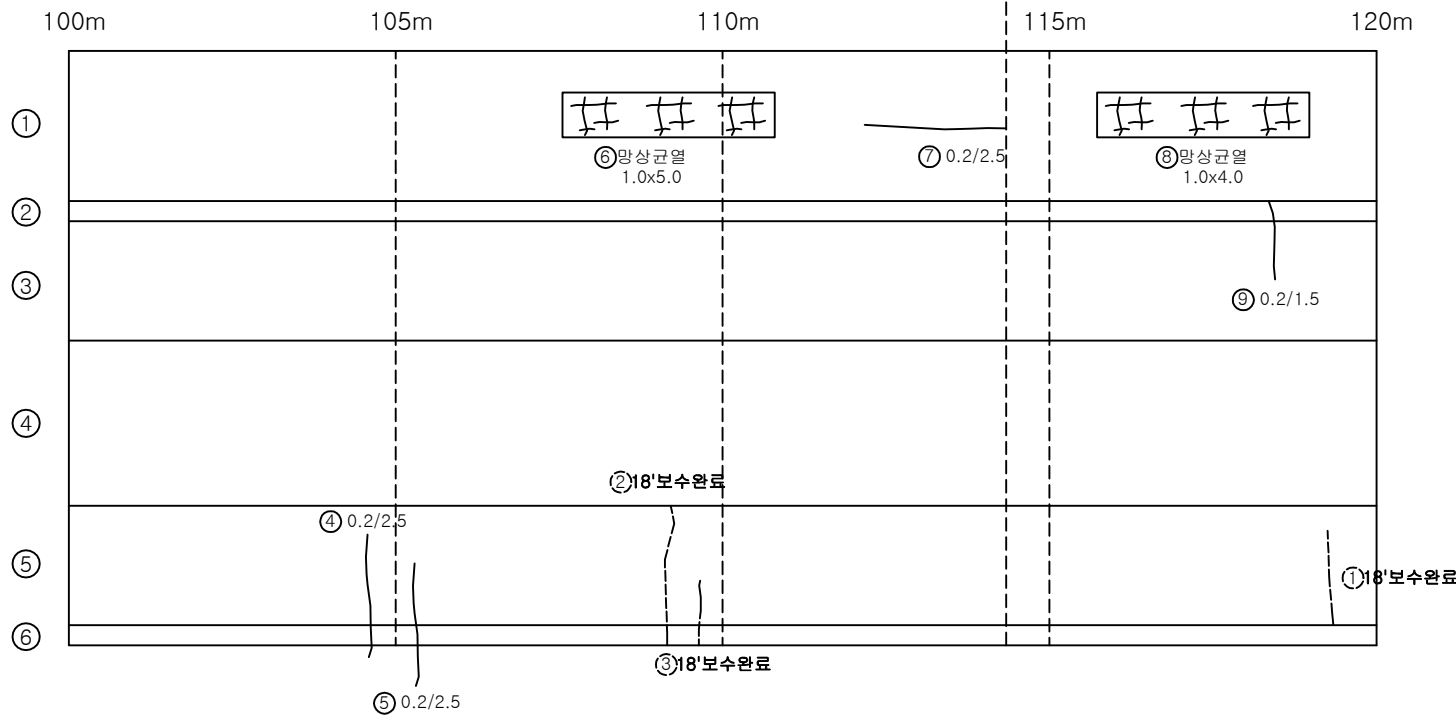
EX. J #4

| 연번 | 작성<br>년도 | 결함내용 | 결함규모 | | | | | 최종보수내역 | | | 비고 | |
|---|---|---|---|---|---|---|---|---|---|---|---|---|
| 1 | 2014 | 균열 | | | | 1.50 | m | 1 | 2018 | 표면처리공법 | 1.80 | |
| 2 | 2016 | 균열 | | | | 2.50 | m | 1 | 2018 | 표면처리공법 | 3.00 | |
| 3 | 2016 | 균열 | | | | 1.00 | m | 1 | 2018 | 표면처리공법 | 1.20 | |
| 4 | 2019 | 균열 | 0.2 | 2.50 | | 2.50 | m | 1 | | | - | 신규 |
| 5 | 2019 | 균열 | 0.2 | 2.50 | | 2.50 | m | 1 | | | - | 신규 |
| 6 | 2019 | 망상균열 | 1.00 | 5.00 | | 5.00 | m <sup>2</sup> | 1 | | | - | 신규 |
| 7 | 2019 | 균열 | 0.2 | 2.50 | | 2.50 | m | 1 | | | - | 신규 |
| 8 | 2019 | 망상균열 | 1.00 | 4.00 | | 4.00 | m <sup>2</sup> | 1 | | | - | 신규 |
| 9 | 2019 | 균열 | 0.2 | 1.50 | | 1.50 | m | 1 | | | - | 신규 |

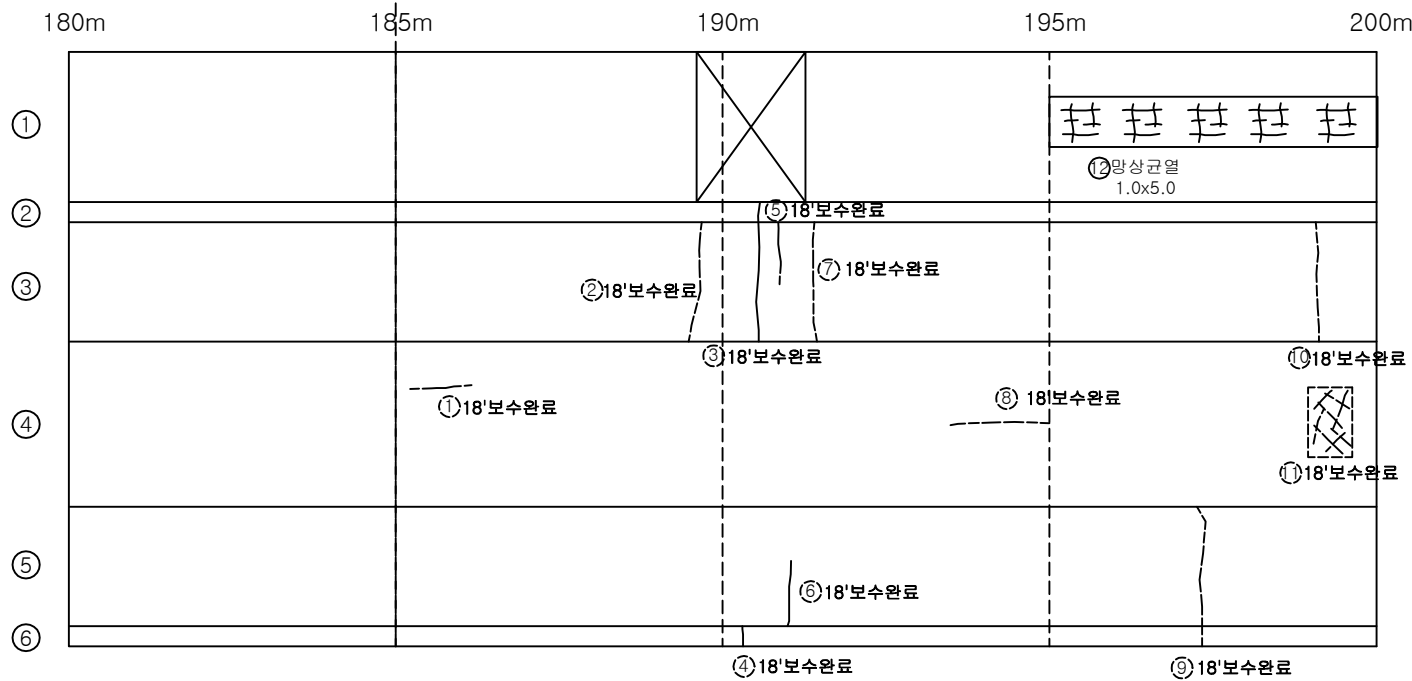
EX. J #7

| 연번 | 작성<br>년도 | 결함내용 | 결함규모 | | | | | 최종보수내역 | | | 비고 | |
|---|---|---|---|---|---|---|---|---|---|---|---|---|
| 1 | 2016 | 바닥균열 | | | | 1.50 | m | 1 | 2018 | 표면처리공법 | 1.80 | |
| 2 | 2016 | 균열 | | | | 2.00 | m | 1 | 2018 | 주입보수공법 | 2.40 | |
| 3 | 2016 | 균열 | | | | 2.50 | m | 1 | 2018 | 주입보수공법 | 3.00 | |
| 4 | 2016 | 균열 | | | | 0.50 | m | 1 | 2018 | 주입보수공법 | 0.60 | |
| 5 | 2016 | 균열 | | | | 1.50 | m | 1 | 2018 | 주입보수공법 | 1.80 | |
| 6 | 2016 | 균열 | | | | 1.50 | m | 1 | 2018 | 주입보수공법 | 1.80 | |
| 7 | 2016 | 균열 | | | | 2.00 | m | 1 | 2018 | 주입보수공법 | 2.40 | |
| 8 | 2016 | 바닥균열 | | | | 2.00 | m | 1 | 2018 | 표면처리공법 | 2.40 | |
| 9 | 2016 | 균열 | | | | 2.50 | m | 1 | 2018 | 주입보수공법 | 3.00 | |
| 10 | 2016 | 균열 | | | | 2.00 | m | 1 | 2018 | 표면처리공법 | 2.40 | |
| 11 | 2016 | 바닥방상균열 | | | | 1.50 | m <sup>2</sup> | 1 | 2018 | 표면처리공법 | 1.80 | |
| 12 | 2019 | 방상균열 | 1.0 | 5.00 | | 5.00 | m <sup>2</sup> | 1 | | | - | 신규 |

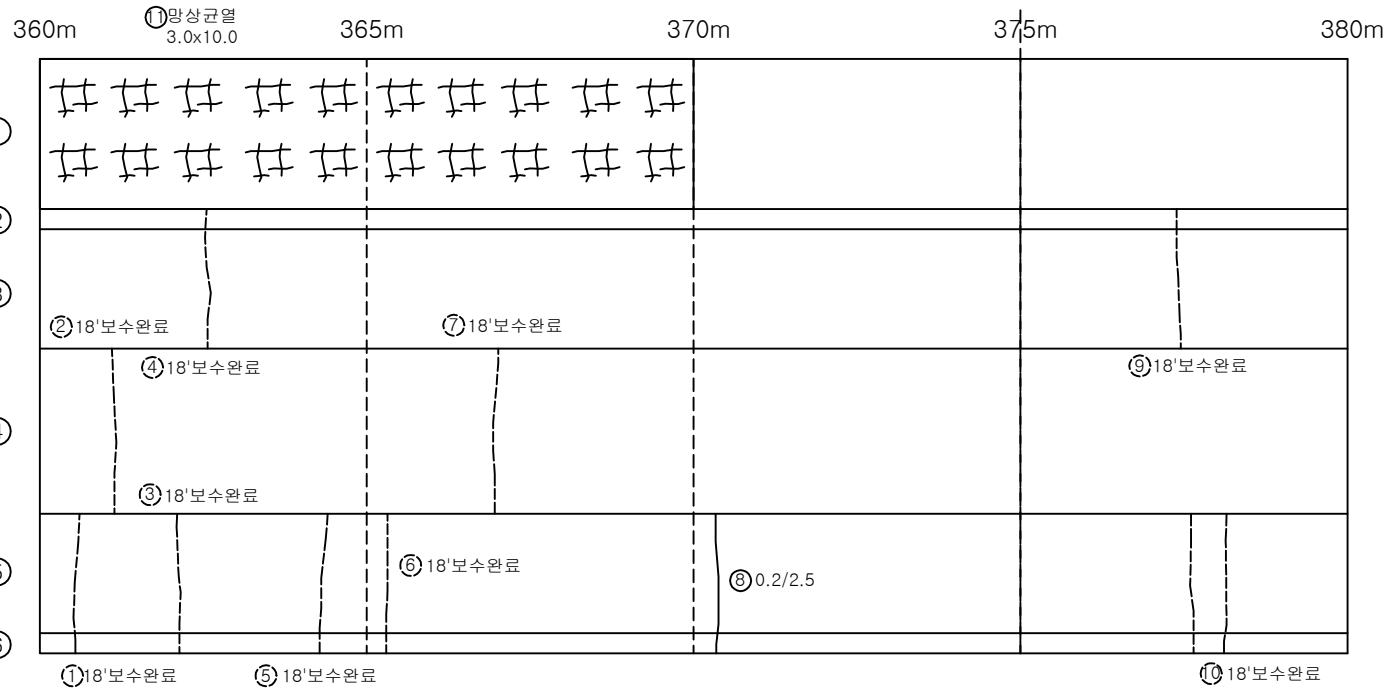
EX. J #14

| 연번 | 작성<br>년도 | 결함내용 | 결함규모 | | | | | 최종보수내역 | | | 비고 | |
|---|---|---|---|---|---|---|---|---|---|---|---|---|
| 1 | 2016 | 균열 | | | | 2.50 | m | 1 | 2018 | 주임보수공법 | 3.00 | |
| 2 | 2016 | 바닥균열 | | | | 3.00 | m | 1 | 2018 | 표면처리공법 | 3.60 | |
| 3 | 2016 | 균열 | | | | 2.50 | m | 1 | 2018 | 표면처리공법 | 3.00 | |
| 4 | 2016 | 균열 | | | | 2.50 | m | 1 | 2018 | 주임보수공법 | 3.00 | |
| 5 | 2016 | 균열 | | | | 2.50 | m | 1 | 2018 | 주임보수공법 | 3.00 | |
| 6 | 2016 | 균열 | | | | 2.50 | m | 1 | 2018 | 주임보수공법 | 3.00 | |
| 7 | 2016 | 바닥균열 | | | | 3.00 | m | 1 | 2018 | 표면처리공법 | 3.60 | |
| 8 | 2016 | 균열 | 0.2 | 2.50 | | 2.50 | m | 1 | | | - | |
| 9 | 2016 | 균열 | | | | 2.50 | m | 1 | 2018 | 주임보수공법 | 3.00 | |
| 10 | 2016 | 균열 | | | | 2.50 | m | 1 | 2018 | 표면처리공법 | 3.00 | |
| 11 | 2019 | 망상균열 | 3.0 | 10.00 | | 30.00 | m <sup>2</sup> | 1 | | | - | 신규 |

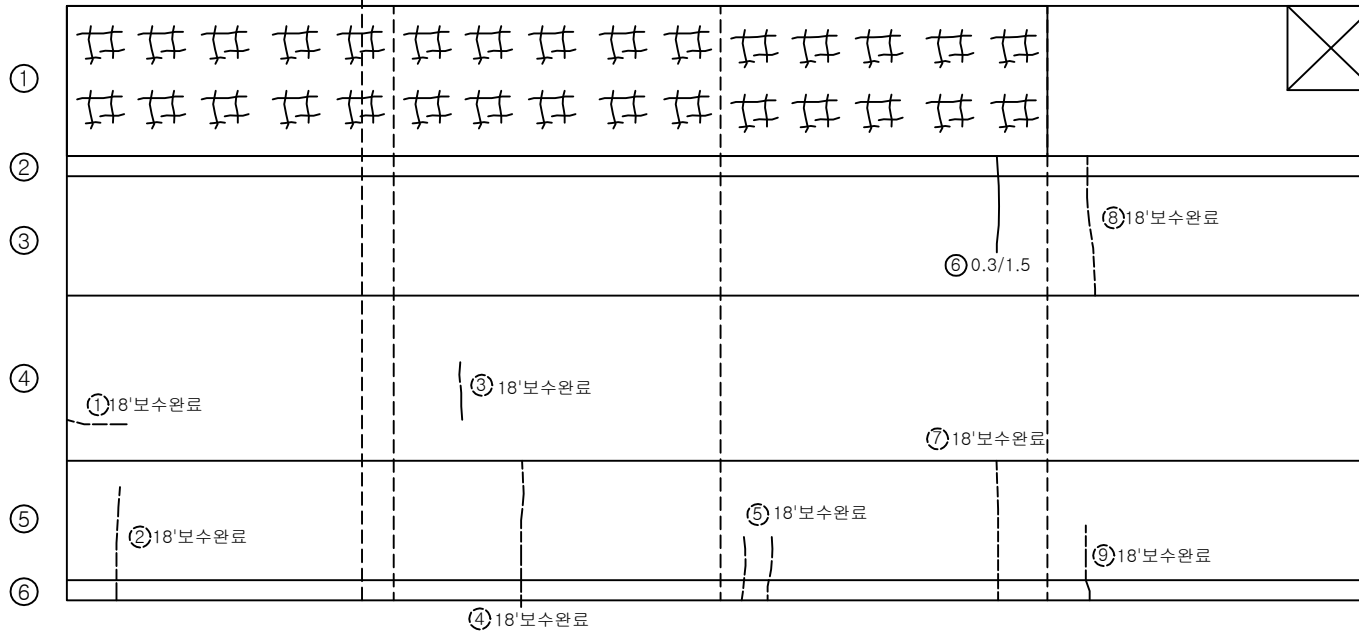
EX. J #15

| 연번 | 작성<br>년도 | 결함내용 | 결함규모 | | | | | 최종보수내역 | | | 비고 | |
|---|---|---|---|---|---|---|---|---|---|---|---|---|
| 1 | 2014 | 바닥균열 | | | | 1.00 | m | 1 | 2018 | 표면처리공법 | 1.20 | |
| 2 | 2016 | 균열 | | | | 2.00 | m | 1 | 2018 | 표면처리공법 | 2.40 | |
| 3 | 2016 | 바닥균열 | | | | 1.00 | m | 1 | 2018 | 표면처리공법 | 1.20 | |
| 4 | 2016 | 균열 | | | | 2.50 | m | 1 | 2018 | 표면처리공법 | 3.00 | |
| 5 | 2016 | 균열 | | | | 1.00 | m | 1 | 2018 | 표면처리공법 | 1.20 | |
| 6 | 2016 | 균열 | 0.3 | 1.50 | | 1.50 | m | 1 | | | - | |
| 7 | 2016 | 균열 | | | | 2.50 | m | 1 | 2018 | 주입보수공법 | 3.00 | |
| 8 | 2016 | 균열 | | | | 2.50 | m | 1 | 2018 | 주입보수공법 | 3.00 | |
| 9 | 2016 | 균열 | | | | 1.00 | m | 1 | 2018 | 표면처리공법 | 1.20 | |
| 10 | 2019 | 망상균열 | 3.0 | 15.00 | | 45.00 | m² | 1 | | | - | 신규 |

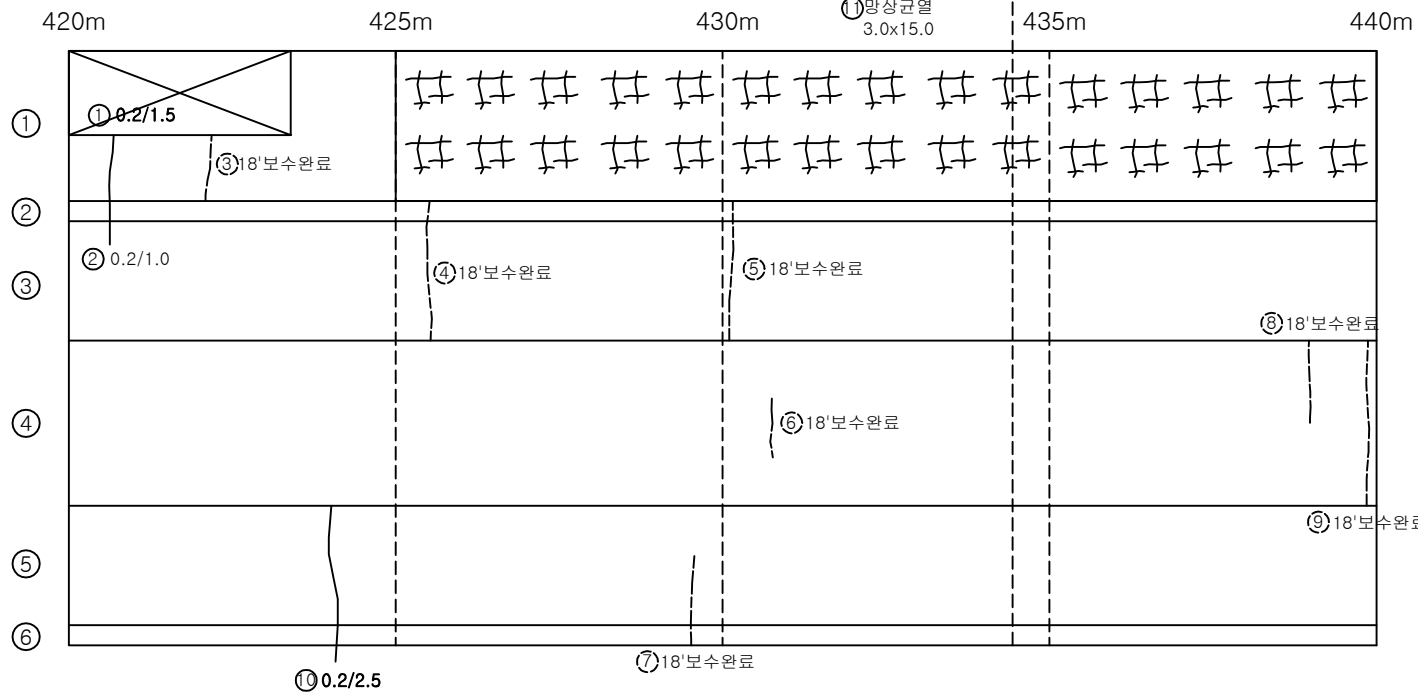
EX. J #16

⑪ 망상균열  
3.0x15.0

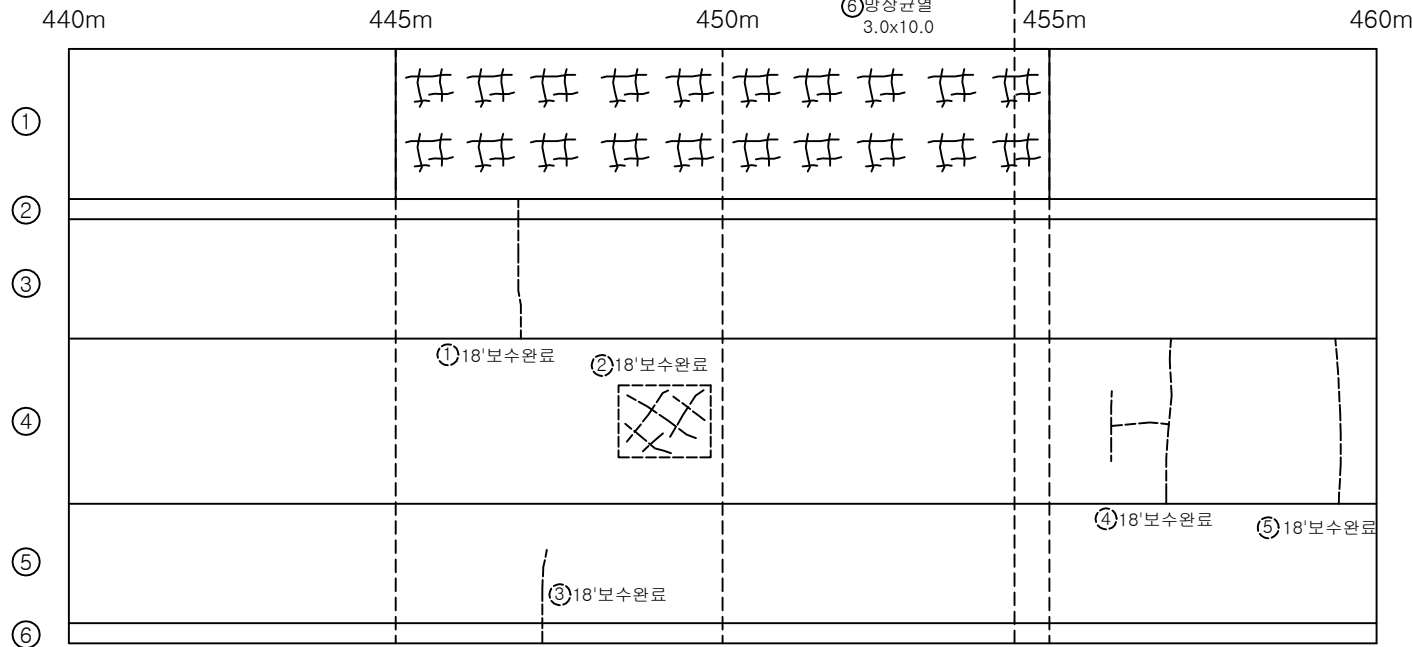
EX. J #17

⑥망상균열  
3.0x10.0

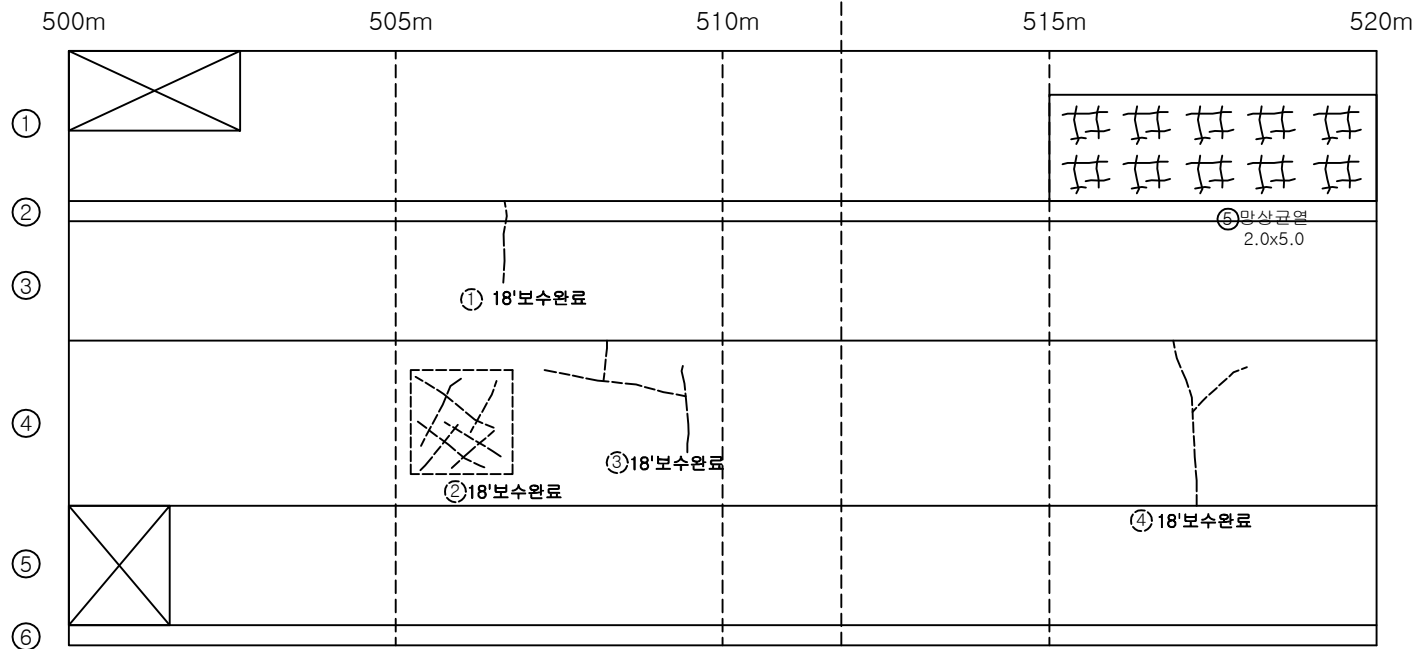
EX. J #19

| 연번 | 작출<br>년도 | 결함내용 | 결함규모 | | | | | 최종보수내역 | | | 비고 |
|---|---|---|---|---|---|---|---|---|---|---|---|
| 1 | 2016 | 균열 | | | | 1.50 | m | 1 | 2018 | 표면처리공법 | 1.80 |
| 2 | 2016 | 바닥망상균열 | | | | 4.00 | m <sup>2</sup> | 1 | 2018 | 표면처리공법 | 4.80 |
| 3 | 2016 | 바닥균열 | | | | 5.00 | m | 1 | 2018 | 표면처리공법 | 6.00 |
| 4 | 2016 | 바닥균열 | | | | 4.00 | m | 1 | 2018 | 표면처리공법 | 4.80 |
| 5 | 2019 | 망상균열 | 2.0 | 5.00 | | 10.00 | m <sup>2</sup> | 1 | | | - 신규 |
