상주영천고속도로 시설물 정밀점검 용역

# 외 관 조 사 망 도

가천교

2019.12

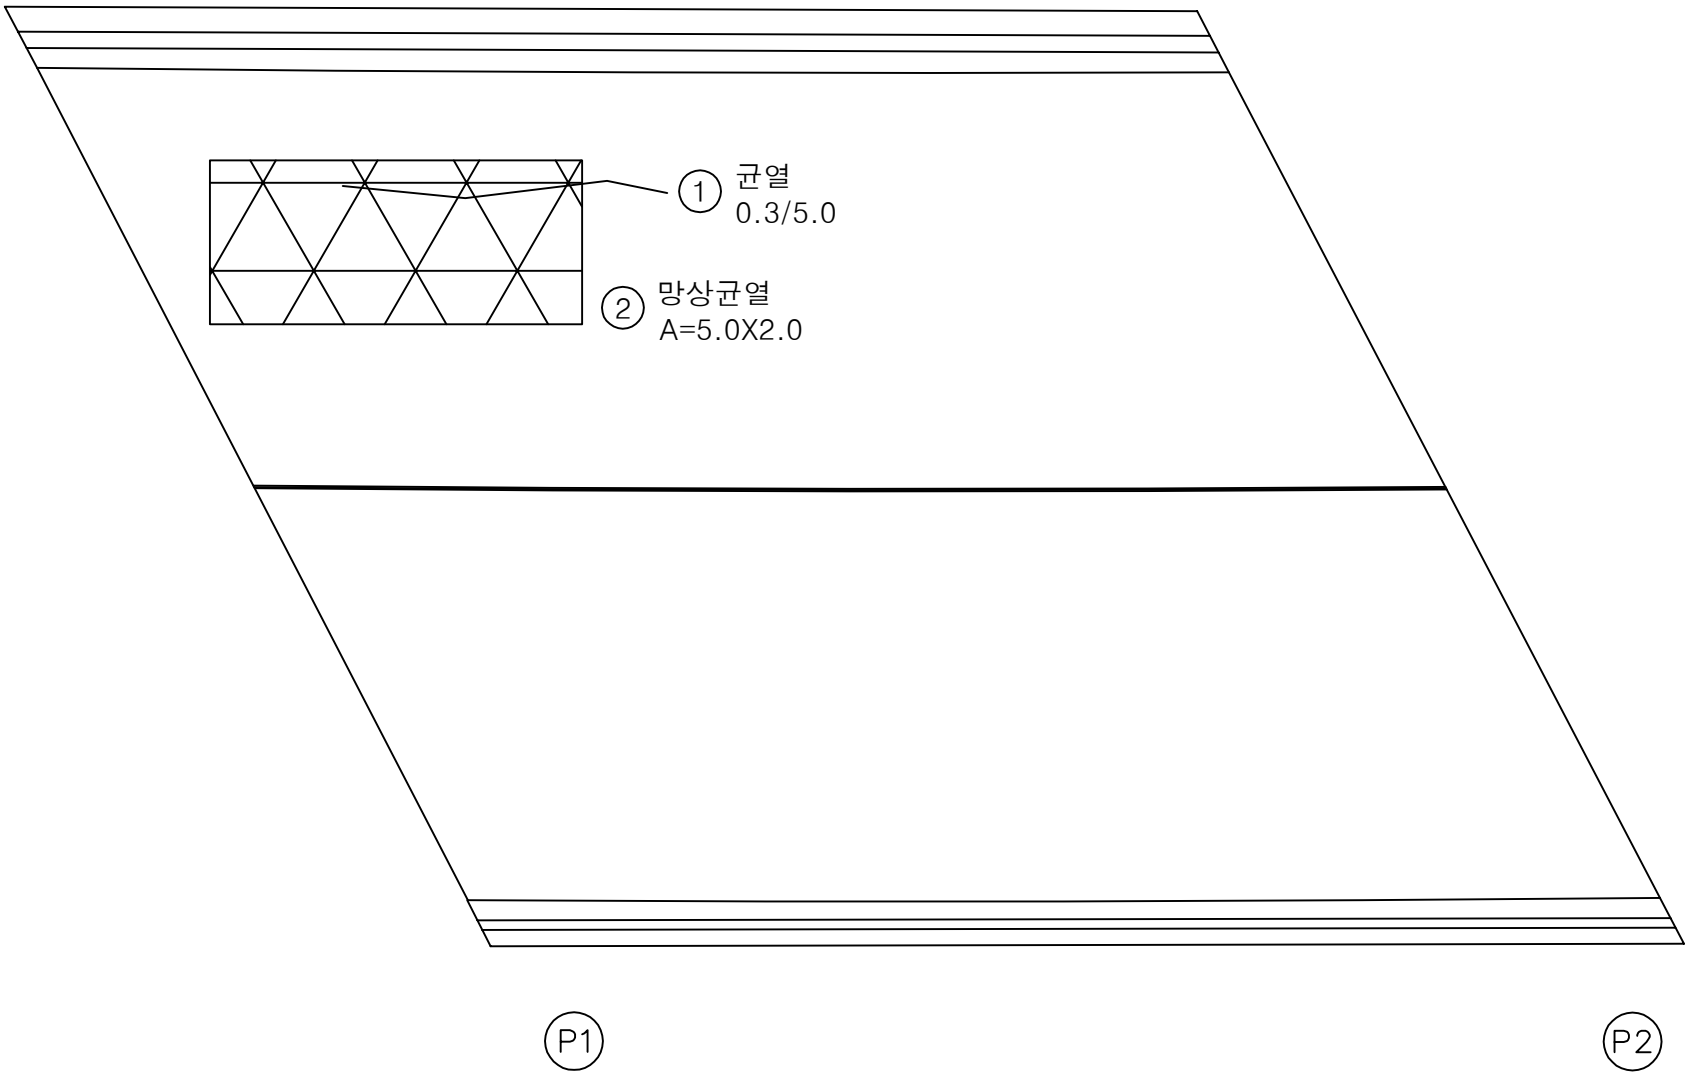
| 번호 | 손상내용 | 손상현황 | | | | | | 비 고 |
|---|---|---|---|---|---|---|---|---|
| 1 | 균열 | 0.3 | 5.0 | | 5.00 | m | 1 | 신규 |
| 2 | 망상균열 | | 5.0 | 2.0 | 10.0 | m <sup>2</sup> | 1 | 신규 |

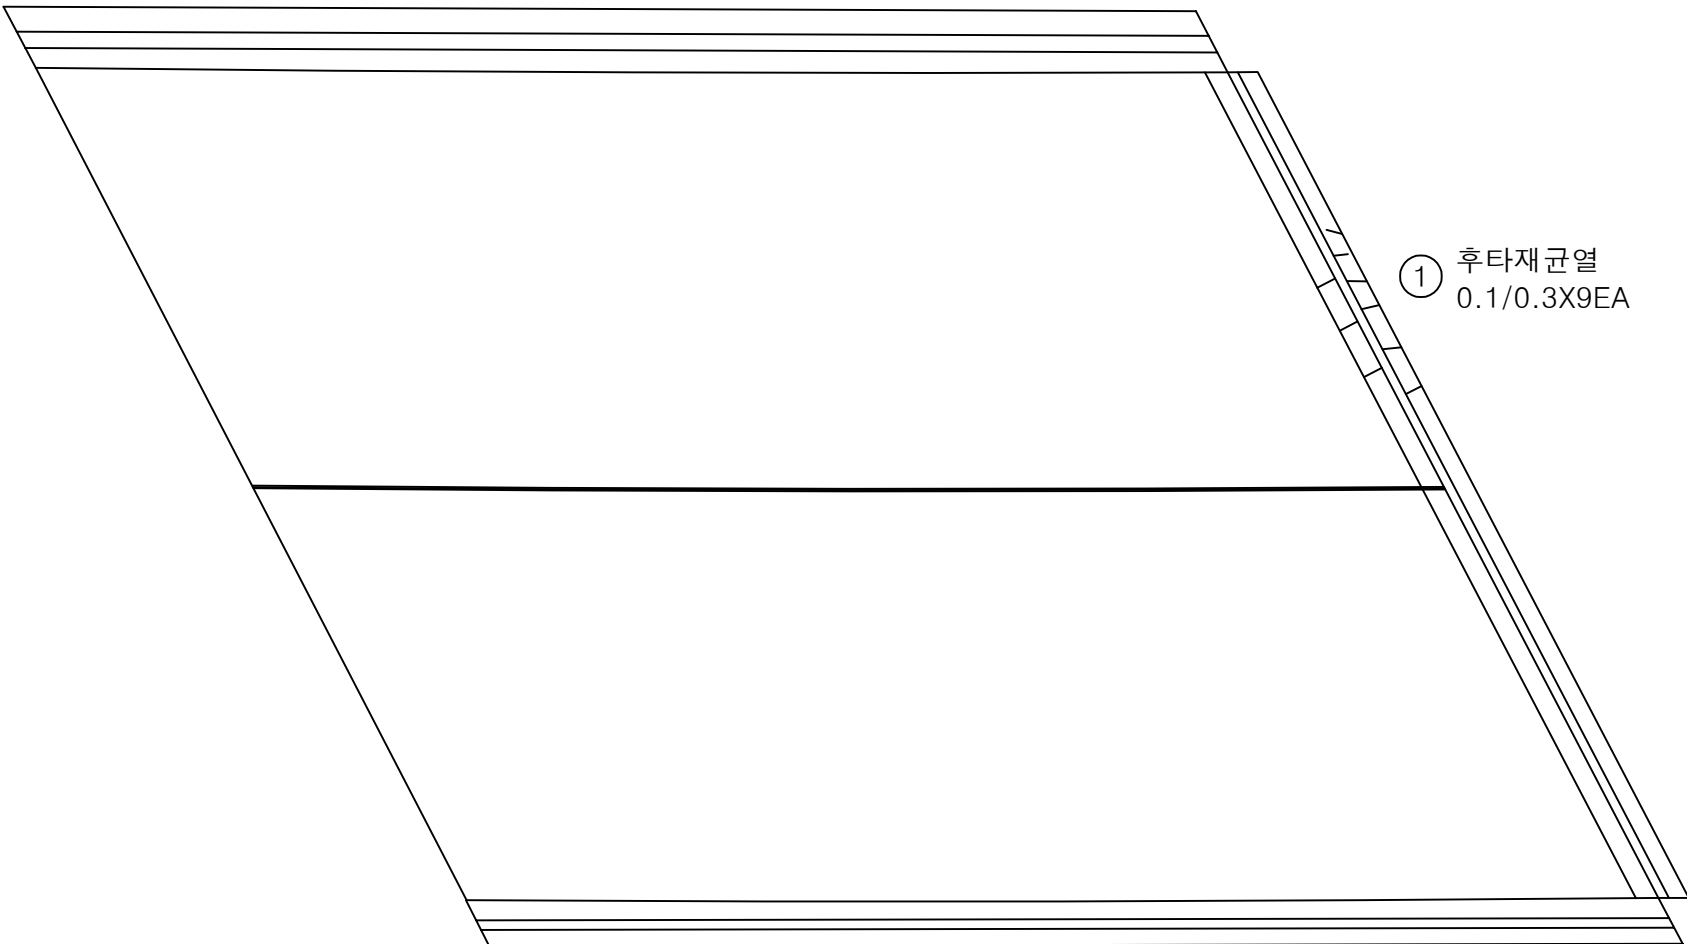
① 후타재균열  
0.1/0.3X9EA

| 번호 | 손상내용 | 손상현황 | | | | | | 비 고 |
|---|---|---|---|---|---|---|---|---|
| 1 | 후타재균열 | 0.1 | 0.3 | | 2.70 | m | 9 | 신규 |
