## 2 외관조사

# [STA.3+670~3+990[오 창]절 토 사 면]

오창절토05

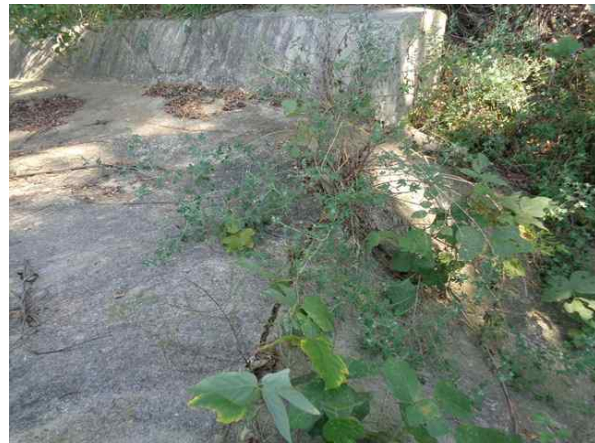
| 위치 | STA.3+750 4소단배수로 |

| 현황 | 균열(0.5mm / 2.5m) |

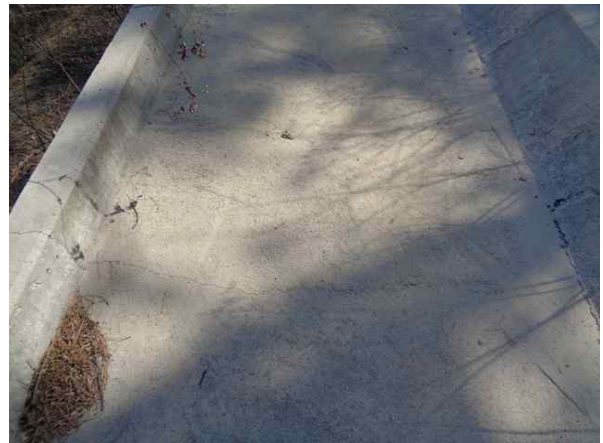
| 위치 | STA.3+780 4소단배수로 |

| 현황 | 균열(1.0mm / 2.5m) |

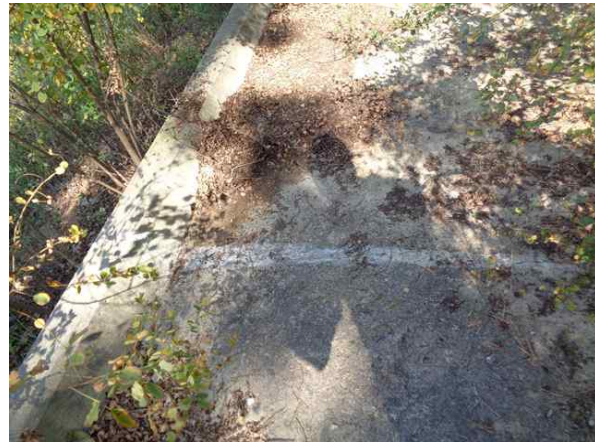
| 위치 | STA.3+780 4소단배수로 |

| 현황 | 균열(1.3mm / 2.5m) |

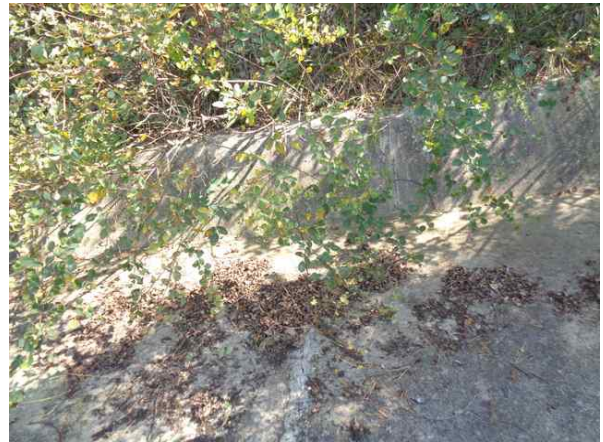
| 위치 | STA.3+790 4소단배수로 |

| 현황 | 균열(0.5mm / 2.5m) |

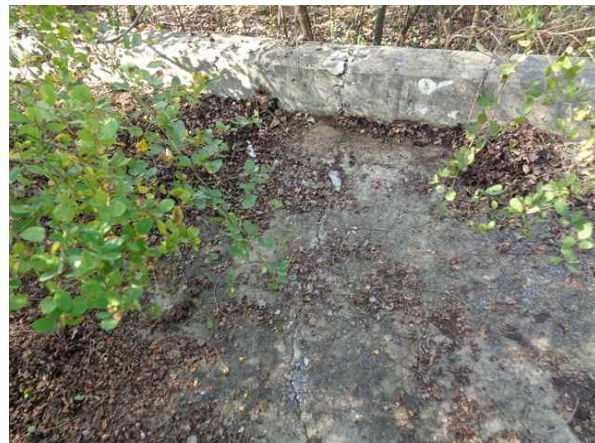
| 위치 | STA.3+810 4소단배수로 |

| 현황 | 균열(0.5mm / 2.5m) |

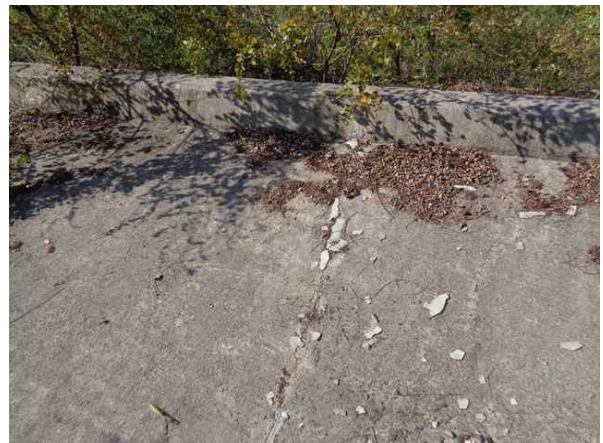
| 위치 | STA.3+830 4소단배수로 |

| 현황 | 균열(0.6mm / 2.5m) |

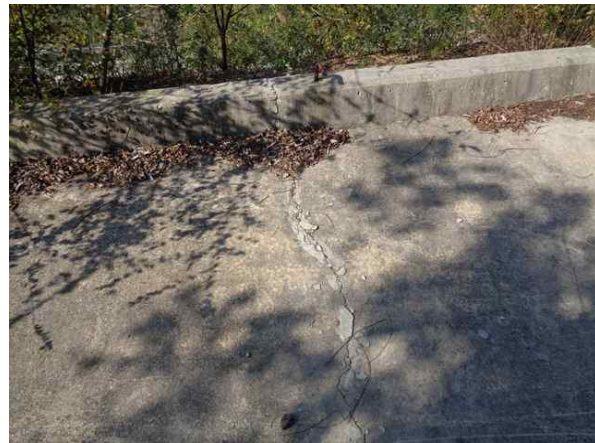
| 위치 | STA.3+840 4소단배수로 |

| 현황 | 균열(0.3mm / 2.5m) |

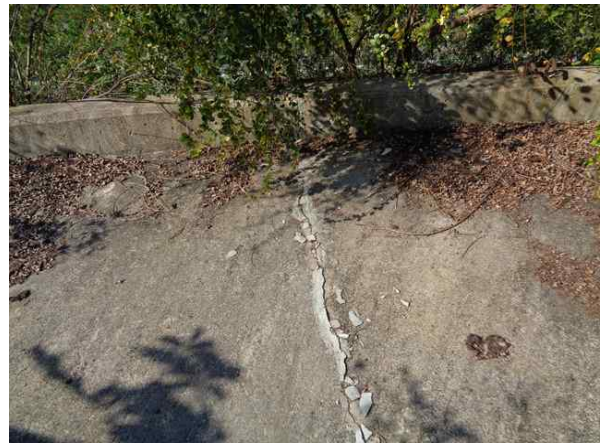
| 위치 | STA.3+850 4소단배수로 |

| 현황 | 균열(0.4mm / 2.5m) |

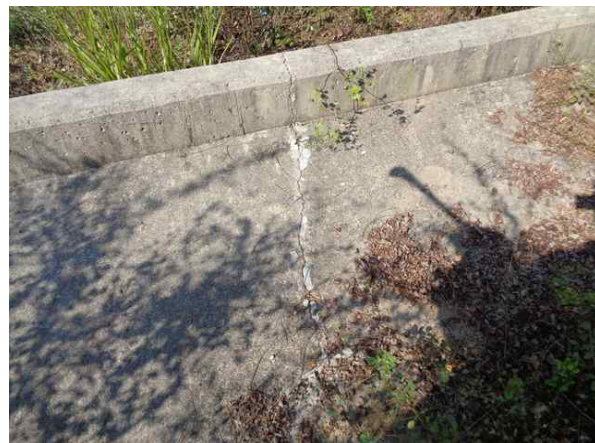
| 위치 | STA.3+860 4소단배수로 |

| 현황 | 균열(0.8mm / 2.5m) |

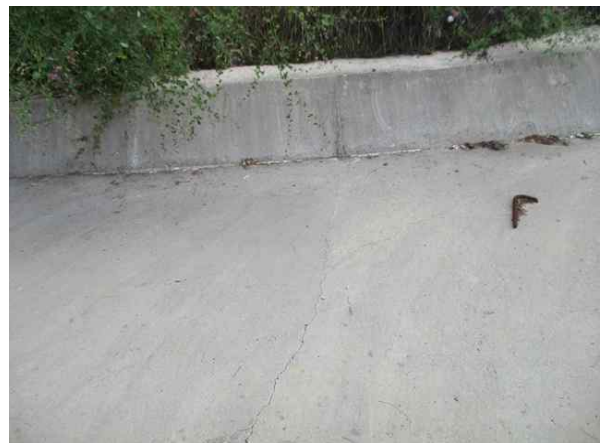
| 위치 | STA.3+870 4소단배수로 |

| 현황 | 균열(0.3mm / 2.5m) |
