## 2 외관조사

# [STA.4+650~4+930(옥 산)절 토 사면]

옥산절토04

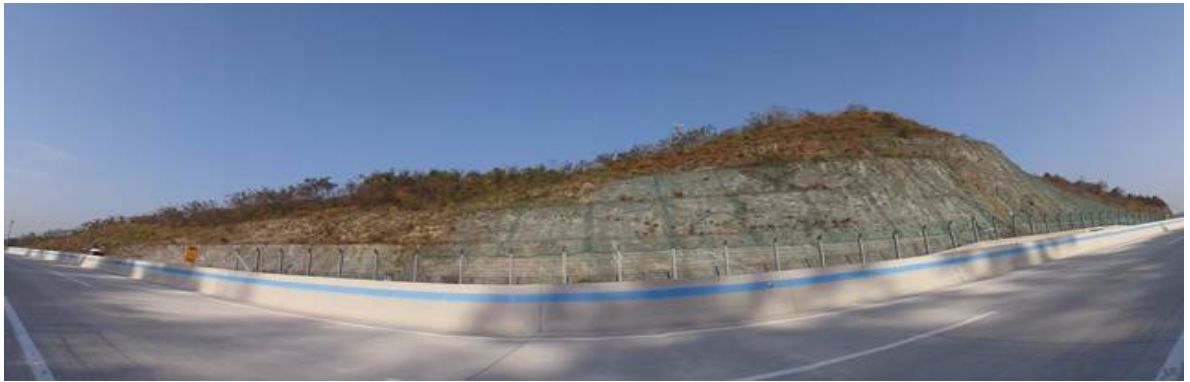
전경

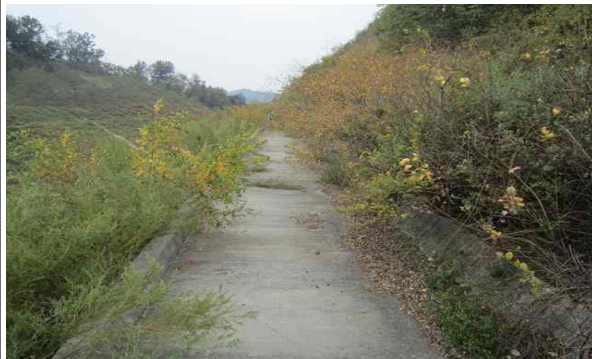
1소단배수로 전경

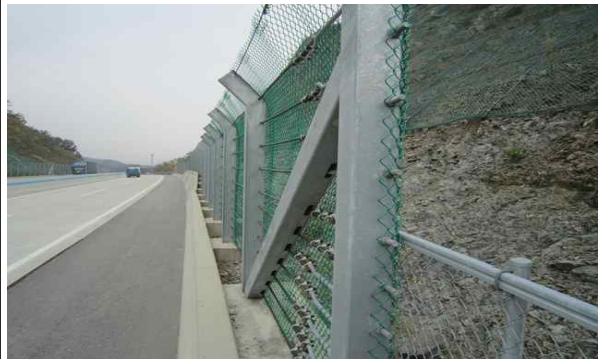
낙석방지울타리 전경

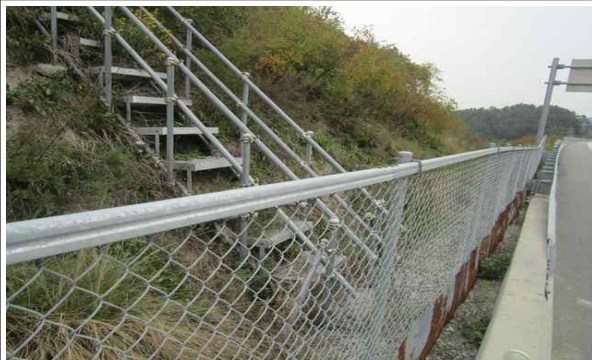
야생동물 유도 울타리 전경

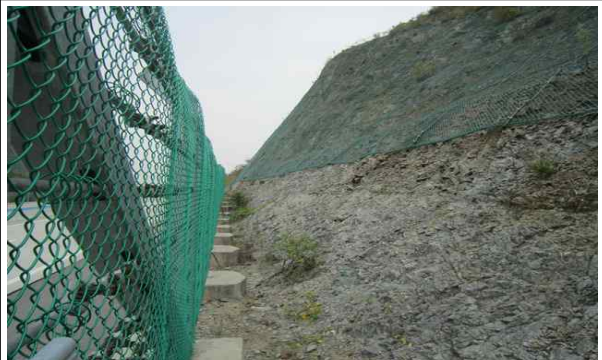
하부 전경

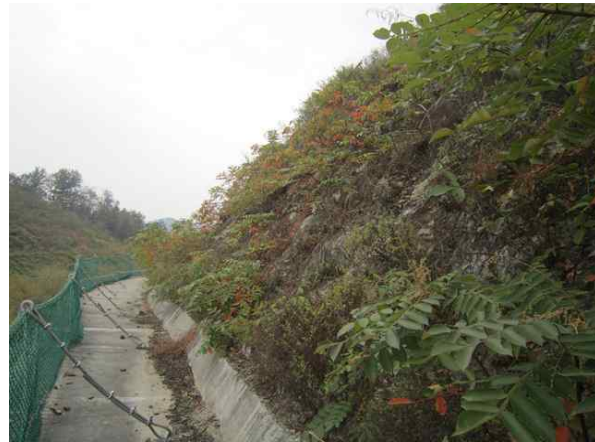
| 위치 | STA.4+860~4+880 5단 |

| 현황 | 이완암 |

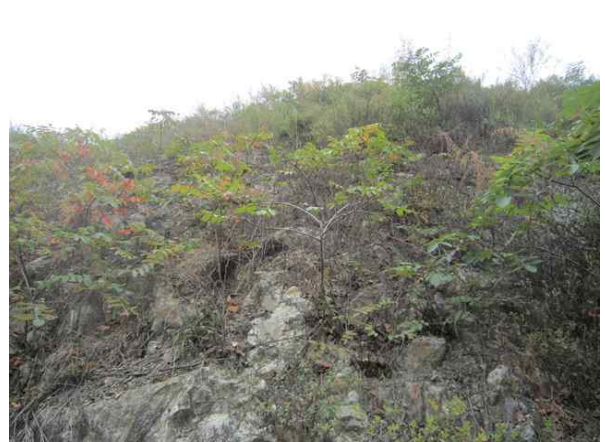
| 위치 | STA.4+860~4+880 5단 |

| 현황 | 이완암 |
