## 2 외관조사

# [STA.4+600~4+920[오 창]절 토 사 면]

오창절토06

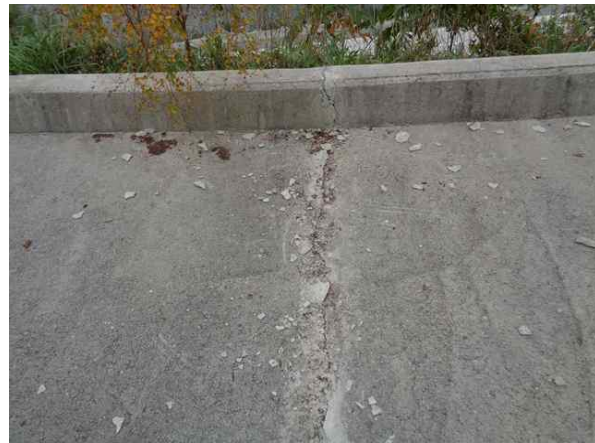
| 위치 | STA.4+780 4소단배수로 |

| 현황 | 재균열(0.5mm / 2.5m) |

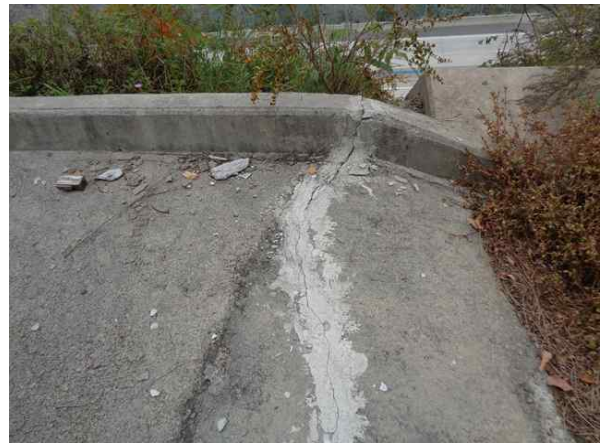
| 위치 | STA.4+800 4소단배수로 |

| 현황 | 재균열(1.0mm / 2.5m) |

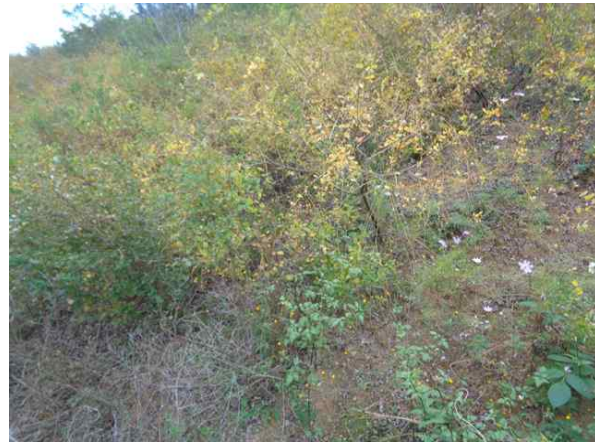
| 위치 | STA.4+700 1단 |

| 현황 | 세굴 - 현재식생양호(A= 5.0m x 5.0m) |

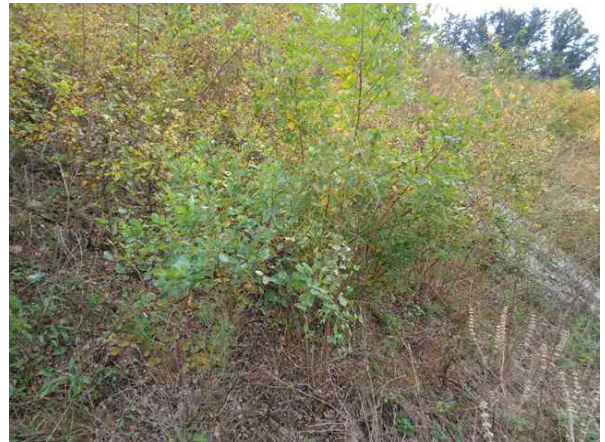
| 위치 | STA.4+700 1단 |

| 현황 | 세굴 - 현재식생양호(A= 5.0m x 5.0m) |

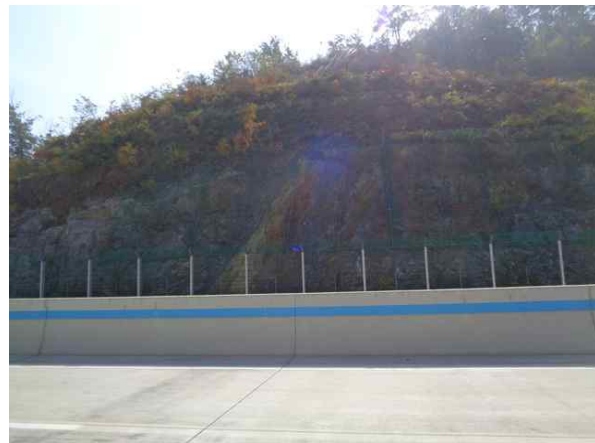
| 위치 | STA.4+780~4+860 1~2단 |

| 현황 | 이완암 |

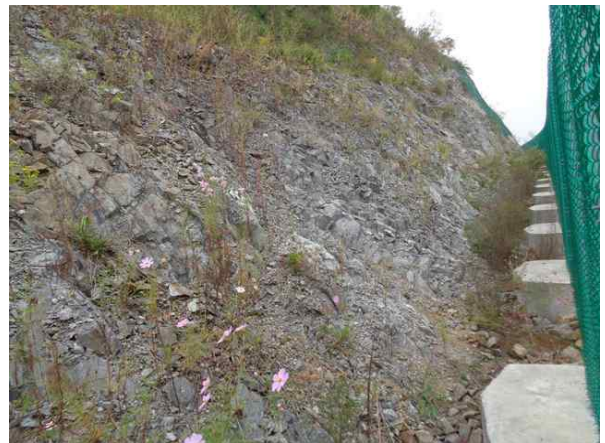
| 위치 | STA.4+780~4+860 1~2단 |

| 현황 | 이완암 |
