## 2 외관조사

# [STA.8+010~8+610(오 창)절 토 사 면]

오창절토11

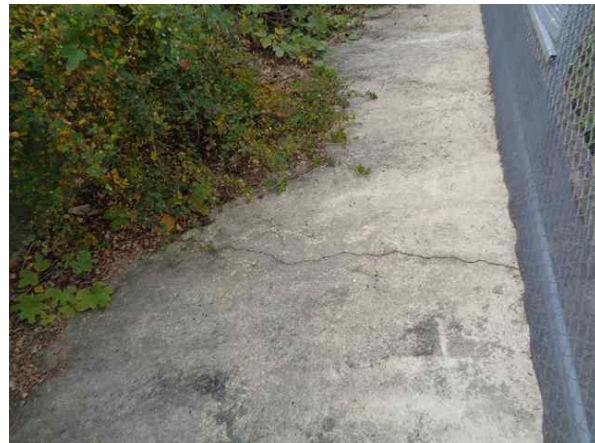
| 위치 | STA.8+310~8+330 3소단배수로 |

| 현황 | 균열(1.0mm / 3.0m) |

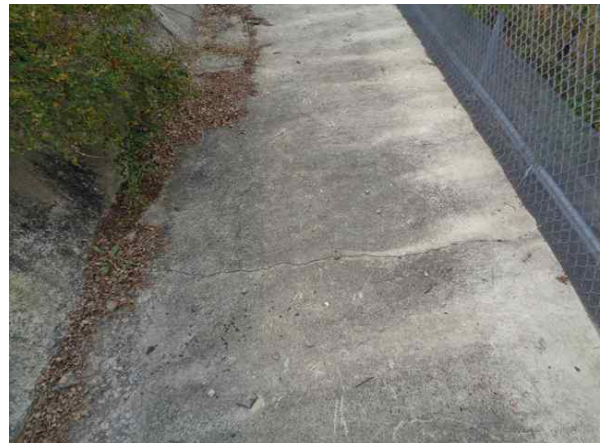
| 위치 | STA.8+350 3소단배수로 |

| 현황 | 균열(1.0mm / 6.0m) |

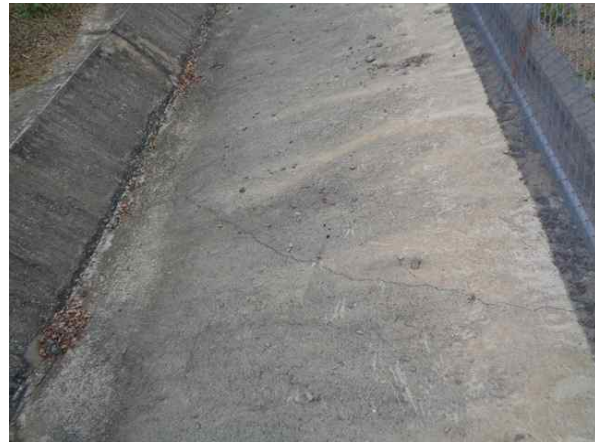
| 위치 | STA.8+370~8+440 3소단배수로 |

| 현황 | 균열(1.0mm / 3.0m) |

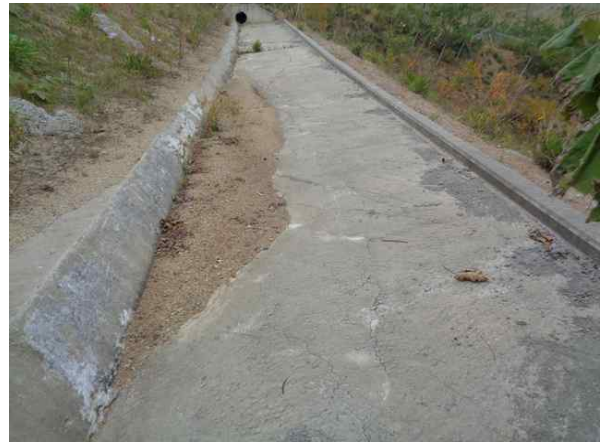
| 위치 | STA.8+470 3소단배수로 |

| 현황 | 망상균열(A= 6.0m x 3.0m) |

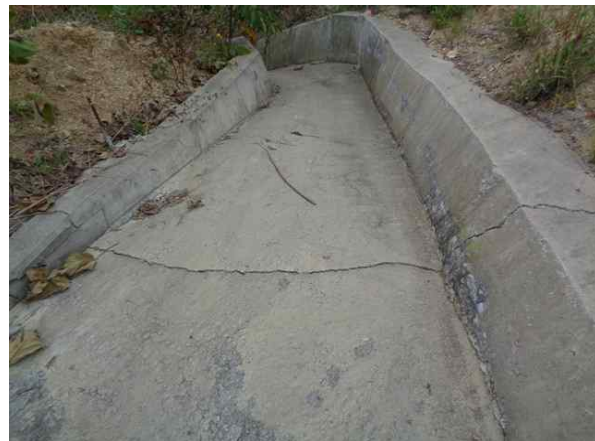
| 위치 | STA.8+480 3소단배수로 |

| 현황 | 파손(A= 0.1m x 2.5m) |

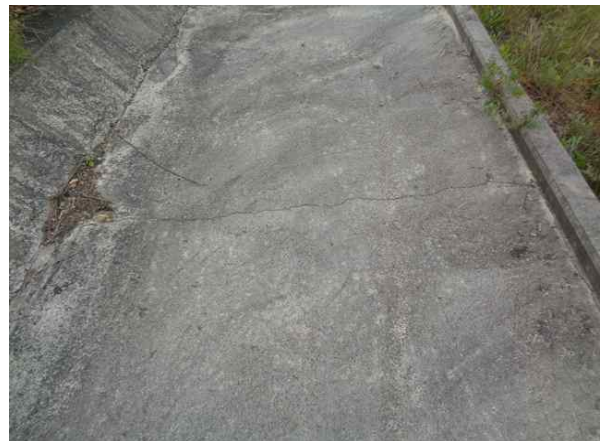
| 위치 | STA.8+570 3소단배수로 |

| 현황 | 균열(1.0mm / 3.0m) |
