## 2 외관조사

# [STA.8+630~8+820[오 창]절 토 사 면]

오창절토12

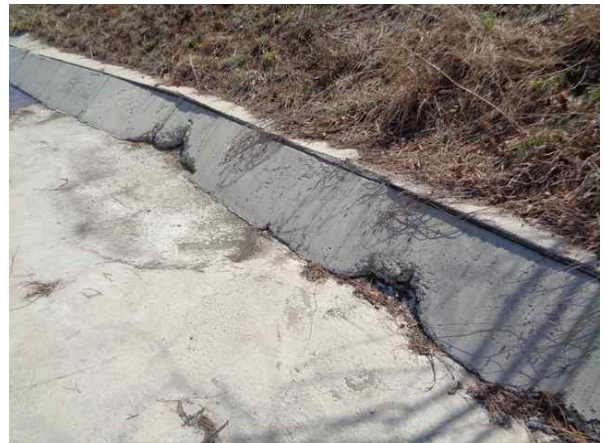
위치 STA.8+670 4소단배수로

현황 시공불량(A= 0.5m x 1.0m)

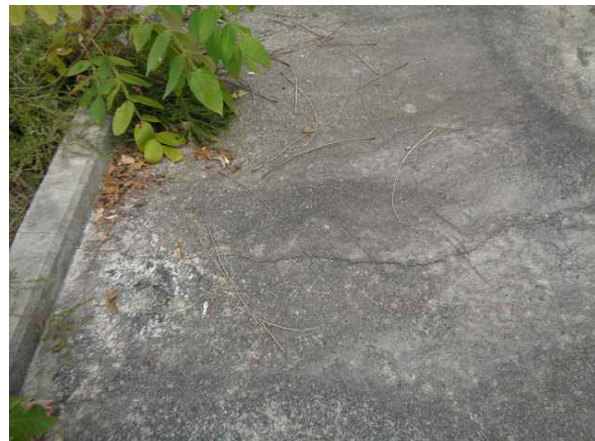
위치 STA.8+680 4소단배수로

현황 균열(2.0mm / 3.0m)

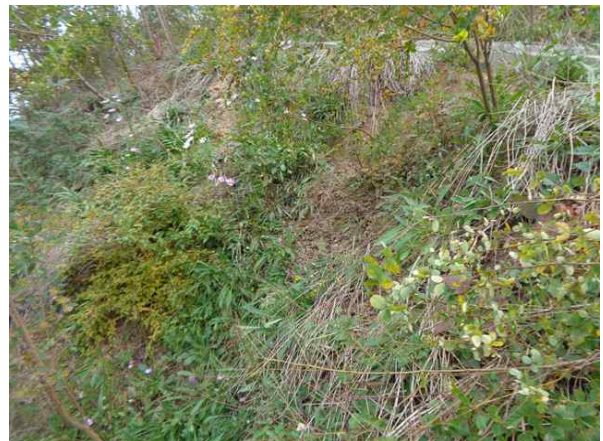
위치 STA.8+780 3단

현황 세굴(A= 1.0m x 5.0m)
