## 2 외관조사

**[서오창IC R-C STA.0+130~0+310(우안)절토사면]**

| 서오창절토02 | |

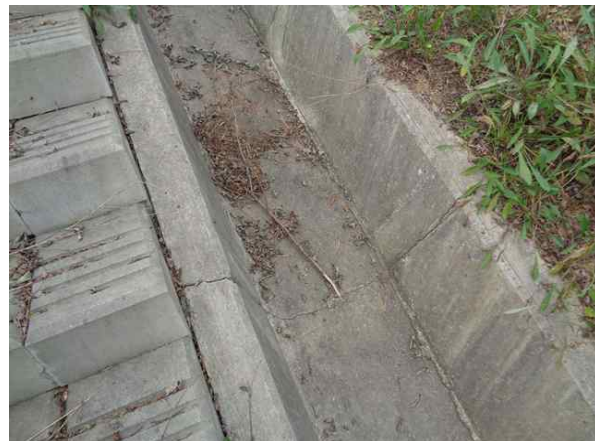
| 위치 | STA.0+720 4소단배수로 |

| 현황 | 균열(0.5mm / 1.5m) |

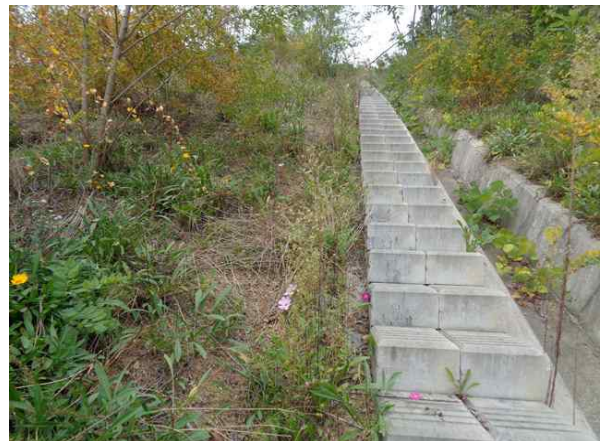
| 위치 | STA.0+760 1~2단 |

| 현황 | 세굴(A= 1.0m x 10.0m) |
