## 1. 도곡2교

## 손상현황 사진

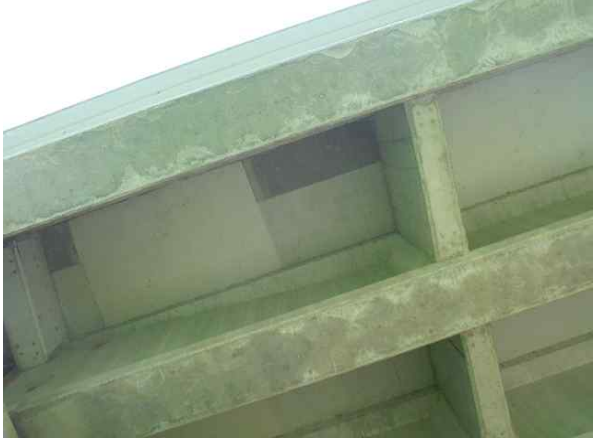
| S1 파손(0.4×0.1) | S2 망상균열(0.4×2.0) |

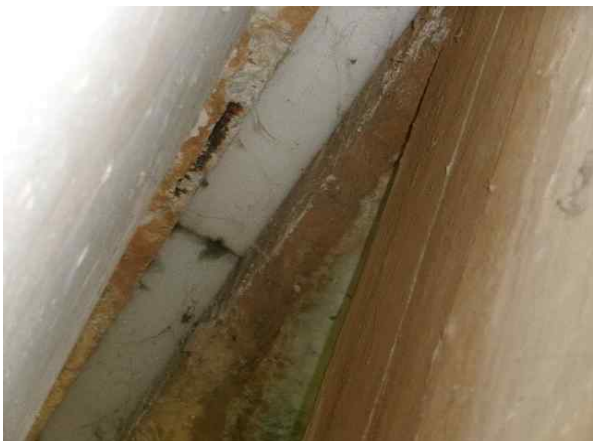
| S2 박락(0.6×0.1) | S2 백업재 탈락 |

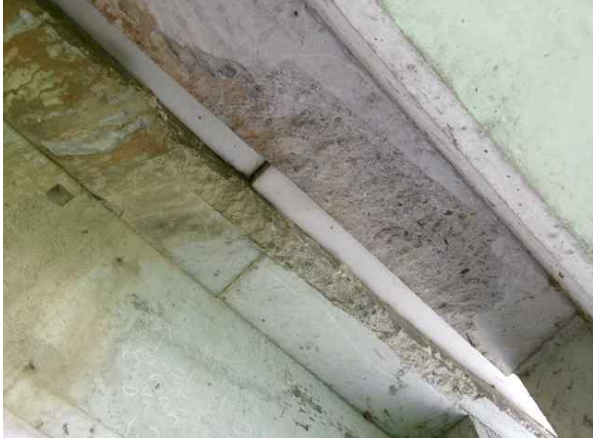
| S3 파손(1.2×0.1) | S3 파손 및 철근노출(0.2×1.0) |

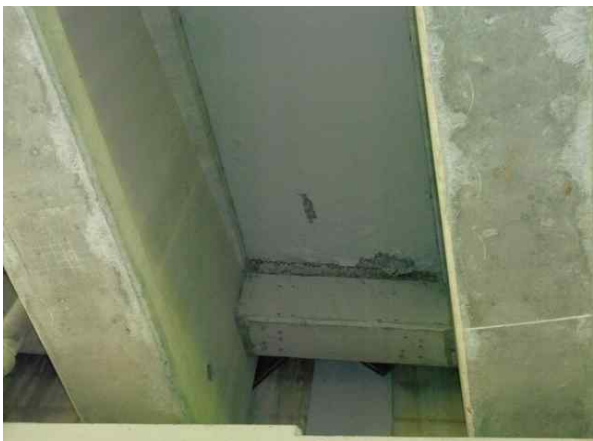
| S4 보수부 박리(0.2×0.3) | S4 보수부 박리(0.3×0.3) |

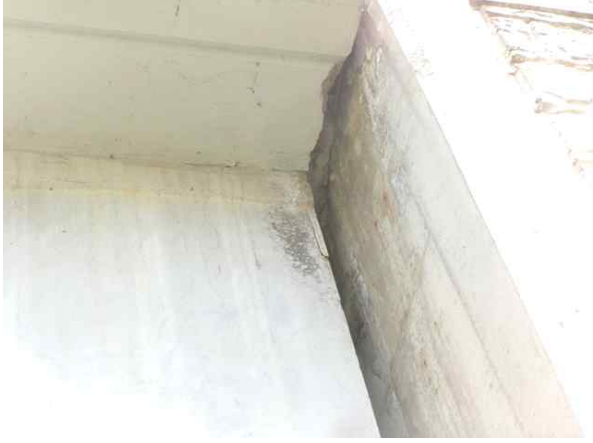
| S1-G1 박리(0.1×0.3) | S1-G1~G9 들뜸 및 박락(1.0×0.3) |

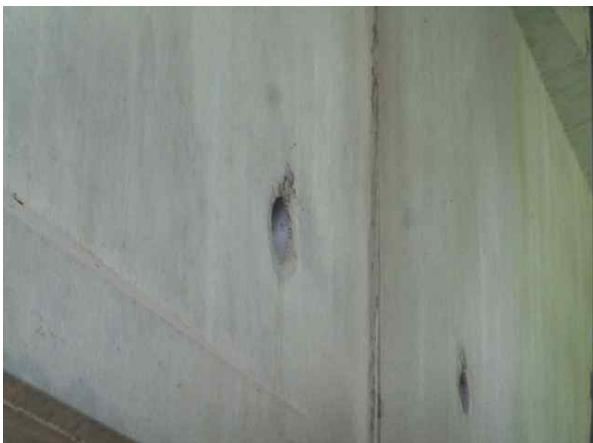
| S2-G9 인양홀 파손(0.1×0.1) | S2-G2 누수흔적(0.3×1.5) |

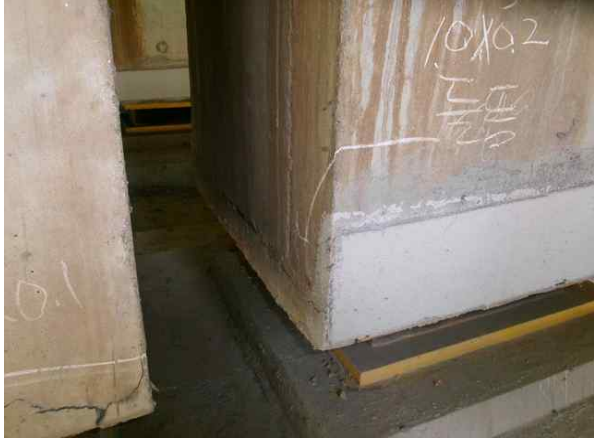
| <p>S2-G2 들뜸(1.0×0.2)</p> | <p>S2-G7 보수부 박락(0.1×0.2)</p> |

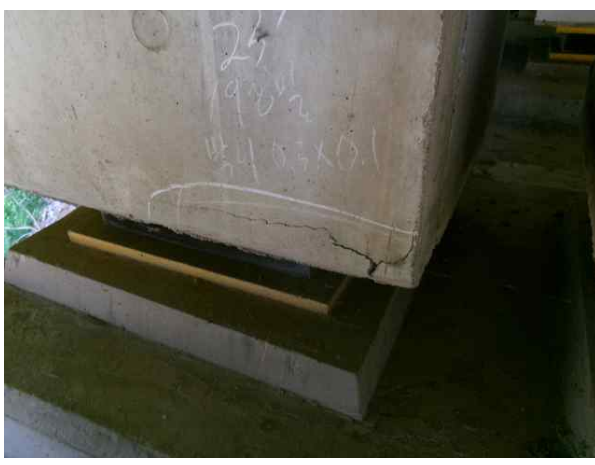
| <p>S3-G2 박락(0.6×0.1)</p> | <p>S3-G5 박리(0.5×0.1)</p> |

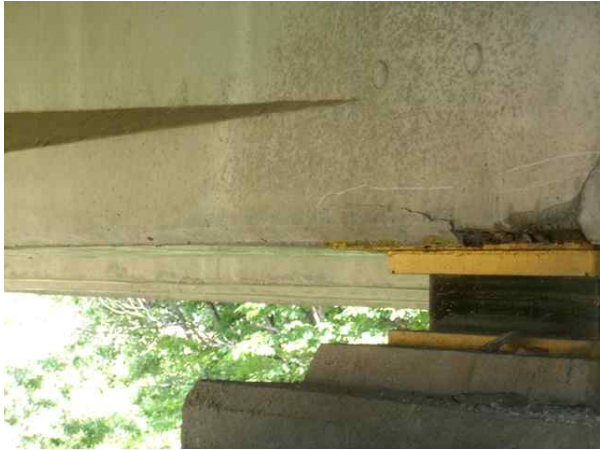
| S3-G6 박리(0.1×0.3) | S4-G9 파손(0.6×0.1) |

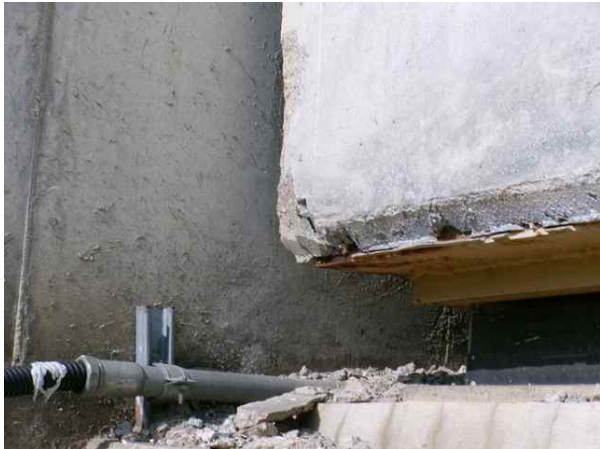
| S4-G1 박락(1.0×0.2) | S4-G5 균열(0.1mm/1.2m) |

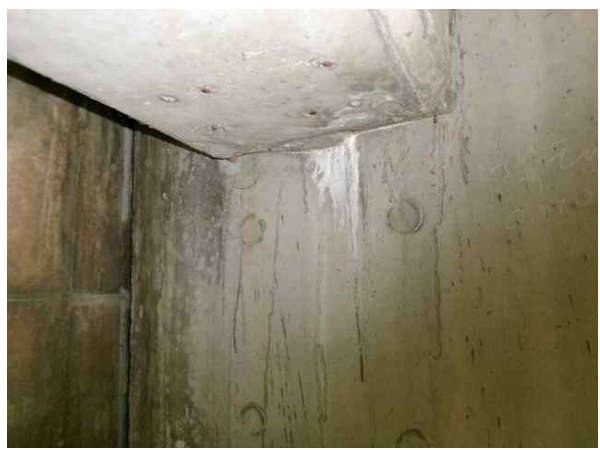
| S4-G5 백태(0.1×0.2) | S4-G5 백태(0.2×1.1) |

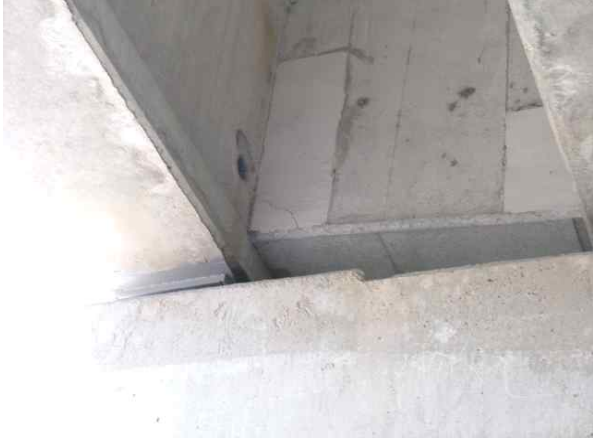
| S2 보수부 박리(0.2×0.2) | S1 균열(0.3mm/0.3m) |

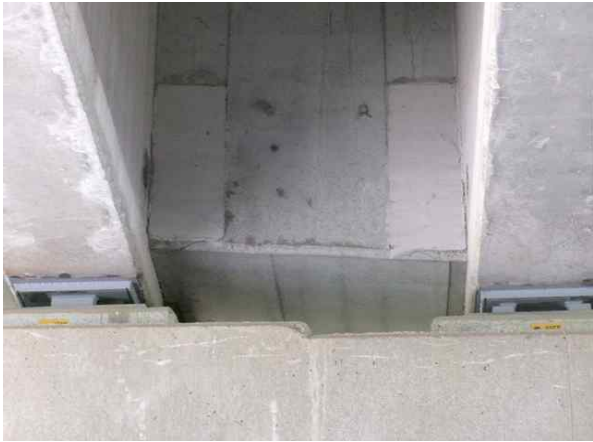
| S1 균열(0.3mm/0.3m) | S1 균열(0.3mm/0.3m) |

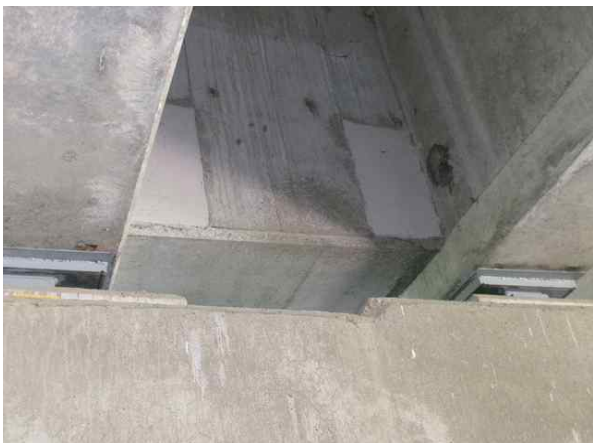
| S2 들뜸(0.2×0.3) | S2 들뜸(0.2×0.3) |

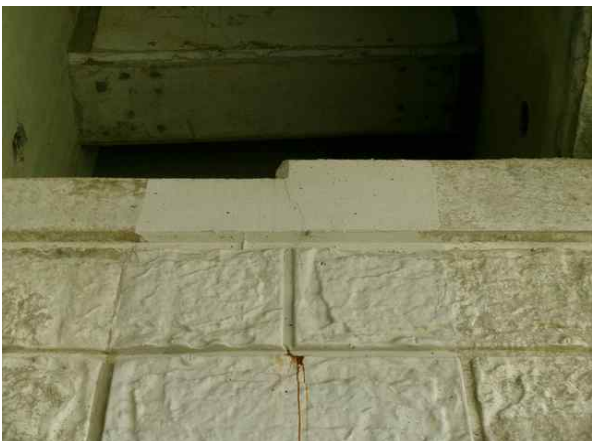
| A1 균열(0.2mm/0.5m) | A1 균열(0.2mm/1.5m) |

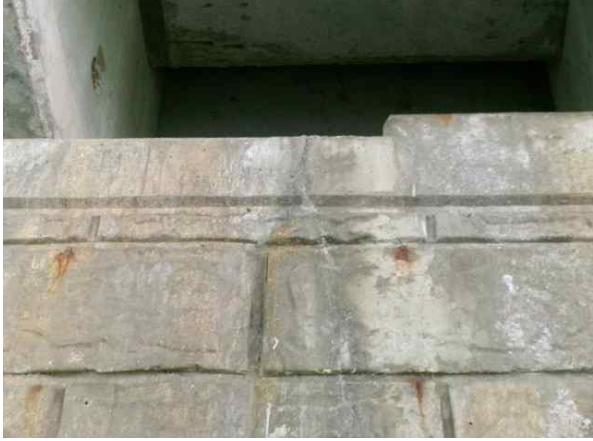
| A1 균열 (0.3mm/0.5m) | A1 망상균열 (0.4×1.3) |

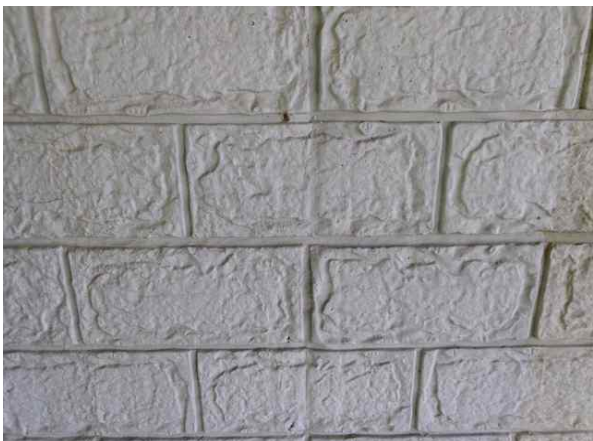
| A1 재균열 (0.1mm/4.0m) | A1 재균열 (0.2mm/3.5m) |

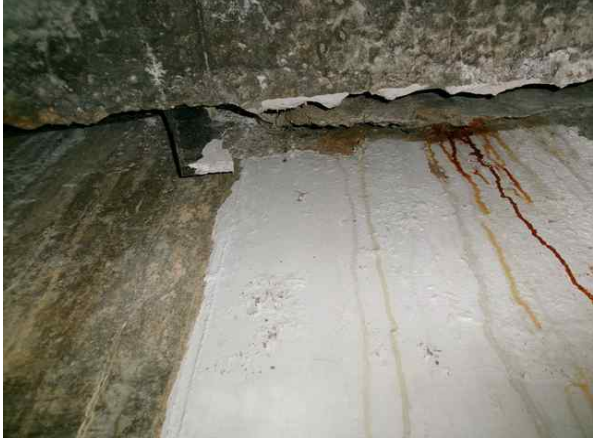
| A2 박락(0.6×0.2) | A1 실런트 탈락(1.5) |

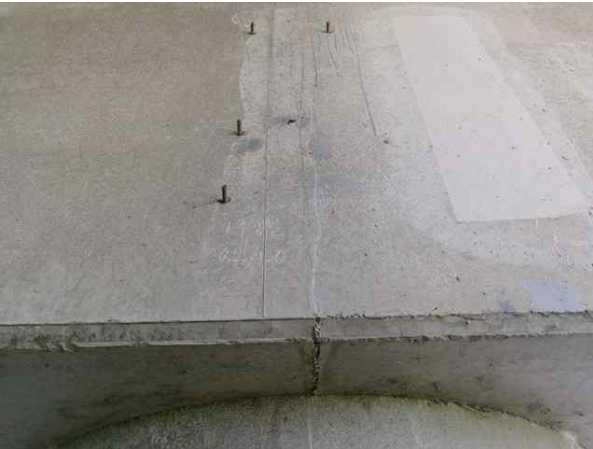
| P1 균열(0.2mm/1.0m) | P1 파손(0.1×0.1) |

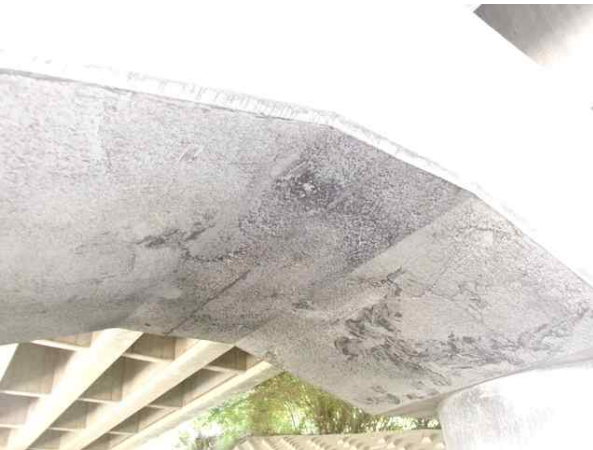
| P1 표면오염(2.5×3.0) | P1 파손(0.1×0.1) |

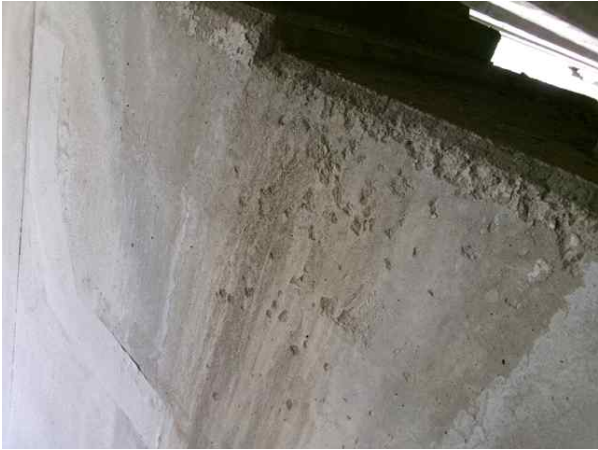
| P1 균열(0.2mm/0.7m) | P2 누수흔적(1.0×3.0) |

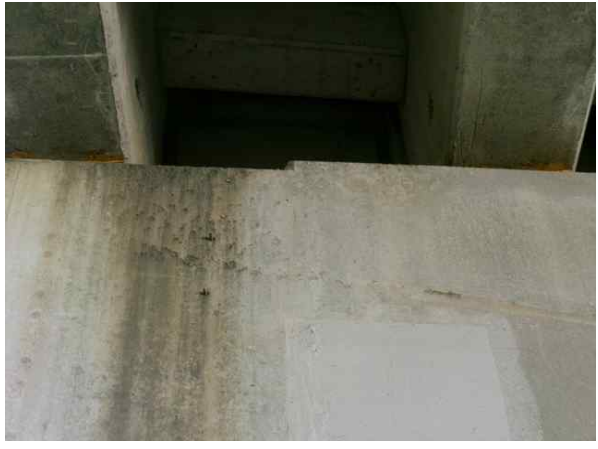
| P2 균열(0.2mm/1.0m) | P2 균열(0.2mm/1.0m) |

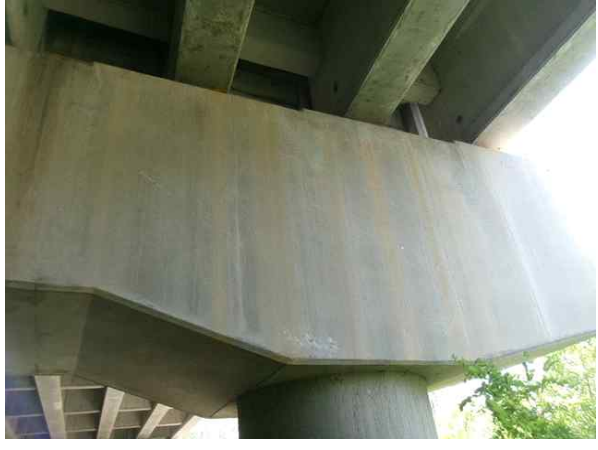
| P2 누수흔적(0.2×2.0) | P2 박락(0.1×0.1) |

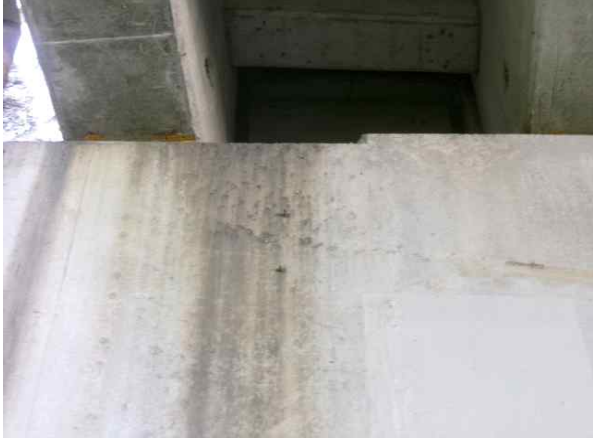
| P2 박리(0.1×0.1) | P2 박리(1.0×2.5) |

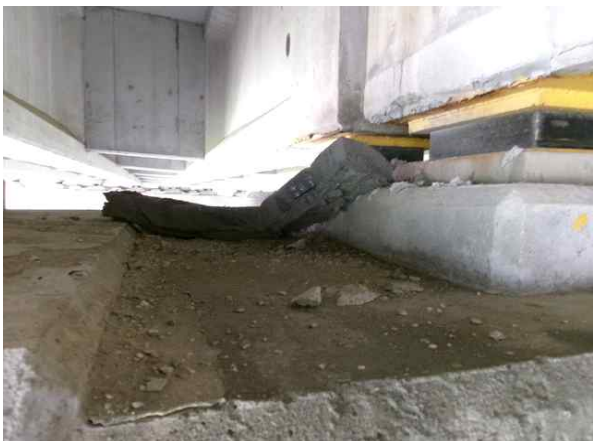
| P2 페콘크리트 적치(1.5×2.5) | P3 균열(0.1mm/0.3m) |

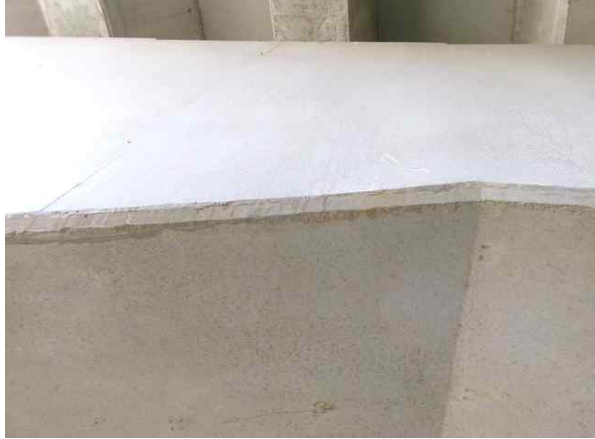
| P3 박리(1.5×0.1) | P3 파손(0.1×0.1) |

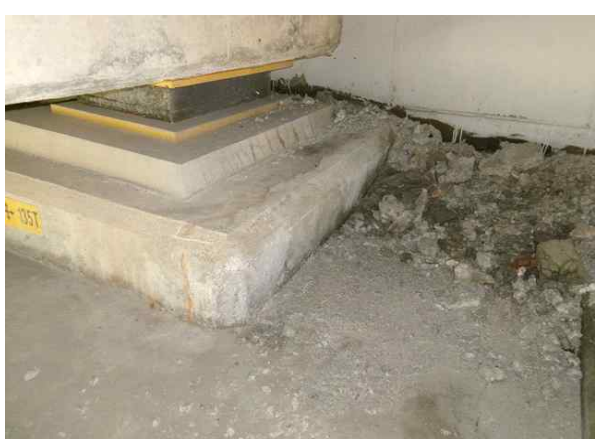
| A1-SH4 받침콘크리트 파손(0.3×0.8) | A1-SH4 받침콘크리트 박리(0.1×0.1) |

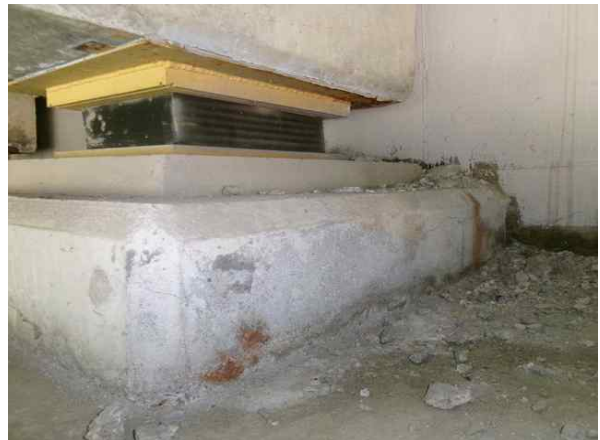
A1-SH6 받침콘크리트 균열(0.3mm/1.0m)

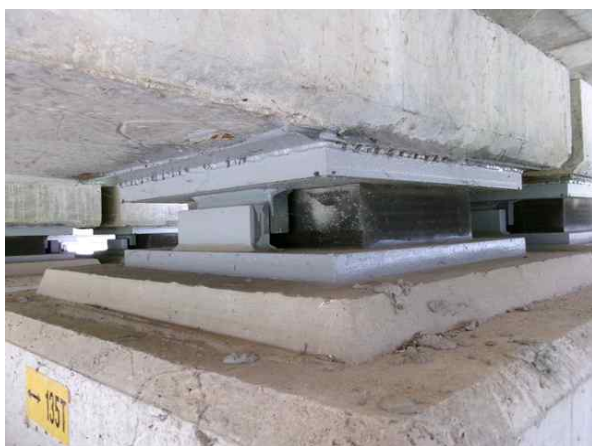
P3-SH11 플레이트 부식 보수

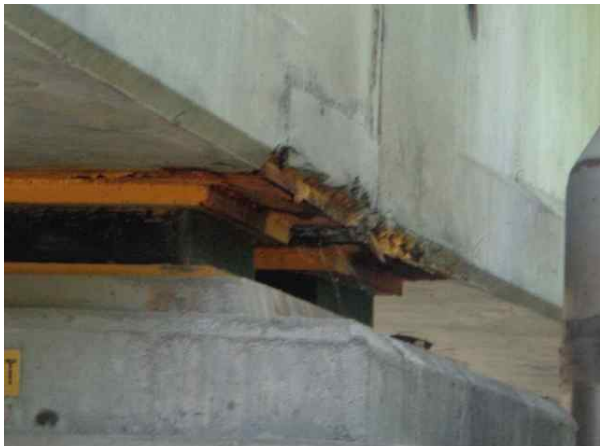
P2-SH9,18 플레이트 부식

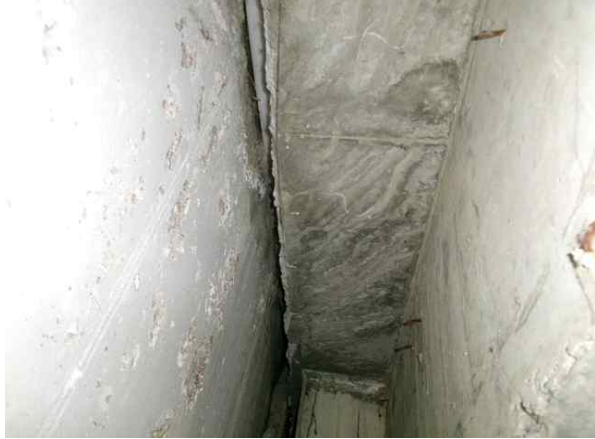
| A1 신축이음 하부누수(0.5×2.0) | A2 본체부식(0.2×1.2) |

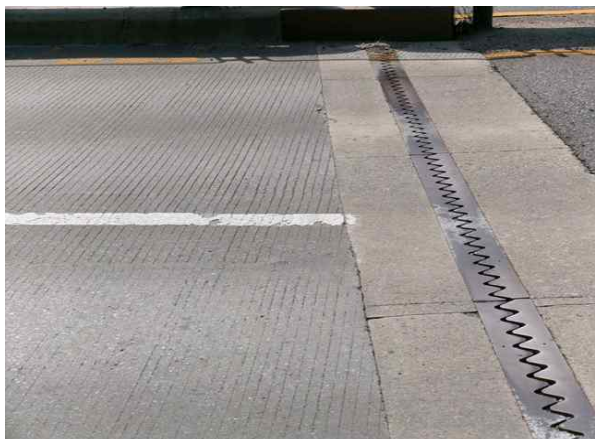
| A2 후타재 균열(0.1mm/0.6m) | A2 후타재 균열(0.3mm/0.6m) |

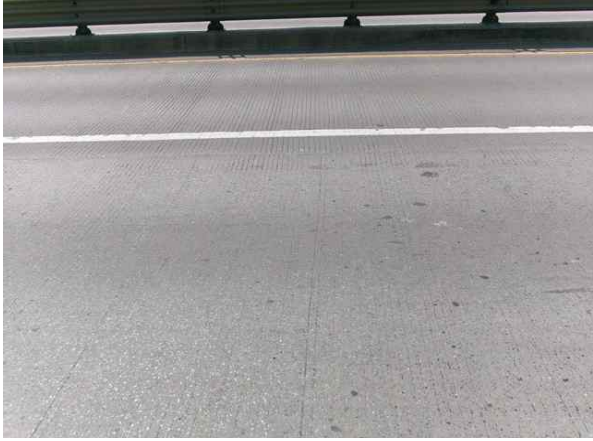
| S1 포장 균열 | S1 포장 망상균열 |

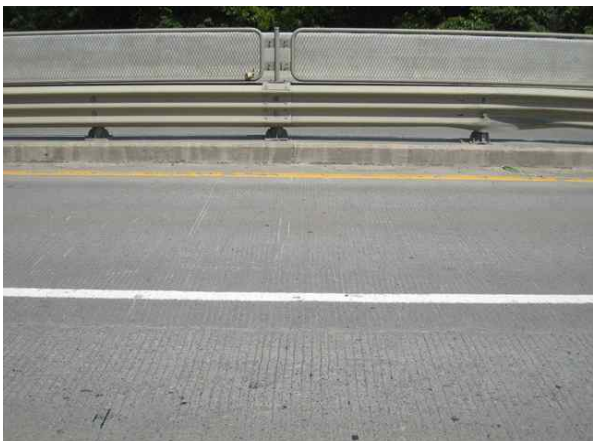
| S4 포장 망상균열 | S4 포장 망상균열 |

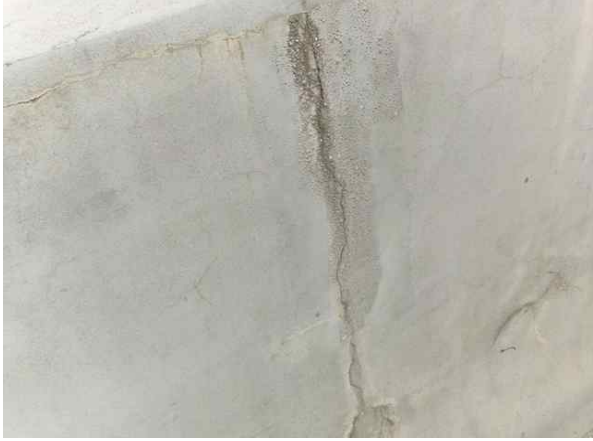
| S1 재균열(0.1mm/1.2m) | S1 재균열(0.2mm/1.4m) |

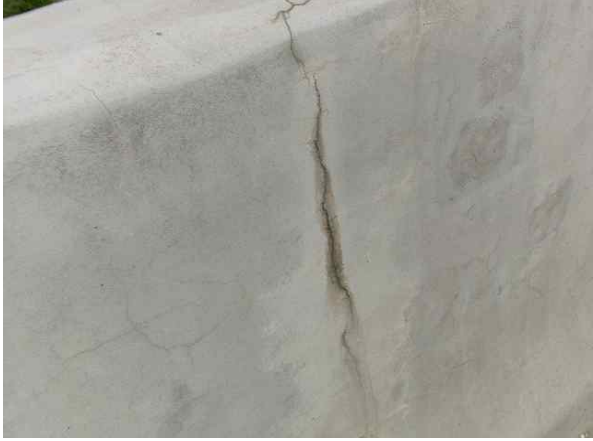
| S2 재균열(0.1mm/0.3m) | S2 재균열(0.2mm/1.5m) |

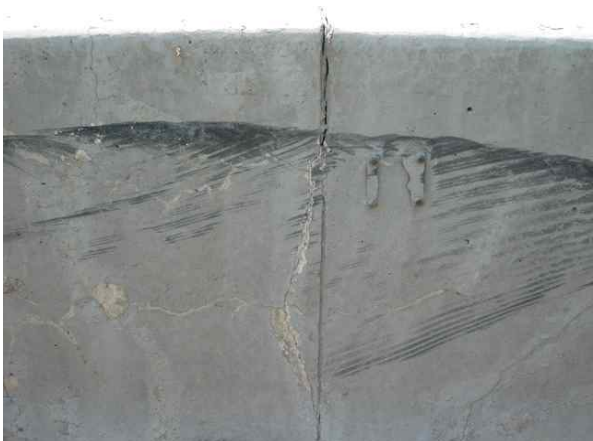
| S4 균열(0.2mm/0.8m) | S4 접속부 용벽 균열(0.3mm/1.0m) |
