## 2. 양성교(상)

## 손상현황 사진

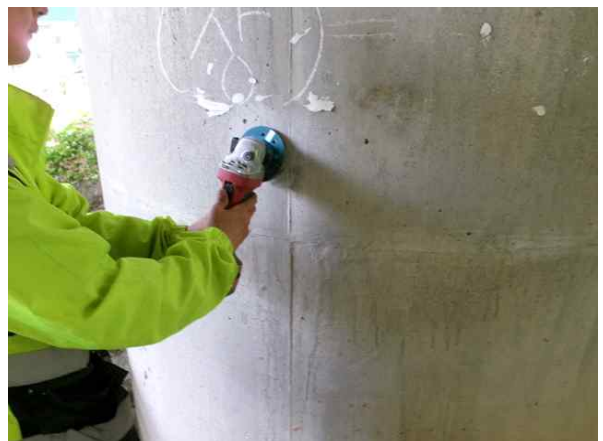
비파괴시험

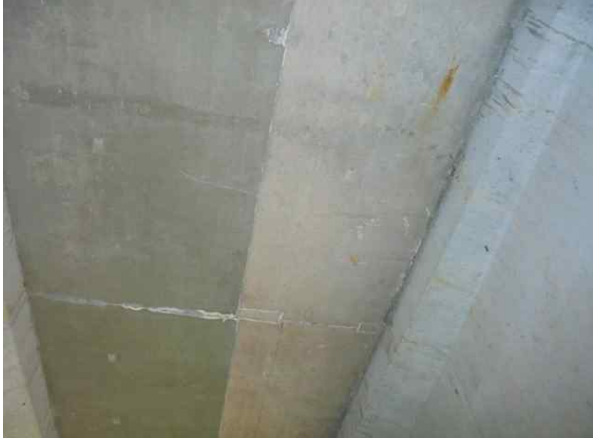
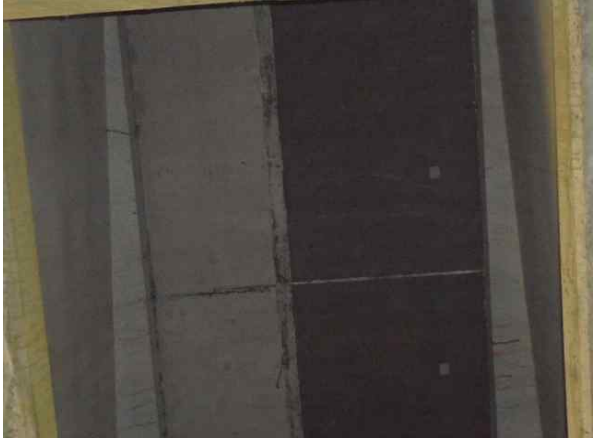
| S1 균열(0.1mm/1.0m) | S3S1 균열(0.1mm/1.6m) 망상균열 보수 |

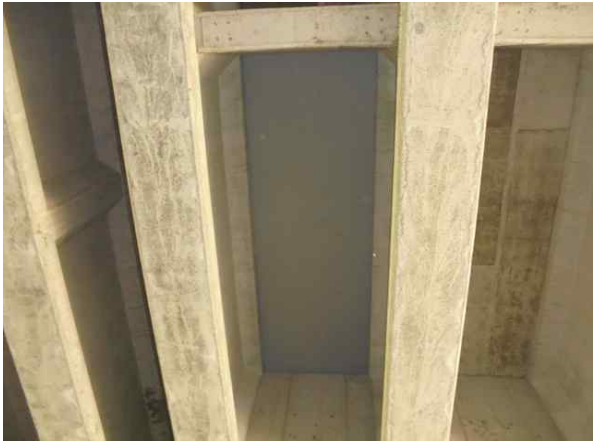
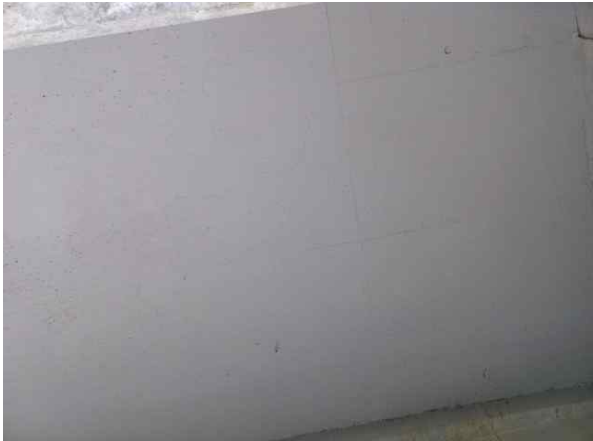
| S2 균열 보수 | S2 재균열(0.2mm/2.5m) |

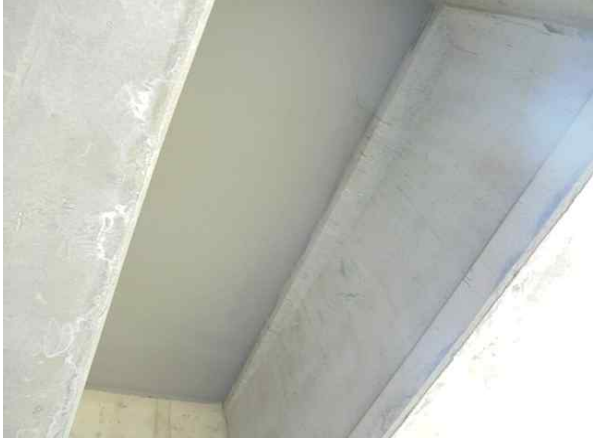
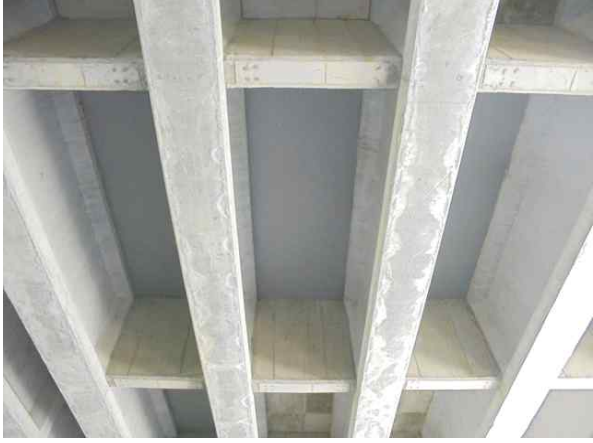
| S8 균열 보수 | S8 백태 보수 |

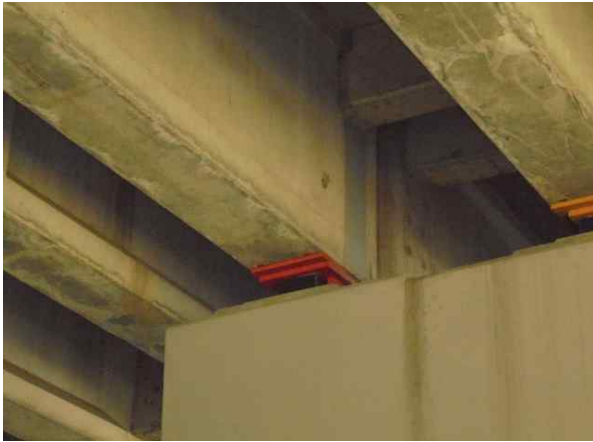
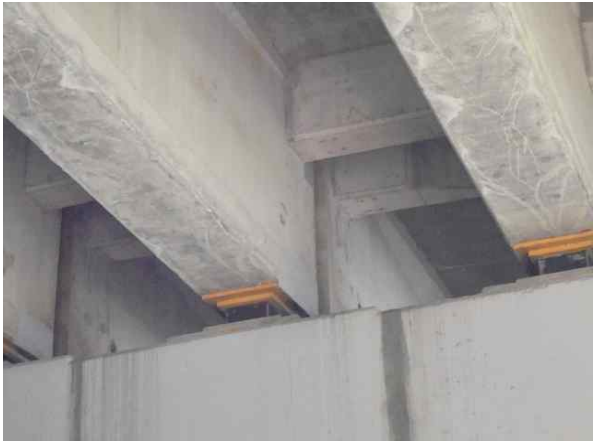
| S3-G1 박락 및 백태 보수 | S3-G3 균열 보수 |

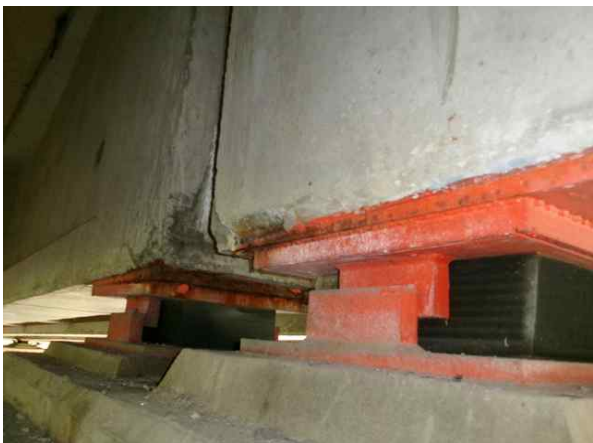
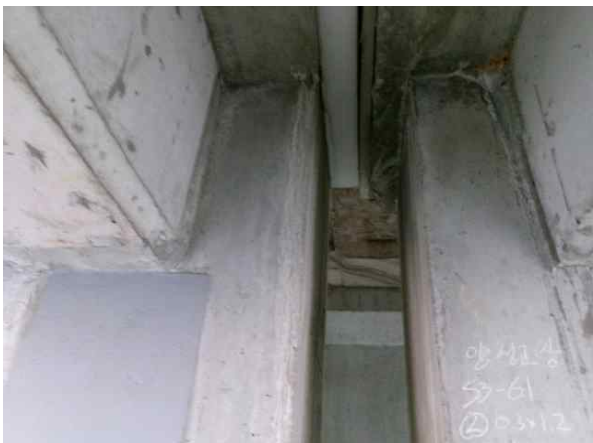
| S3-G1 박락(0.1×0.3) | S3-G1 백태(0.1×1.0) |

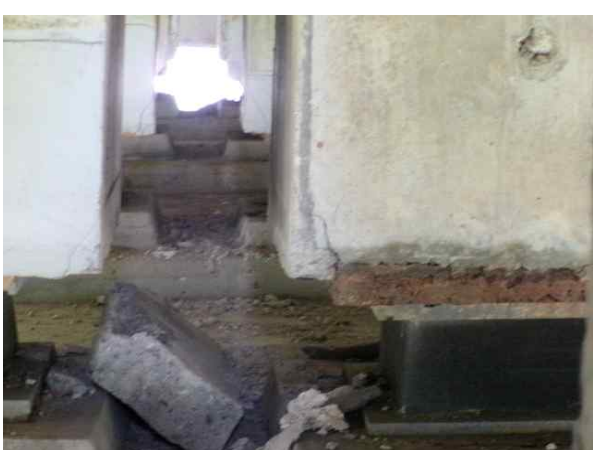
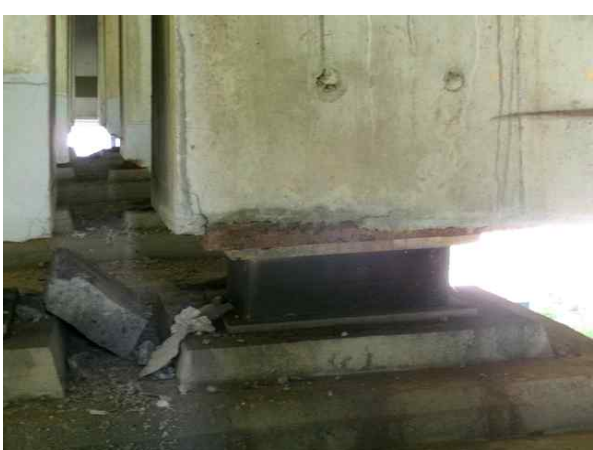
| S7-G1~6 들뜸(1.0×0.3) | S7-G5 파손(0.4×0.2) |

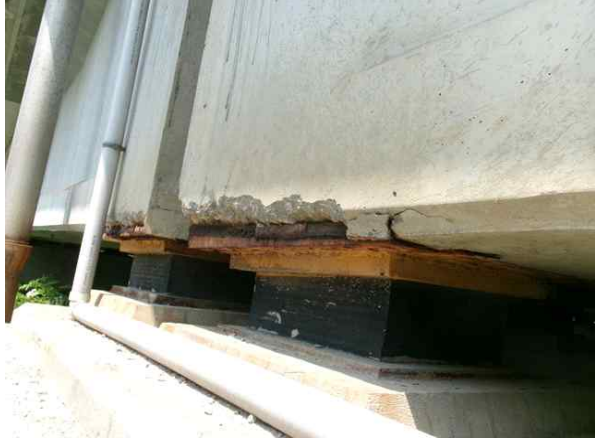
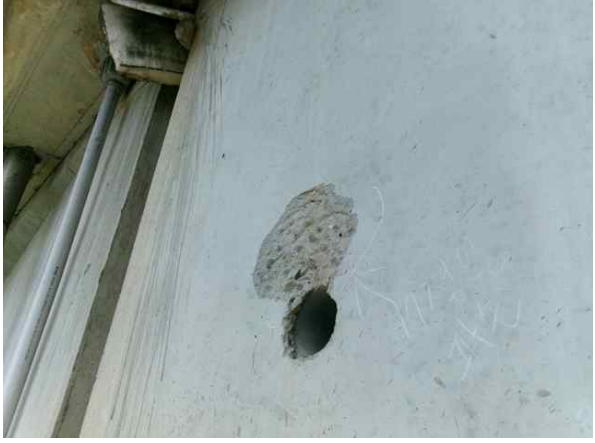
| <p>S7-G6 박락(1.0×0.3)</p> | <p>S7-G6 파손(0.2×0.2)</p> |

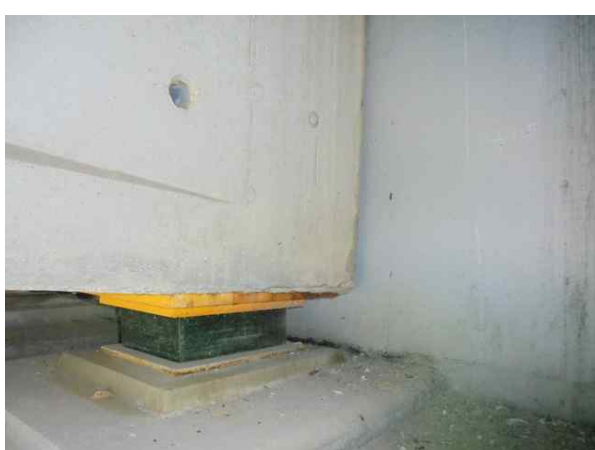
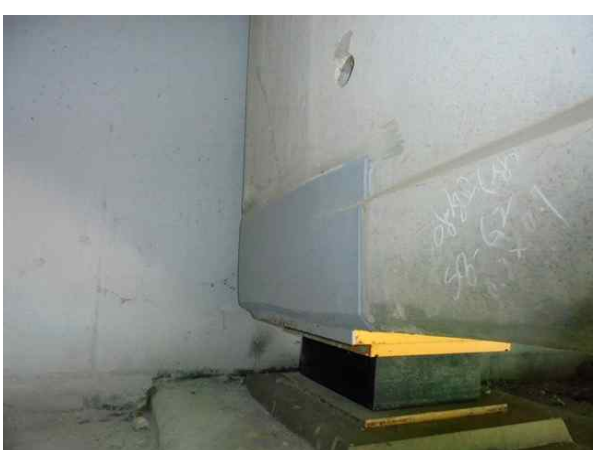
| <p>S8-G1 박락(0.1×0.8)</p> | <p>S8-G2 박락 보수</p> |

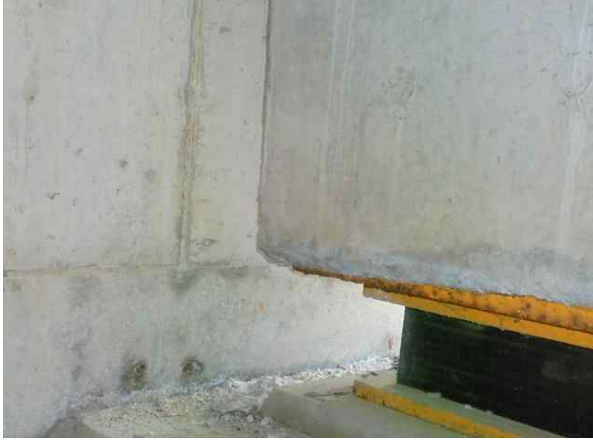
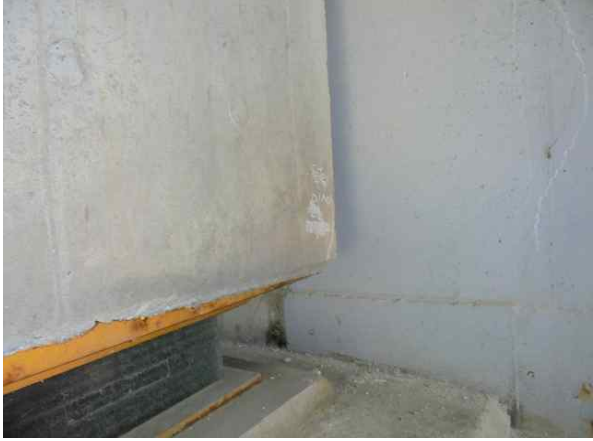
| S8-G6 들뜸(1.0×0.1) | S8-G6 들뜸(1.0×0.1) |

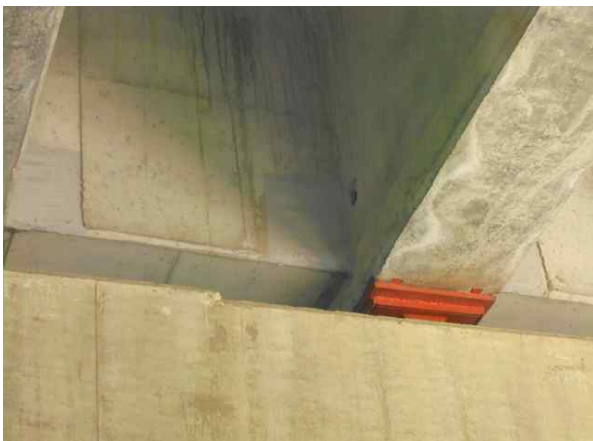
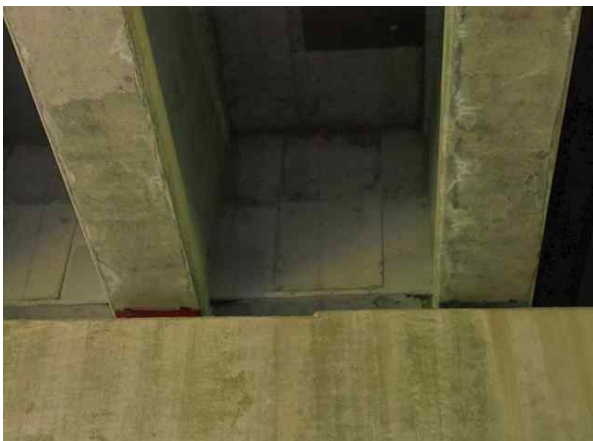
| S2 보수부 들뜸(0.3×0.3) | S3 재균열 보수 |

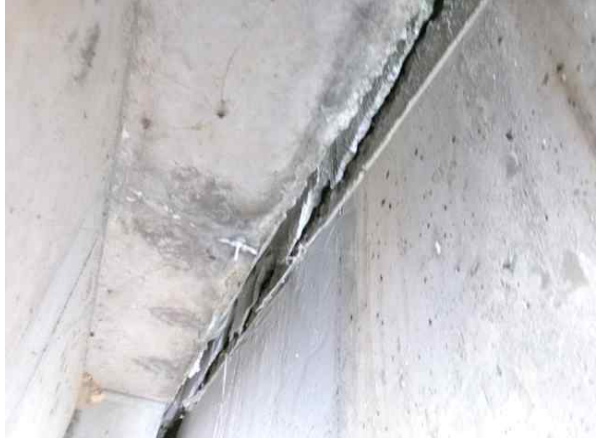
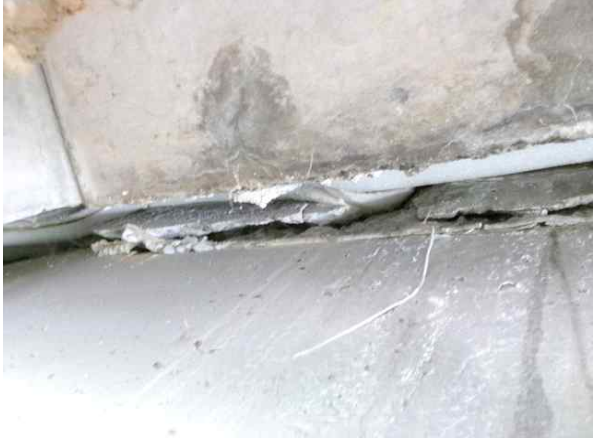
| A2 파손(2.0×1.0) | A2 파손(2.0×1.0) |

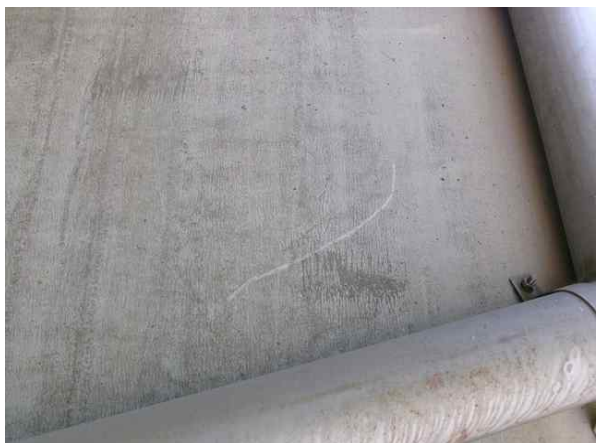
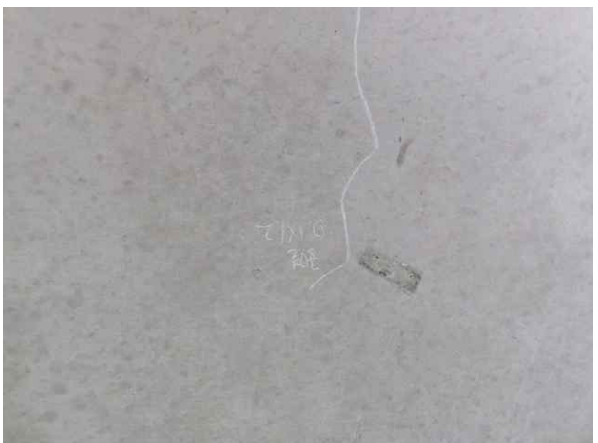
| P1 코핑부 균열(0.2mm/0.4m) | P1 코핑부 균열(0.2mm/2.4m) |

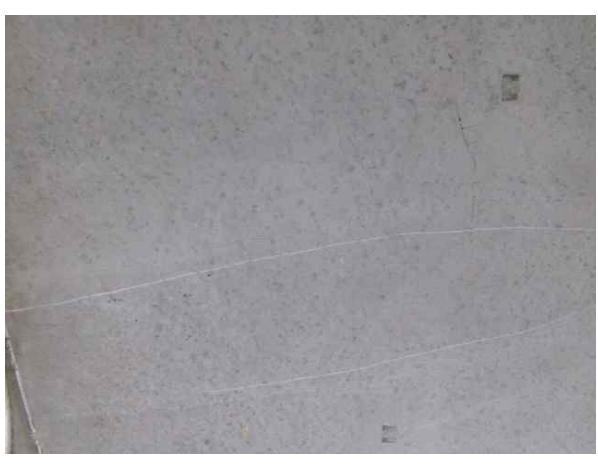
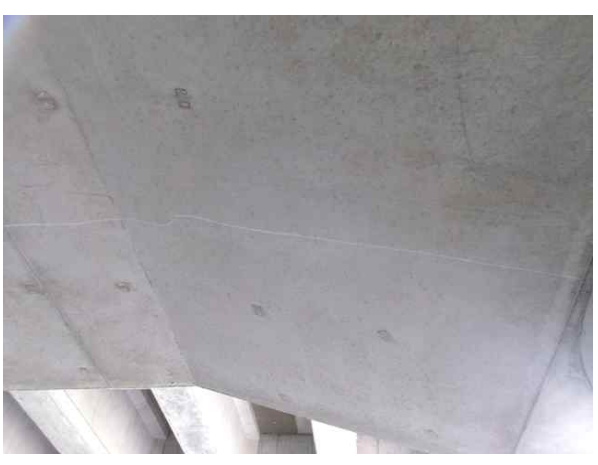
| P2 코핑부 균열(0.2mm/1.5m) | P2 코핑부 균열(0.2mm/4.0m) |

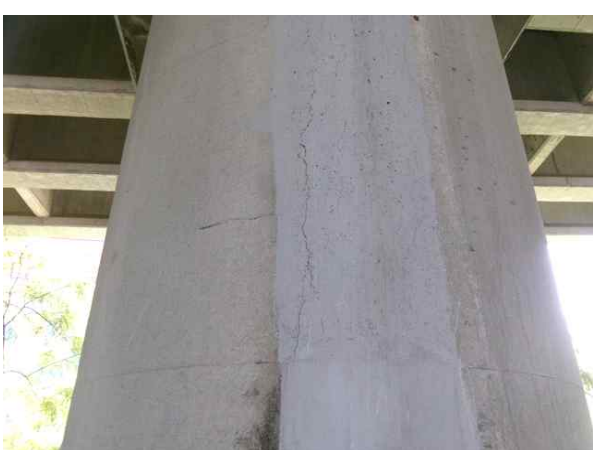
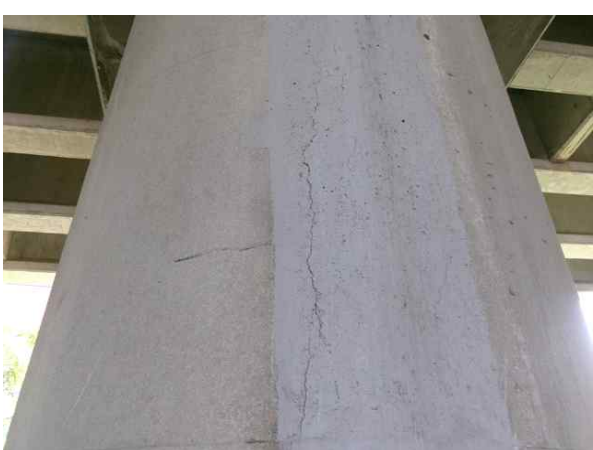
| <p>P6 기둥부 재균열(0.3mm/1.0m)</p> | <p>P6 기둥부 재균열(0.3mm/1.0m)</p> |

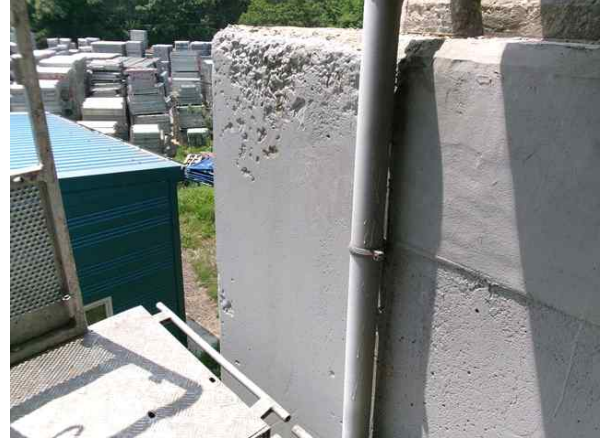
P6 코평부 박리(0.4×1.5)

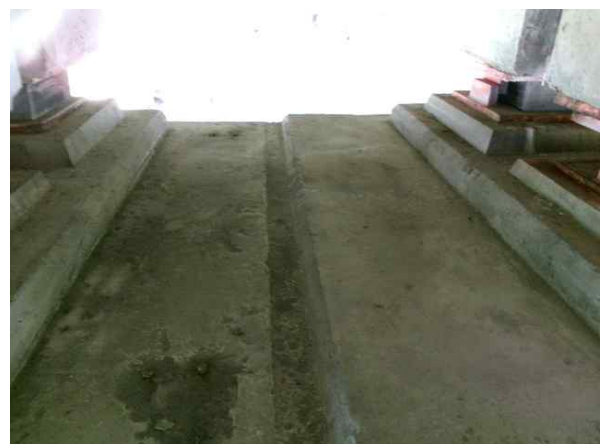
P6 코평부 상면 체수1.2×2.5)

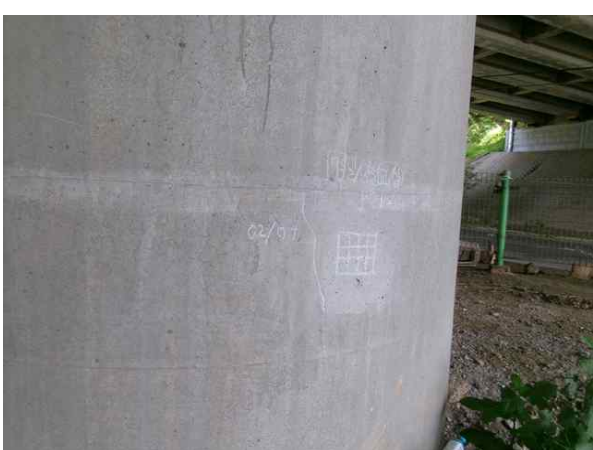
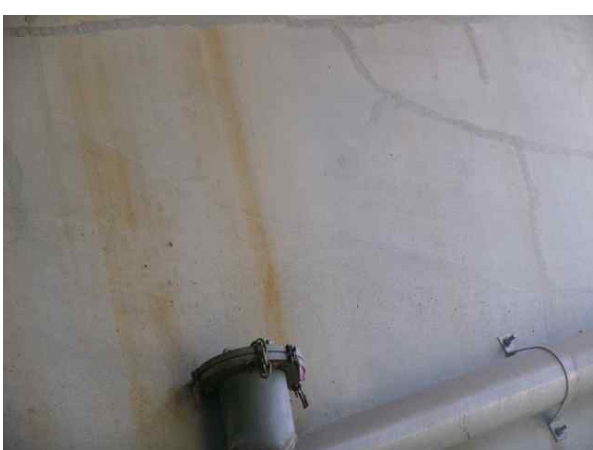
| P7 코핑부 균열(0.2mm/0.4m) | P7 코핑부 균열(0.2mm/1.5m) |

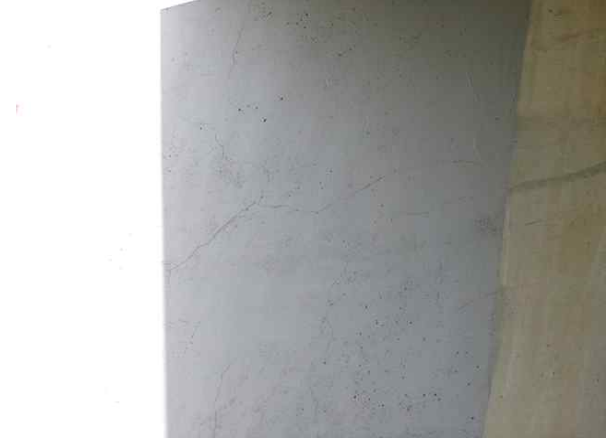
| P7 코핑부 망상균열(1.5×2.5) | P7 코핑부 망상균열(1.6×2.0) |

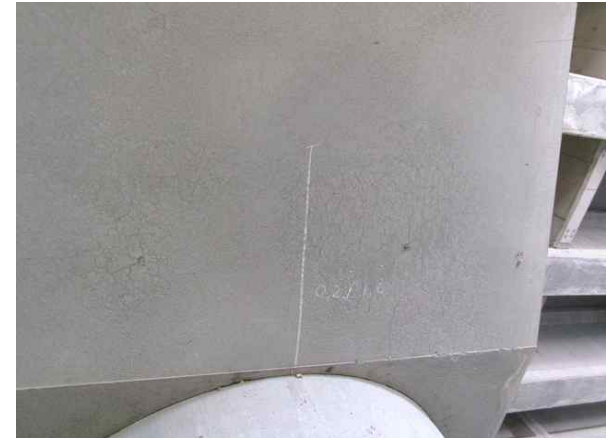
| P7 코핑부 채균열(0.2mm/1.2m) | P7 코핑부 균열(0.2mm/1.0m) |

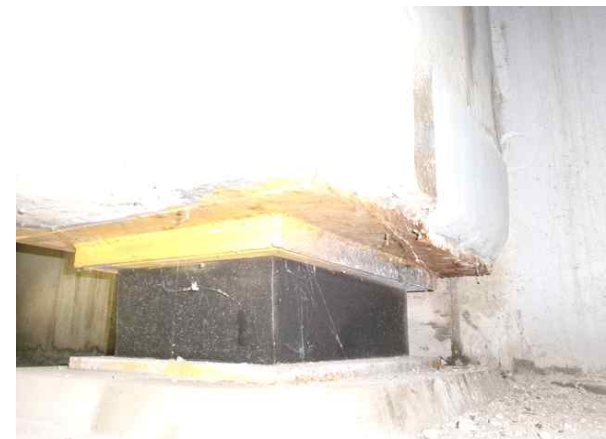
| P7 하부 웬스 파손 | A1-SH2 본체 부식 |

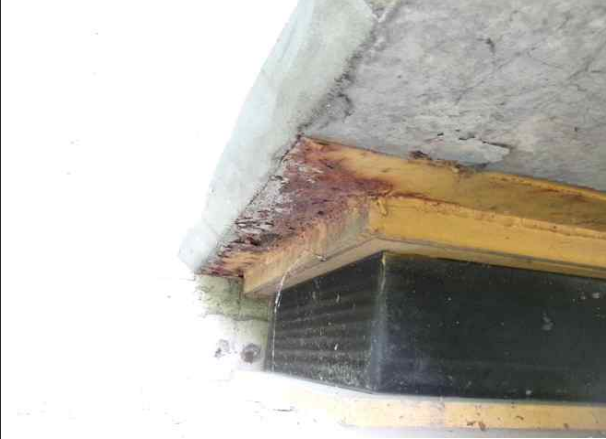
| <p>A1-SH3 본체 부식</p> | <p>A1-SH5 본체 부식</p> |

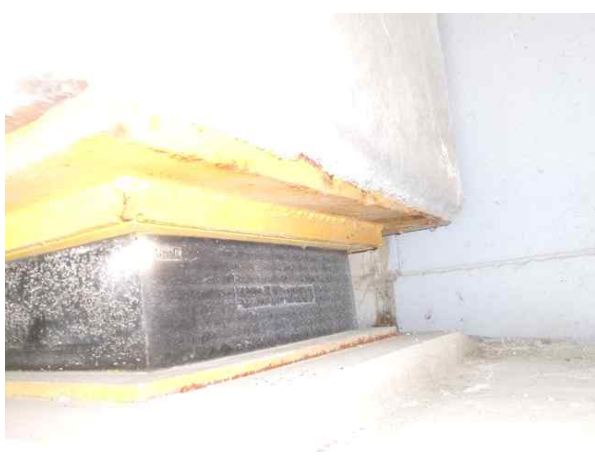
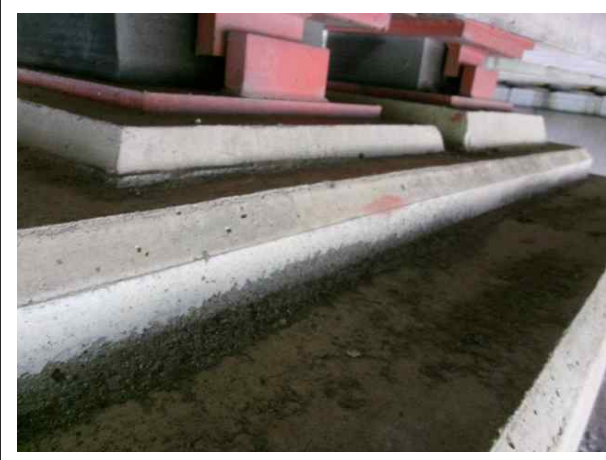
| <p>A2-SH5 본체 부식</p> | <p>P1-SH5 받침물탈 균열(0.1mm/0.1m)</p> |

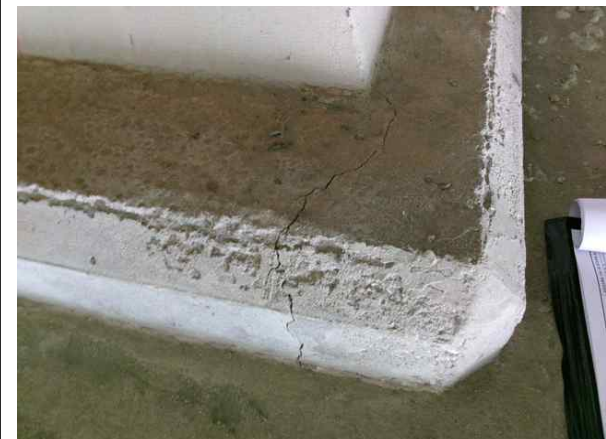
| <p>P3-SH1 물탈 박락(0.1×0.1)</p> | <p>P3-SH1 받침물탈 균열(0.5mm/0.5m)</p> |

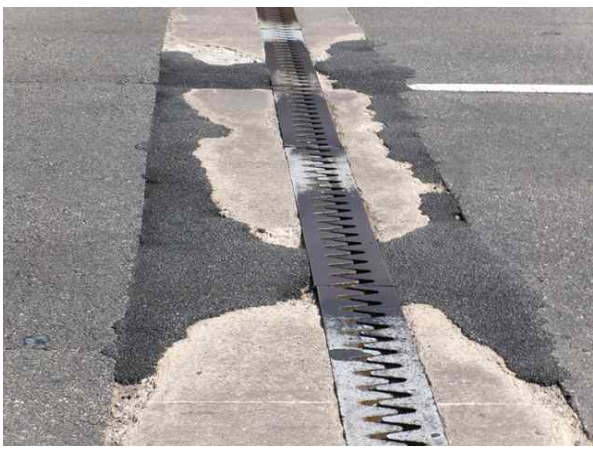
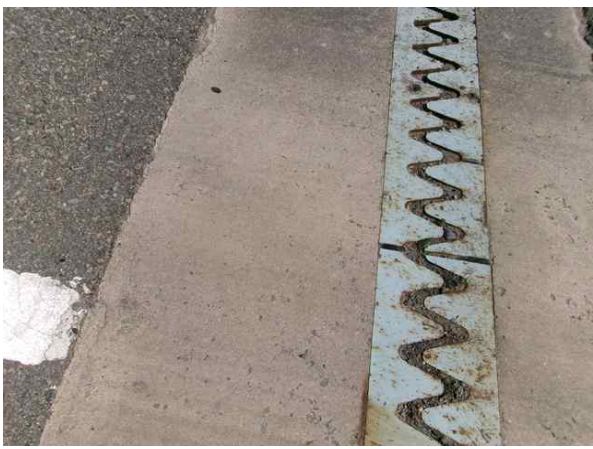
| A1 후타재 파손 보수 | A1 후타재 균열(0.2mm/0.6m) |

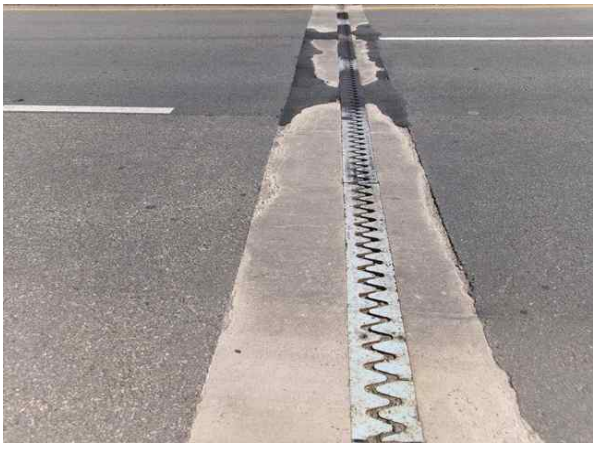
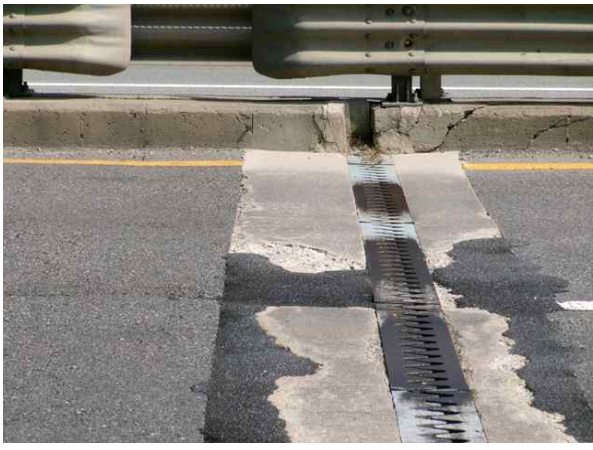
| A1 후타재 파손(0.2×2.0) | A1 후타재 파손(0.3×0.5) |

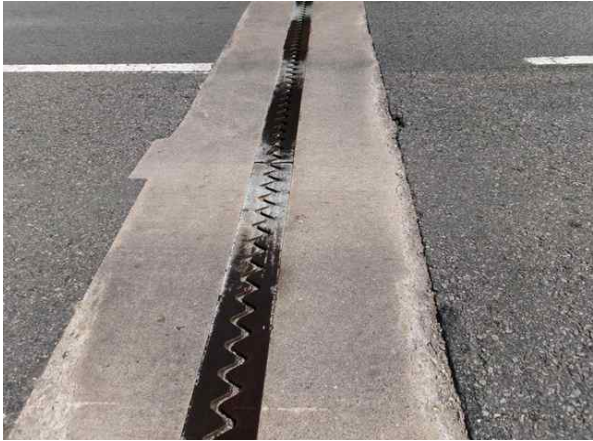
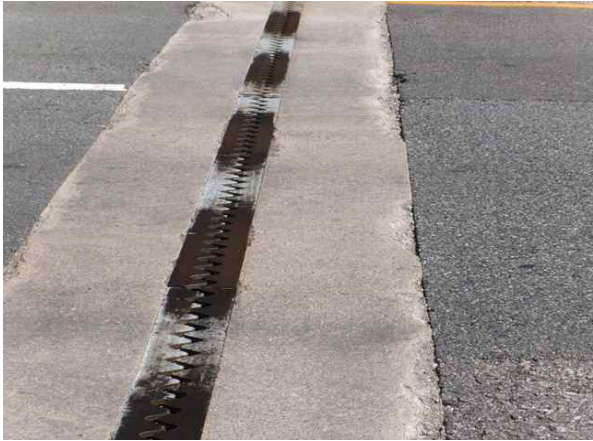
| A2 후타재 균열(0.1mm/0.5m) | A2 후타재 마모(0.5×1.0) |

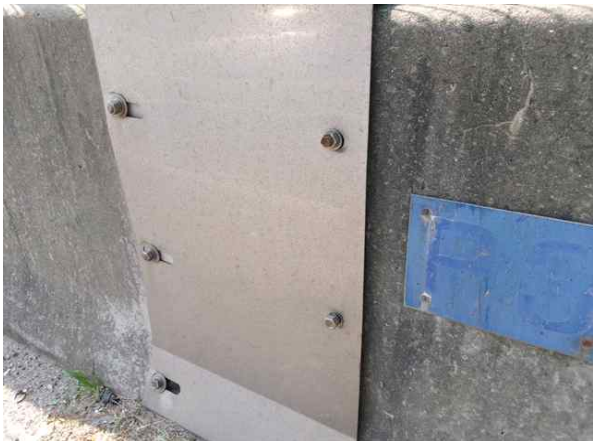
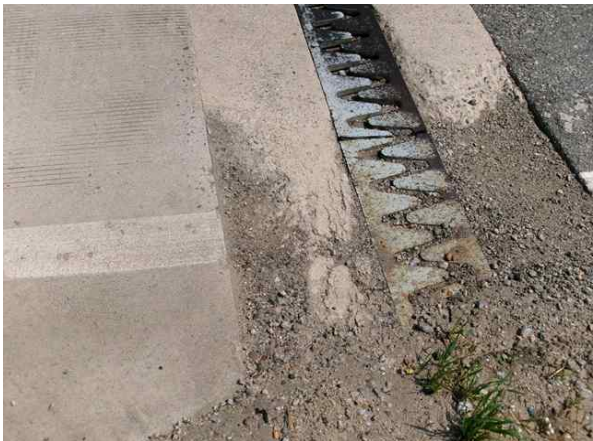
| P3 차수판 볼트 체결불량 보수 | P3 후타재 파손(0.2×0.5) |

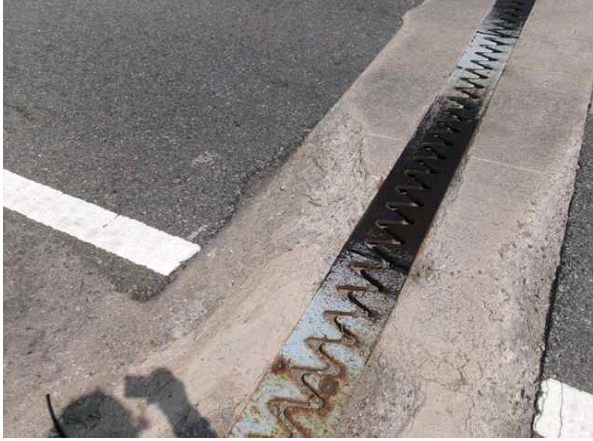
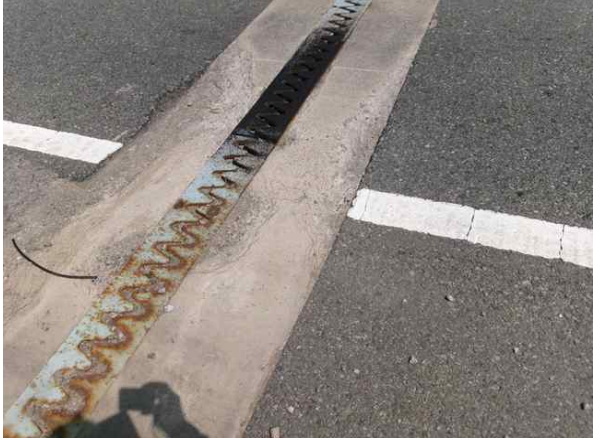
| P6 후타재 파손(0.1×0.4) | P6 후타재 파손(0.3×1.0) |

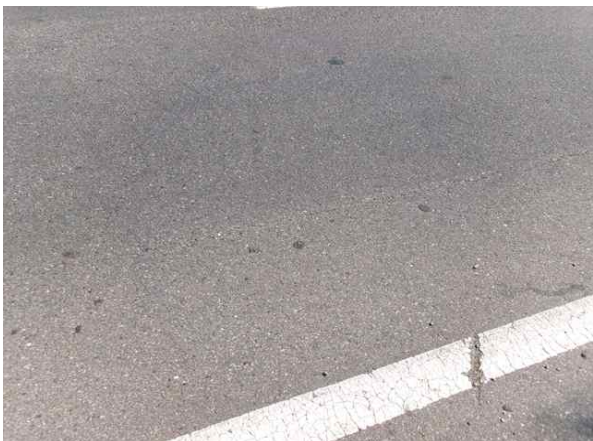
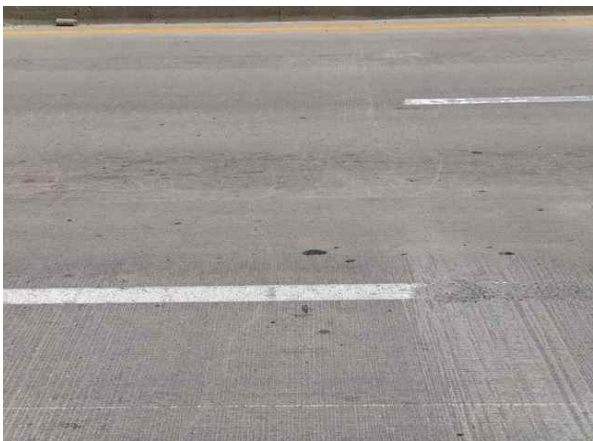
| S1 아스콘 균열(3.0) | S2 포장 균열(1.0) |

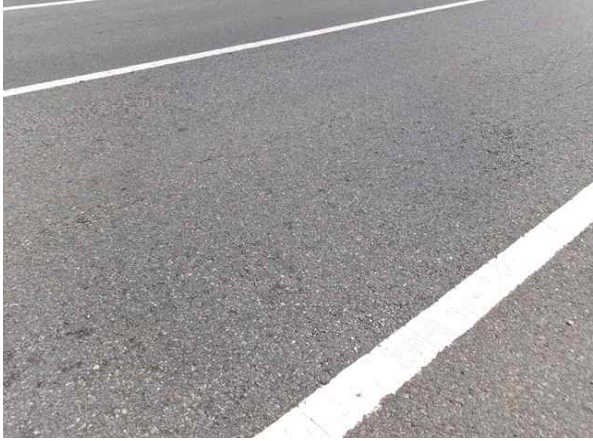
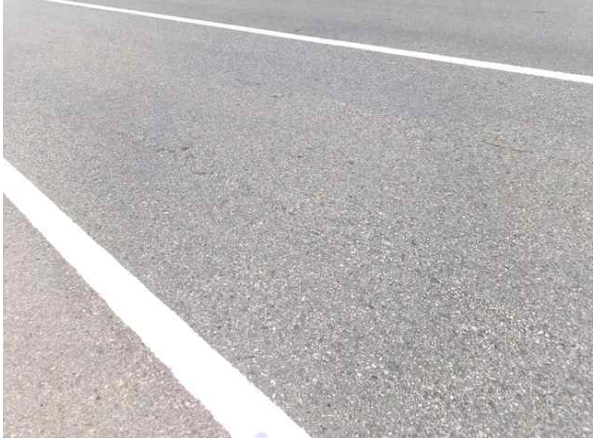
| S6 아스콘 망상균열(1.2×3.0) | S4 아스콘 균열(2.0) |

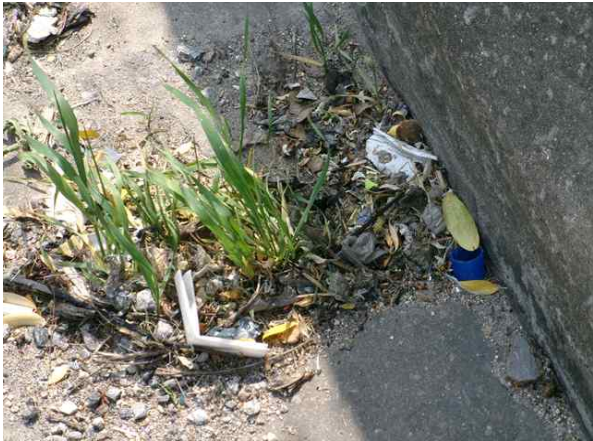
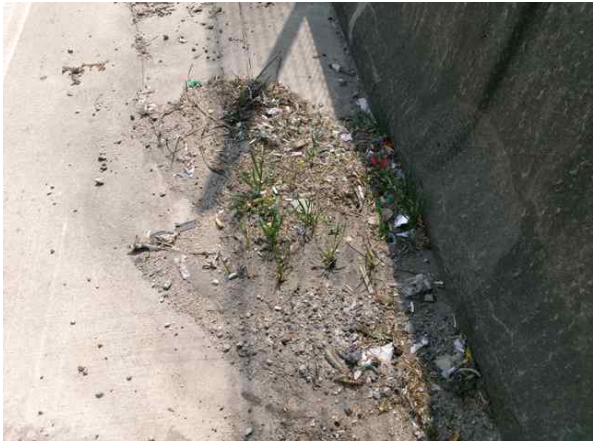
| S1 그레이팅 망실, 막힘 | S2 배수구 막힘 |

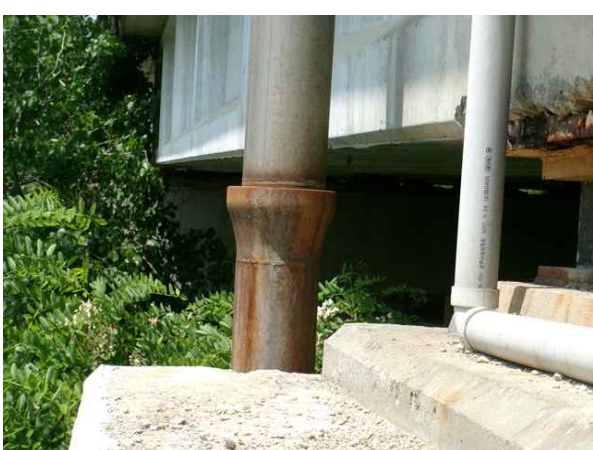
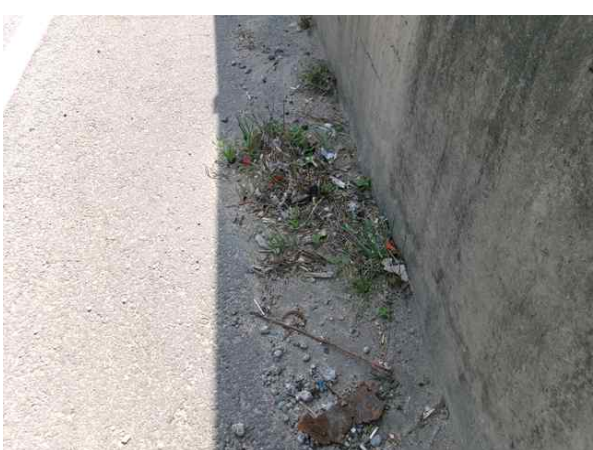
| S6 배수관 막힘, 부식 | S7 배수구 막힘 |

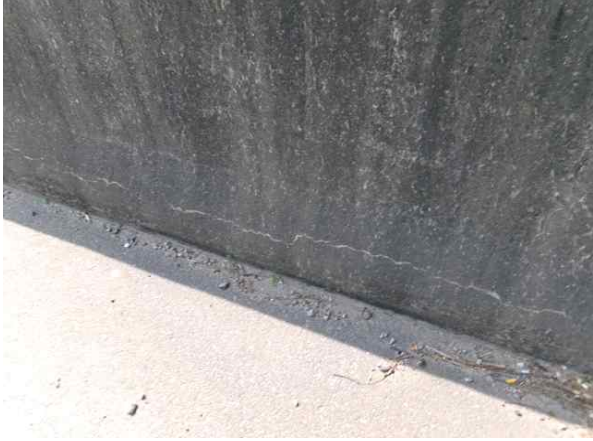
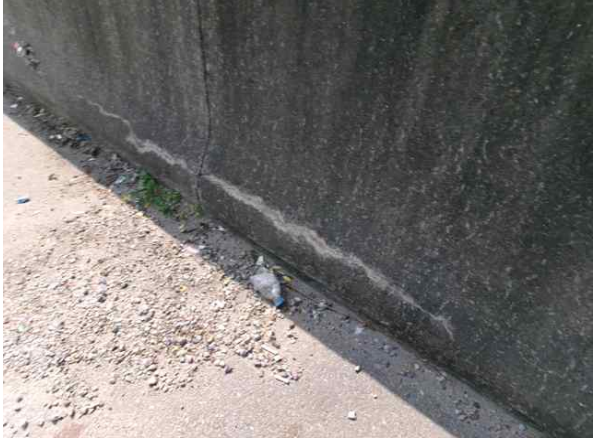
| S1 균열(0.2mm/2.0m) | S1 균열(0.2mm/2.5m) |

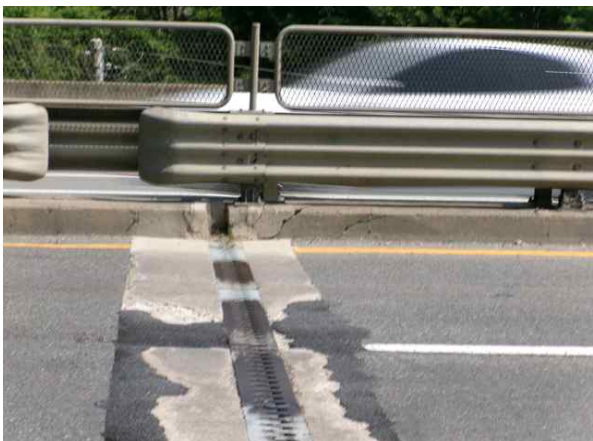
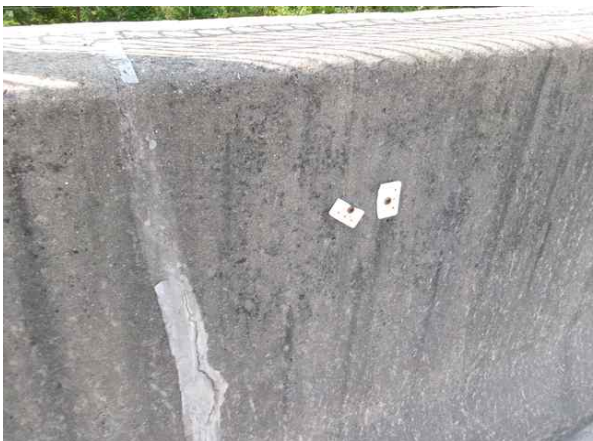
| S1 중분대 파손(0.2×1.0) | S2 텔레이네이트 파손 |

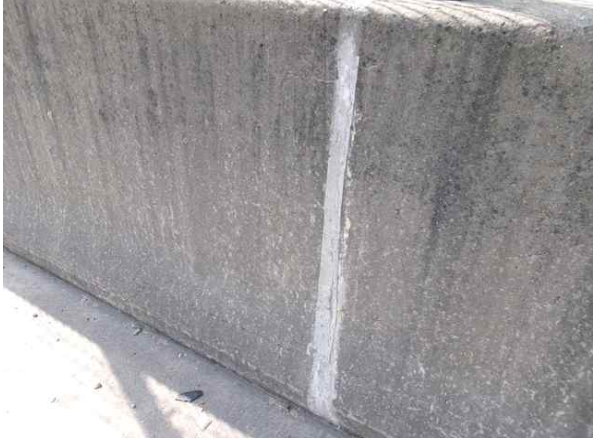
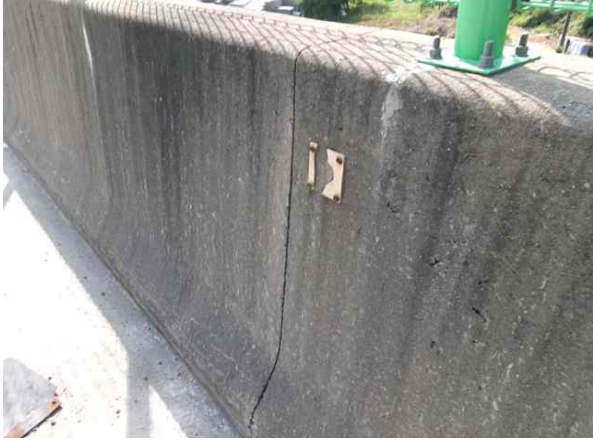
| S2 재균열 (0.2mm/2.5m) | S3 텔레이네이트 파손 |

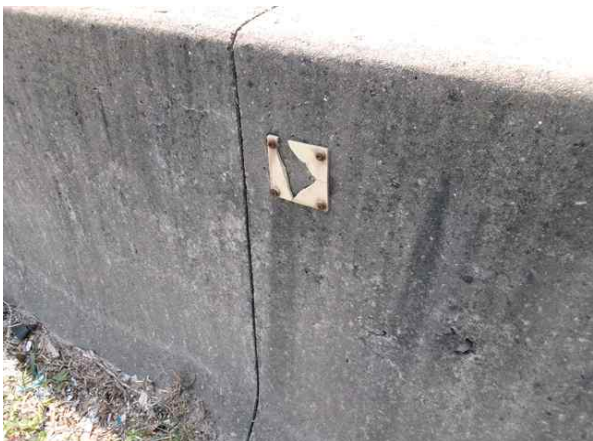
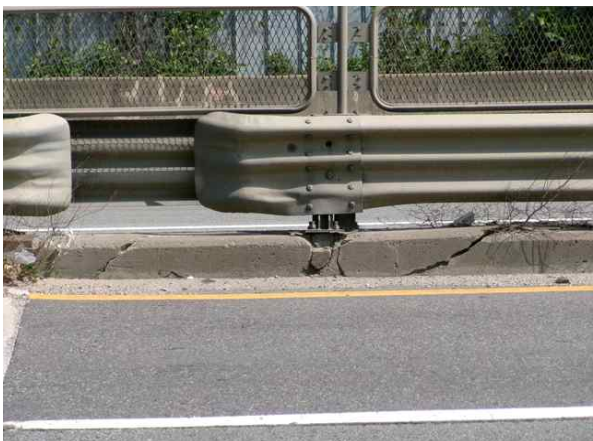
| S4 텔레이네이트 파손 | S4 중분대 파손 (0.2×2.5) |

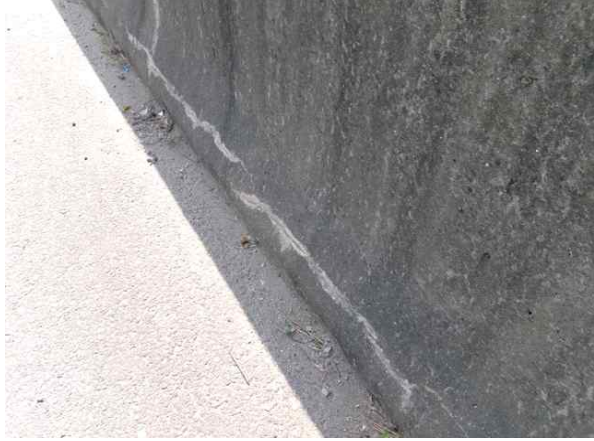
| S5 재균열 (0.2mm/2.5m) | S6 균열 (0.2mm/3.0m) |

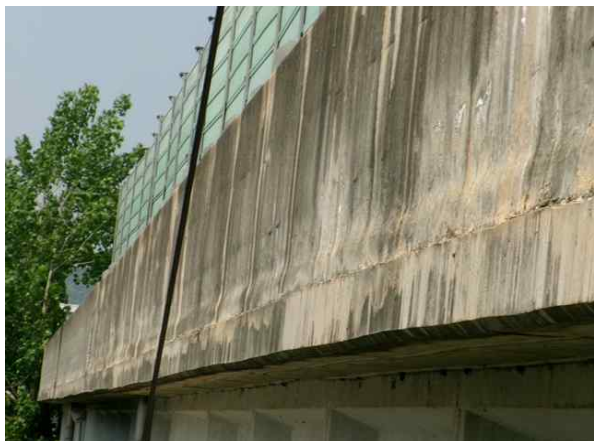
| S7 파손 (0.2×0.4) | S8 균열부 백태 (0.8) |
