### 3. 양성교(하)

## 손상현황 사진

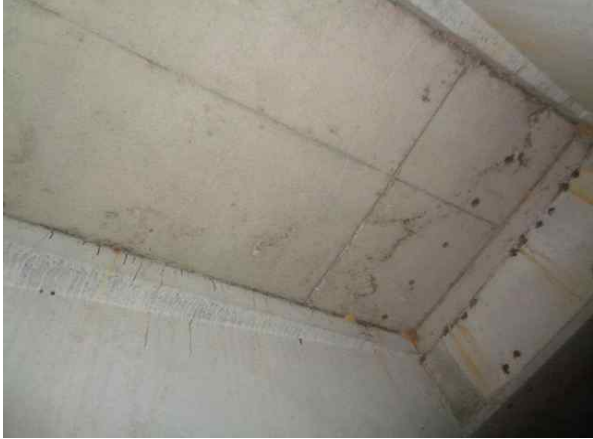
| S1 균열(0.1mm/1.7m) | S1 박락 보수 |

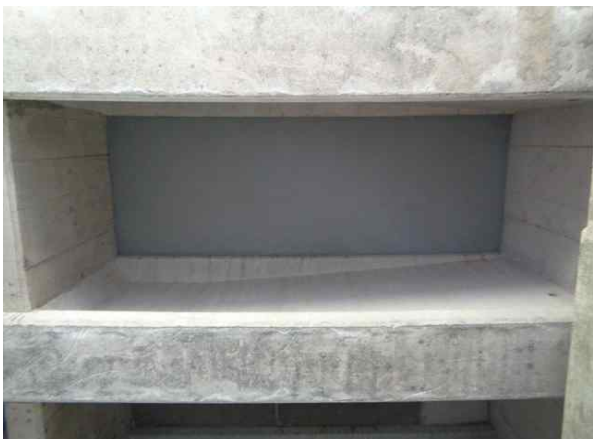
| S2 균열 보수 | S2 균열(0.2mm/1.5m) |

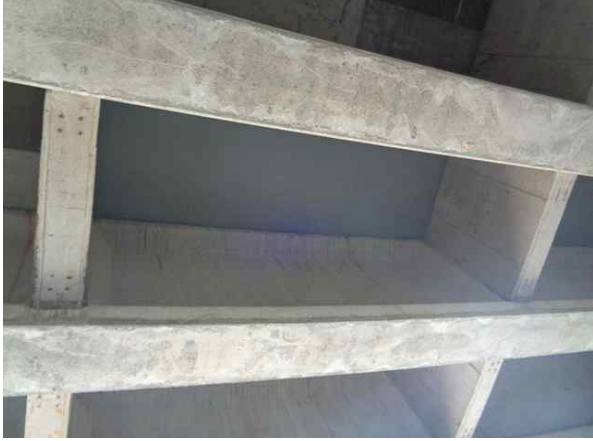
| S2 균열부 백태 보수 | S2 물끓기흠 미시공 |

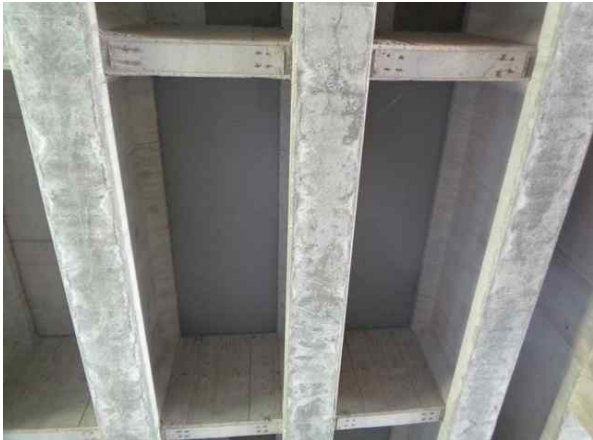
| S2 균열 보수 | S4 박락 및 철근노출(0.3×0.2) |

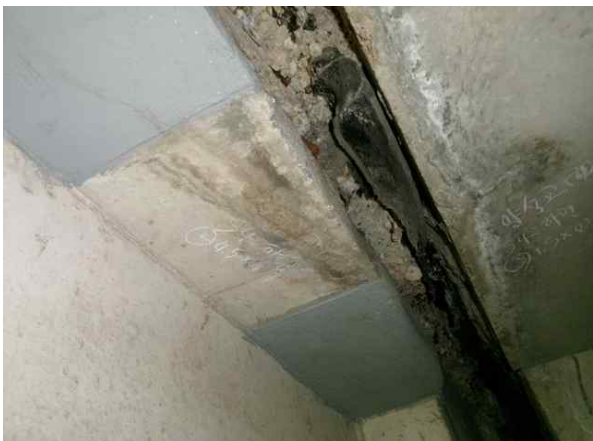
| S4 박락 보수 | S4 물끓기흠 미시공 |

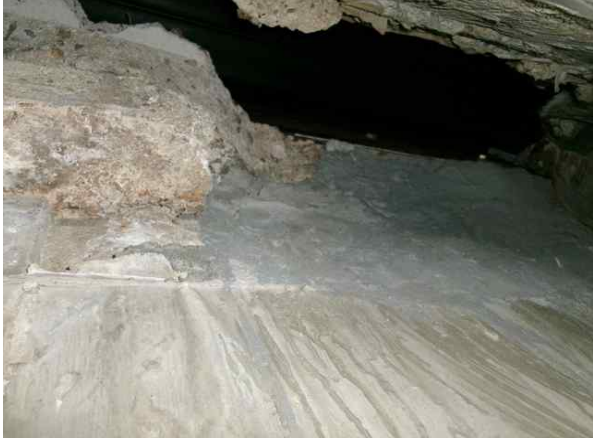
| S4 파손, 재료분리 보수 | S4 파손 (0.6×0.1) |

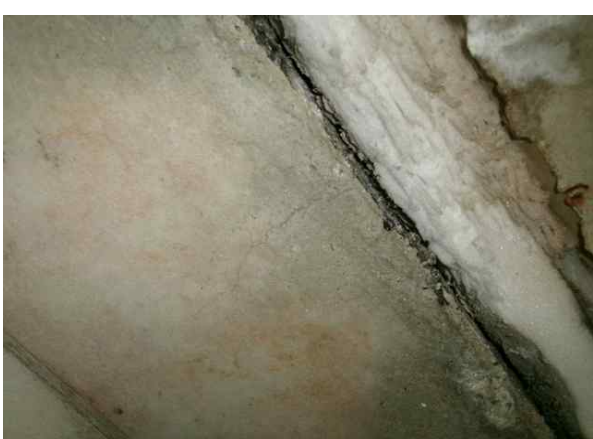
| S6 균열(0.2mm/0.3m) | S6 박락 (0.1×0.3) |

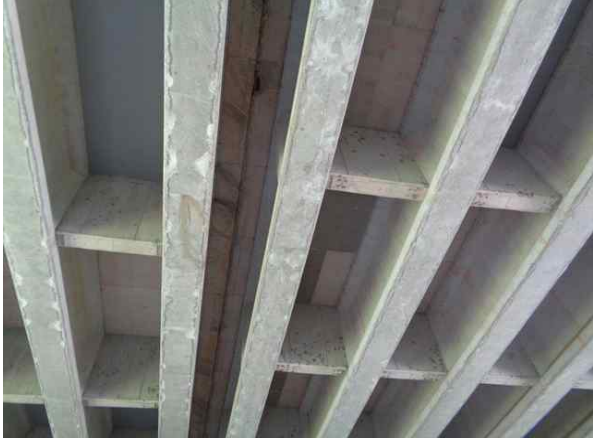
| S6 물끓기흙 미시공 | S6 파손 및 철근노출(0.2×0.6) |

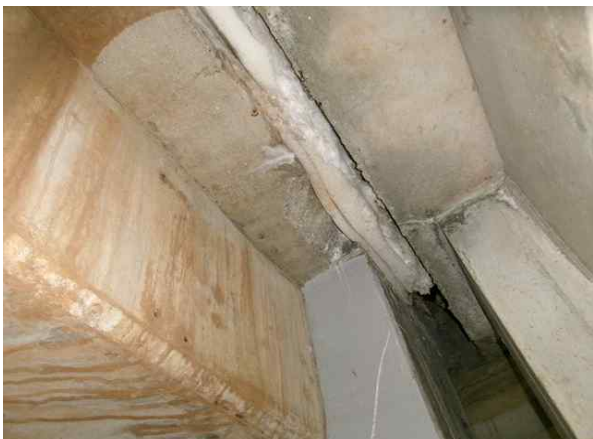
| S7 파손 (0.2×0.5) | S8 균열(0.1mm/1.6m) |

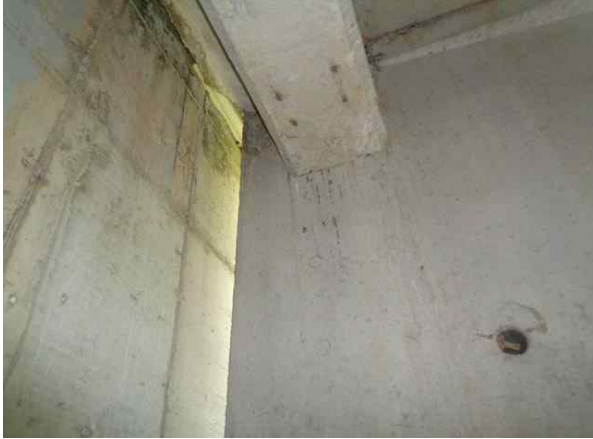
| S1-G1 백태(0.3×0.2) | S3-G1 박락(0.7×0.2) |

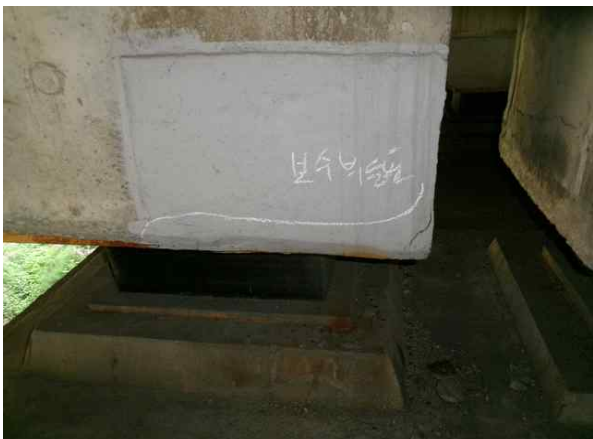
| S3-G1~6 보수부 들뜸(0.5×0.2) | S4-G1 박락 및 철근노출(0.5×0.5) |

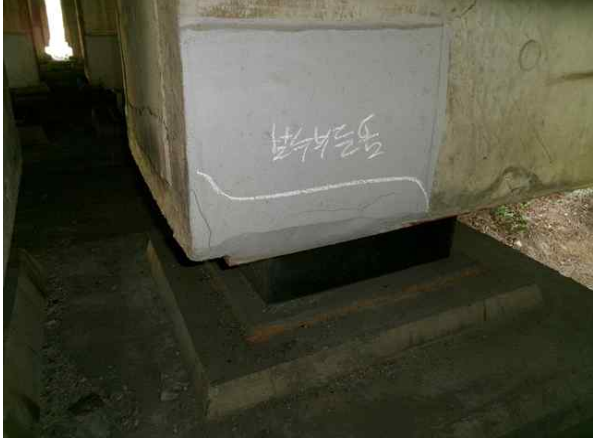
| S4-G1~6 보수부 들뜸(0.5×0.3) | S6-G1 박리 보수 |

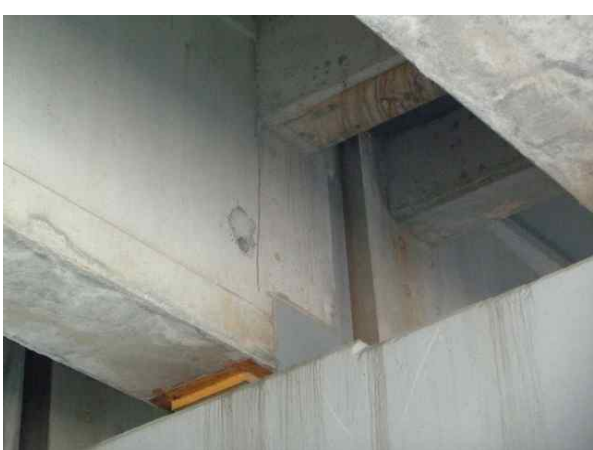
| S7-G3 균열 보수 | S7-G1~6 들뜸(1.0×0.3) |

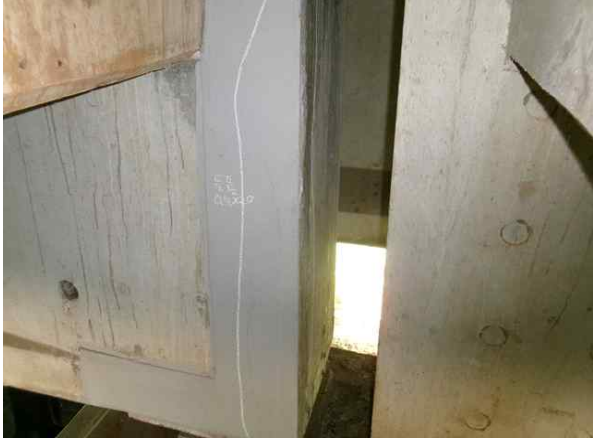
| S7-G6 들뜸(0.5×2.0) | S8-G2 박락 보수 |

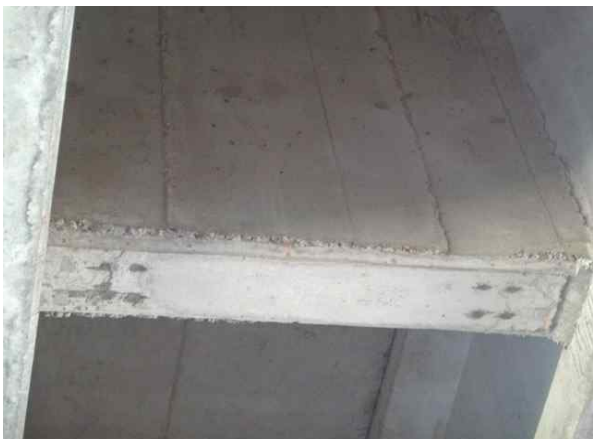
| S3 재료분리(0.1×1.5) | S3 재료분리(0.1×1.5) |

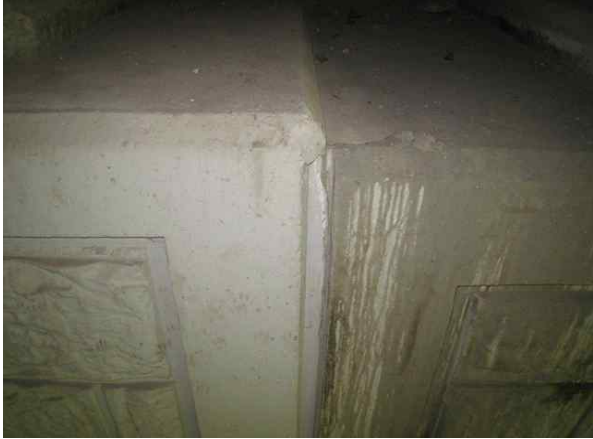
| A1 균열(0.3mm) | A1 법면배수로 토사퇴적 |

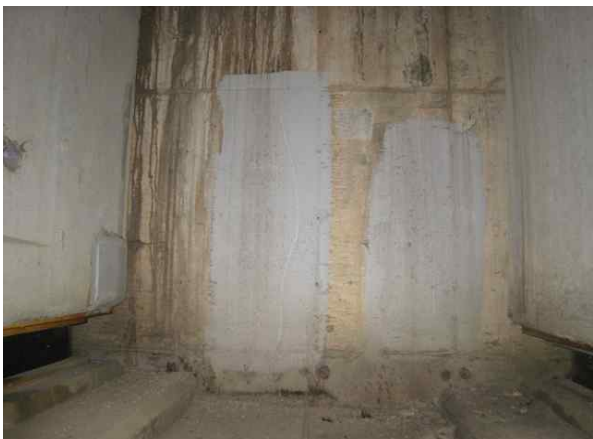
| A1 균열(0.2mm) | A1 재료분리(0.6×0.2) |

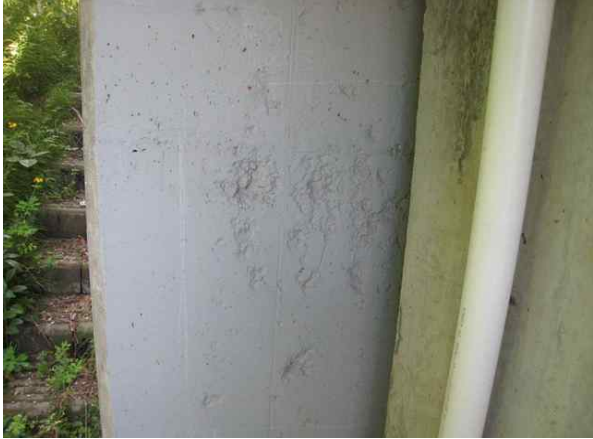
| A2 박리(0.6×0.6) | A2 파손(0.1×0.8) |

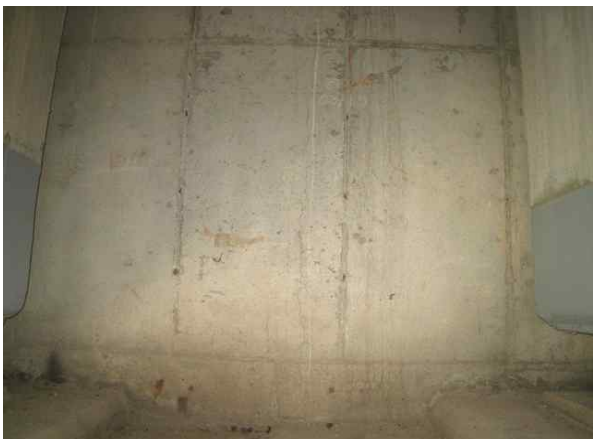
| A2 균열(0.3mm) | A2 보호블럭 침하 |

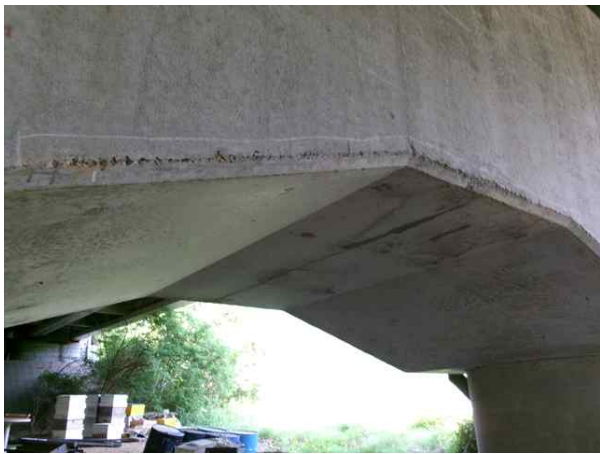
| <p>P1 코핑부 재료분리(0.1×4.0)</p> | <p>P1 코핑부 배면 균열 보수</p> |

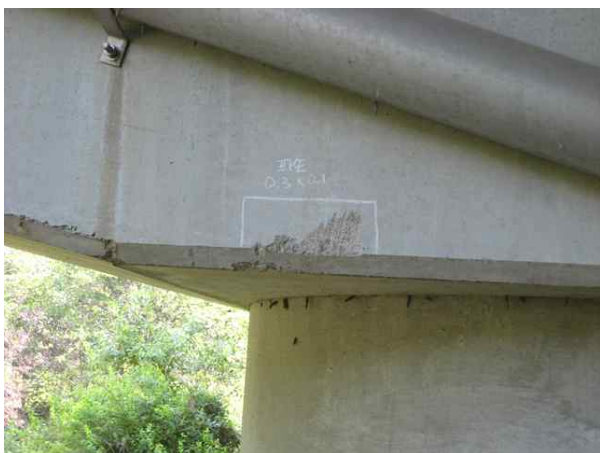
| <p>P2 코핑부 파손(0.3×0.1)</p> | <p>P2 코핑부 균열(0.2mm/0.5m)</p> |

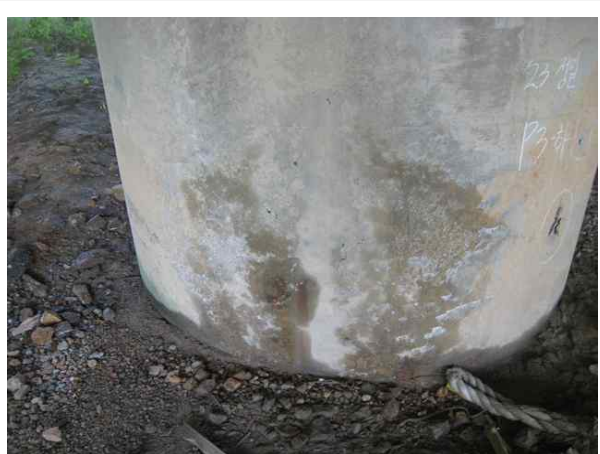
| <p>P3 코핑부 파손(1.5×1.0)</p> | <p>P3 기둥부 철근노출(0.1×0.2)</p> |

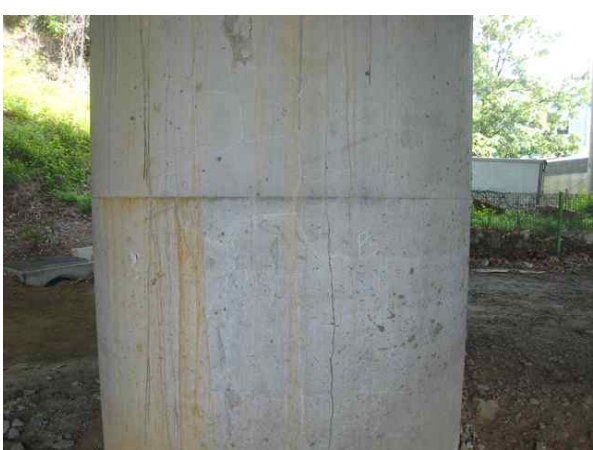
| P5 기둥부 망상균열(0.2mm) | P5 기둥부 균열(0.2mm) |

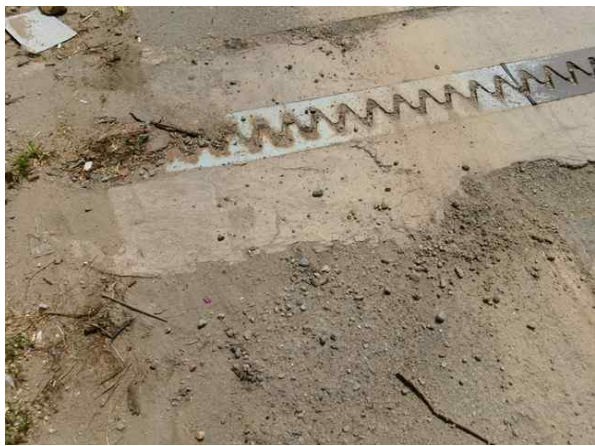
| P6 후타재 박리(0.1×1.2) | P6 후타재 파손(0.1×1.2) |

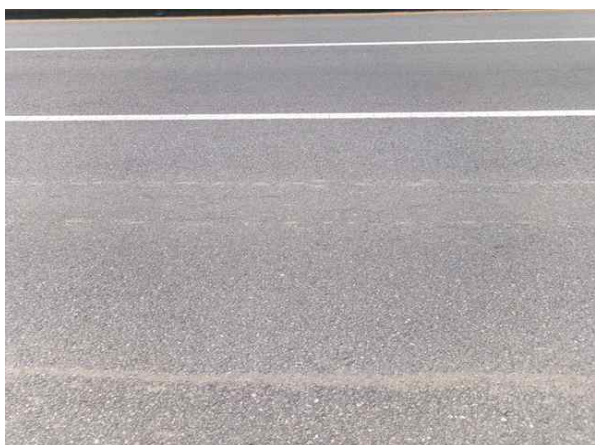
| S1 아스콘 균열(4.0) | S1 아스콘 마모(2.0×0.6) |

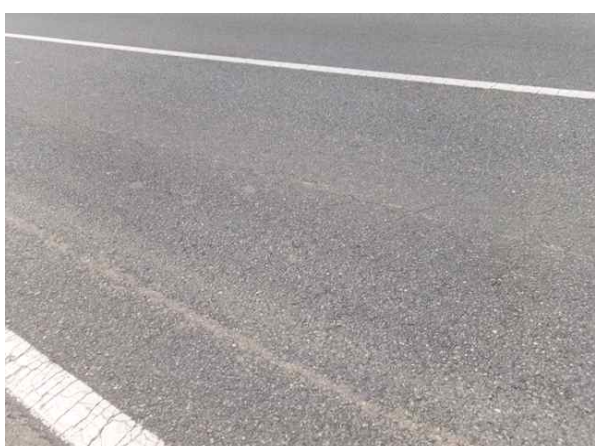
| S1 아스콘 균열(20.0) | S2 아스콘 균열(1.4) |

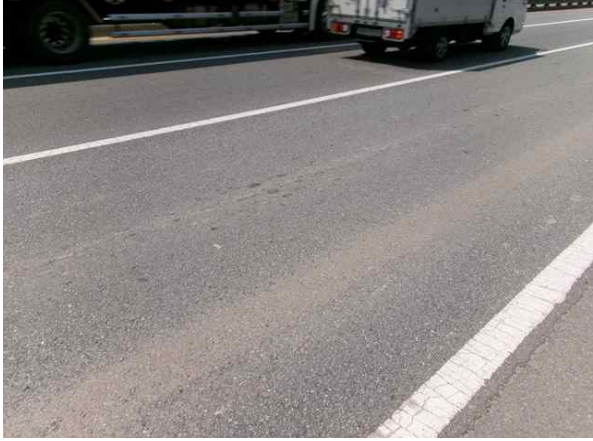
| S3 아스콘 균열(7.0) | S4 아스콘 망상균열(1.5×11.0) |

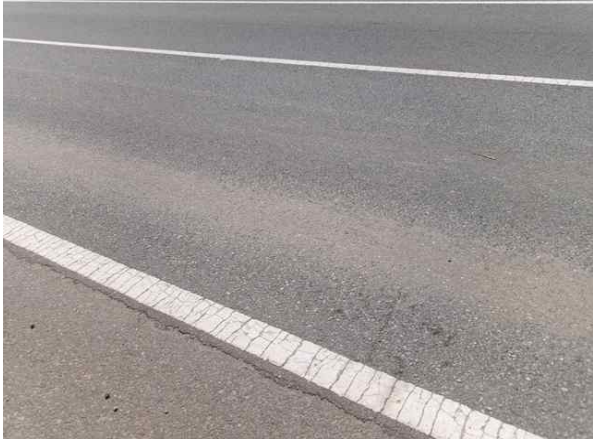
| S4 아스콘 망상균열(2.0×2.0) | S5 아스콘 망상균열(1.5×9.0) |

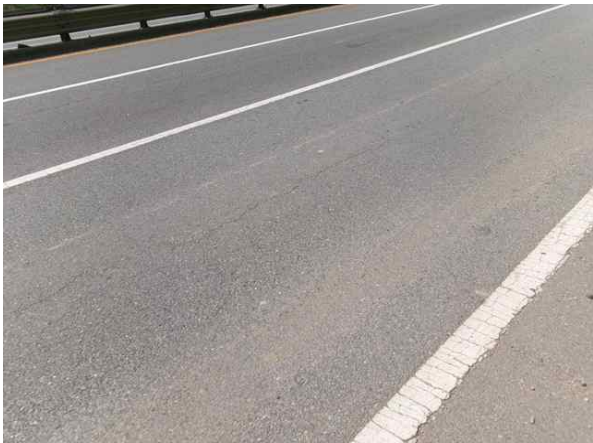
| S5 아스콘 균열(5.0) | S6 아스콘 망상균열(1.5×5.0) |

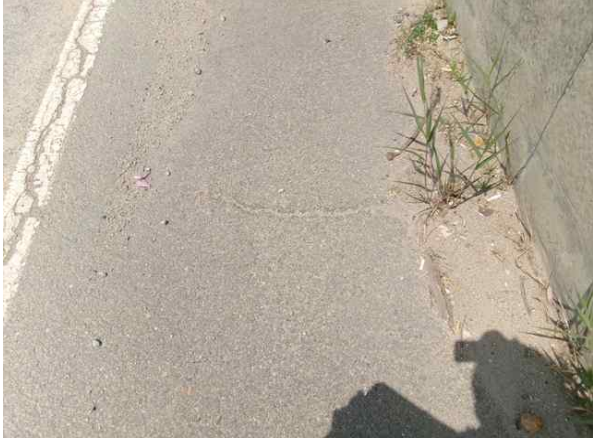
| S6 아스콘 균열(1.5) | S6 아스콘 패임 보수 |

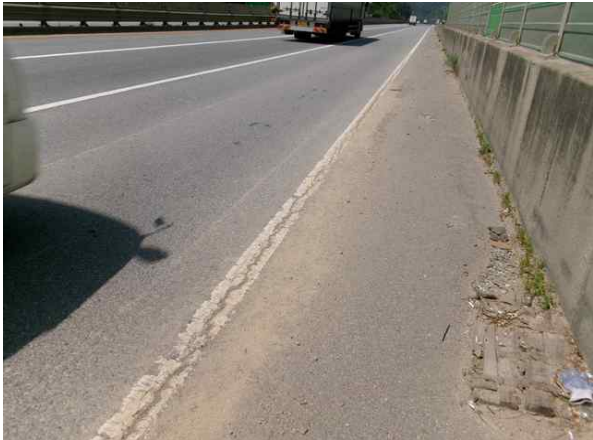
| S6 포장 균열(30.0) | S7 아스콘 망상균열(0.2×0.2) |

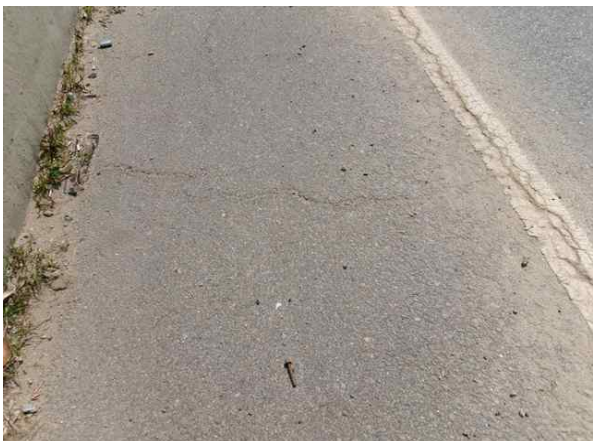
| S7 포장 균열(1.5) | S8 아스콘 패임 보수 |

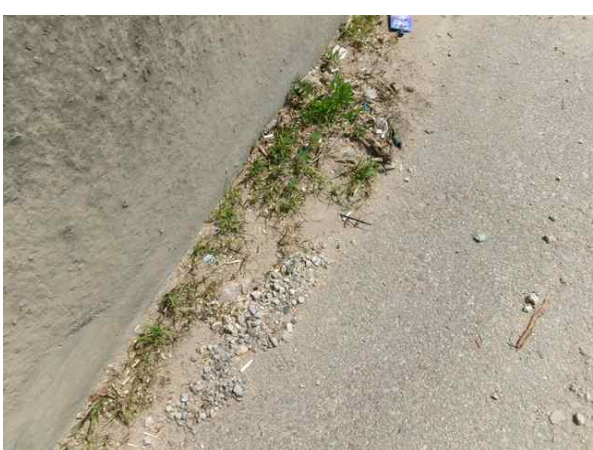
| <p>S6 배수구 막힘</p> | <p>S7 배수구 막힘</p> |

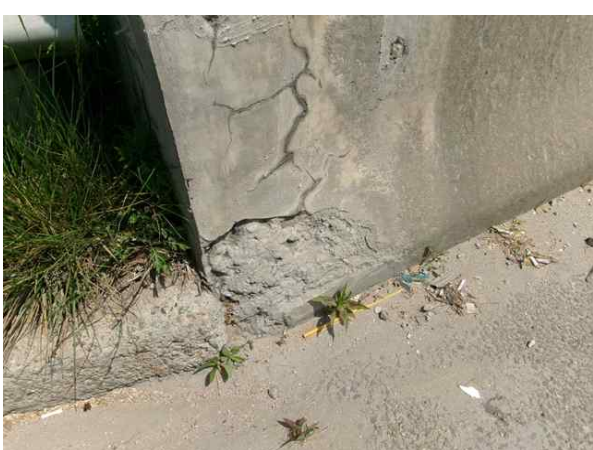
| <p>S1 파손(0.3×0.3)</p> | <p>S2 균열(0.1mm/5.0m)</p> |

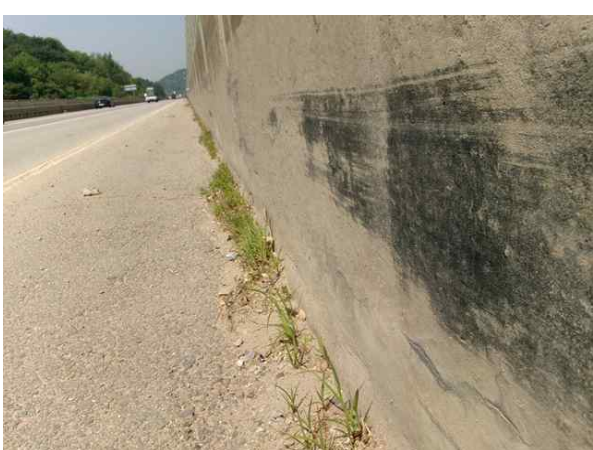
| S8 균열부 백태(0.2×30.0) | S8 텔리네이트 파손 |
