## 2. 천안2교

## 손상현황 사진

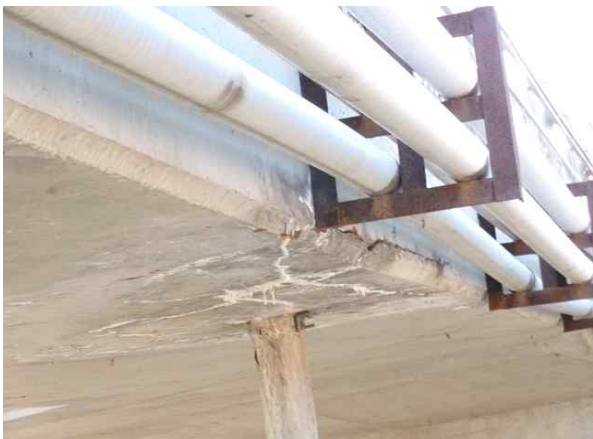
| S1 파손 (0.3m×2.0m) | S1 파손 및 철근노출 |

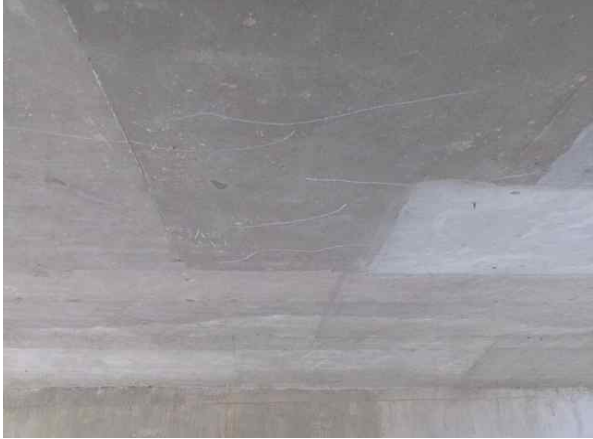
| S1 균열 (CW=0.1mm) | S2 균열 (CW=0.1mm) |

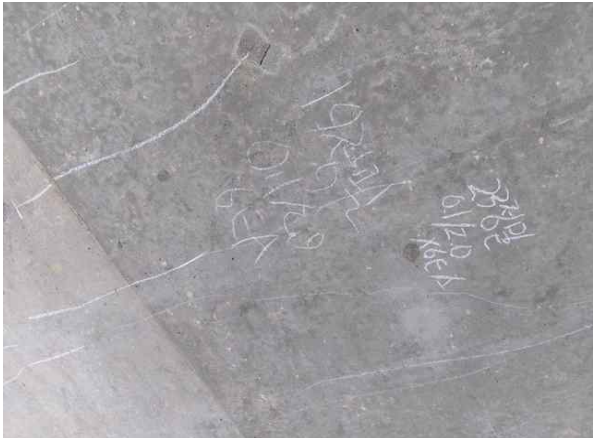
| S2 균열 (CW=0.1mm) | S2 균열 (CW=0.2mm) |

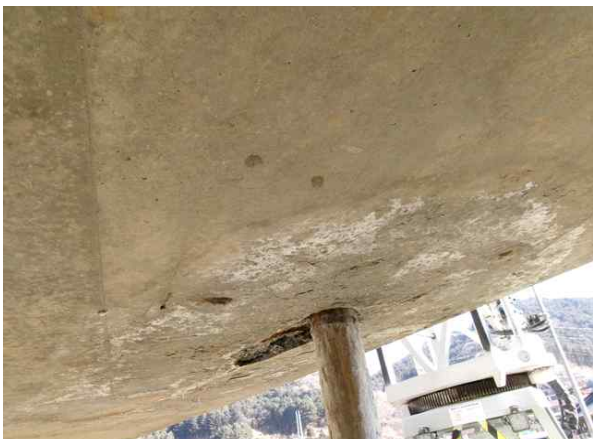
| S2 누수 및 백태 (0.8m×1.8m) | S2 누수 및 백태 (1.5m×1.5m) |

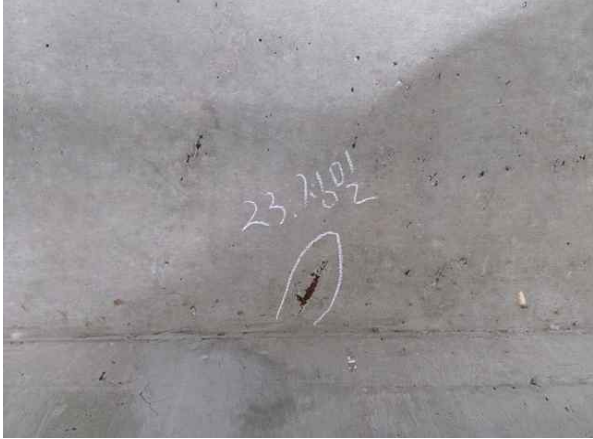
| S2 철근노출 (0.1m×0.1m×2EA) | S2 철근노출 (0.1m×0.1m×2EA) |

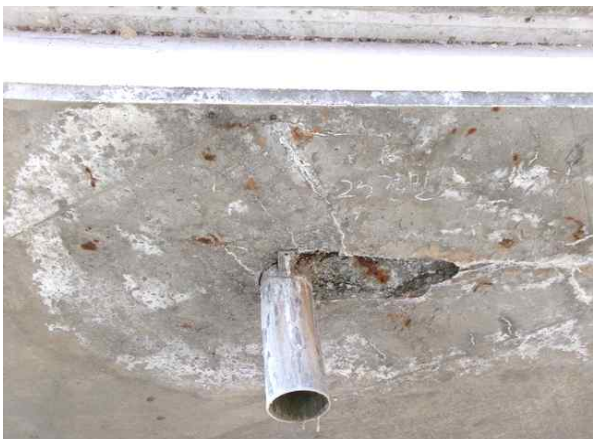
| S2 파손 및 철근노출 (2.0m×1.0m) | S3 균열 (CW=0.2mm) |

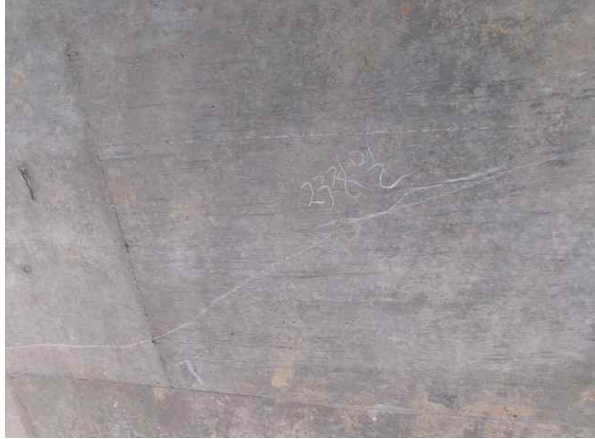
| S3 균열 (CW=0.2mm) | S3 균열 (CW=0.2mm) |

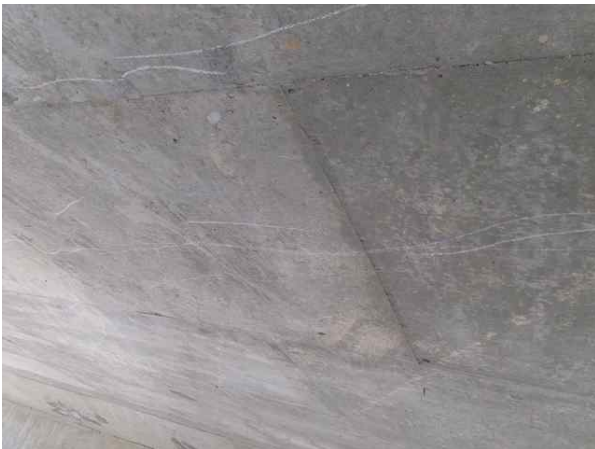
| S3 균열 (CW=0.2mm) | S3 누수 및 백태 (0.8m×2.0m) |

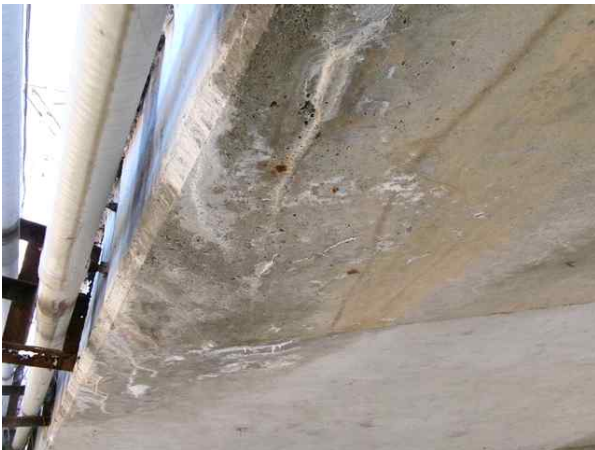
| S3 실링미처리 | S3 누수 및 백태 (1.0m×1.0m) |

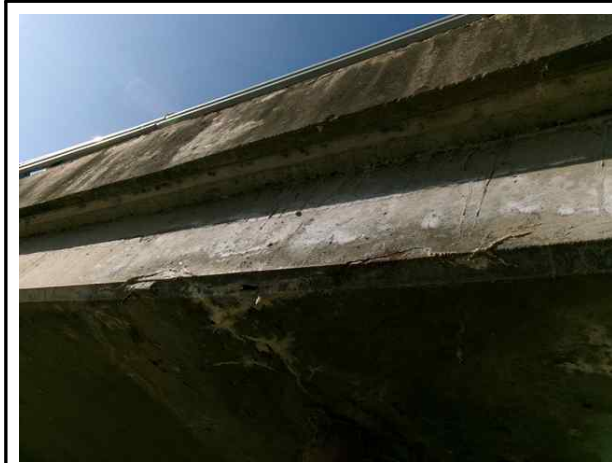
S3 박리 (0.1m×0.6m)

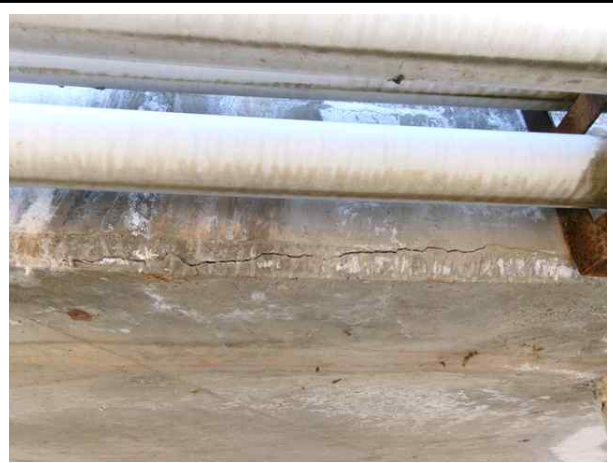
S3 파손 (4.0m×0.3m)

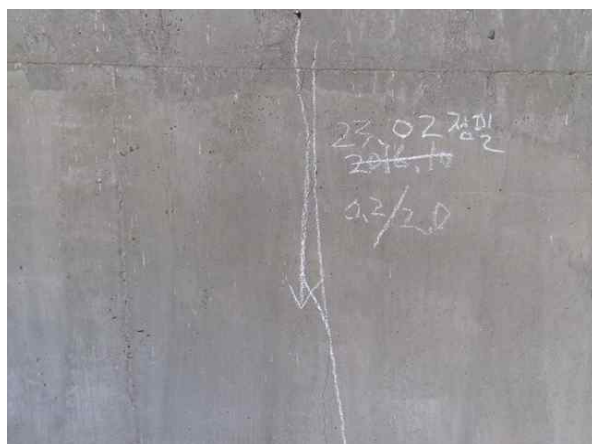
A1 균열 (CW=0.2mm)

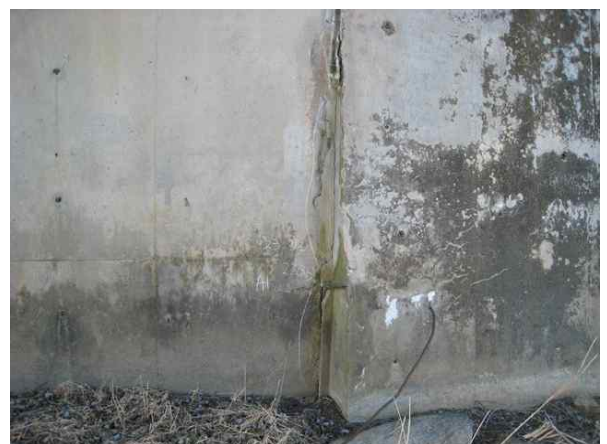
A1 하단 박리 (0.3m×2.0m)

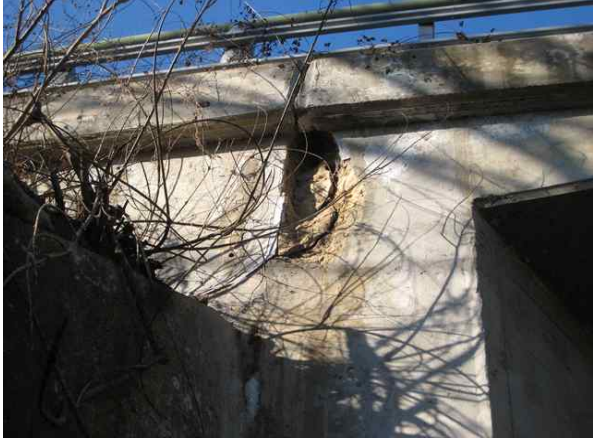
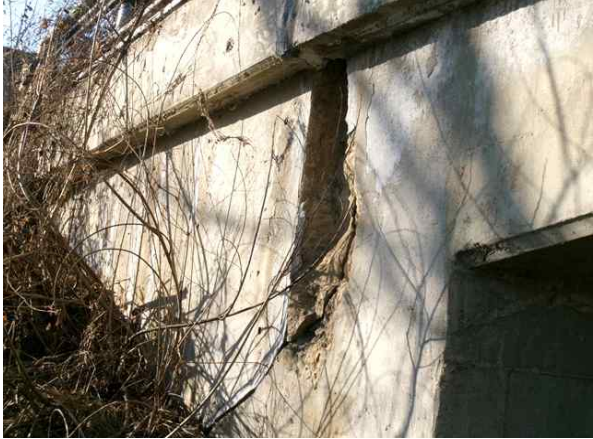
| A1 측면 상단 파손(0.8m×1.0m) | A1 측면 상단 파손(0.8m×1.0m) |

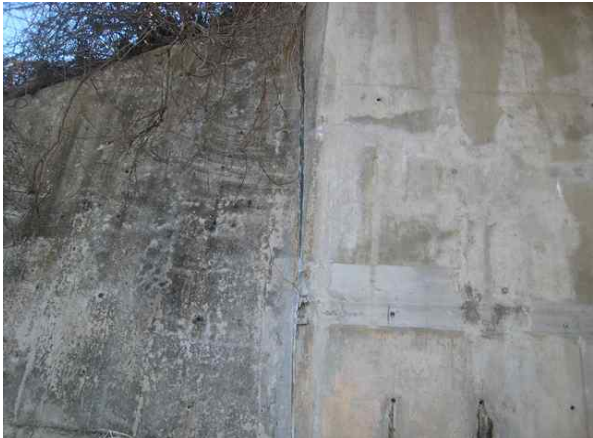
| A1 접속부 실링재 박리(0.1m×5.0m) | A2 누수흔적(0.3m×2.0m) |

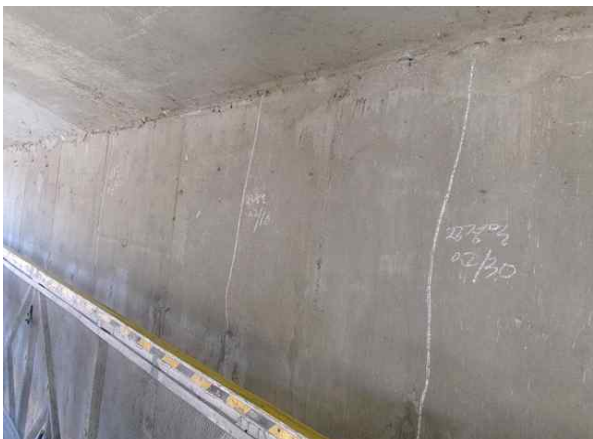
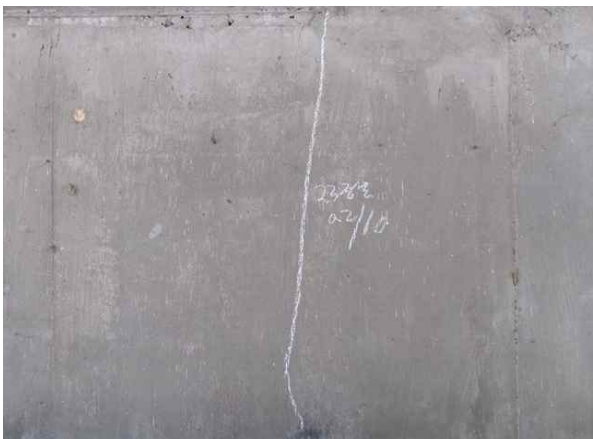
| A2 균열 (CW=0.2mm) | A2 균열 (CW=0.2mm) |

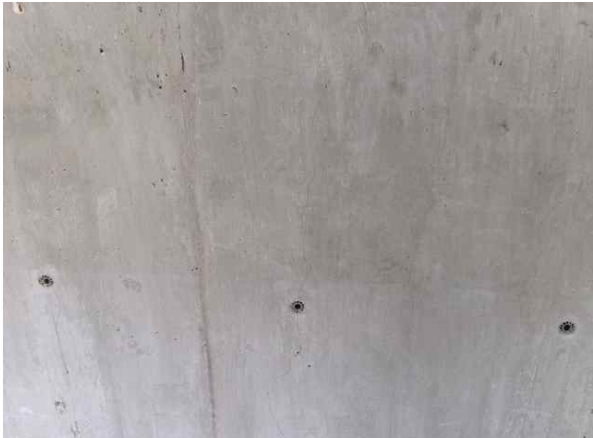
| P1 균열 (CW=0.1mm) | P1 균열 (CW=0.2mm) |

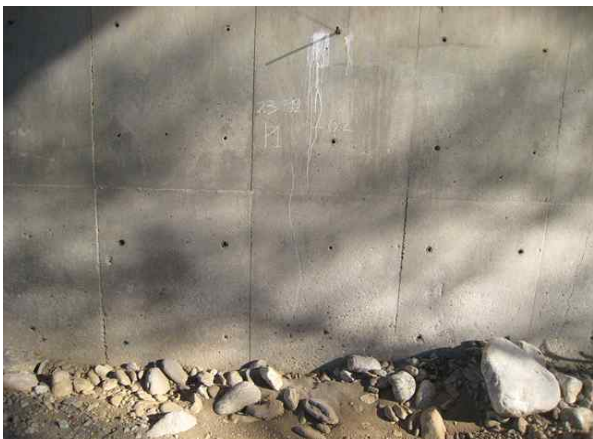
| P1 균열 (CW=0.3mm) | P1 균열 (CW=0.5mm) |

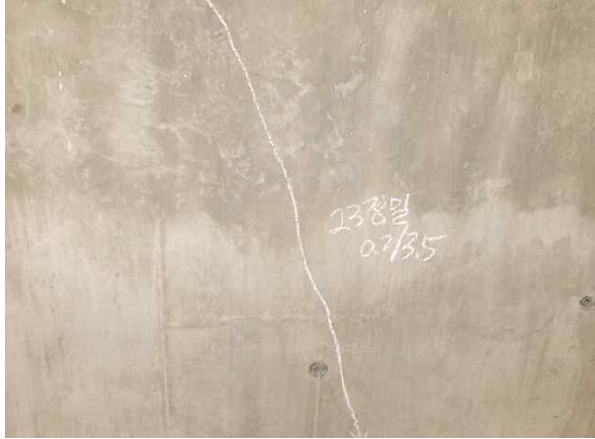
| P1 균열 (CW=0.2mm) | P2 폐자재적치 |

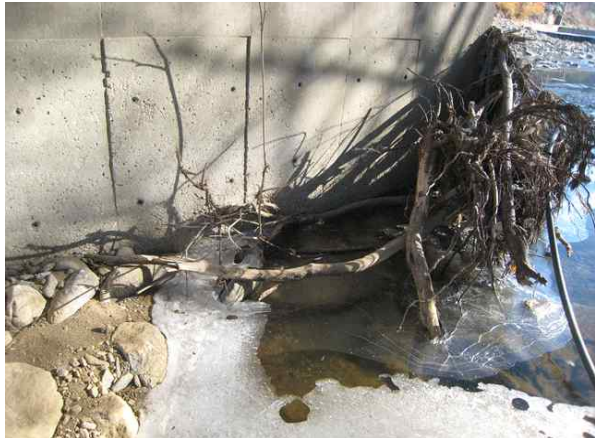
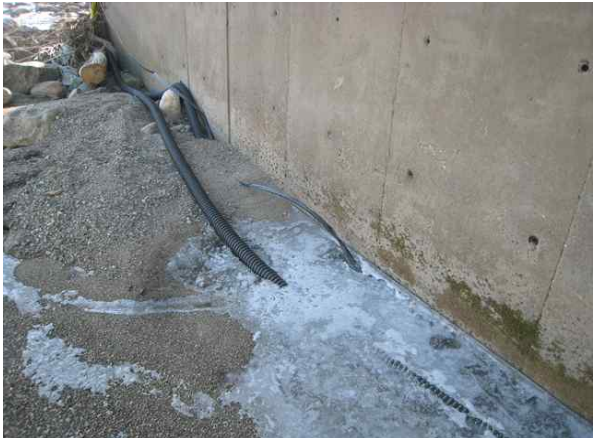
| P1 하단부 침식 (3.0m×0.4m) | P1 하단부 침식 (3.0m×0.4m) |

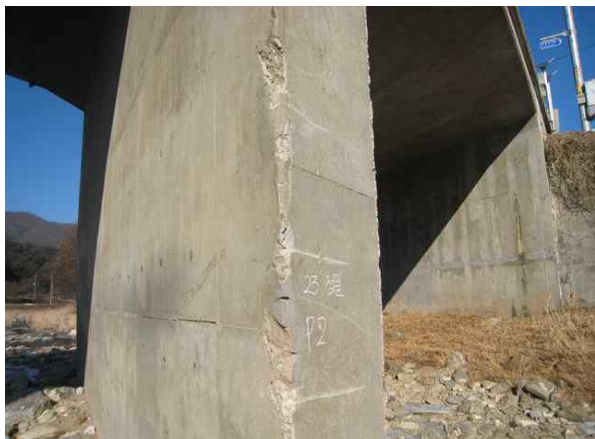
| P2 박락 (0.3m×3.5m) | P2 박락 및 철근노출 (0.8m×2.0m) |

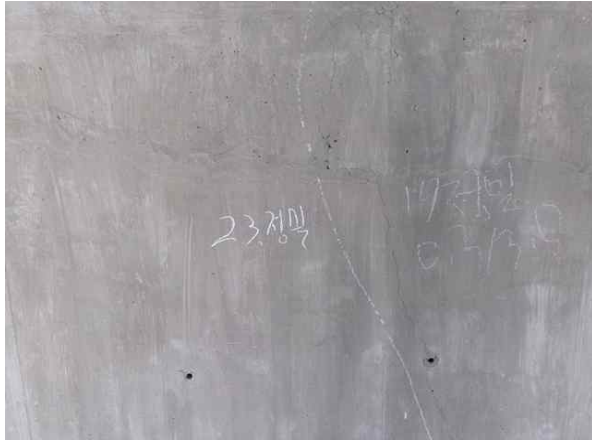
P2 균열 (CW=0.3mm)

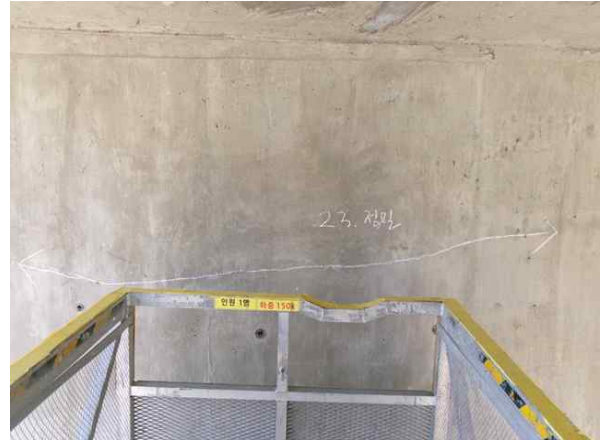
P2 균열 (CW=0.2mm)

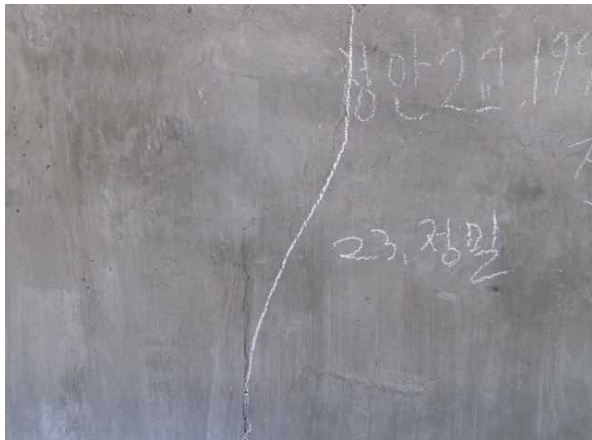
P2 균열 (CW=0.3mm)

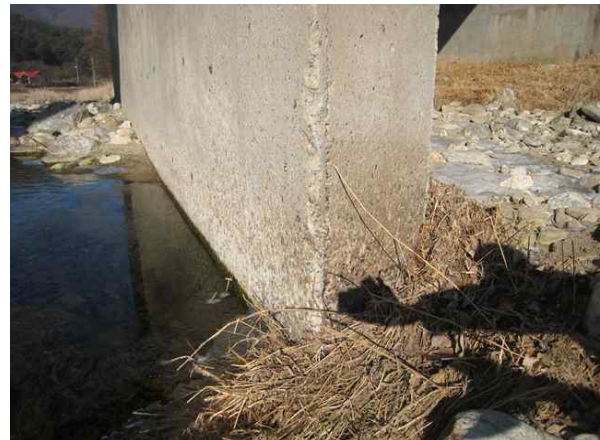
P1 하단부 침식(9.0m×0.4m)

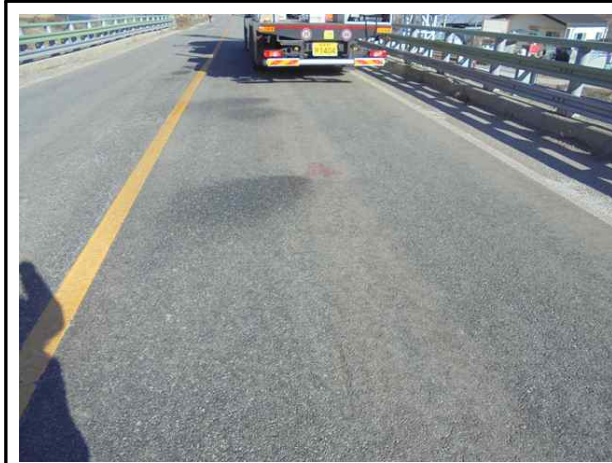
S1 굽힘 (0.1m×0.3m×4EA)

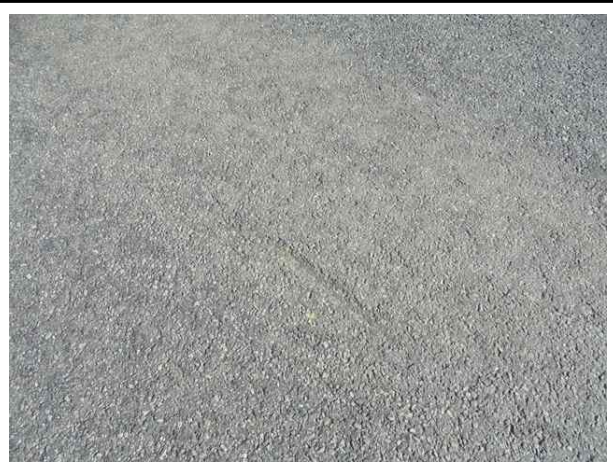
S1 굽힘 (0.1m×0.3m×4EA)

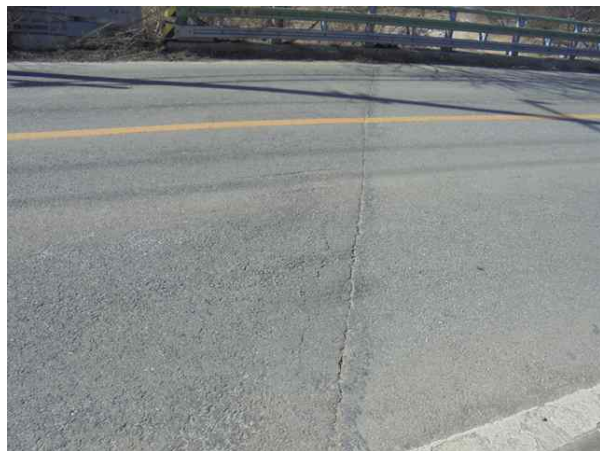
S1 접속부 균열 (3.0m)

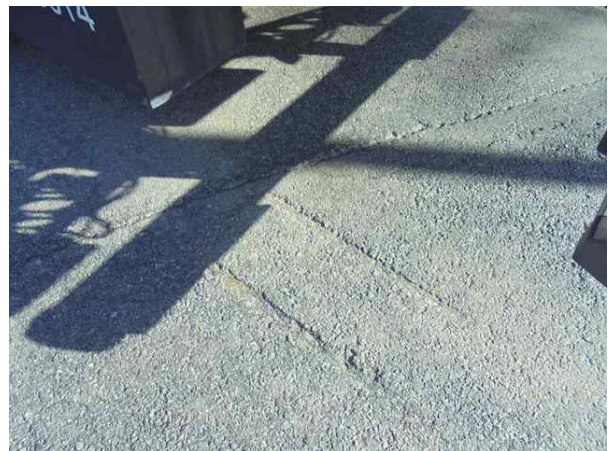
S1 접속부 굽힘 (0.1m×0.5m×2EA)

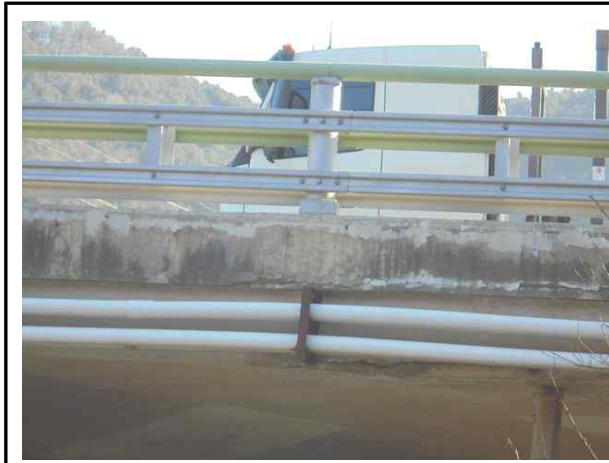
S1 외측 철근노출 (0.1m×2.0m)

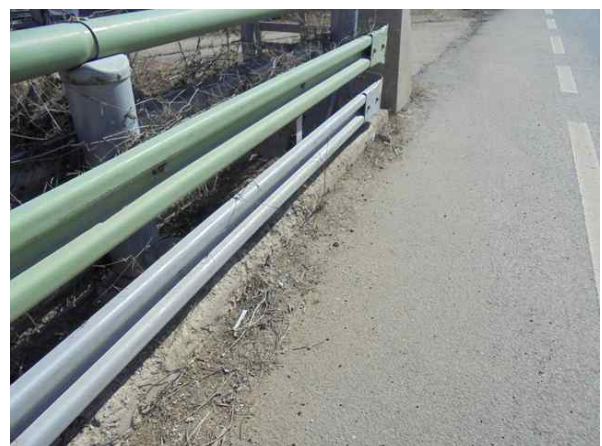
S1 접속부 연석 파손 (0.8m×0.3m)

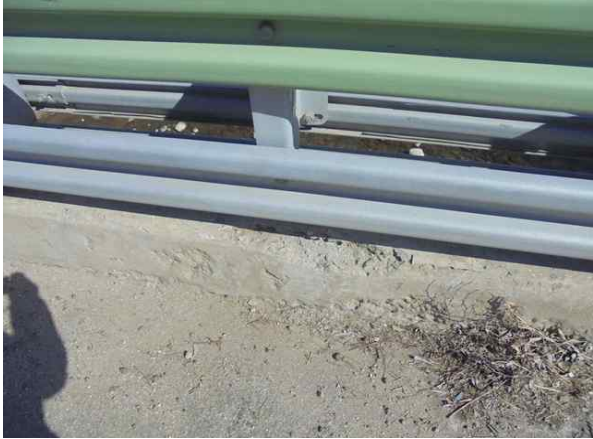
| <p>S2 연석 박락 (0.6m×0.1m×2EA)</p> | <p>S2 외측 철근노출 (0.1m×1.0m)</p> |

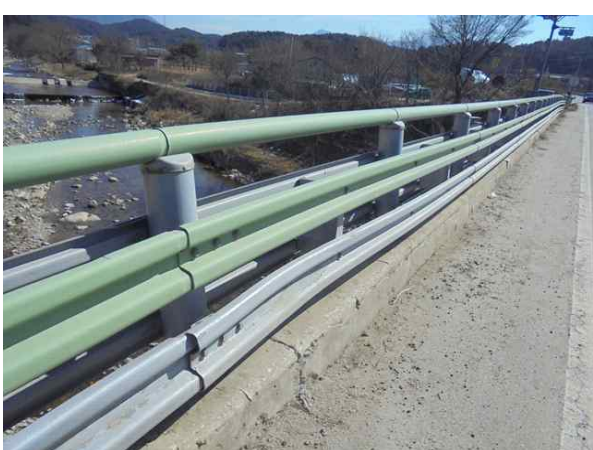
| <p>S3 난간 변형 (2.0m)</p> | <p>S3 지주파손 (1EA)</p> |

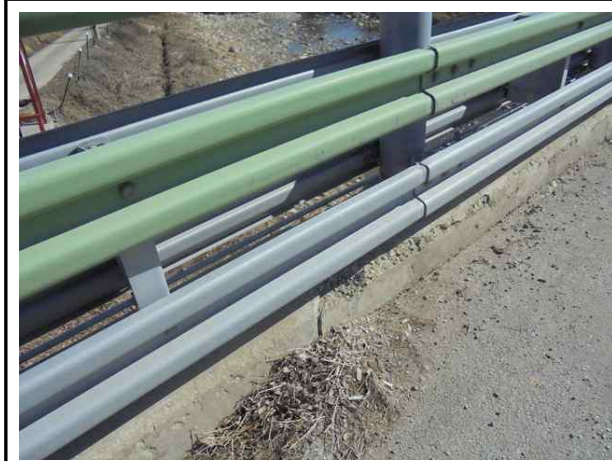
S3 연석 박락(0.2m×0.2m)

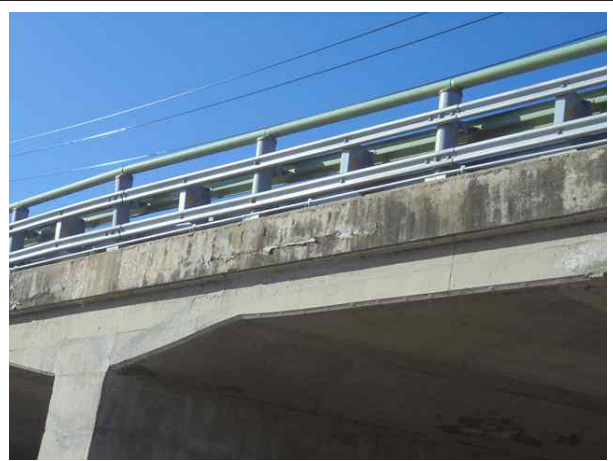
S3 외측 철근노출(0.1m×2.0m)

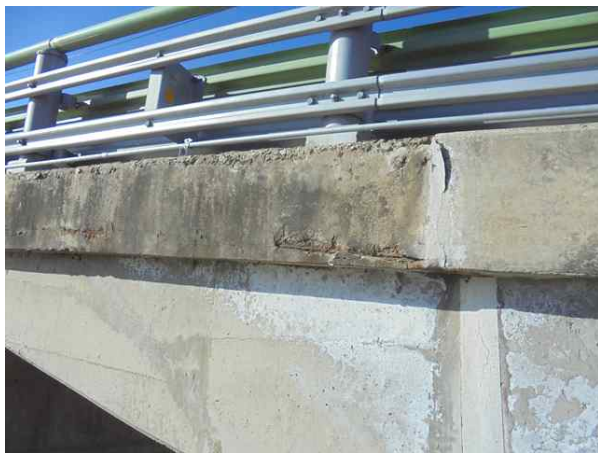
S3 외측 철근노출(0.1m×3.0m)

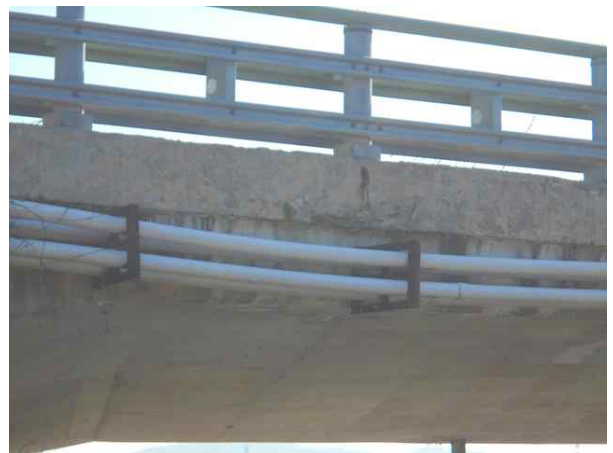
S3 외측 파손(0.2m×0.5m)

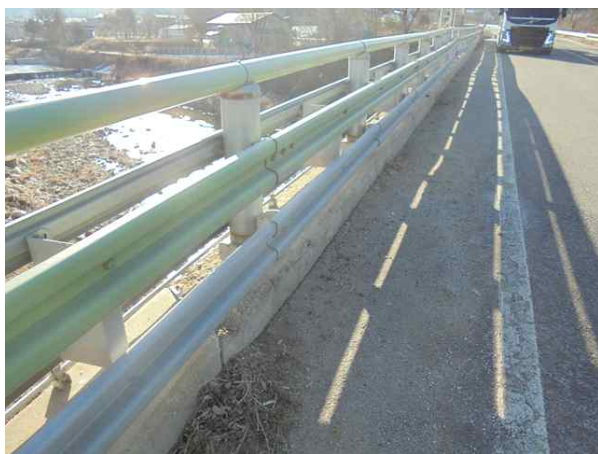
S3 연석 표면박리(0.7m×12.5m)

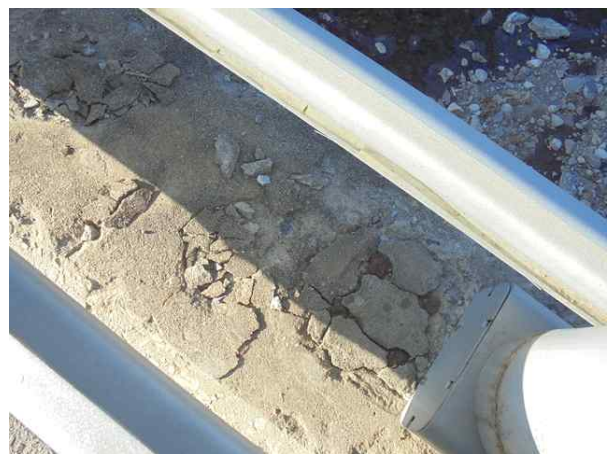
S3 연석 표면박리(0.7m×12.5m)
