### 3. 도 곡 2 교

바닥판하면 손상현황

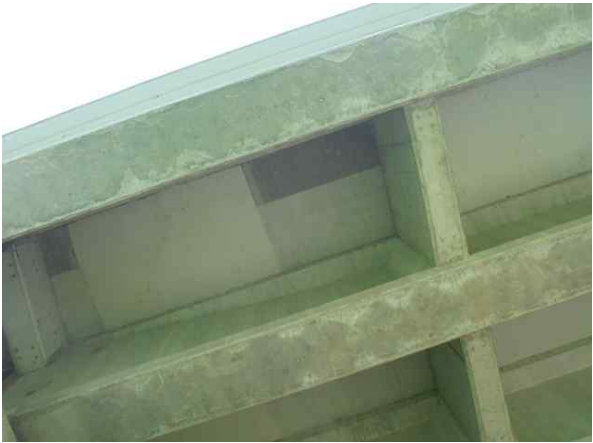
| S1 파손(0.4×0.1) | S2 망상균열(0.4×2.0) |

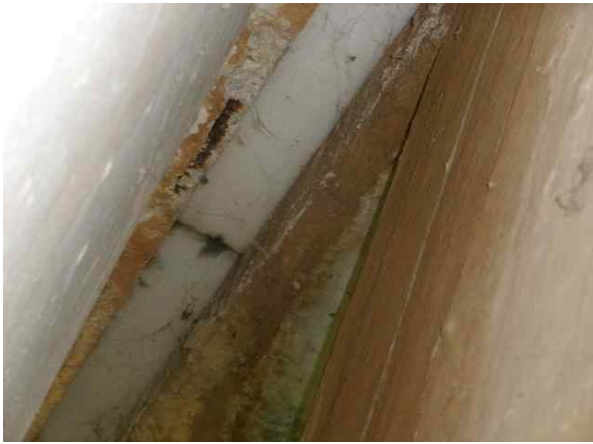
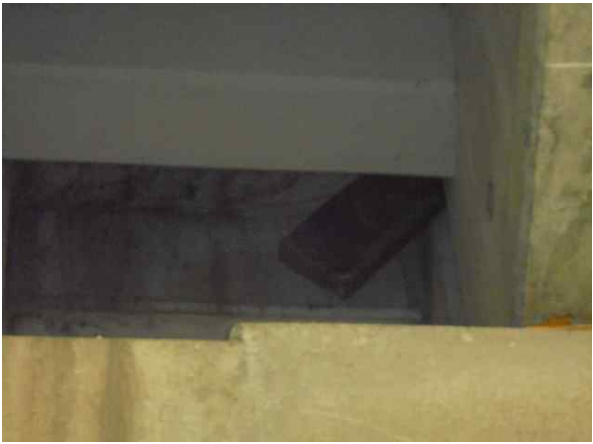
| S2 박락(0.6×0.1) | S2 백엽재 탈락 |

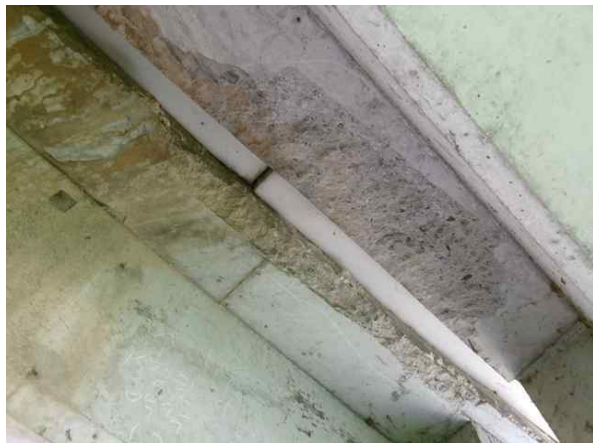
S3 파손(1.2×0.1)

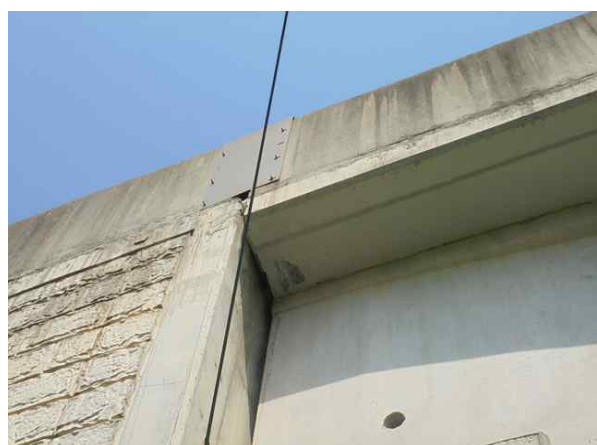
S4 보수부 박리(0.3×0.3)

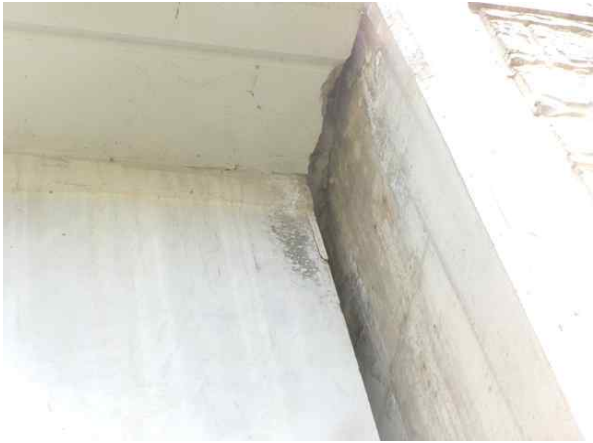
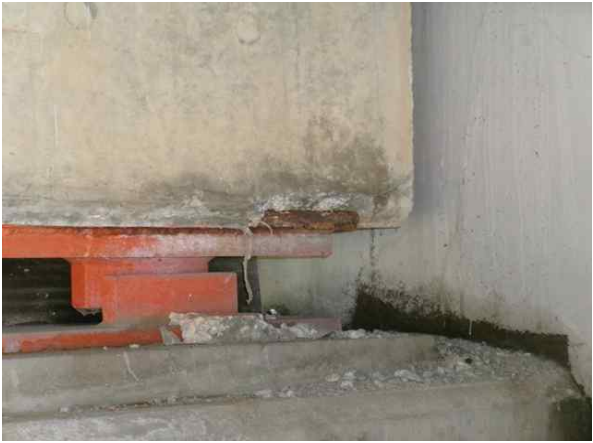
| S1-G1 박리(0.1×0.3) | S1-G1~G9 들뜸 및 박락(1.0×0.3) |

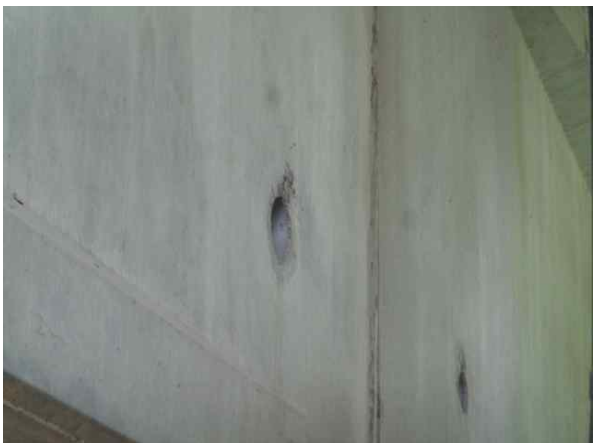
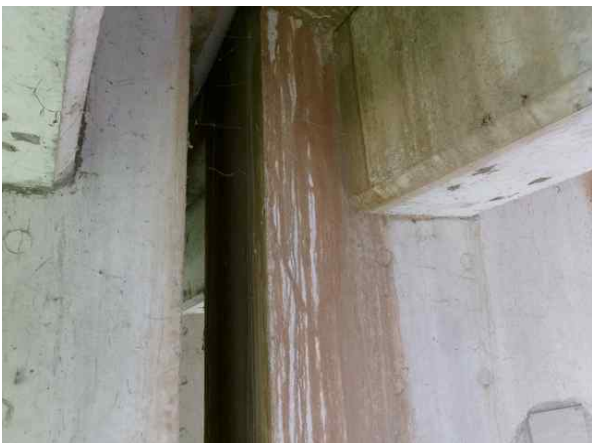
| S2-G9 인양홀 파손(0.1×0.1) | S2-G2 누수흔적(0.3×1.5) |

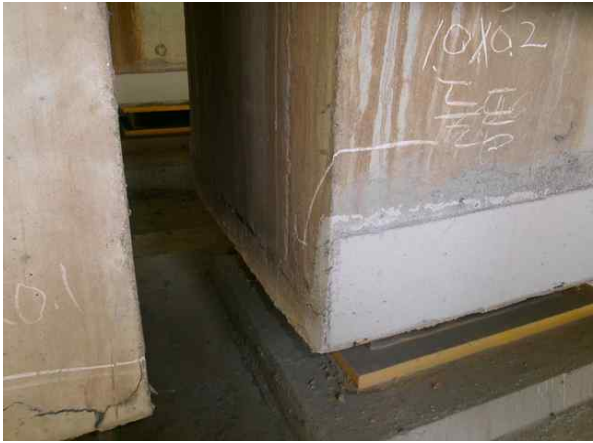
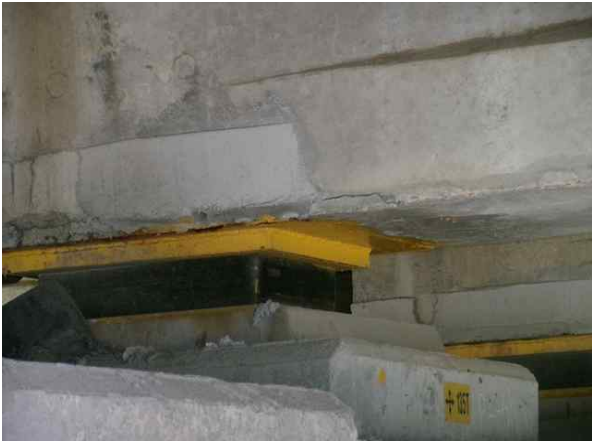
| S2-G2 들뜸(1.0×0.2) | S2-G7 보수부 박락(0.1×0.2) |

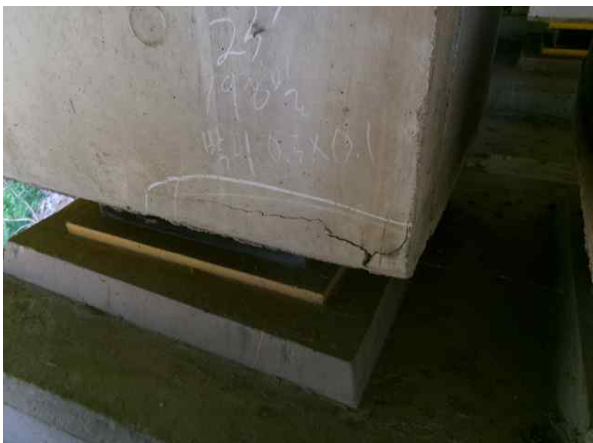
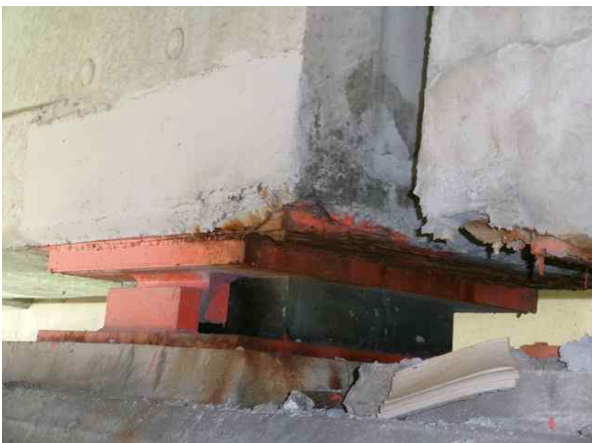
| S3-G2 박락(0.6×0.1) | S3-G5 박리(0.5×0.1) |

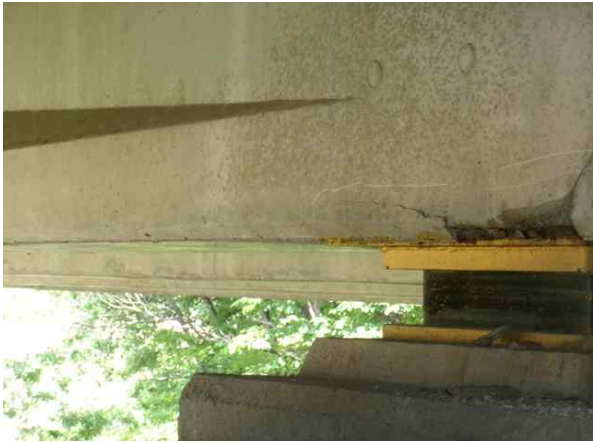
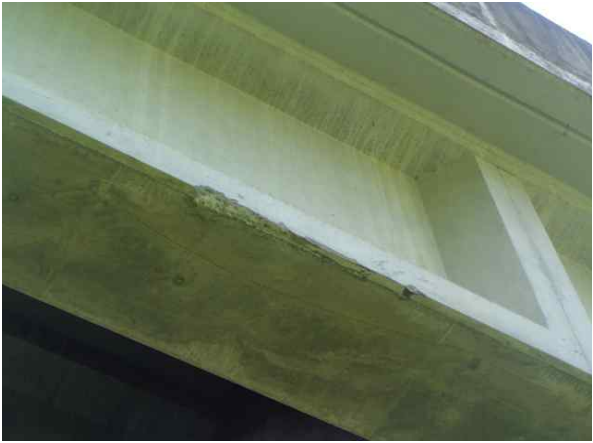
| S3-G6 박리(0.1×0.3) | S4-G9 파손(0.6×0.1) |

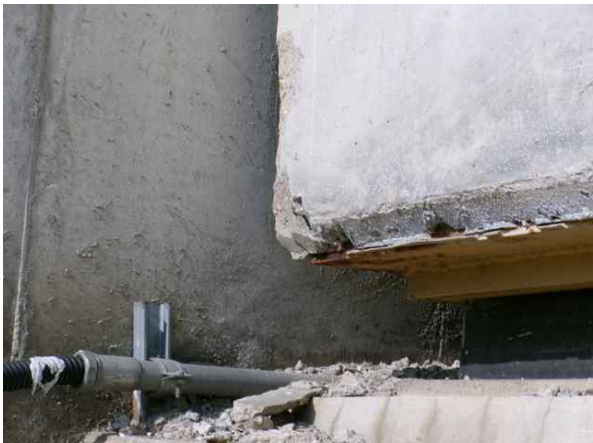
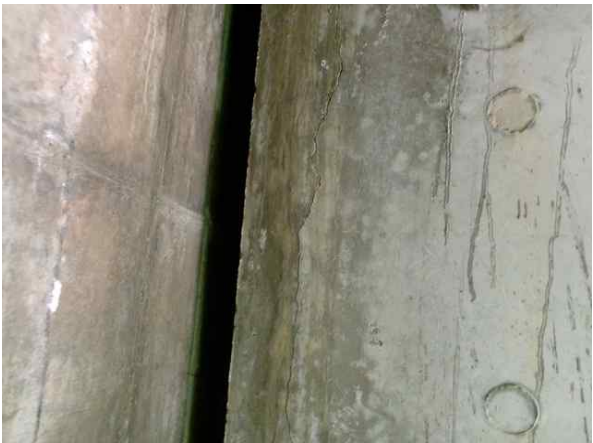
| S4-G1 박락(1.0×0.2) | S4-G5 균열(0.1mm/1.2m) |

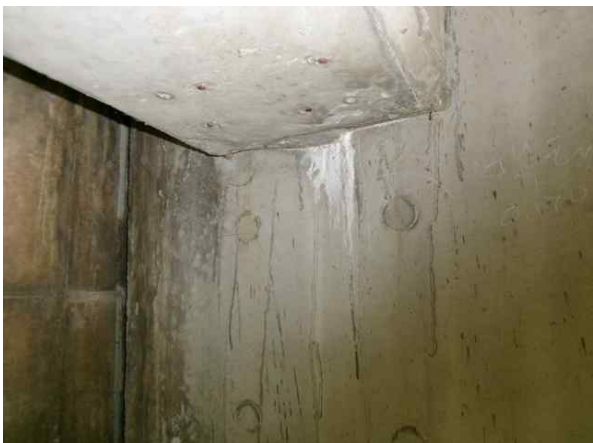
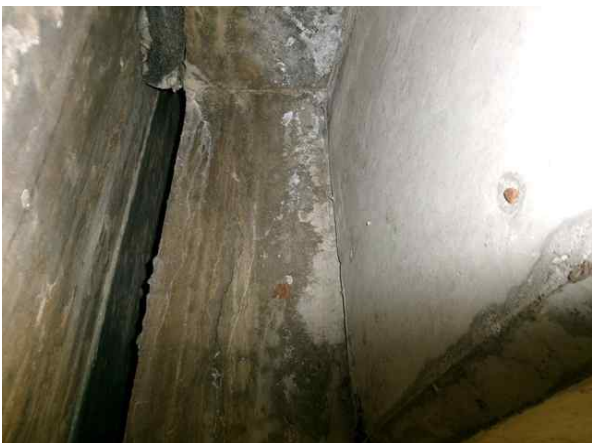
| S4-G5 백태(0.1×0.2) | S4-G5 백태(0.2×1.1) |

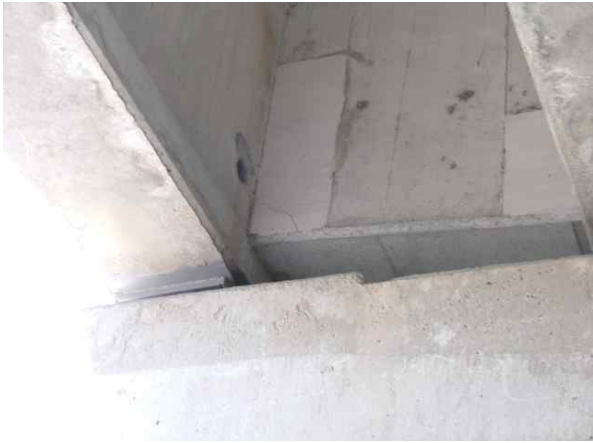
| S2 보수부 박리(0.2×0.2) | S1 균열(0.3mm/0.3m) |

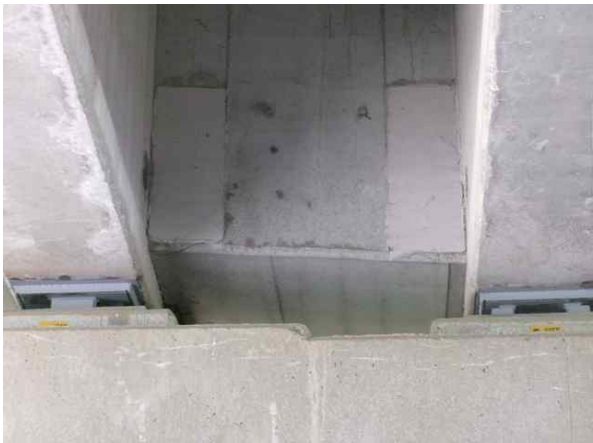
| S1 균열(0.3mm/0.3m) | S1 균열(0.3mm/0.3m) |

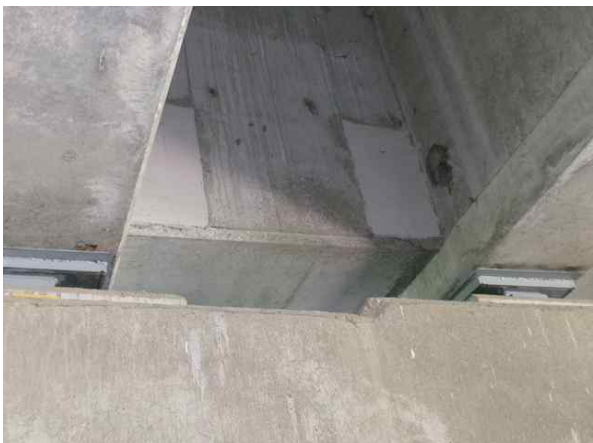
| S2 들뜸(0.2×0.3) | S2 들뜸(0.2×0.3) |

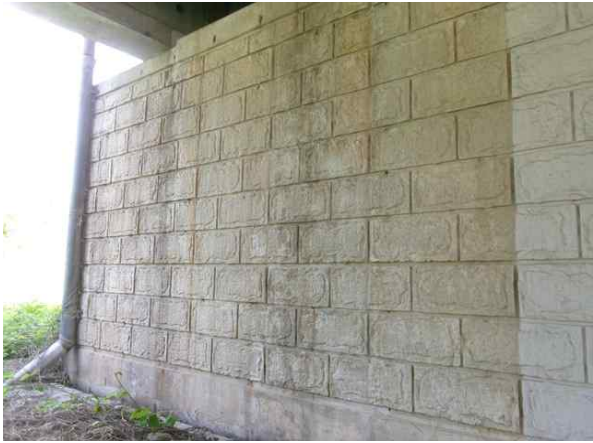
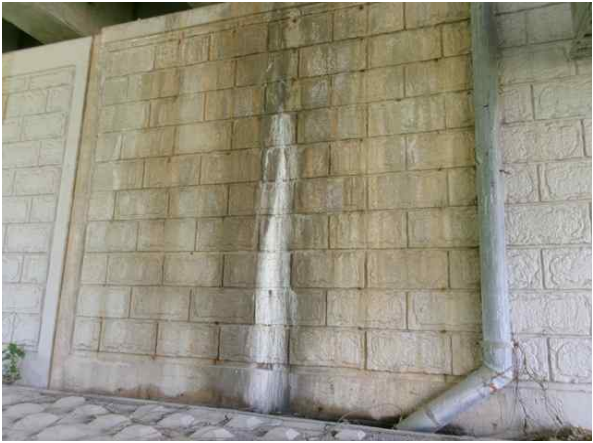
| A1 누수흔적 (0.5×2.2) | A1 백태 (0.3×2.5) |

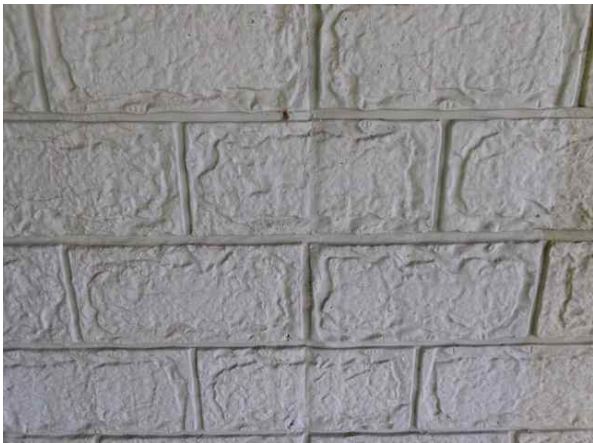
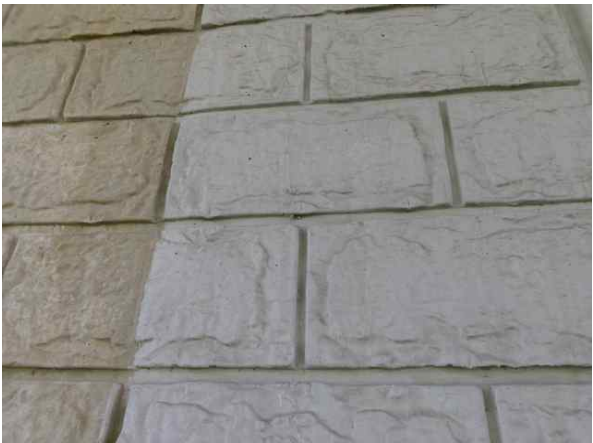
| A1 재균열 (0.1mm/4.0m) | A1 재균열 (0.2mm/3.5m) |

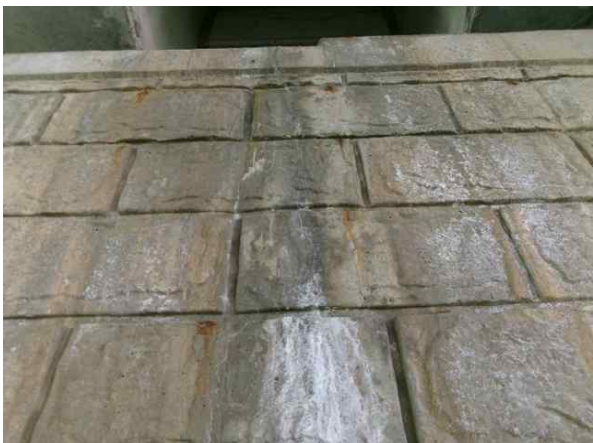
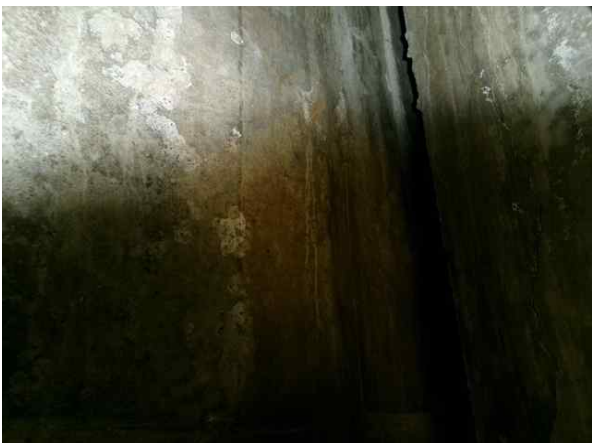
| A1 재균열 (0.3mm/3.5m) | A1 재균열 (0.3mm/0.5m) |

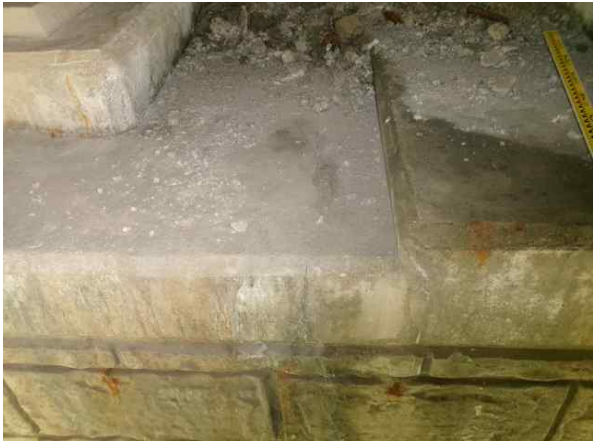
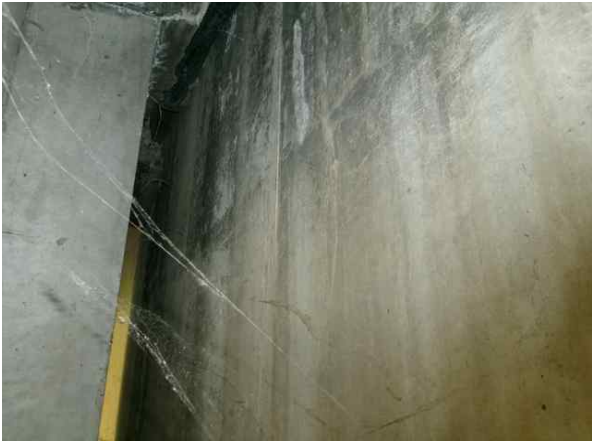
| A1 균열 (0.5mm/0.8m) | A1 누수흔적 (0.5×2.0) |

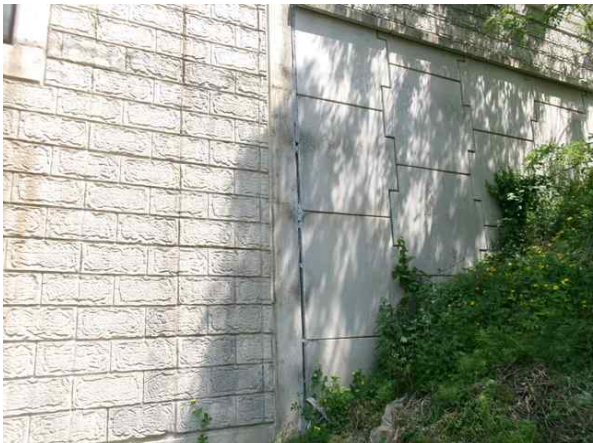
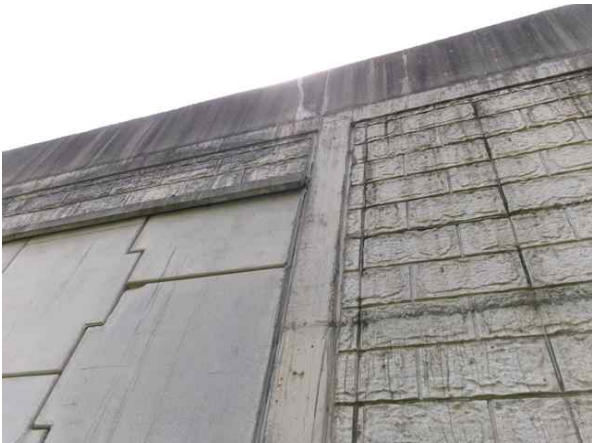
| A1 실런트 탈락 (4.0) | A1 실런트 탈락 (2.0) |

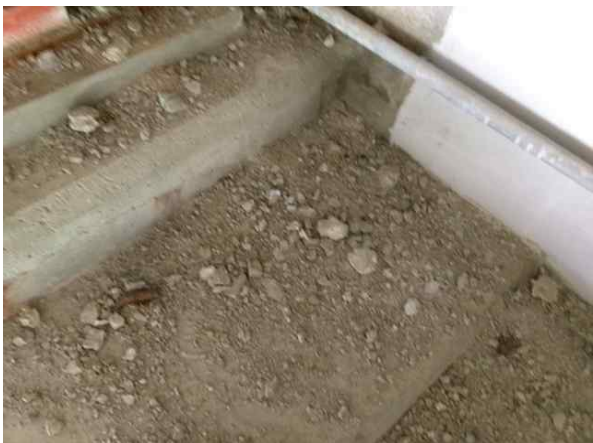
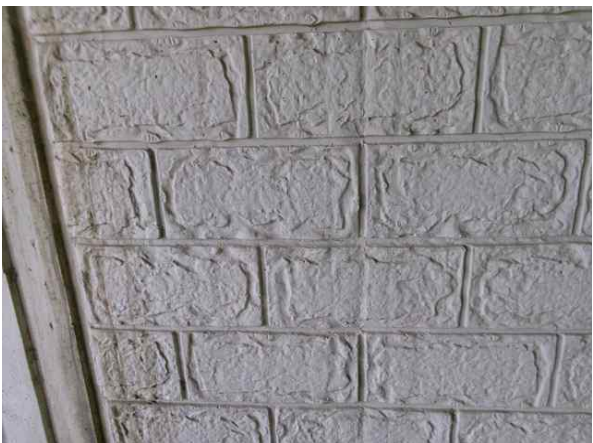
| A1 페콘크리트 적치 (1.5×1.0) | A2 균열 (0.1mm/3.0m) |

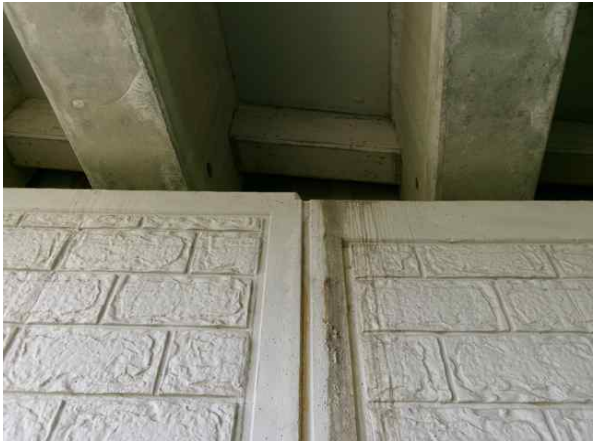
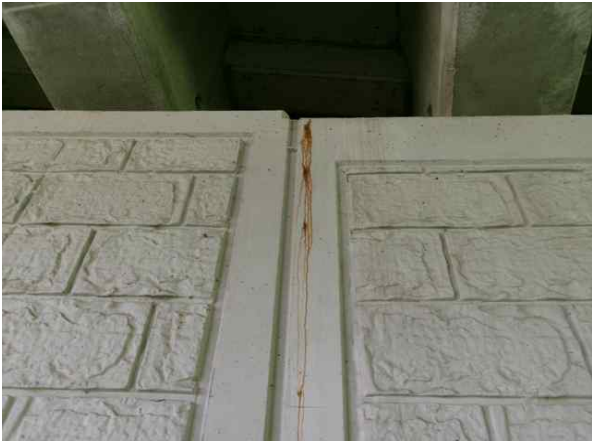
| A2 균열(0.3mm/0.5m) | A2 녹오염(0.1×3.0) |

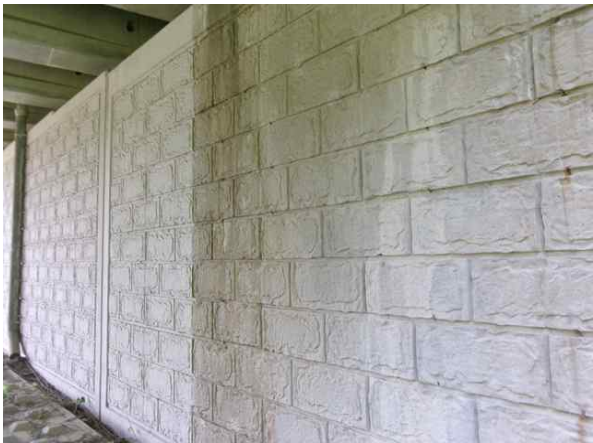
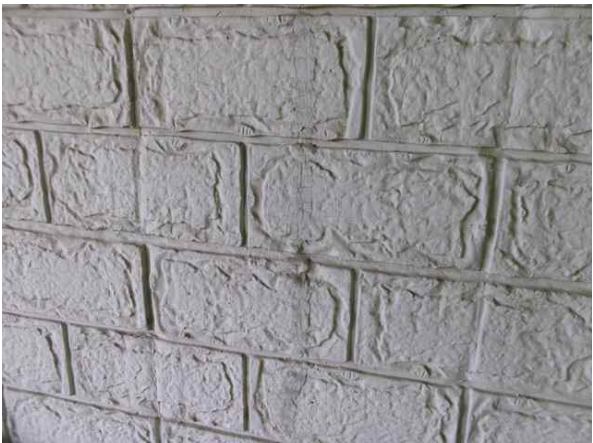
| A2 누수흔적(0.5×3.5) | A1 망상균열(0.1×4.0) |

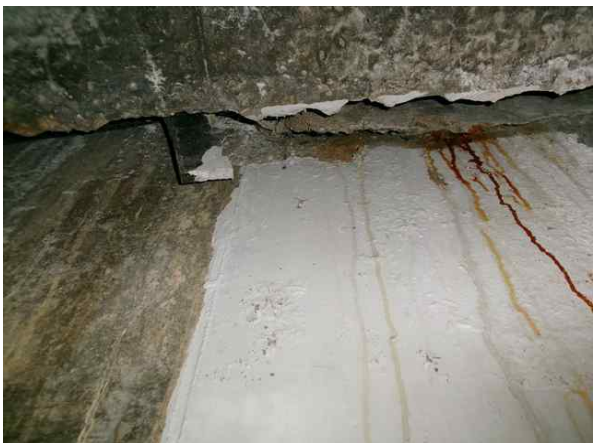
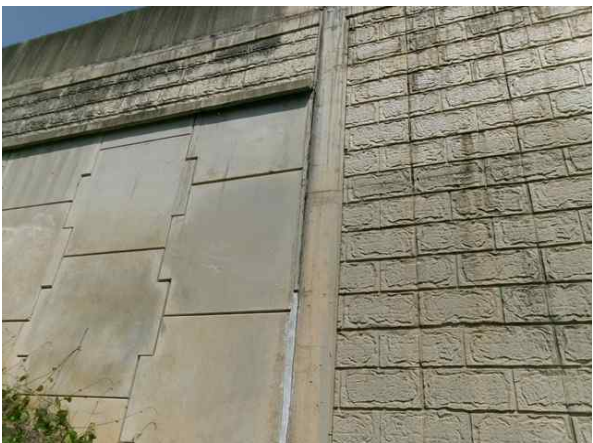
| A2 박락(0.6×0.2) | A1 실런트 탈락(1.5) |

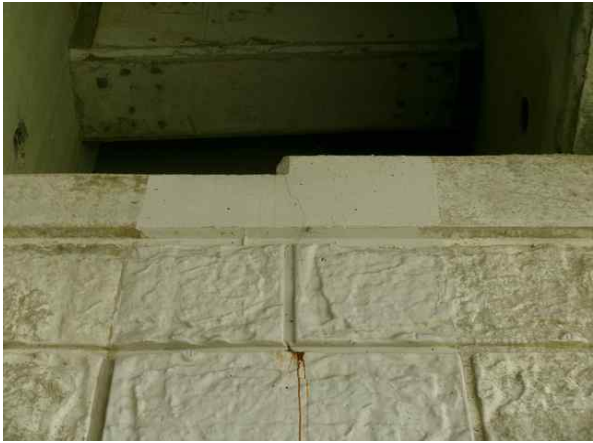
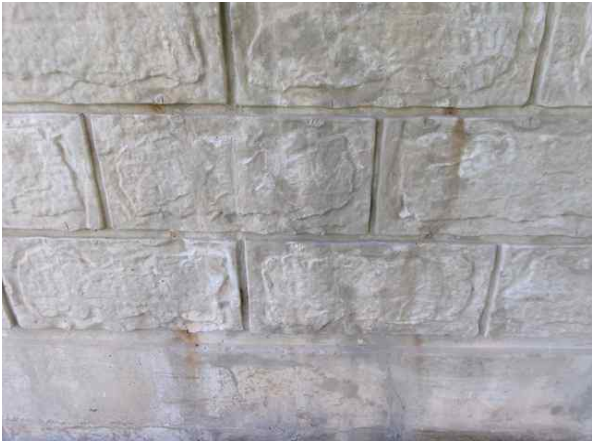
| A1 균열 (0.2mm/0.5m) | A1 균열 (0.2mm/1.5m) |

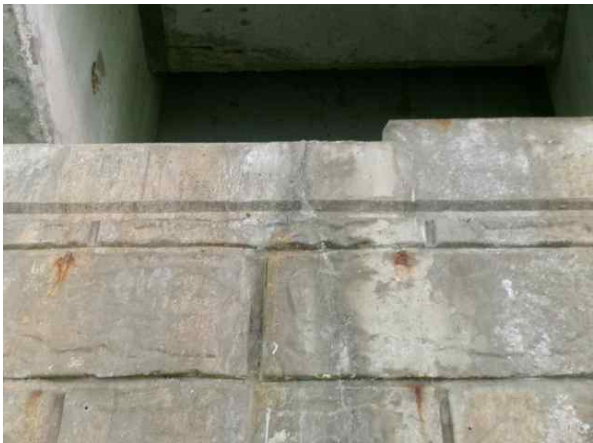
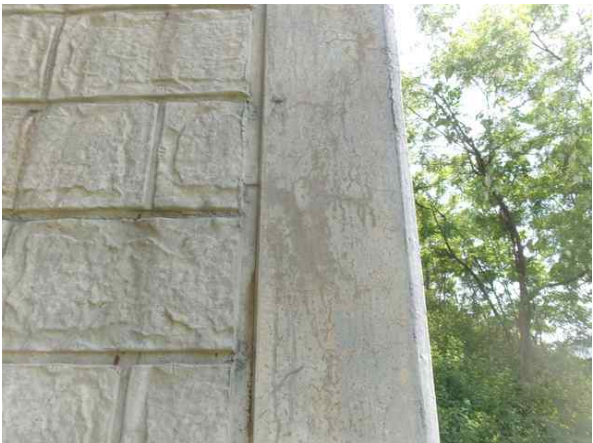
| A1 균열 (0.3mm/0.5m) | A1 망상균열 (0.4×1.3) |

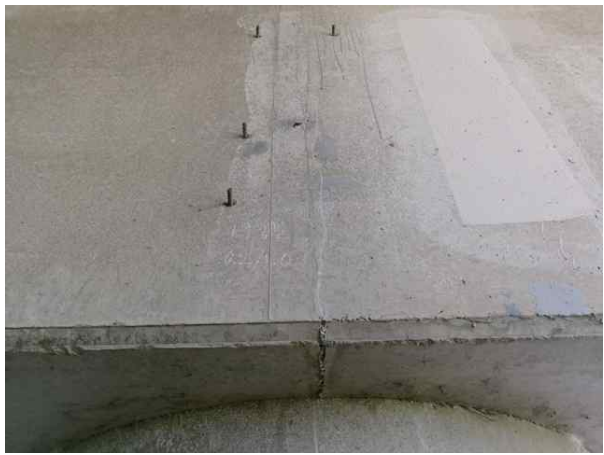
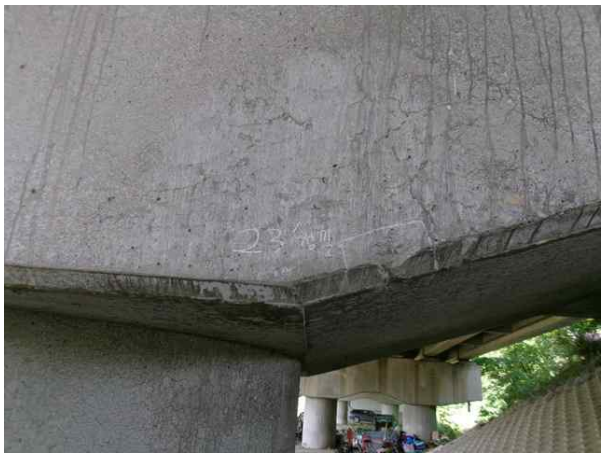
| P1 균열 (0.2mm/1.0m) | P1 파손 (0.1×0.1) |

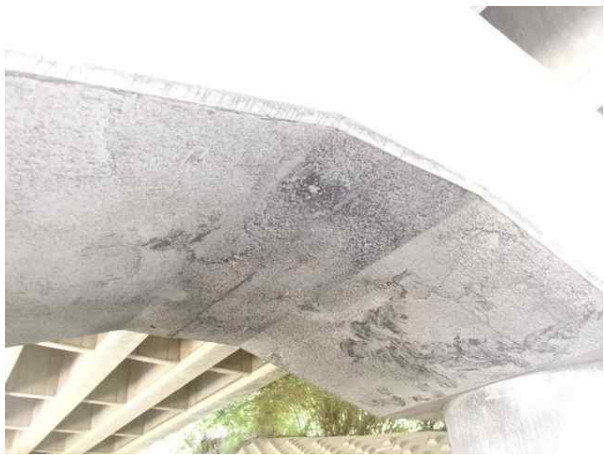
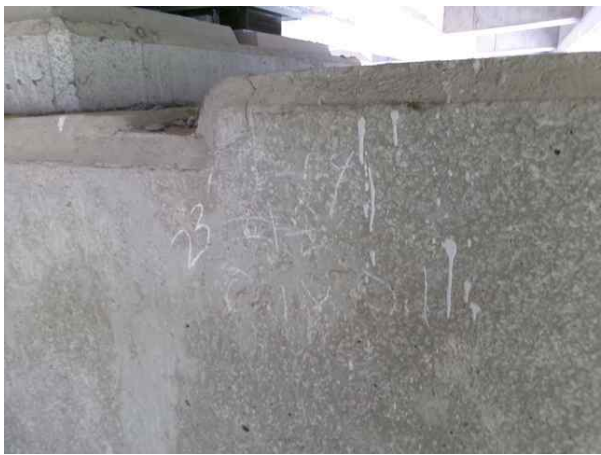
| P1 표면오염 (2.5×3.0) | P1 파손 (0.1×0.1) |

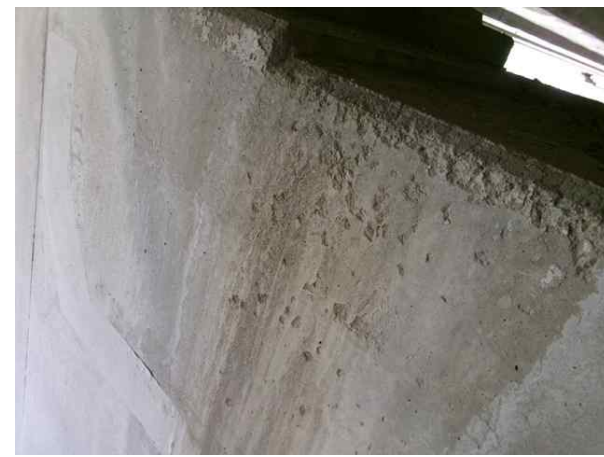
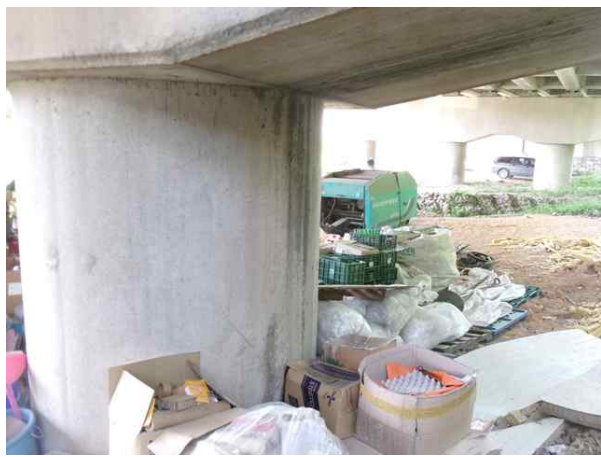
| P1 균열 (0.2mm/0.7m) | P2 누수흔적 (1.0×3.0) |

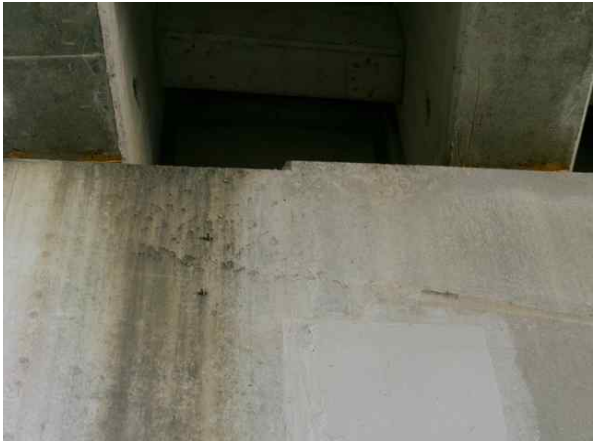
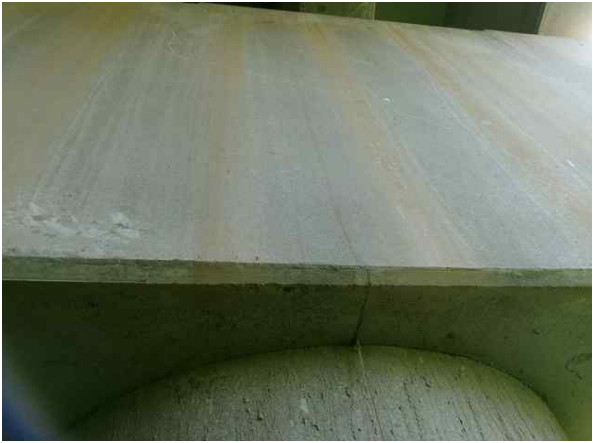
| P2 균열 (0.2mm/0.8m) | P2 균열 (0.2mm/1.0m) |

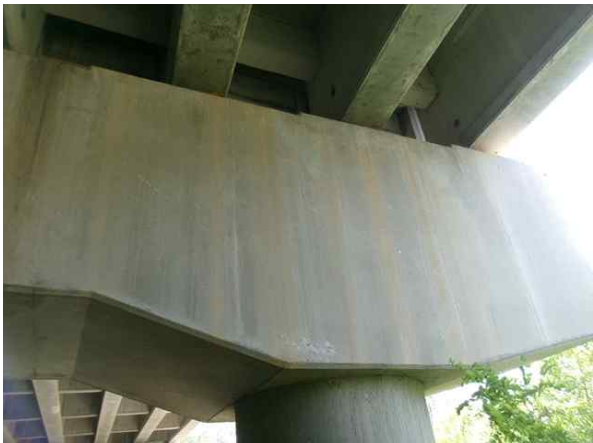
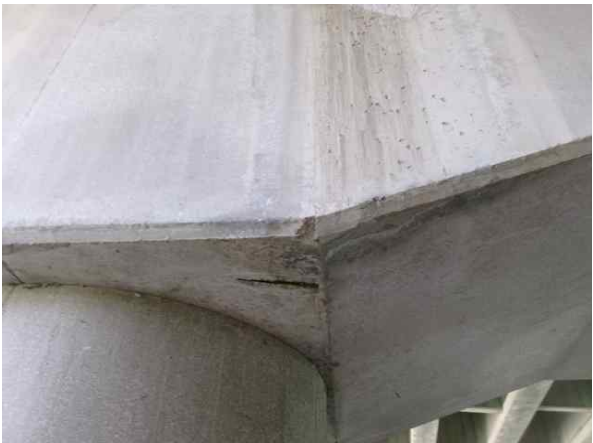
| P2 누수흔적 (0.2×2.0) | P2 박락 (0.1×0.1) |

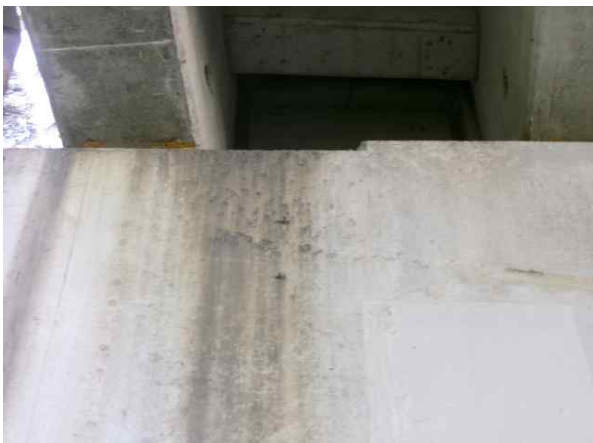
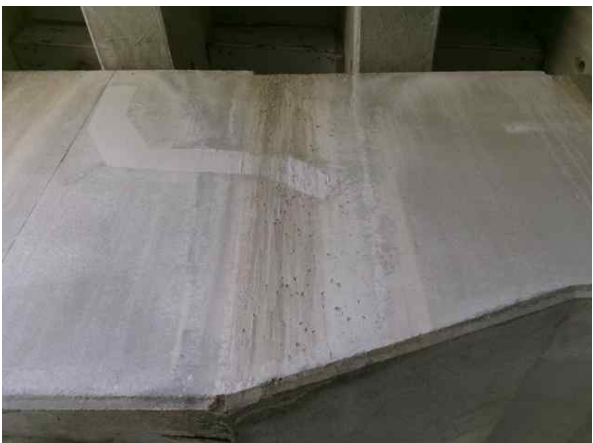
| P2 박리 (0.1×0.1) | P2 박리 (1.0×2.5) |

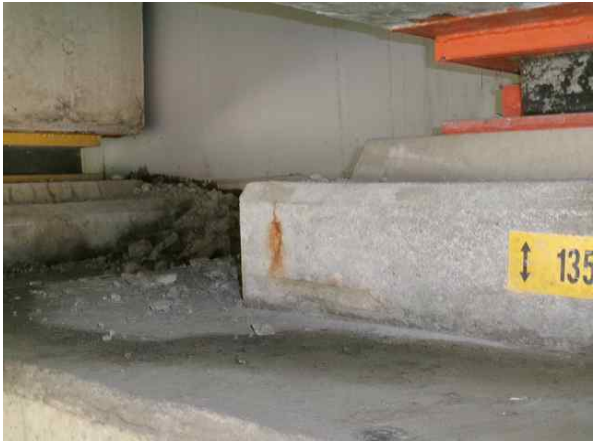
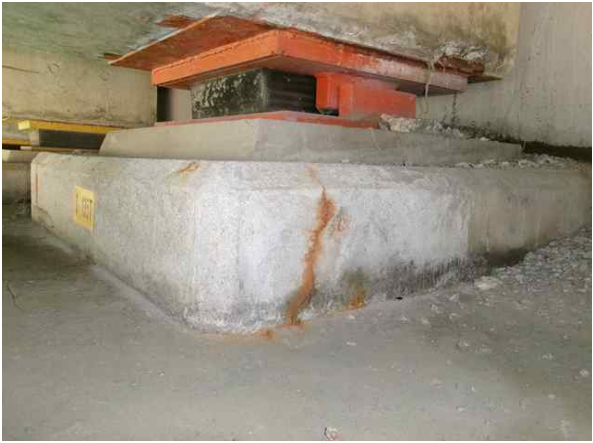
| A1-SH5 받침콘크리트 파손(1.0×0.5) | A1-SH5 받침콘크리트 파손(1.0×0.5) |

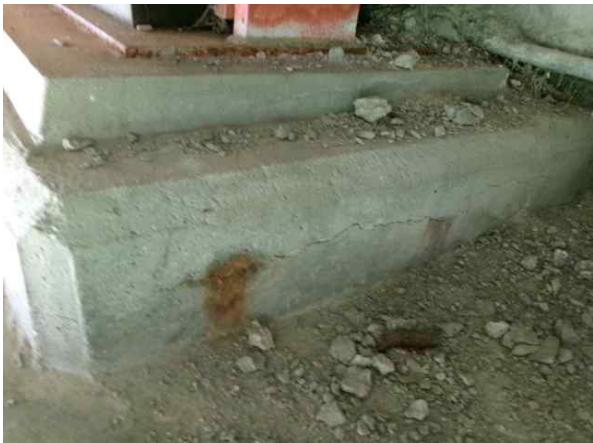
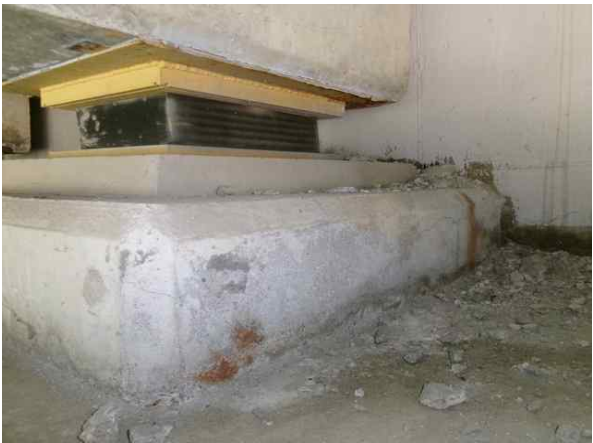
| A1-SH5 받침콘크리트 균열(0.3mm/0.4m) | A1-SH6 받침콘크리트 균열(0.3mm/1.0m) |

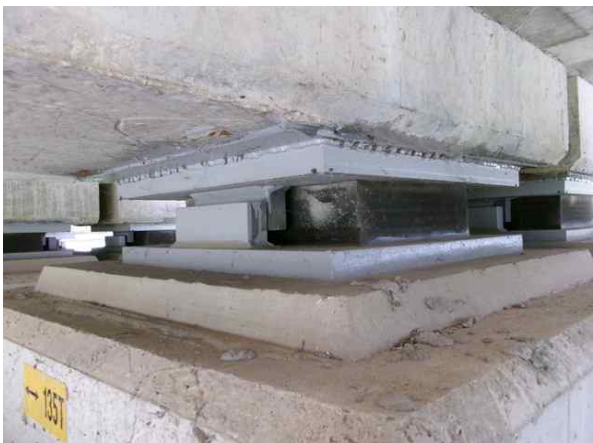
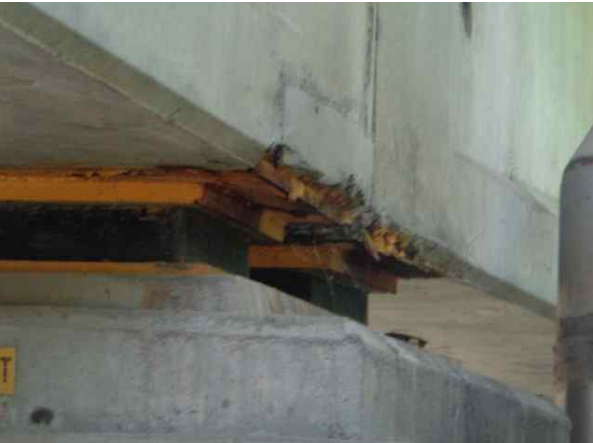
| P3-SH11 플레이트 부식 보수 | P2-SH9,18 플레이트 부식 |

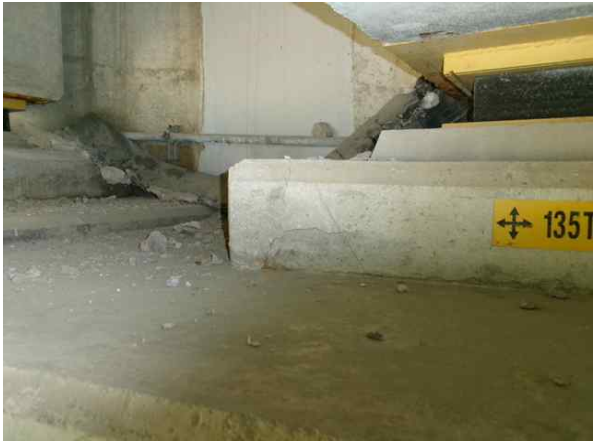
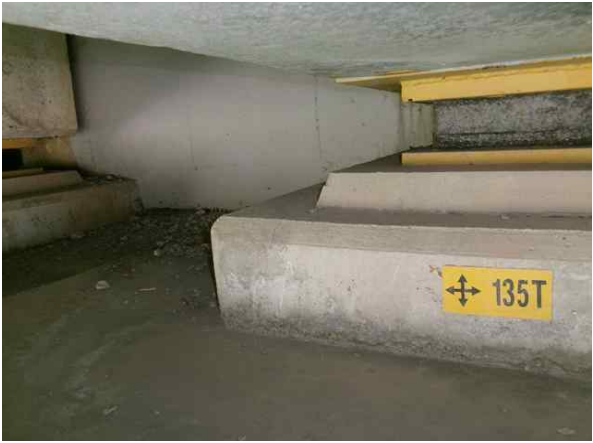
| A1-SH3 받침콘크리트 균열(0.3mm/0.4m) | A1-SH3 받침콘크리트 균열(0.3mm/0.5m) |

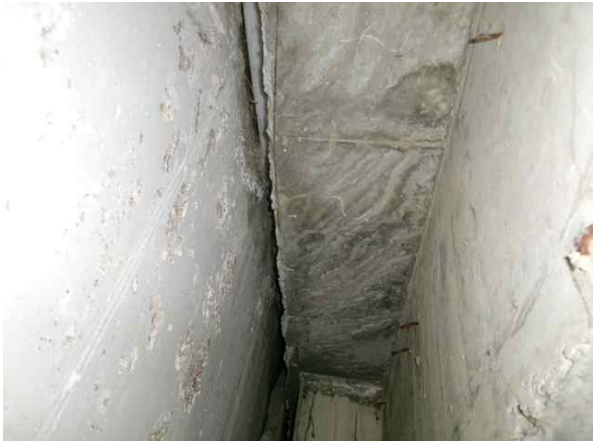
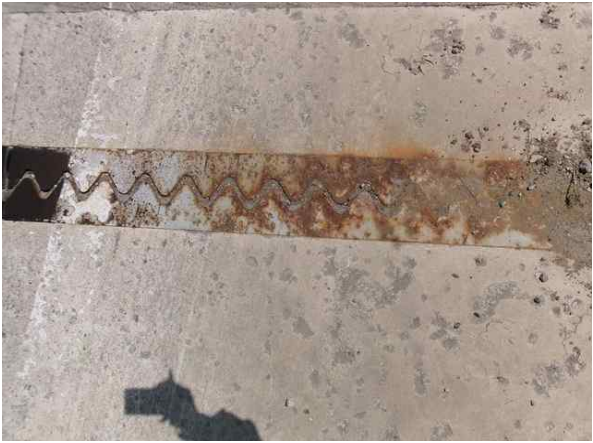
| A1 신축이음 하부누수(0.5×2.0) | A2 본체부식(0.2×1.2) |

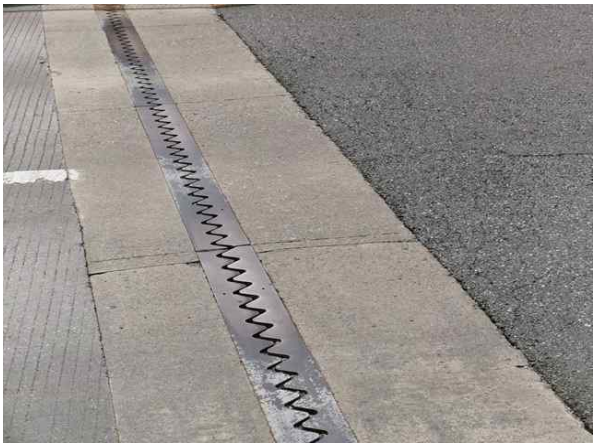
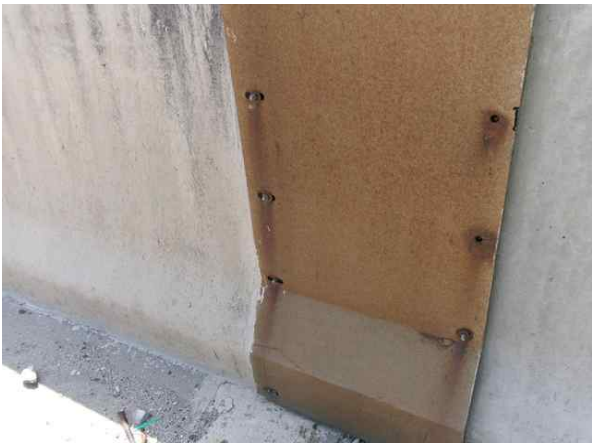
| A2 유간 토사퇴적(1.9) | A2 차수판 볼트탈락 |

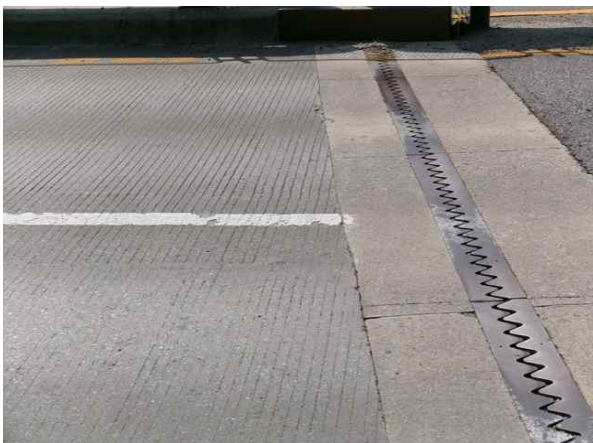
| A2 후타재 균열(0.1mm/0.6m) | A2 후타재 균열(0.3mm/0.6m) |
