역 동 교

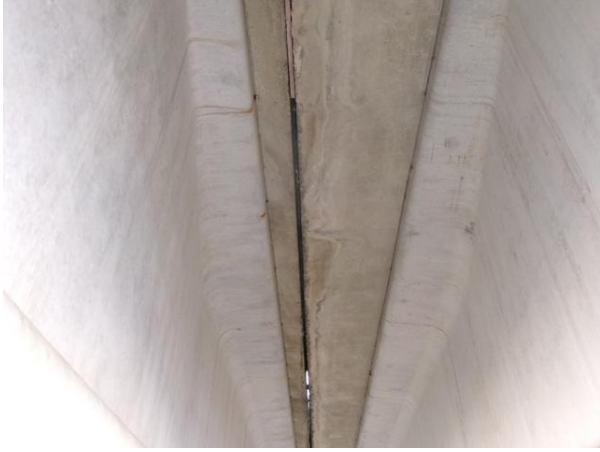
| <p>역동교 바닥판하면 S1 중조인트부 박리 45.0*0.1</p> | <p>역동교 바닥판하면 S1-A1 박리 0.2*0.5</p> |

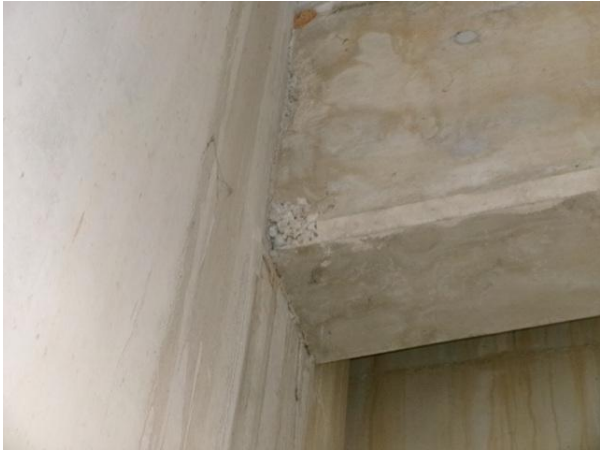
| <p>역동교 가로보 S1-G6~7 재료분리 0.2*0.2</p> | <p>역동교 가로보 S1-G7~8 재료분리 0.2*0.2</p> |

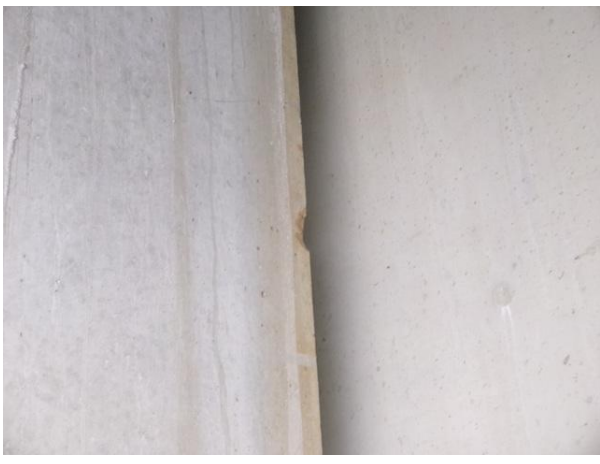
| <p>역동교 거더 S1-G4(A1) 파손 0.1*0.1</p> | |

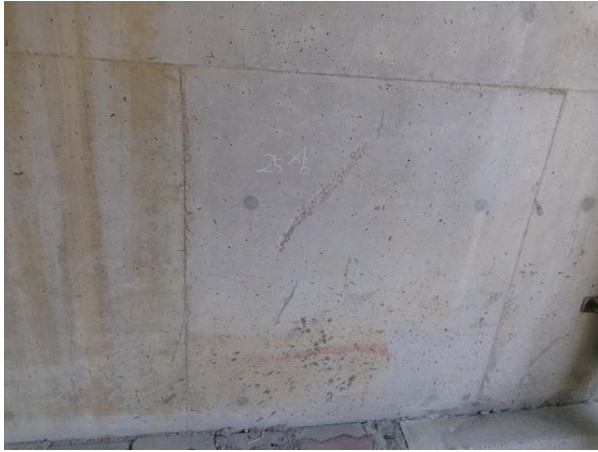
역동교 교대 A1 구체 긁힘 0.3\*0.5

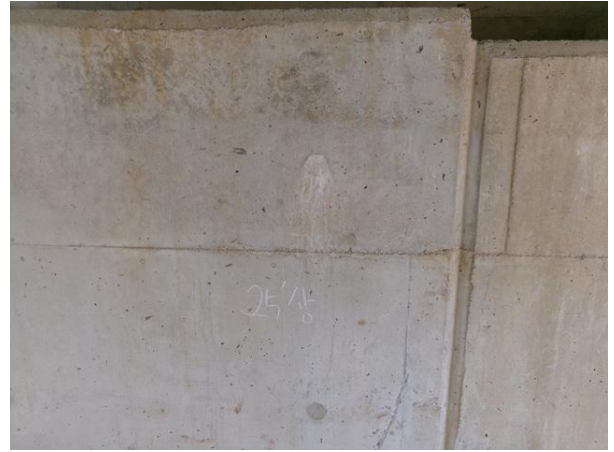
역동교 교대 A1 구체 백태 0.1\*0.1

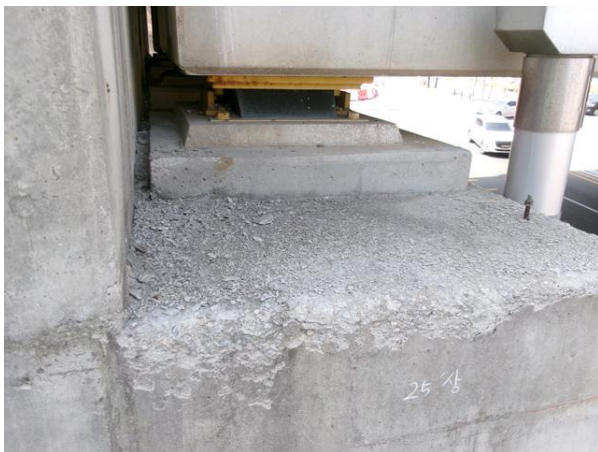
역동교 교대 A1 구체 상면 박리 1.0\*1.5

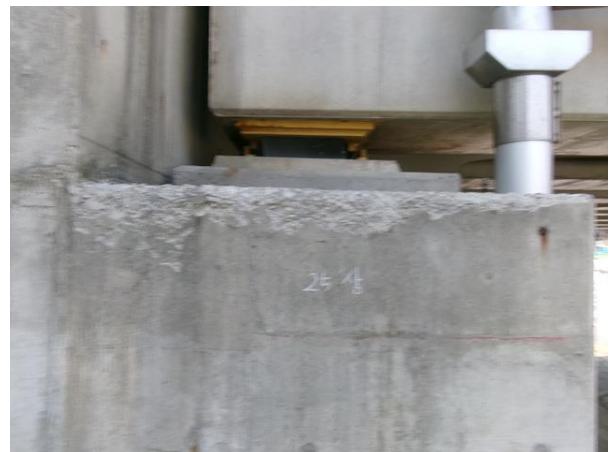
역동교 교대 A1 구체 좌측 박리 1.5\*0.3 - 사진 흔들렸네;;

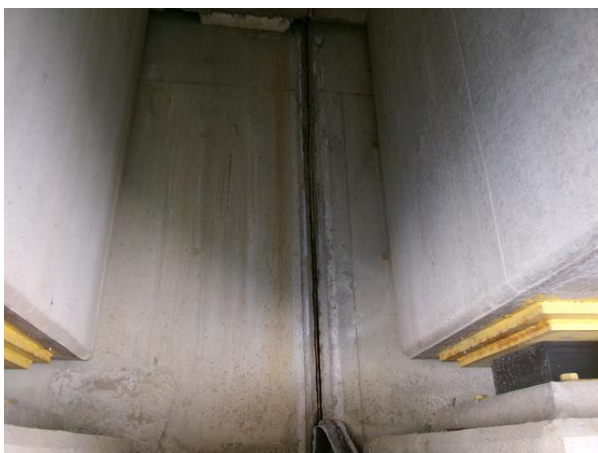
역동교 교대 A1 실란트 파손 5.0m

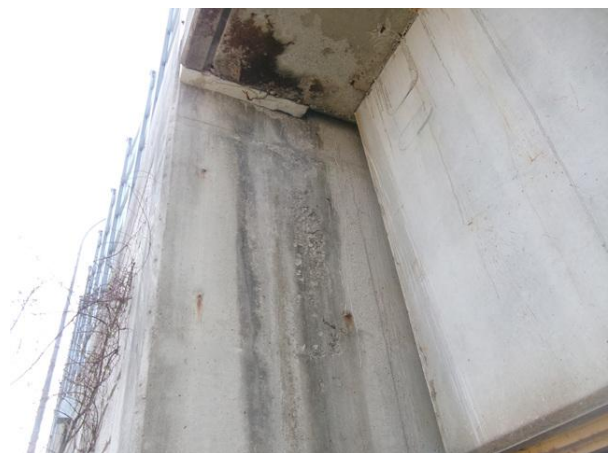
역동교 교대 A1 흉벽 박리 0.4\*1.0

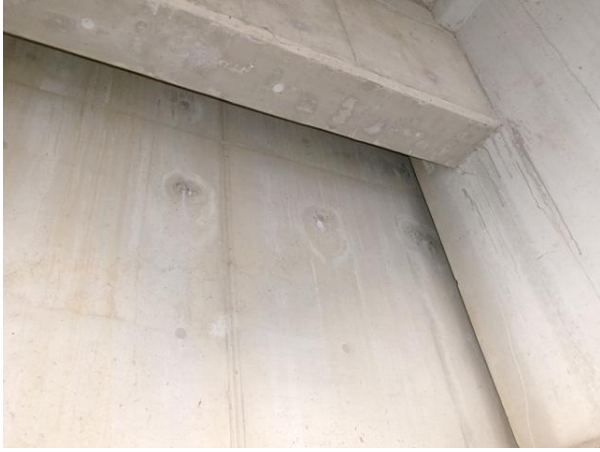
| <p>역동교 교대 A1 흉벽 백태 0.1*0.1*3EA</p> | <p>역동교 교대 A2 구체 망상균열 1.5*1.0</p> |

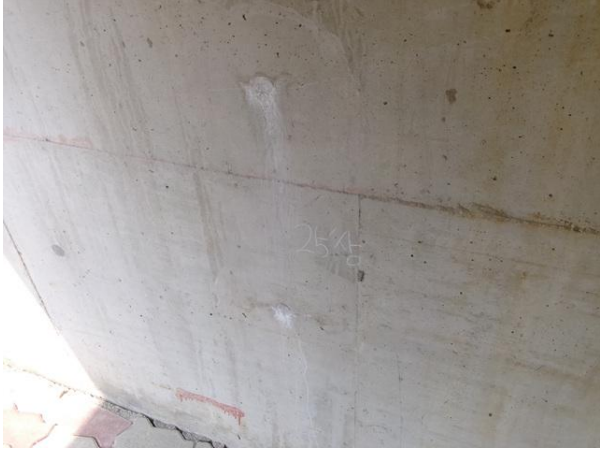
| <p>역동교 교대 A2 구체 백태 0.1*0.2*2EA</p> | <p>역동교 교대 A2 실란트 파손 5.0m</p> |

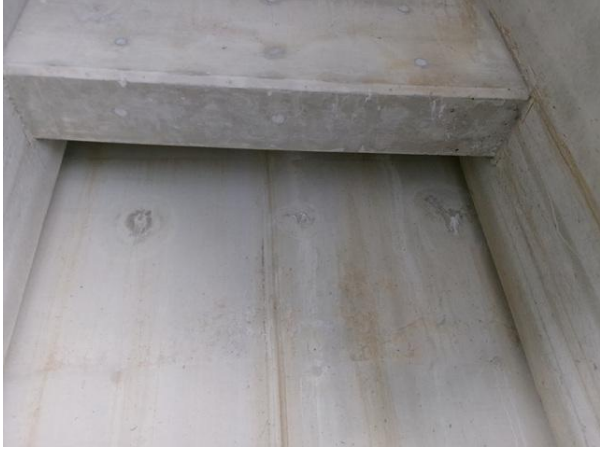
| <p>역동교 교대 A2 흉벽 백태 0.1*0.1*3EA</p> | <p>역동교 교대 A2 흉벽 백태 0.1*0.2</p> |

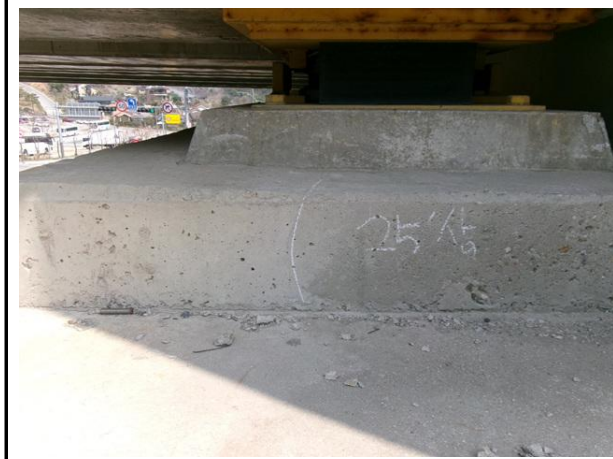
역동교 교량받침 A1-SH4 받침콘크리트 균열  
0.1/0.3

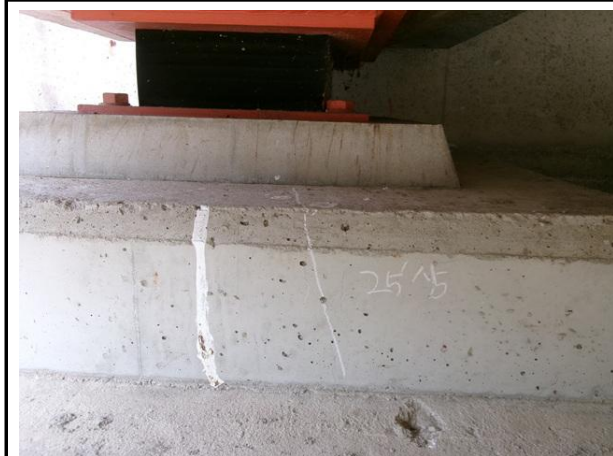
역동교 교량받침 A2-SH1 받침콘크리트 균열  
0.1/0.3

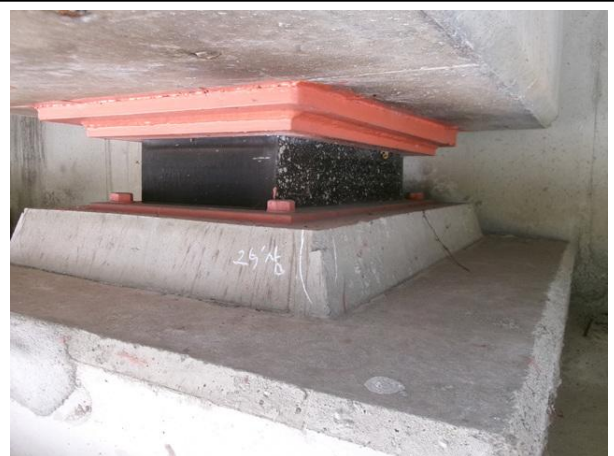
역동교 교량받침 A2-SH3 무수축물탈 박락 0.1\*0.1

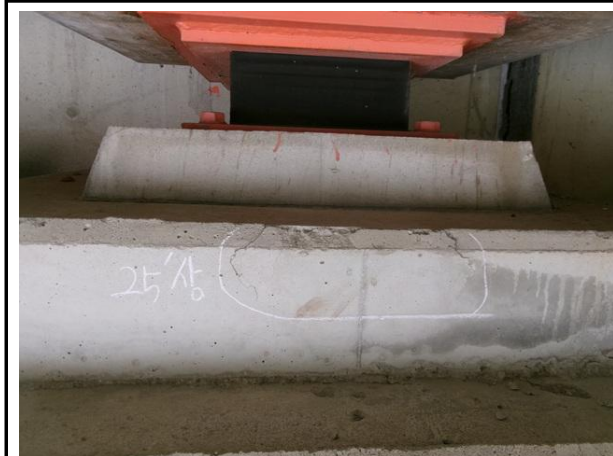
역동교 교량받침 A2-SH4 받침콘크리트 충분리  
0.3\*0.1

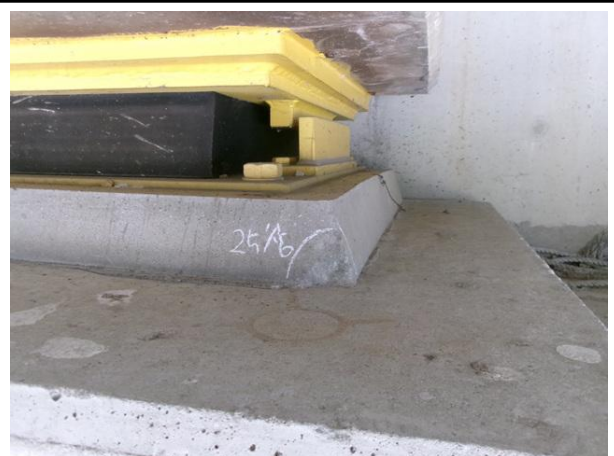
역동교 교량받침 A2-SH7 무수축물탈 파손 0.1\*0.1

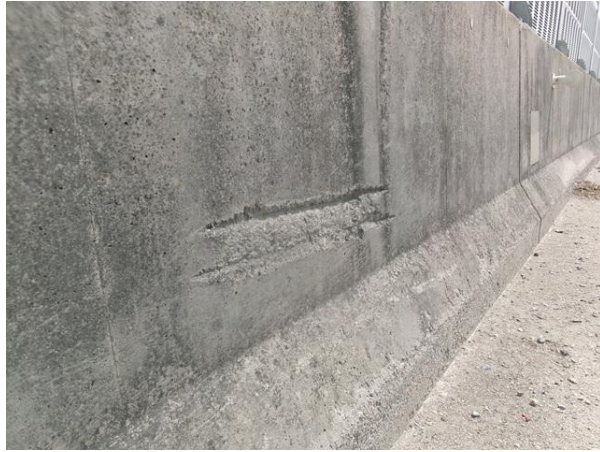
역동교 수원방향 방호벽 S1 긁힘 0.2\*0.8\_신규

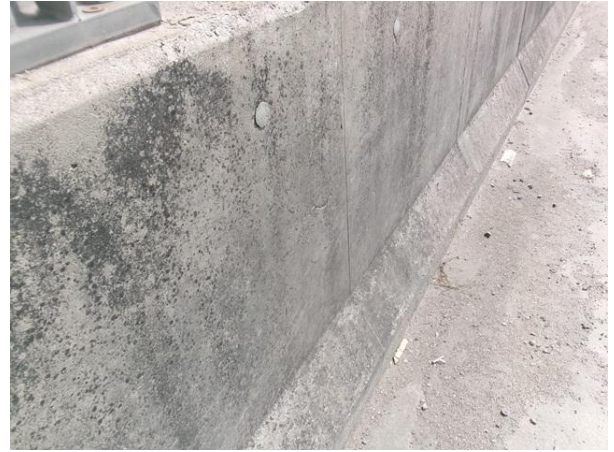
역동교 수원방향 방호벽 S1 박리 0.3\*0.3\_신규

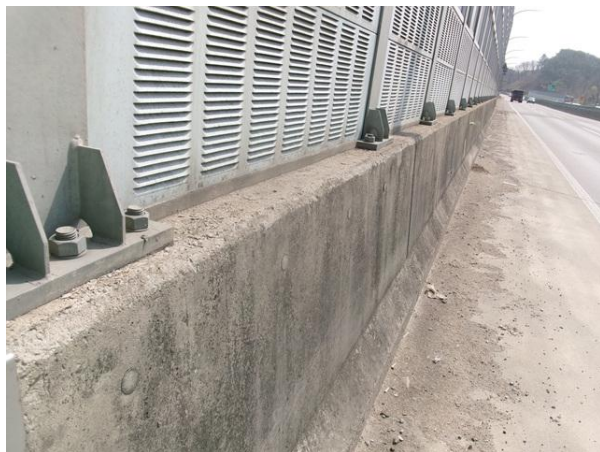
역동교 수원방향 방호벽 S1 열화 1.0\*45.0\_신규

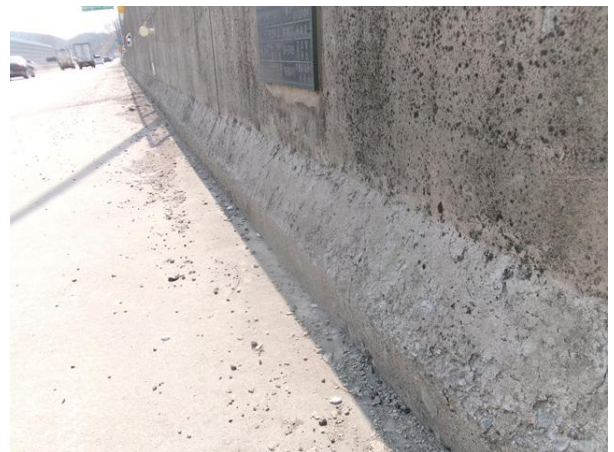
역동교 이천방향 방호벽 S1 박리(열화) 0.3\*45.0

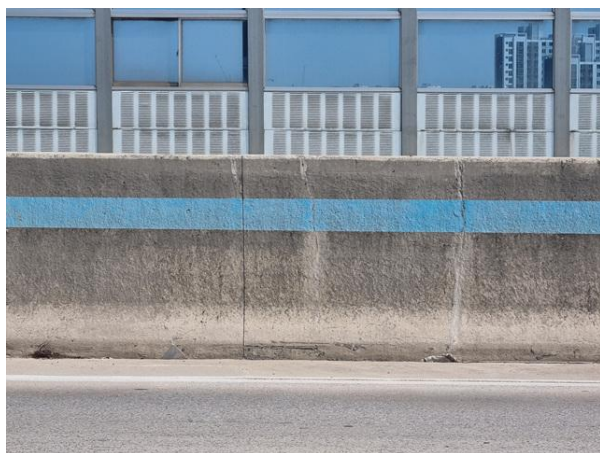
역동교 이천방향 방호벽 S1 중분대 균열  
0.3/1.0\*3EA\_신규

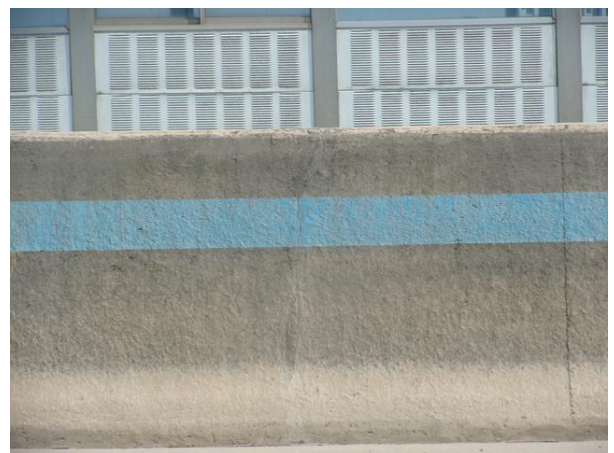
역동교 이천방향 방호벽 S1 중분대 균열  
0.3/1.5\_신규
