신기교

## 바닥판하면 손상현황

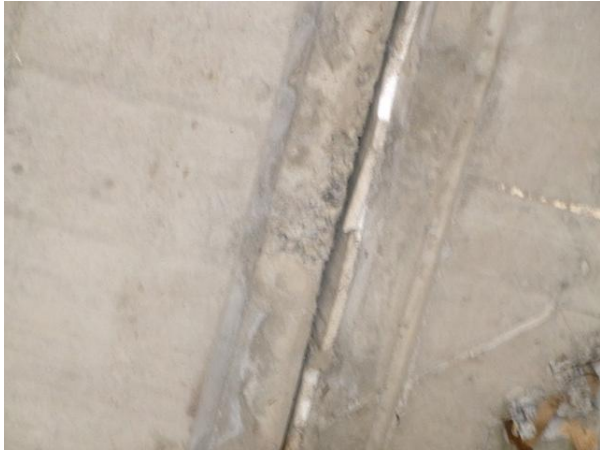
신기교 바닥판하면 S1-A1 재료분리 0.1\*0.2

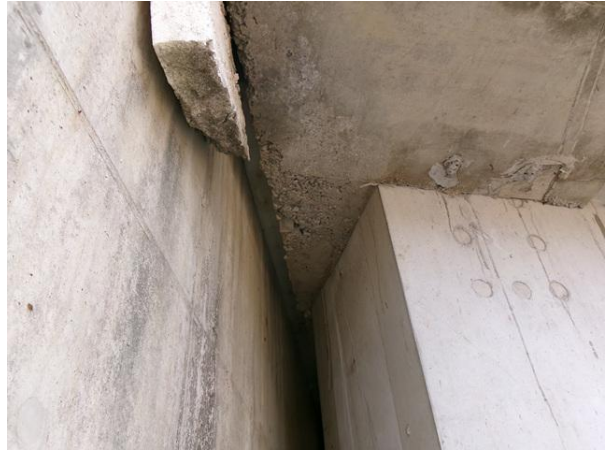
신기교 바닥판하면 S1-A1 재료분리 0.3\*0.4

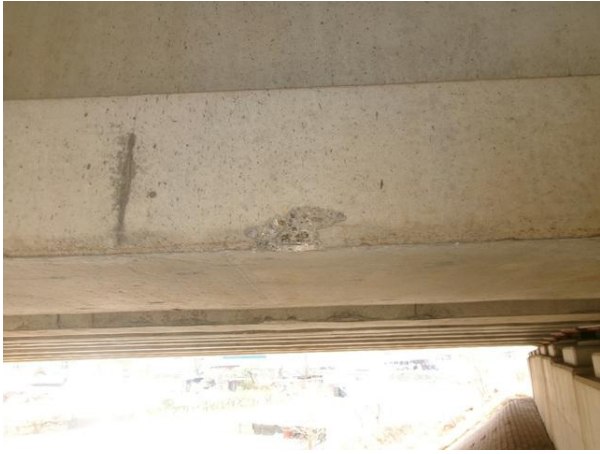
| <p>신기교 거더 S1-G09 박락 0.1*0.1 -신규-</p> | |

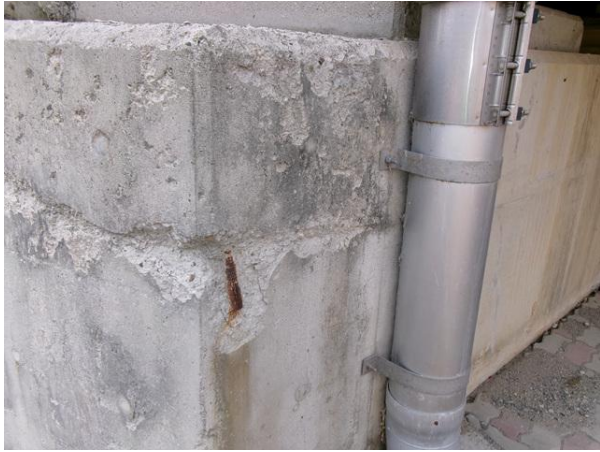
신기교 교대 A1 구체 박리 및 철근노출 0.5\*0.5

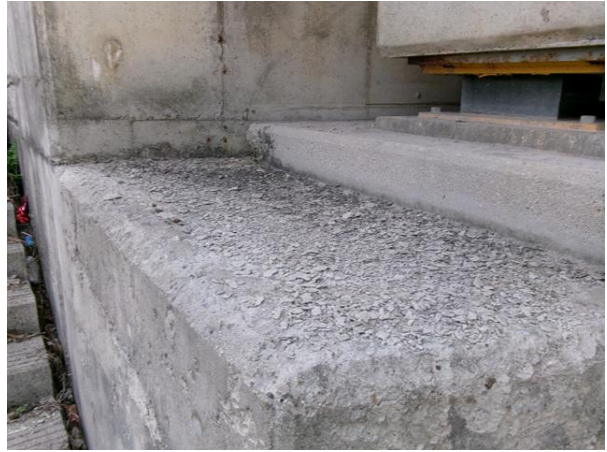
신기교 교대 A1 구체 상면 콘크리트 박리 1.52\*0.5

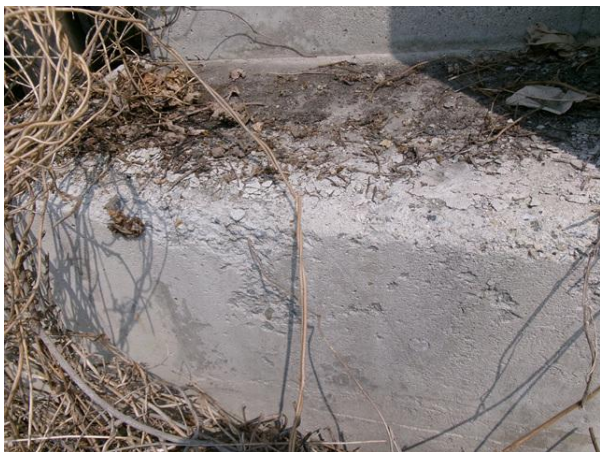
신기교 교대 A1 구체 우측면 콘크리트 박리 0.2\*0.6

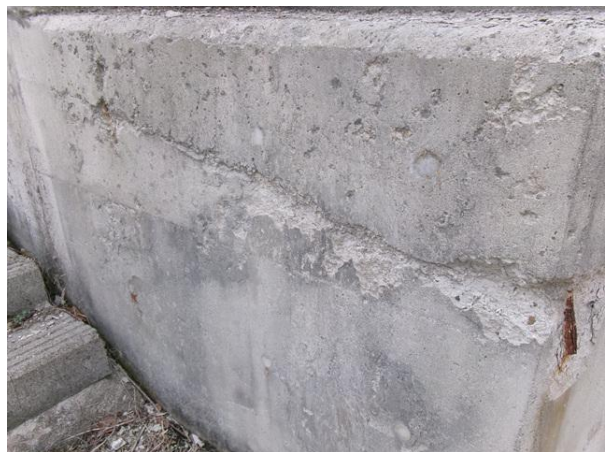
신기교 교대 A1 구체 좌측면 콘크리트 박리 0.2\*1.5

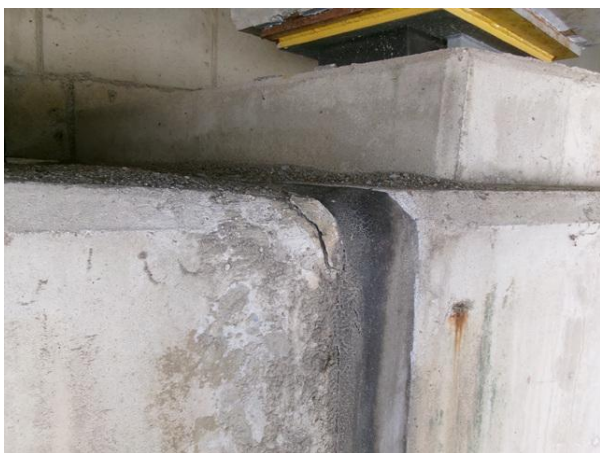
신기교 교대 A1 구체 콘크리트 들뜸 0.1\*0.1

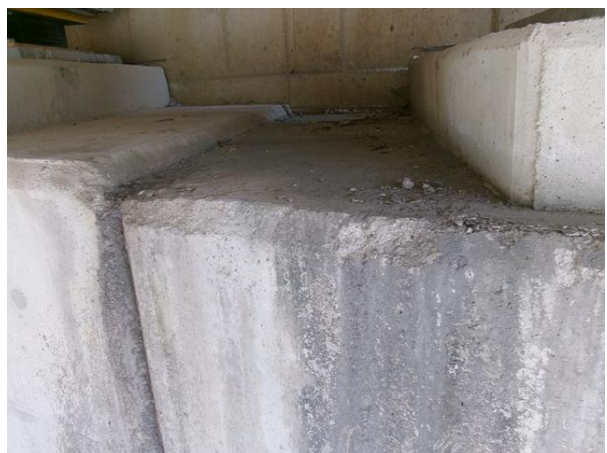
신기교 교대 A1 구체 콘크리트 박리 0.1\*0.8

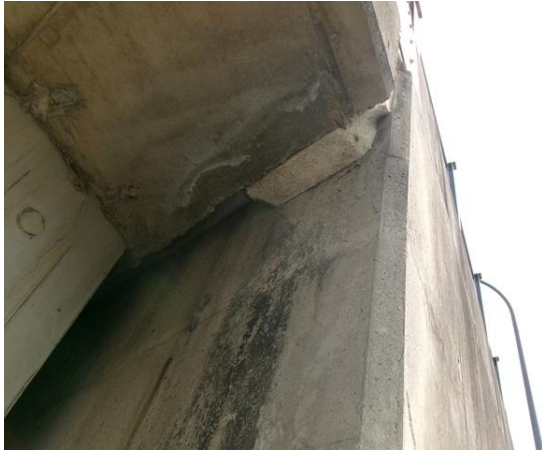
신기교 교대 A1 흉벽 콘크리트 박리 0.3\*0.3

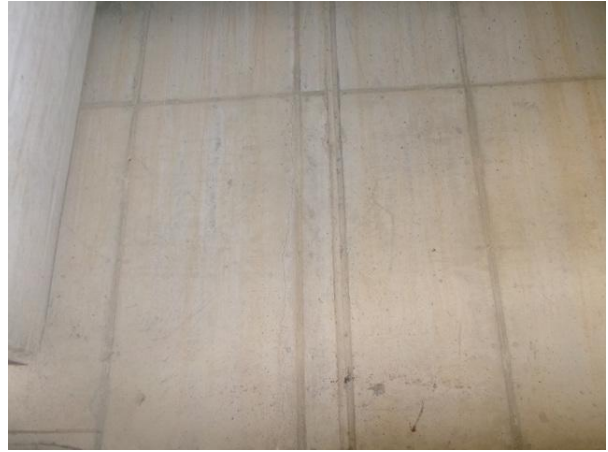
신기교 교대 A2 균열 0.2/2.0 -신규-

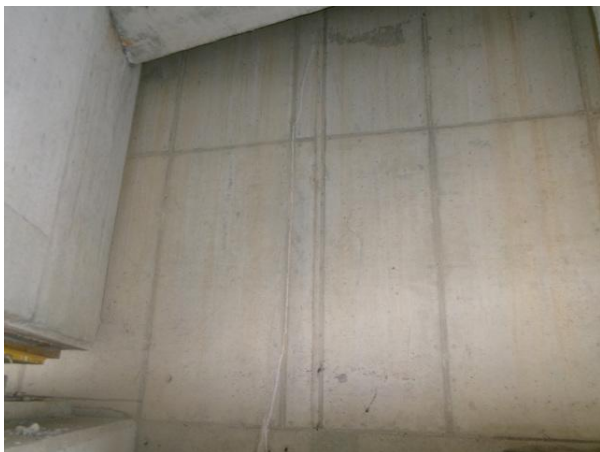
신기교 교대 A2 균열 0.2/2.0 -신규-

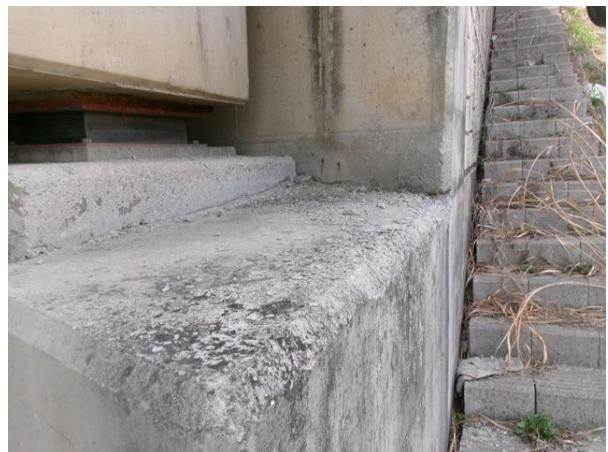
신기교 교대 A2 박리 0.5\*2.0 -신규-

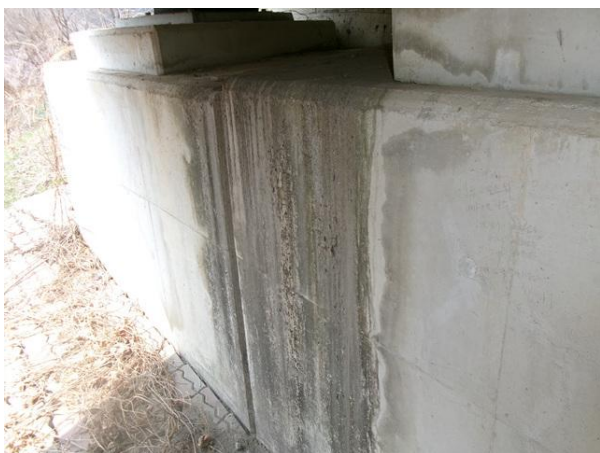
신기교 교대 A2 표면오염 0.6\*4.0 -신규-

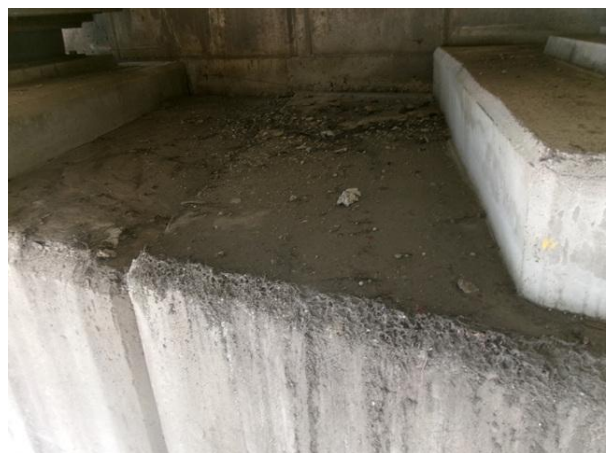
신기교 교대 A2 표면오염 1.5\*4.0 -신규-

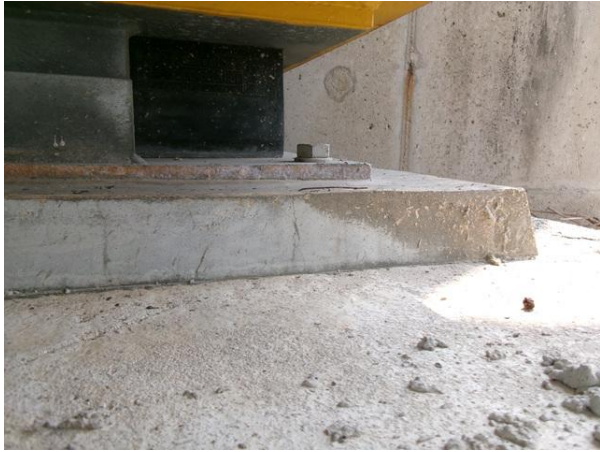
신기교 교량받침 A1-SH1 무수축몰탈 균열 0.1/0.1

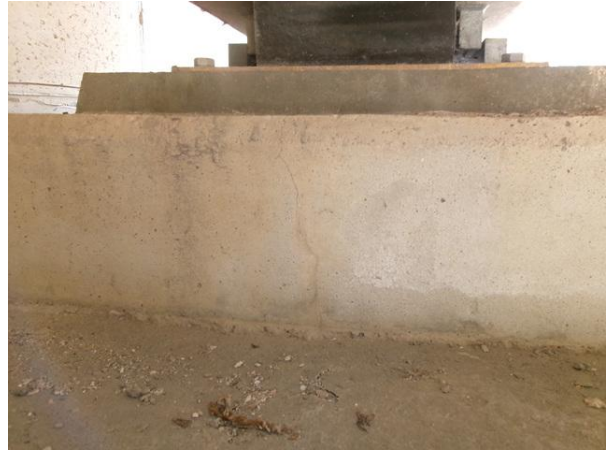
신기교 교량받침 A1-SH1 받침콘크리트 균열 0.1/0.2

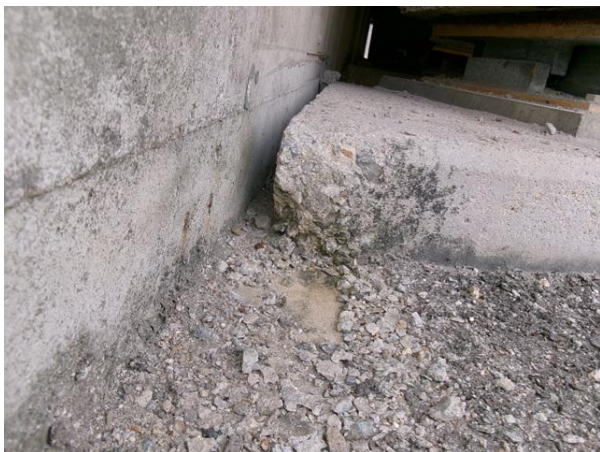
신기교 교량받침 A1-SH10 받침콘크리트 박리 0.2\*0.2

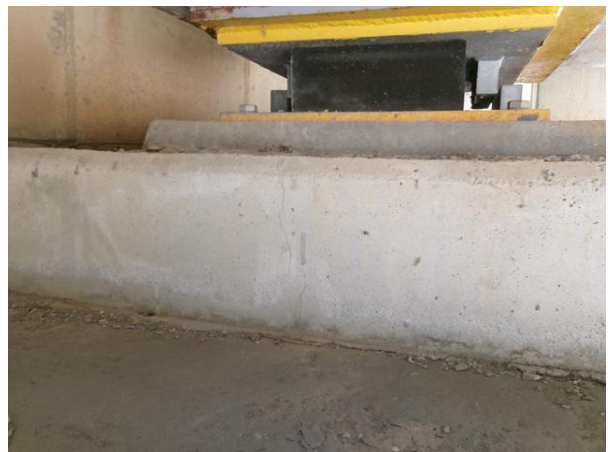
신기교 교량받침 A1-SH2 받침콘크리트 균열 0.1/0.2

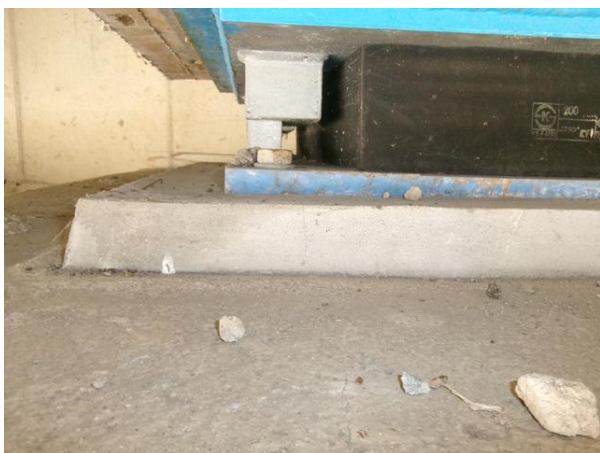
신기교 교량받침 A1-SH8 무수축몰탈 균열 0.1/0.1

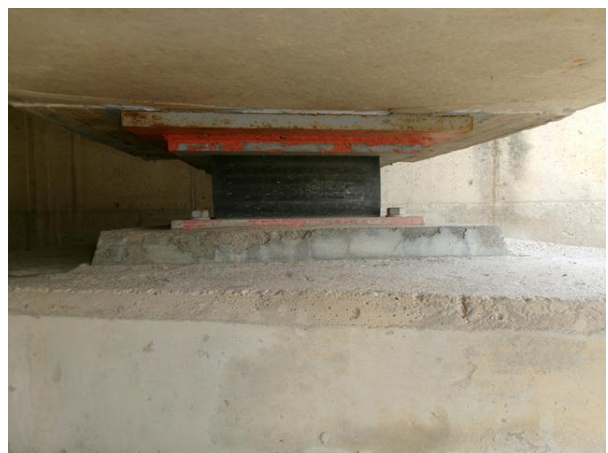
신기교 교량받침 A2-SH10 무수축몰탈 박락 0.2\*0.5 -신규-

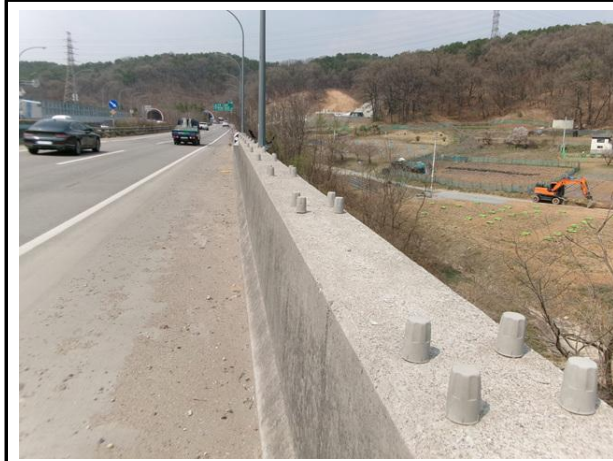
신기교 수원방향 방호벽 S1 열화 40\*0.5

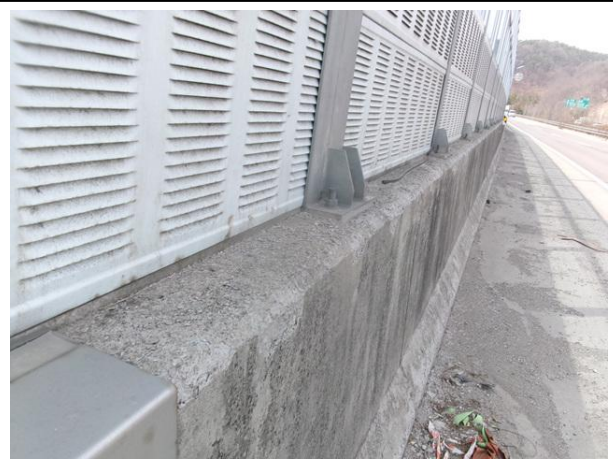
신기교 이천방향 방호벽 S1 박리(열화)  
1.2\*40.0\_신규

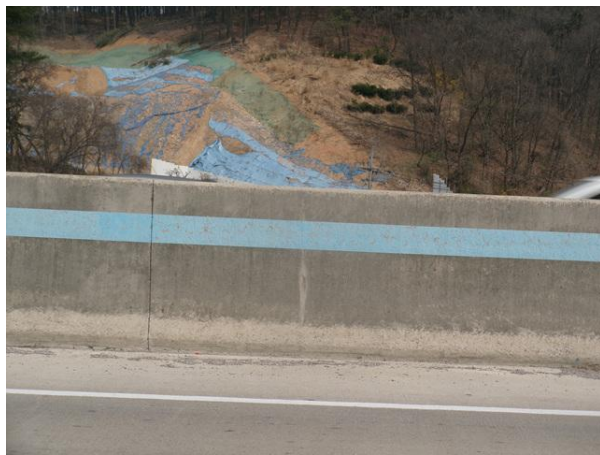
신기교 이천방향 방호벽 S1 중분대 균열  
0.3/1.0\_신규

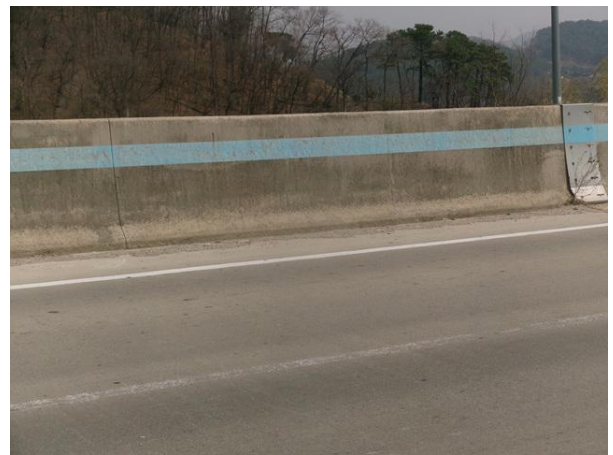
신기교 이천방향 방호벽 S1 중분대 박리(열화)  
0.5\*40.0\_신규
