안터교

## 바닥판하면 손상현황

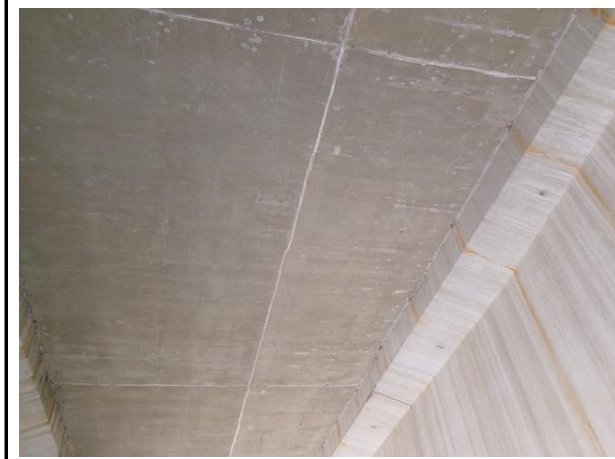
안터교 바닥판하면 S1 종방향균열 0.2/3.0

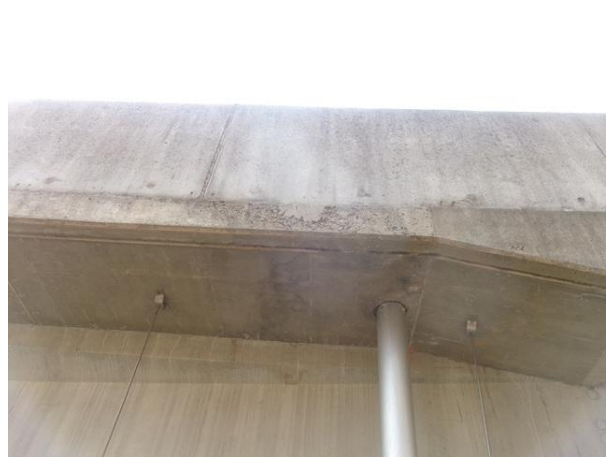
안터교 바닥판하면 S1 측면 재료분리 1.0\*0.2

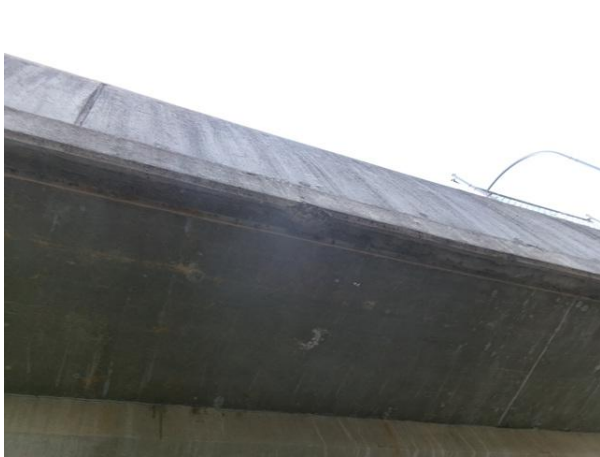
안터교 바닥판하면 S1 콘크리트 파손 0.1\*0.2

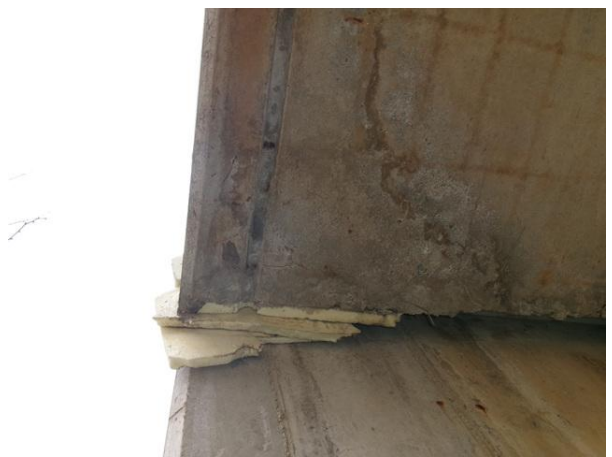
안터교 바닥판하면 S1-A1 횡방향균열 0.2/0.3

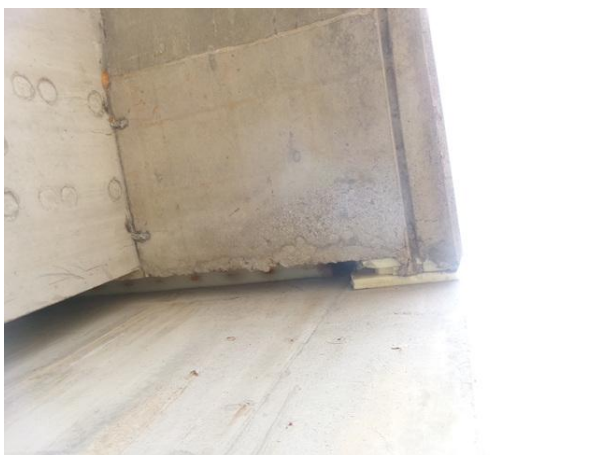
안터교 바닥판하면 S1-A2 박리 0.5\*0.3

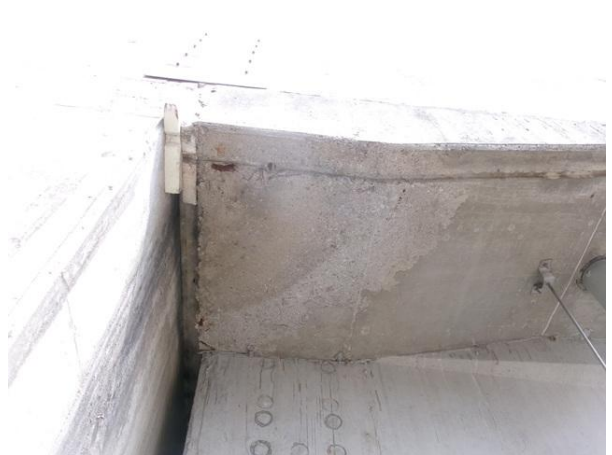
안터교 바닥판하면 S1-A2 박리 1.0\*1.0

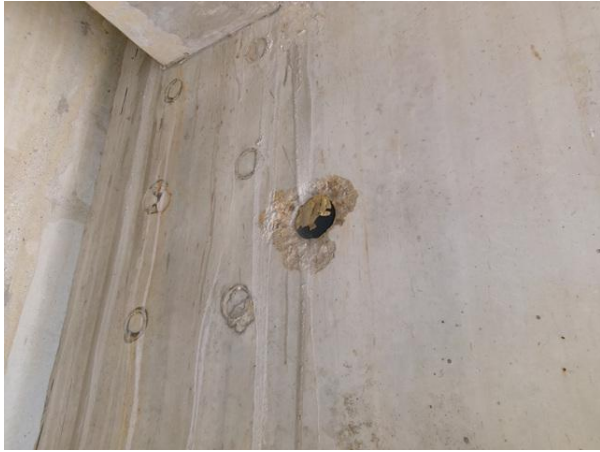
안터교 거더 S1-G1 A1측 인양홀 파손 0.2\*0.2

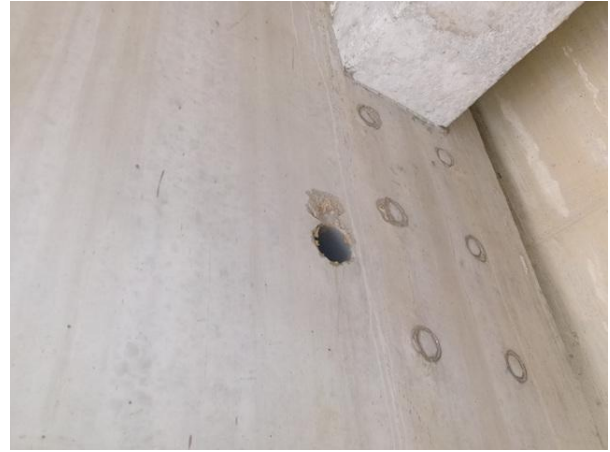
안터교 거더 S1-G1 인양홀 파손 0.2\*0.2 우

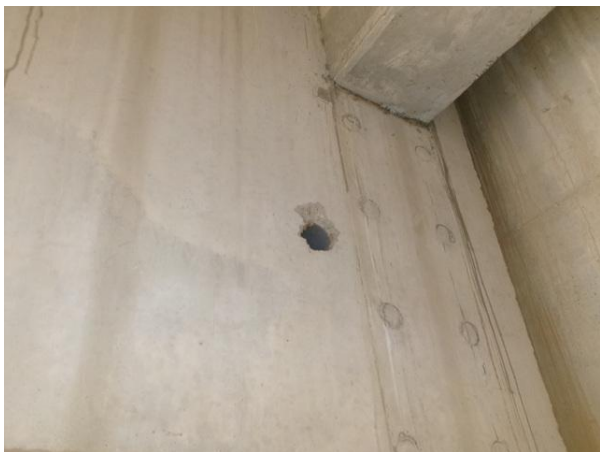
안터교 거더 S1-G2 인양홀 파손 0.2\*0.2 우

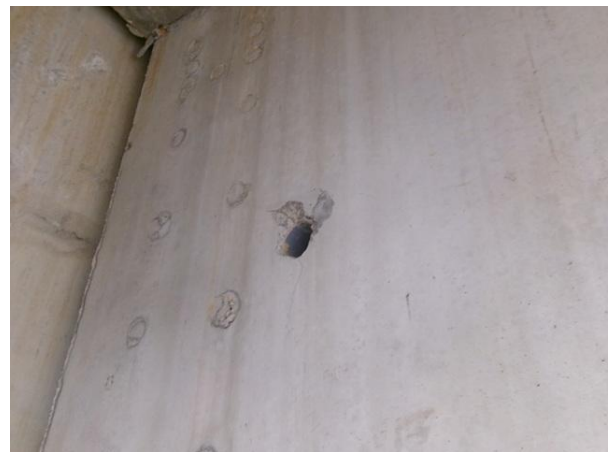
안터교 거더 S1-G4 A1측 인양홀 파손 0.2\*0.2

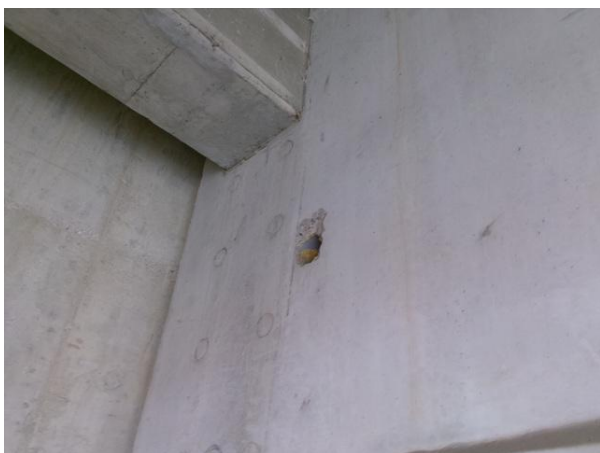
안터교 거더 S1-G4 인양홀 파손 0.2\*0.2 좌

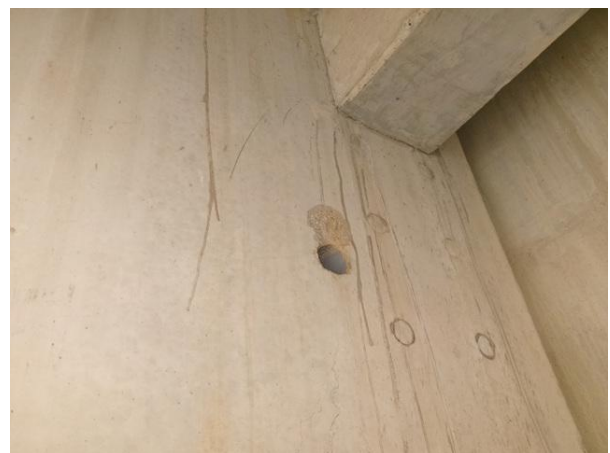
안터교 거더 S1-G7 인양홀 파손 0.2\*0.2 좌

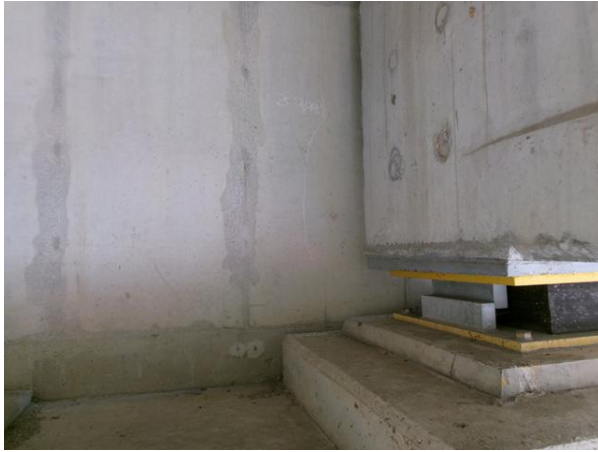
안터교 교대 A1 균열 0.2/1.0\_신규

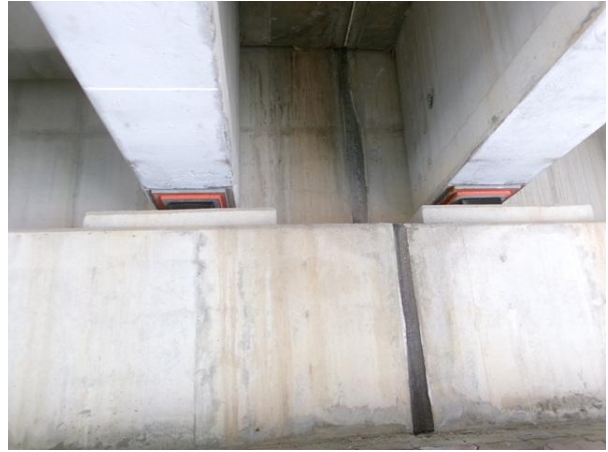
안터교 교대 A1 누수흔적 4.0\*1.0\_신규

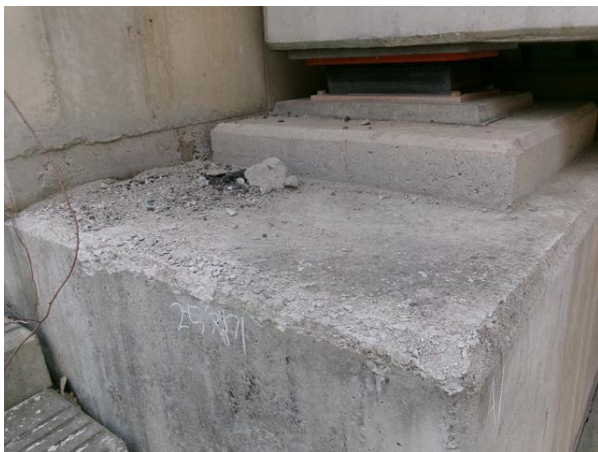
안터교 교대 A1 박리 0.3\*1.5\_신규

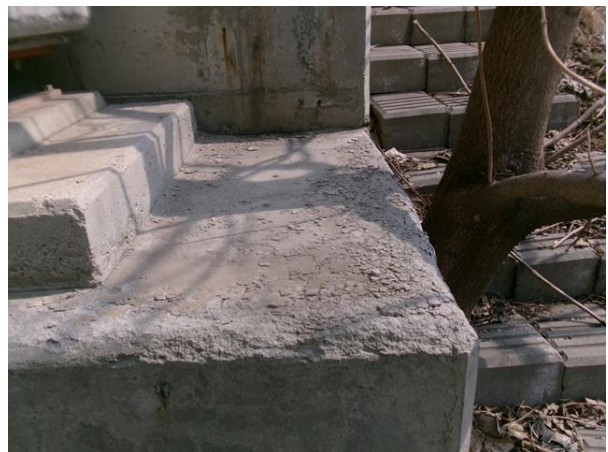
안터교 교대 A1 박리 0.5\*1.5\_신규

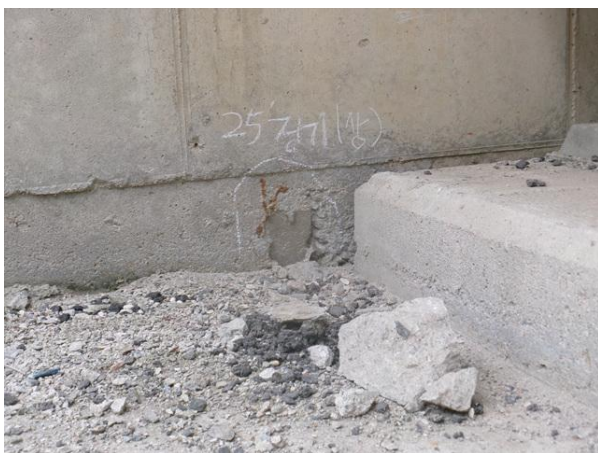
안터교 교대 A1 파손 0.3\*0.3\_신규

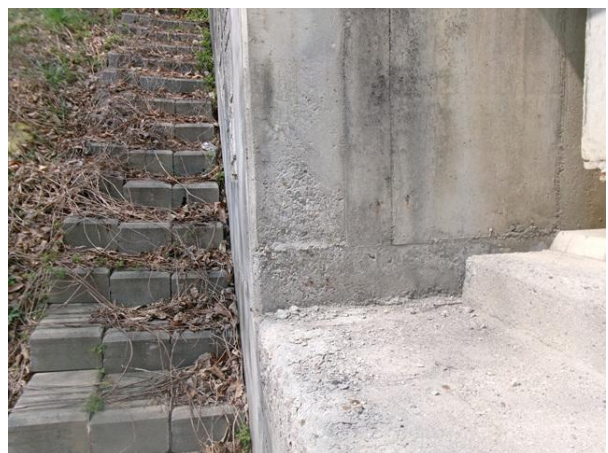
안터교 교대 A2 박리 0.3\*0.3 -신규-

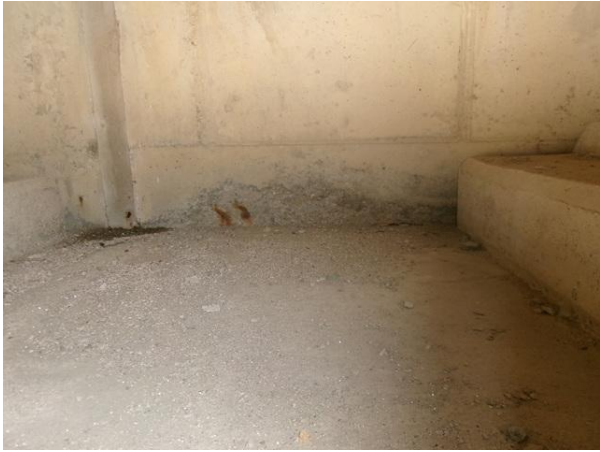
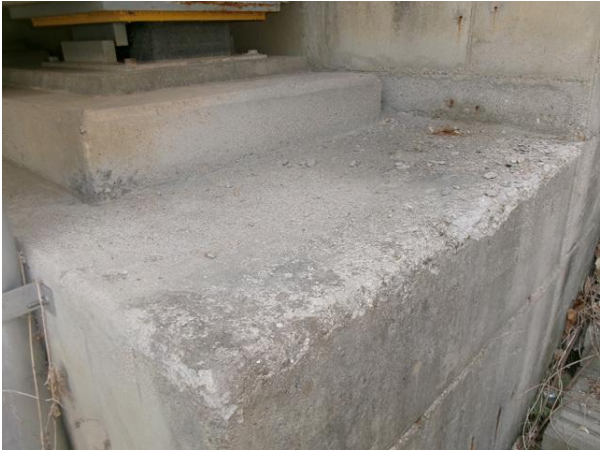
| <p>안터교 교대 A2 박리 0.5*0.1 -신규-</p> | <p>안터교 교대 A2 박리 0.5*1.0 -신규-</p> |

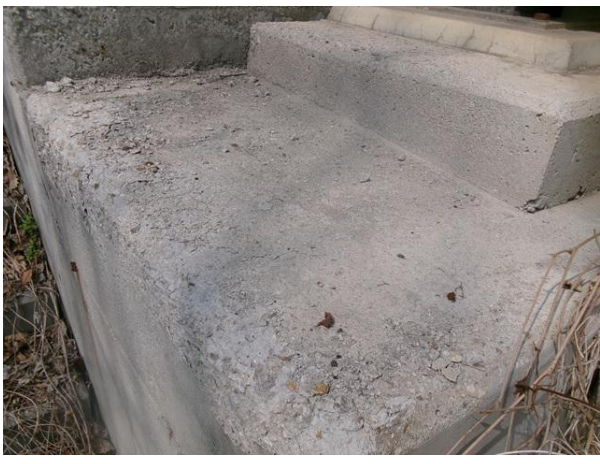
| <p>안터교 교대 A2 박리 0.5*1.0 -신규-</p> | |

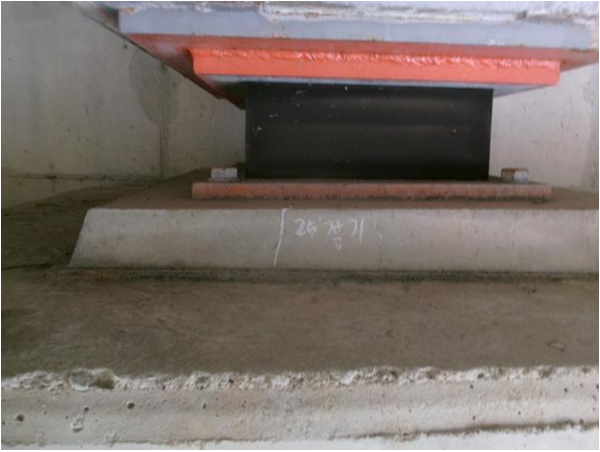
| <p>안터교 교량받침 A1-SH3 무수축물탈 균열<br/>0.2/0.3_신규</p> | |

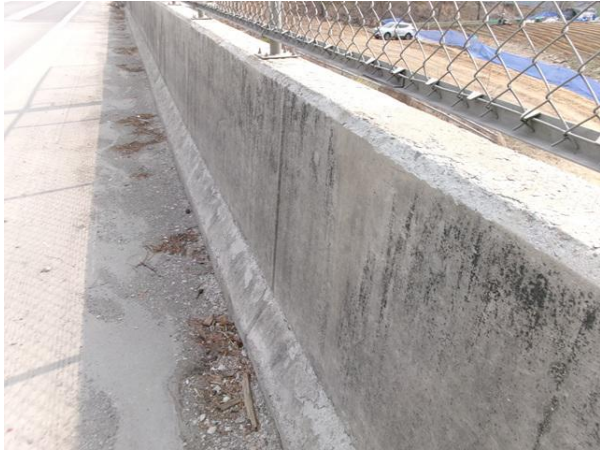
안터교 이천방향 방호벽 S1 열화 30.0\*0.5\*2

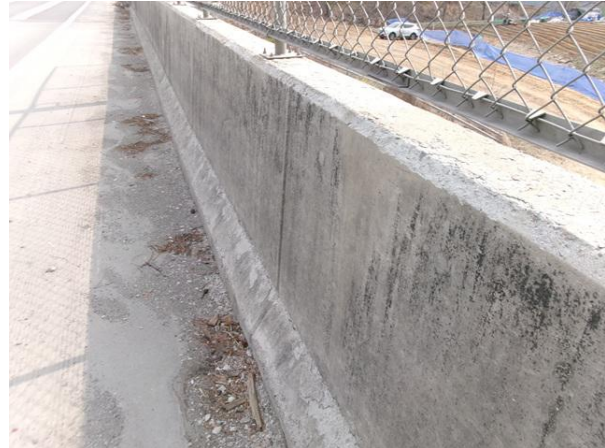
| <p>안터교 이천방향 방호벽 S1 열화 30.0*0.5*2</p> | |
