문산- 선유 #1

손상물량표

| | 관 입 | | 망상균열 | | 재료부리 | 용역명<br>2025년도 경기북부 지중구조물<br>·2중시설을 정밀안전점검 용역 |

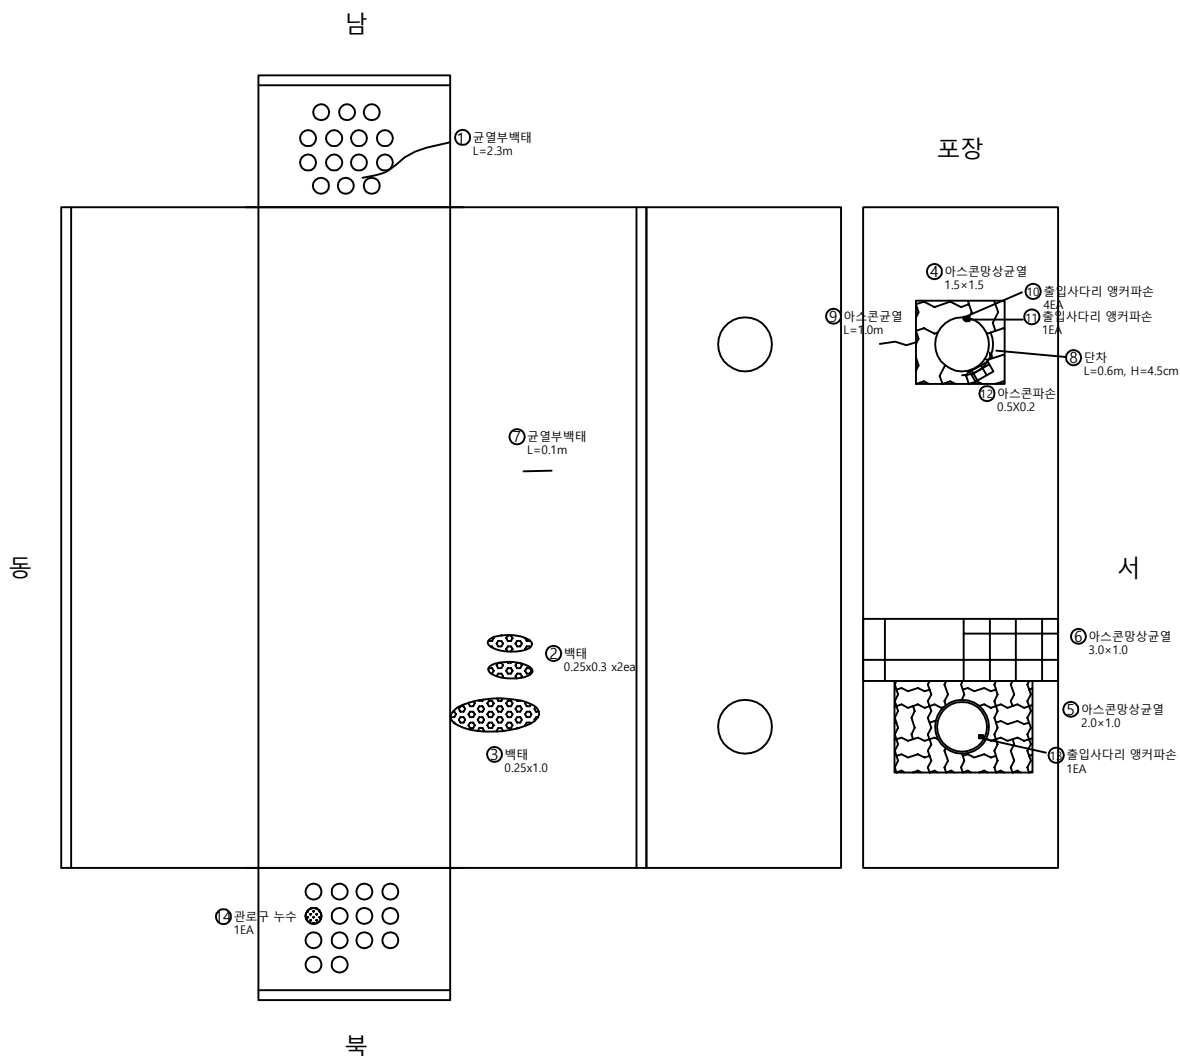
| 번호 | 신(0)<br>구(P) | 손상내용 | 손상규모 | | | 개소 | 수량 | 단위 | 비고 |
|---|---|---|---|---|---|---|---|---|---|
| 1 | 구 | 균열부백테 | | | 2.30 | 1 | 2.30 | m | |
| 2 | 구 | 백테 | | 0.25 | 0.30 | 2 | 0.15 | m' | |
| 3 | 구 | 백테 | | 0.25 | 1.00 | 1 | 0.25 | m' | |
| 4 | 구 | 아스콘망상균열 | | 1.50 | 1.50 | 1 | 2.25 | m' | |
| 5 | 구 | 아스콘망상균열 | | 2.00 | 1.00 | 1 | 2.00 | m' | |
| 6 | 구 | 아스콘망상균열 | | 3.00 | 1.00 | 1 | 3.00 | m' | |
| 7 | 구 | 균열부백테 | | | 0.10 | 1 | 0.10 | m | |
| 8 | 구 | 단차 | | 0.60 | | 1 | 0.60 | m | |
| 9 | 구 | 아스콘균열 | | | 1.00 | 1 | 1.00 | m | |
| 10 | 구 | 출입사다리 앵커파손 | | | | 4 | 4.00 | EA | |
| 11 | 신 | 출입사다리 앵커파손 | | | | 1 | 1.00 | EA | |
| 12 | 신 | 아스콘파손 | | 0.50 | 0.20 | | 0.10 | m' | |
| 13 | 신 | 출입사다리 앵커파손 | | | | 1 | 1.00 | EA | |
| 14 | 신 | 관로구 누수 | | | | 1 | 1.00 | EA | |
