## 4. 향산2교 RAMP-A교

손상현황

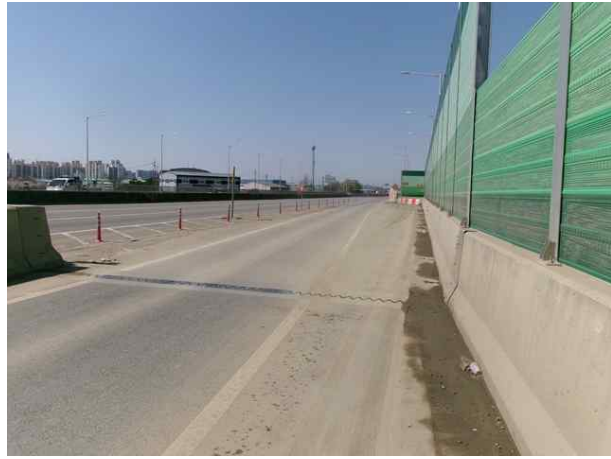
교면포장 전경

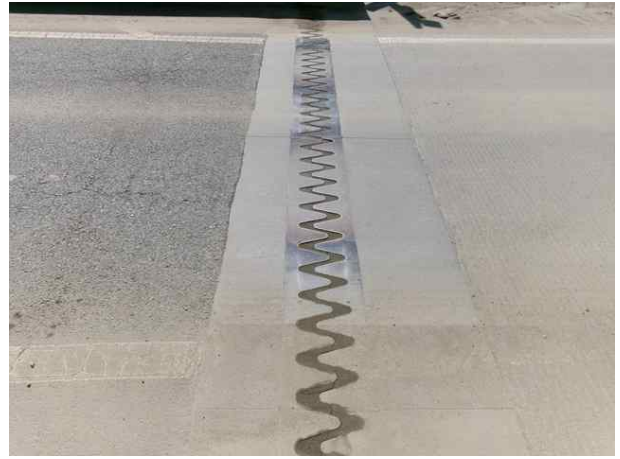
신축이음장치 전경

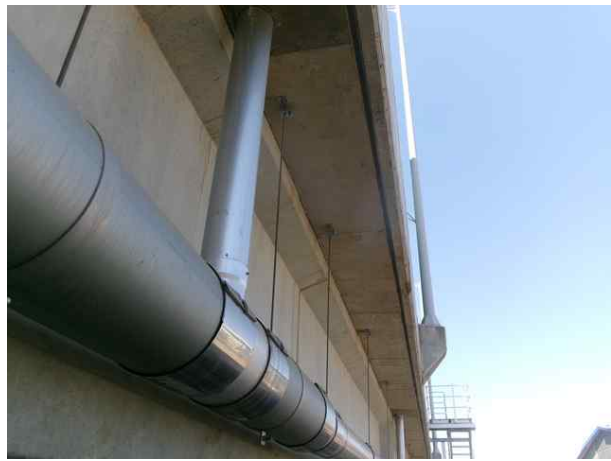
바닥판하면 전경

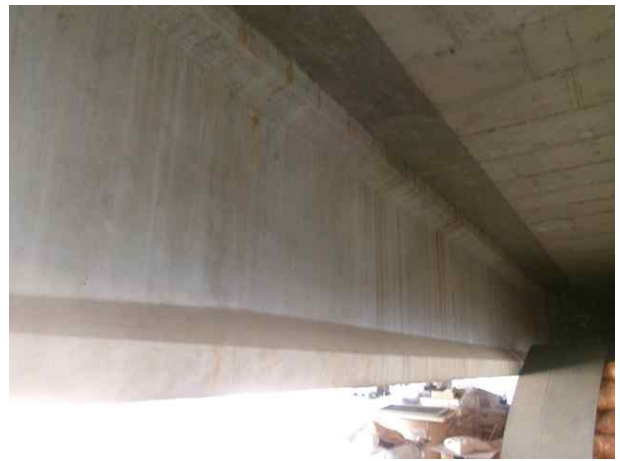
거더 전경

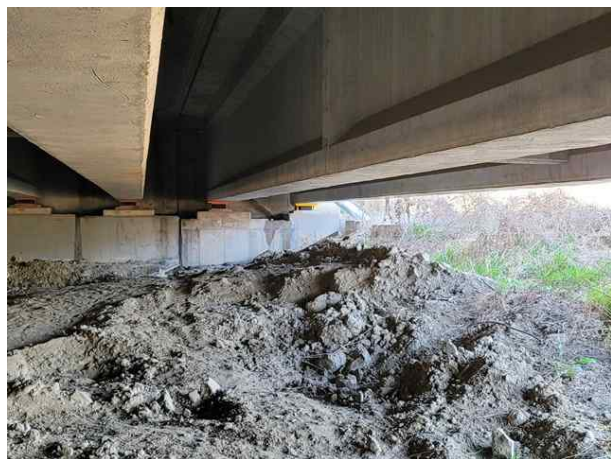
교대 전경

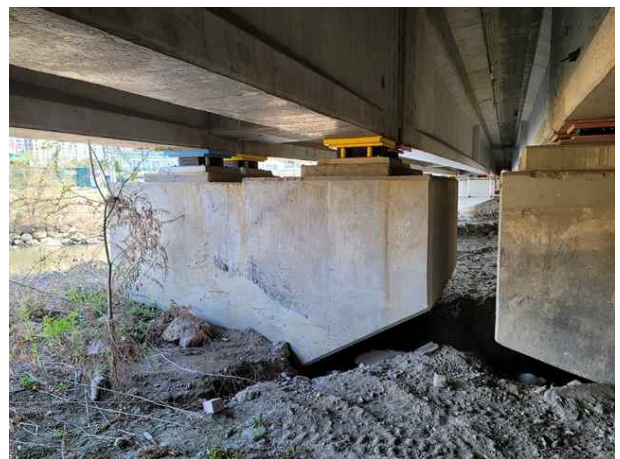
교각 전경

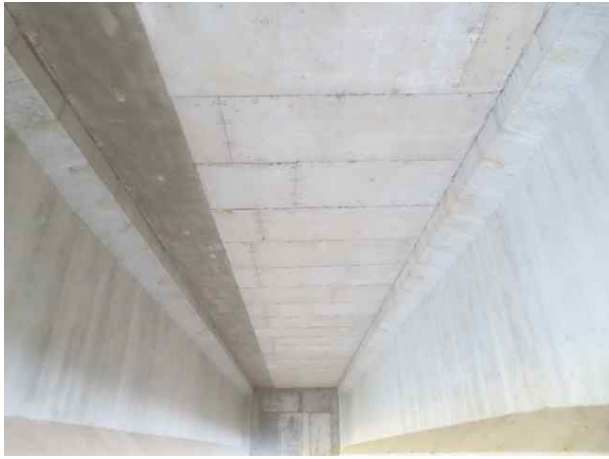
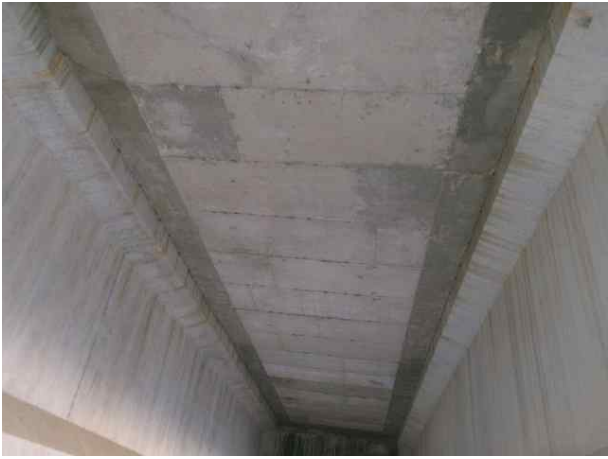
| 01<br>(25년 하반기) | 바닥판 하면(S5) 상태양호 | 01<br>(26년 상반기) | 바닥판 하면(S5) 상태양호 |

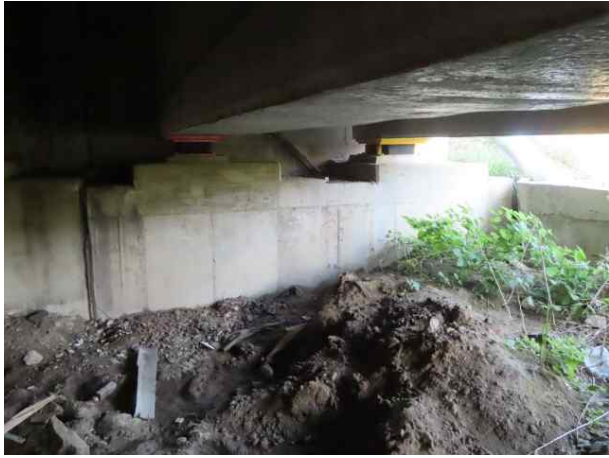
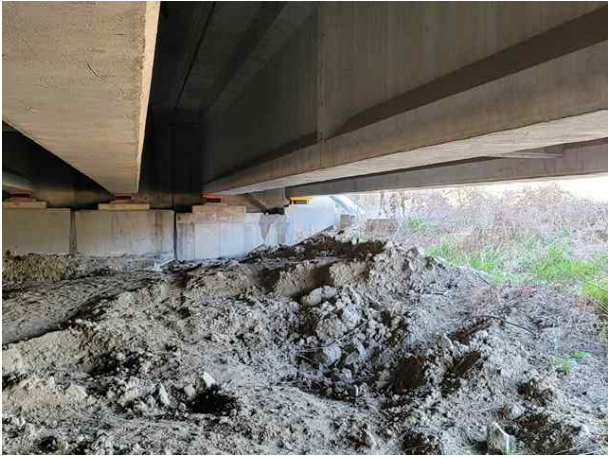
| 02<br>(25년 하반기) | 교대(A1) 상태양호 | 02<br>(26년 상반기) | 교대(A1) 상태양호 |

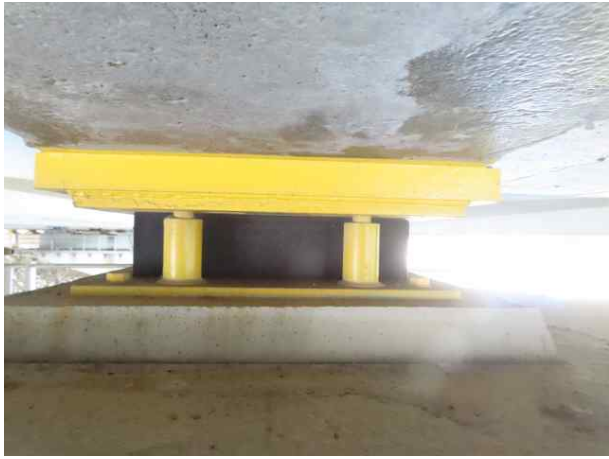
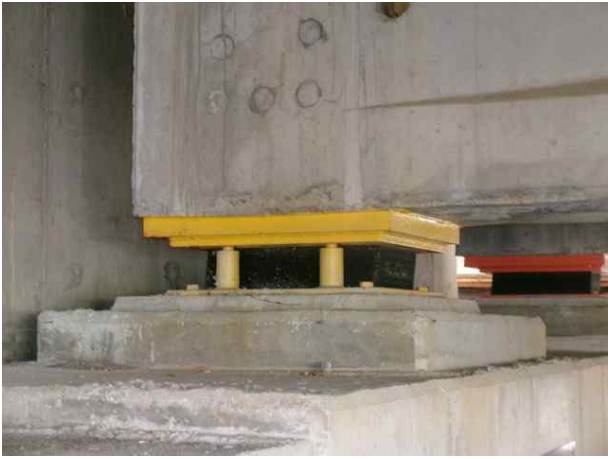
| 03<br>(25년 하반기) | 교량받침(P5) 상태양호 | 03<br>(26년 상반기) | 교량받침(P5) 상태양호 |

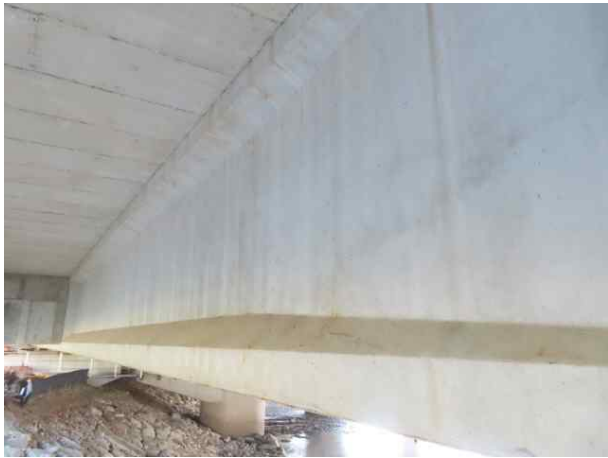
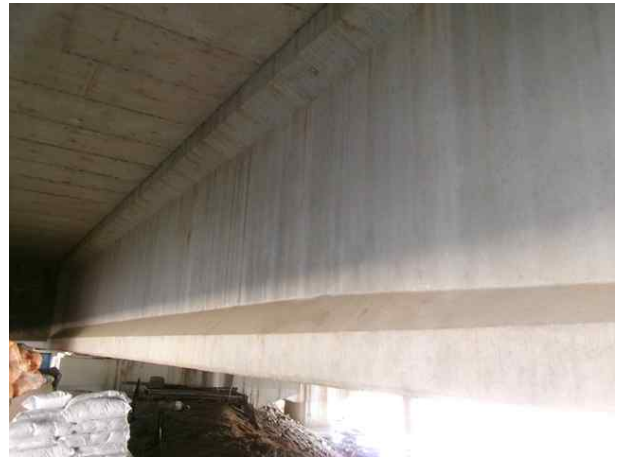
| 04<br>(25년 하반기) | 거더(S5) 상태양호 | 04<br>(26년 상반기) | 거더(S5) 상태양호 |

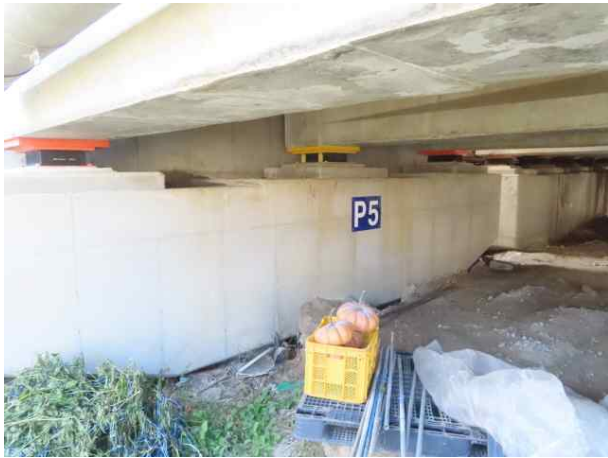
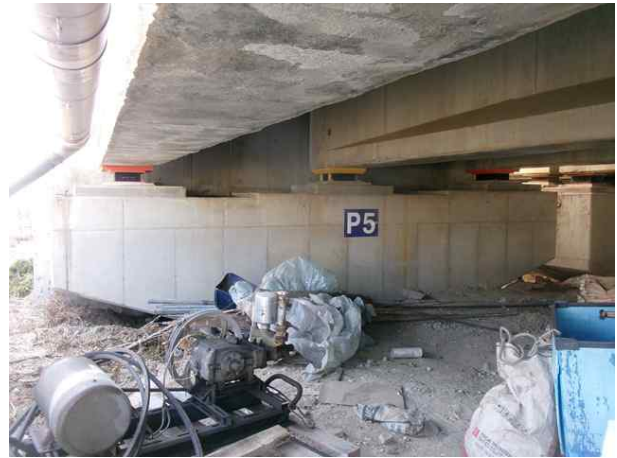
| 05<br>(25년 하반기) | 교각(P5) 상태양호 | 05<br>(26년 상반기) | 교각(P5) 상태양호 |

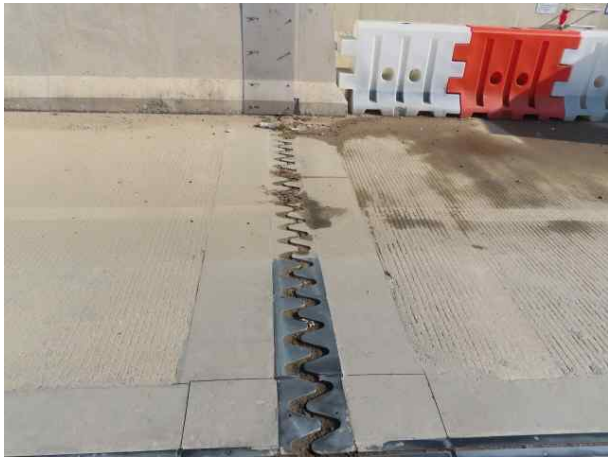
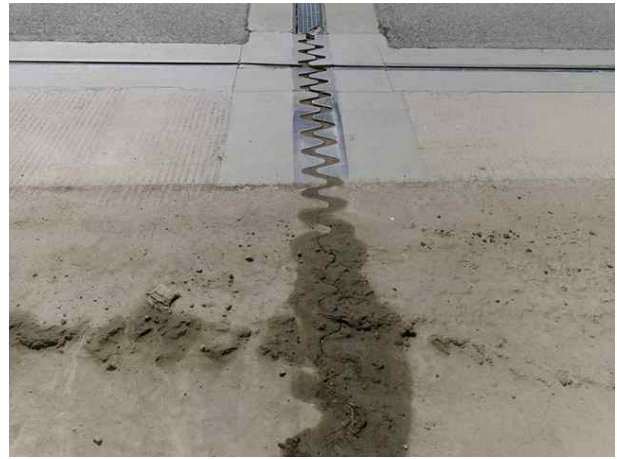
| 06<br>(25년 하반기) | 신축이음(P2) 상태양호 | 06<br>(26년 상반기) | 신축이음(P2) 상태양호 |

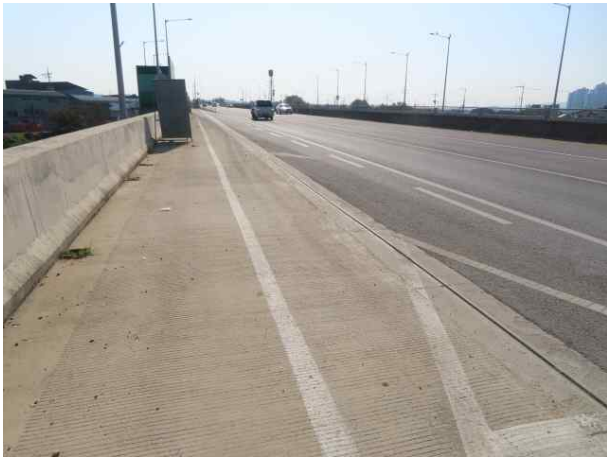
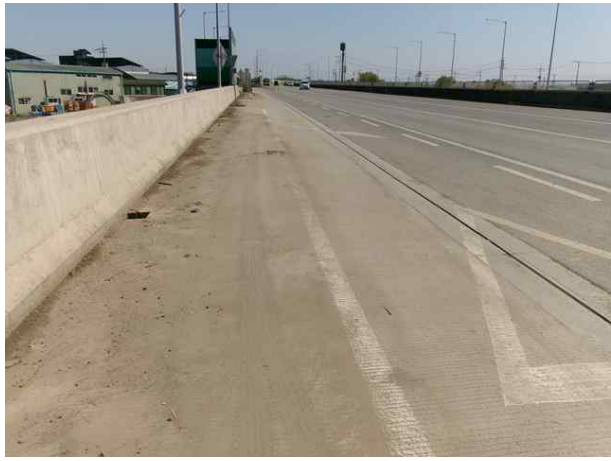
| 07<br>(25년 하반기) | 교면포장(S1) 상태양호 | 07<br>(26년 상반기) | 교면포장(S1) 상태양호 |

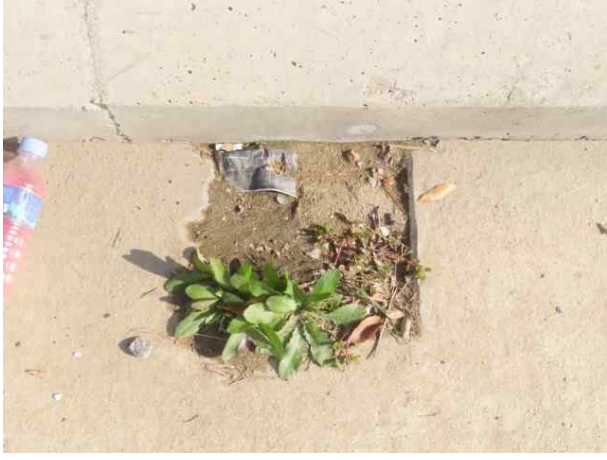
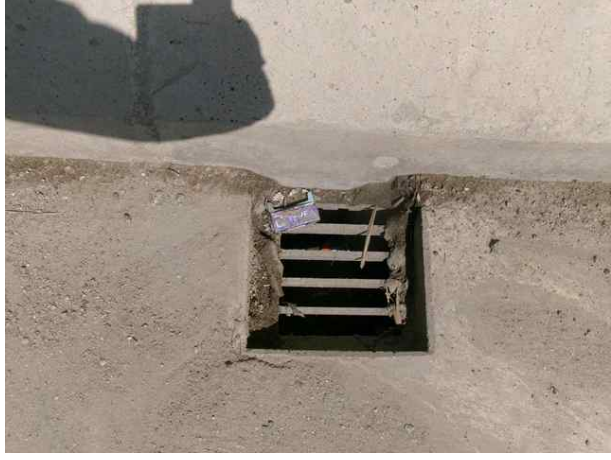
| 08<br>(25년 하반기) | 배수구(S1) 막힘 | 08<br>(26년 상반기) | 배수구(S1) 막힘 -보수- |

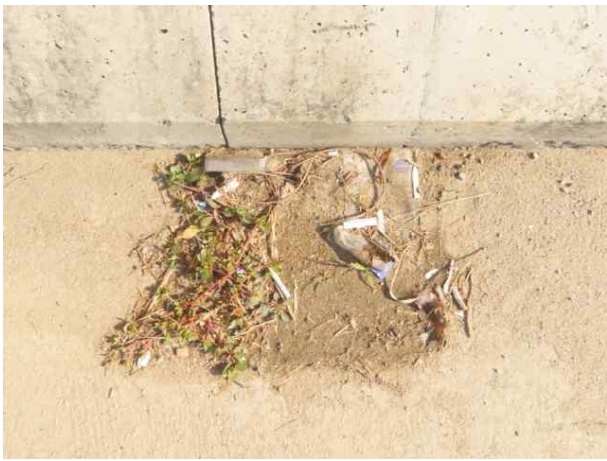
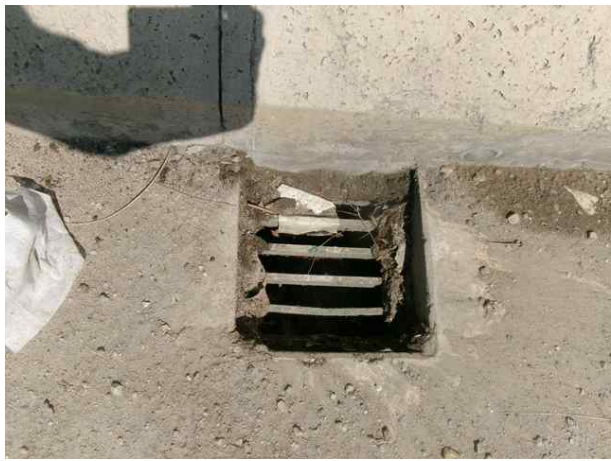
| 09<br>(25년 하반기) | 배수구(S1) 막힘 | 09<br>(26년 상반기) | 배수구(S1) 막힘 -보수- |

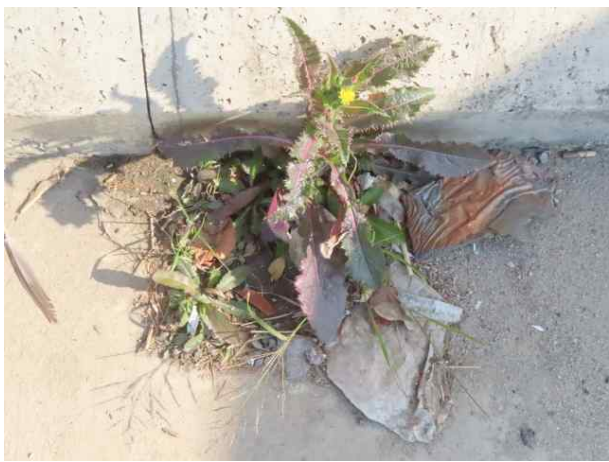
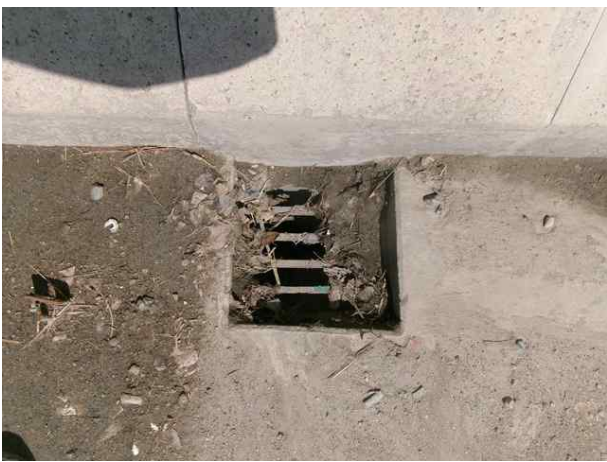
| 10<br>(25년 하반기) | 배수구(S1) 막힘 | 10<br>(26년 상반기) | 배수구(S1) 막힘 -보수- |

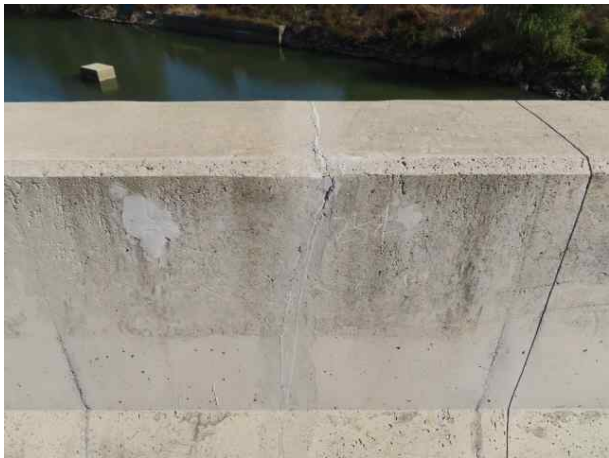
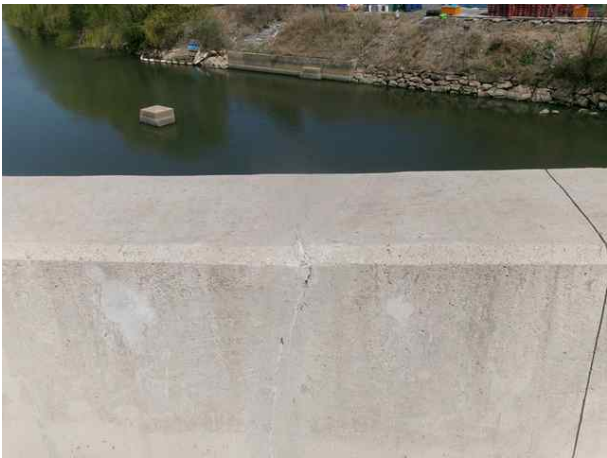
| 11<br>(25년 하반기) | 방호벽(S2) 균열(0.3mm이상) | 11<br>(26년 상반기) | 방호벽(S2) 균열(0.3mm이상) |

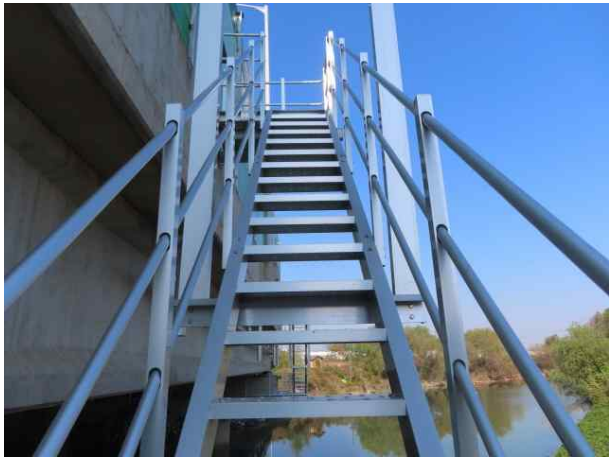
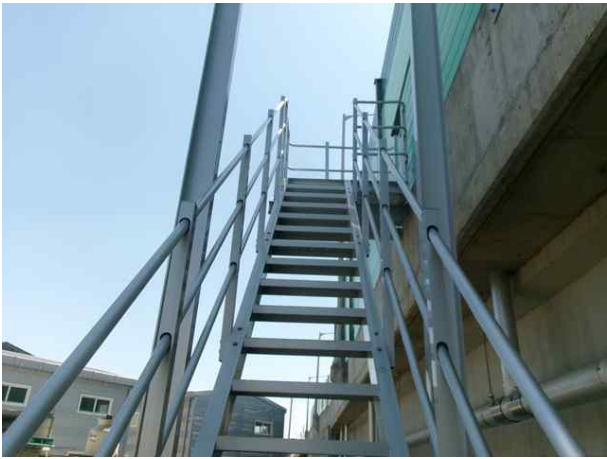
| 12<br>(25년 하반기) | 점검사다리(P4) 상태양호 | 12<br>(26년 상반기) | 점검사다리(P4) 상태양호 |

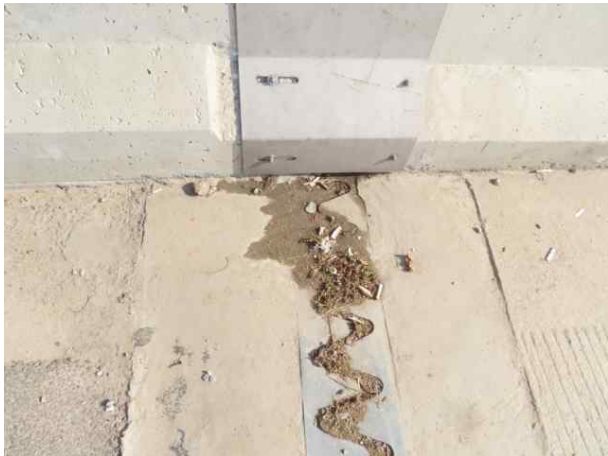
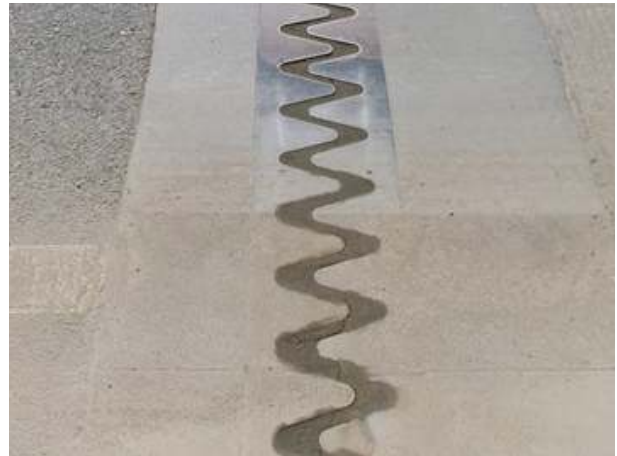
| 13<br>(26년 상반기) | 신축이음(A1) 유간 토사퇴적 | 13<br>(26년 상반기) | 신축이음(A25) |

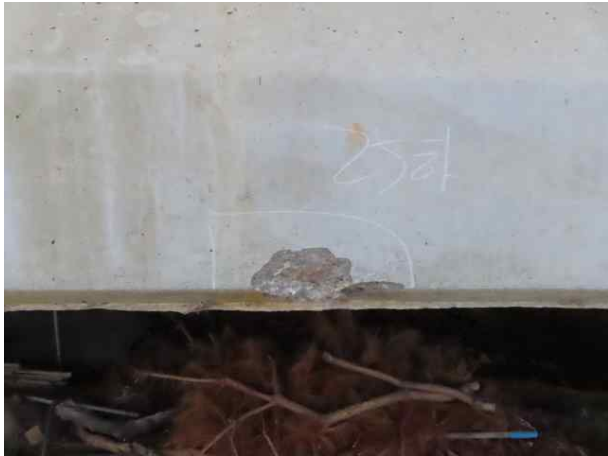
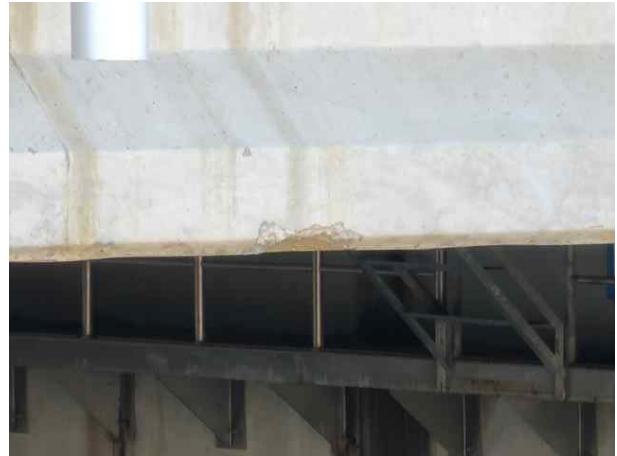
| 14<br>(26년 상반기) | 거더(S3-G1) 좌측 파손 | 14<br>(26년 상반기) | 거더(S25-G1) |
