## 5. 향산2교 RAMP-B교

손상현황

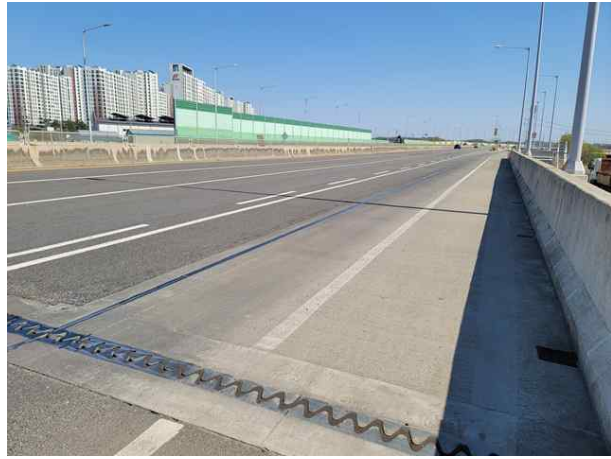
교면포장 전경

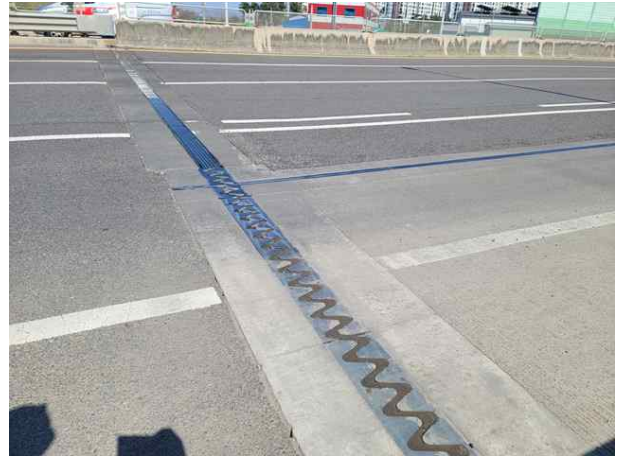
신축이음장치 전경

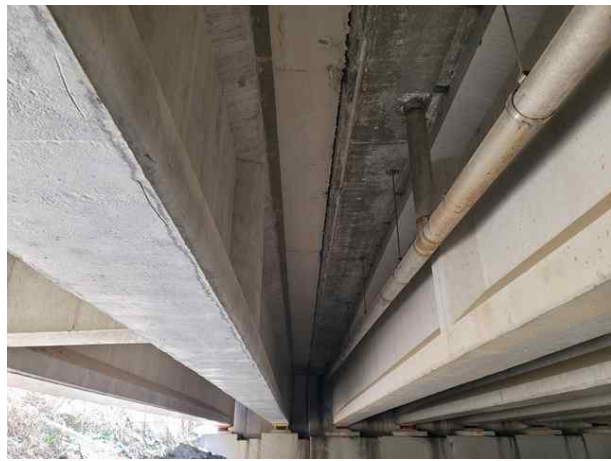
바닥판하면 전경

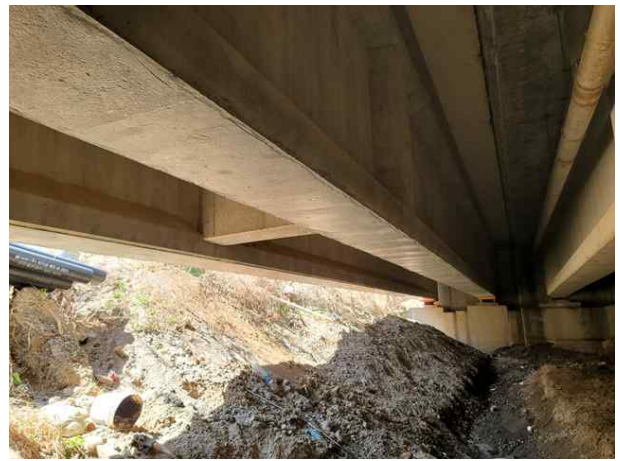
거더 전경

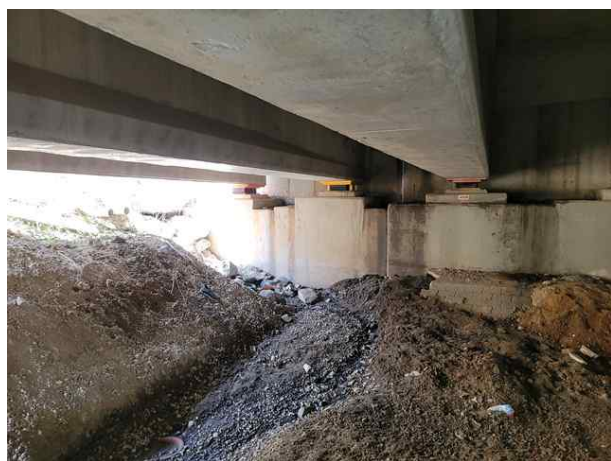
교대 전경

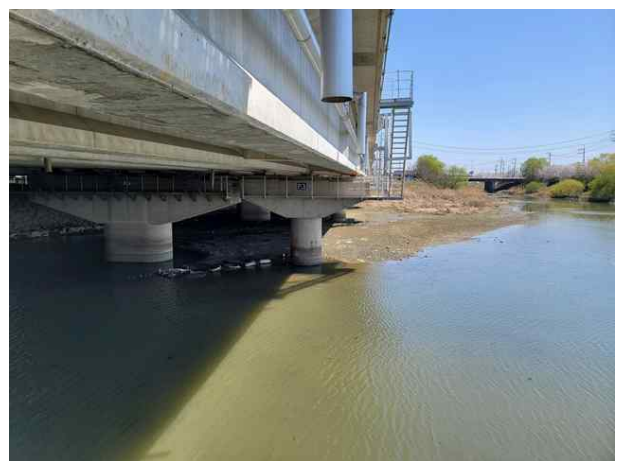
교각 전경

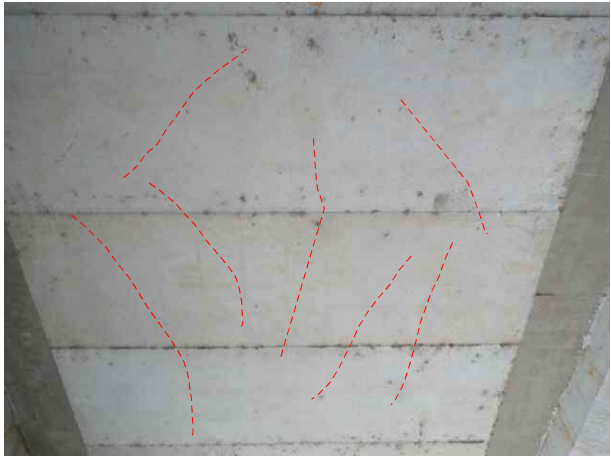
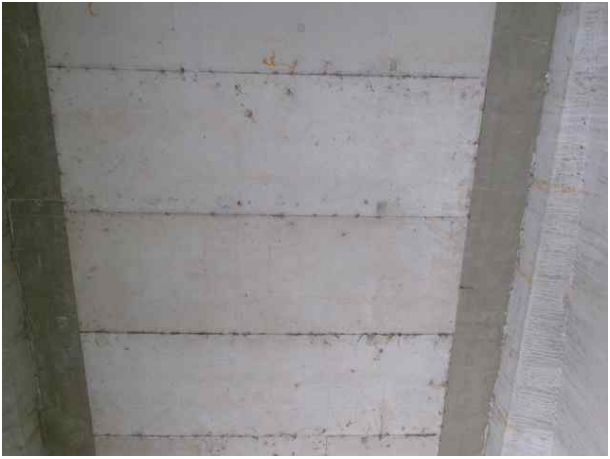
| 01<br>(25년 하반기) | 바닥판 하면(S5)<br>망상균열(cw=0.2mm) | 01<br>(26년 상반기) | 바닥판 하면(S5)<br>망상균열(cw=0.2mm) |

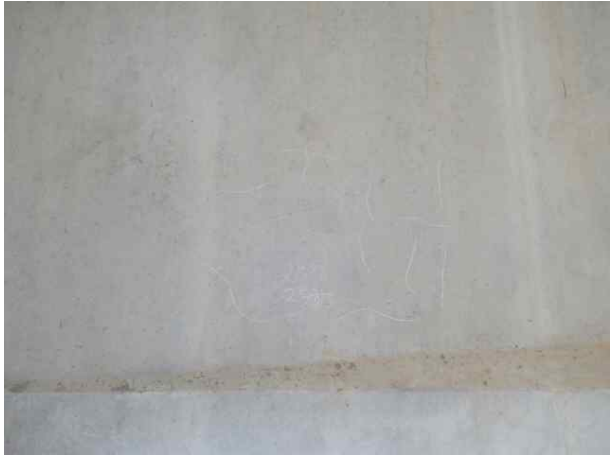
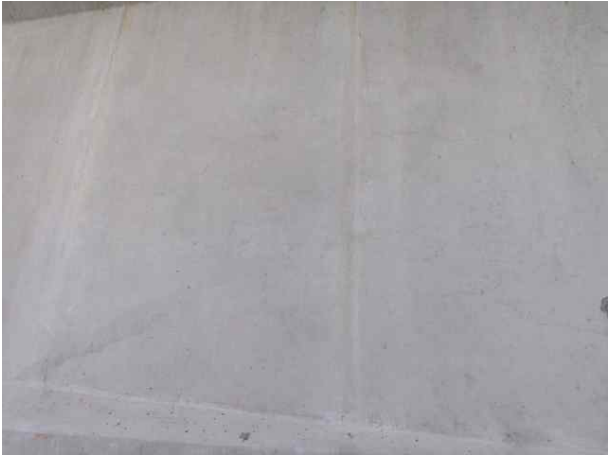
| 02<br>(25년 하반기) | 거더(S5-G3-LW)<br>망상균열(cw=0.2mm) | 02<br>(26년 상반기) | 거더(S5-G3-LW)<br>망상균열(cw=0.2mm) |

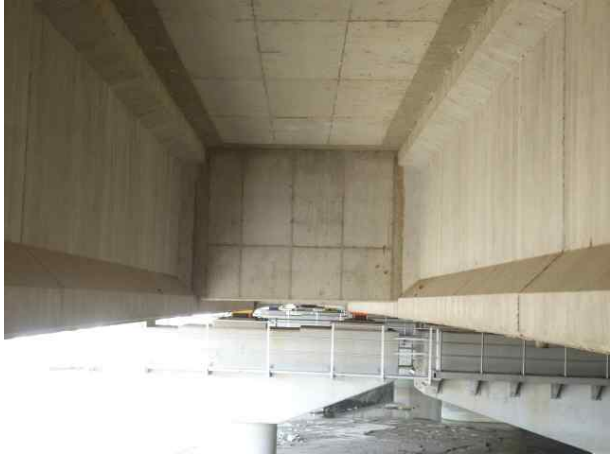
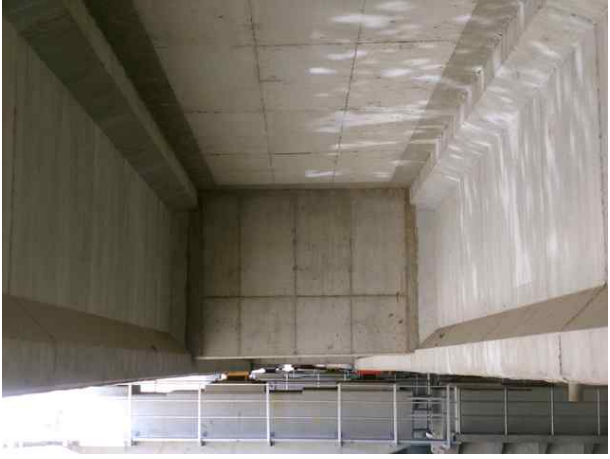
| 03<br>(25년 하반기) | 가로보(S5) 상태양호 | 03<br>(26년 상반기) | 가로보(S5) 상태양호 |

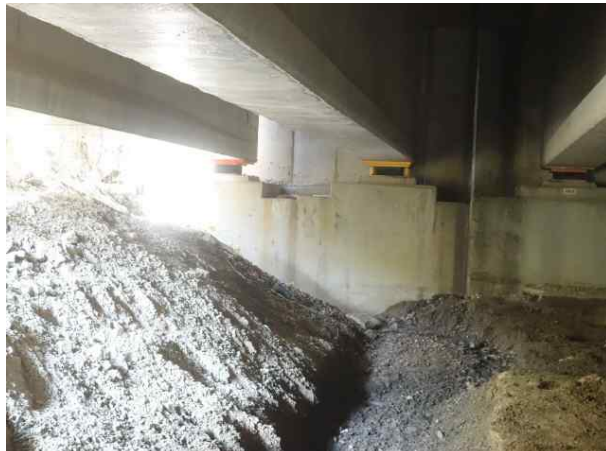
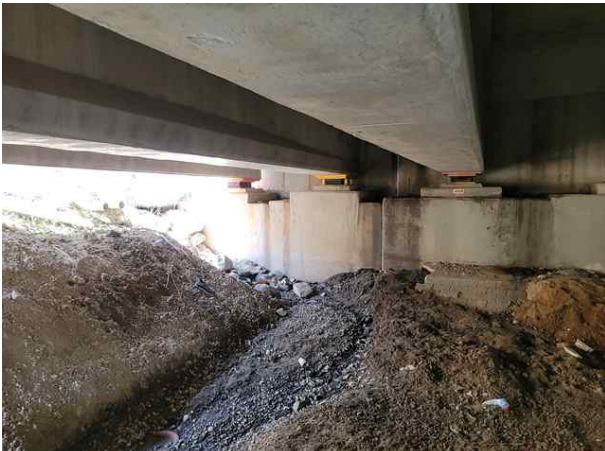
| 04<br>(25년 하반기) | 교대(A1) 상태양호 | 04<br>(26년 상반기) | 교대(A1) 상태양호 |

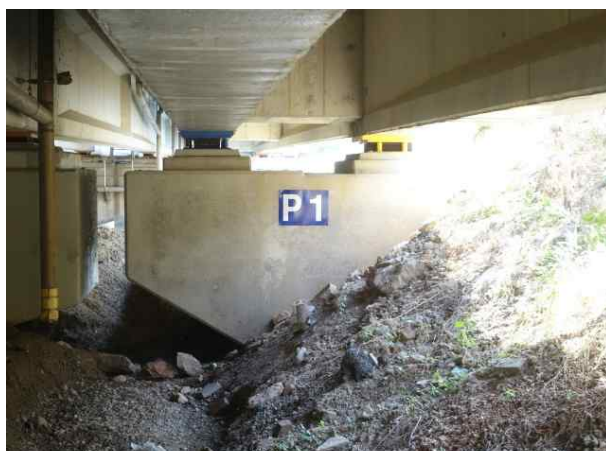
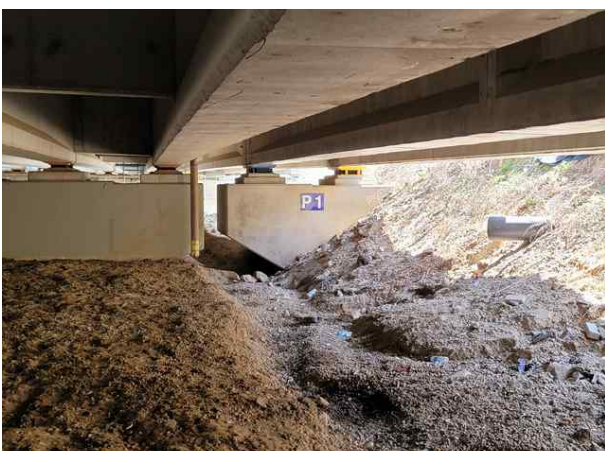
| 05<br>(25년 하반기) | 교각(P1) 상태양호 | 05<br>(26년 상반기) | 교각(P1) 상태양호 |

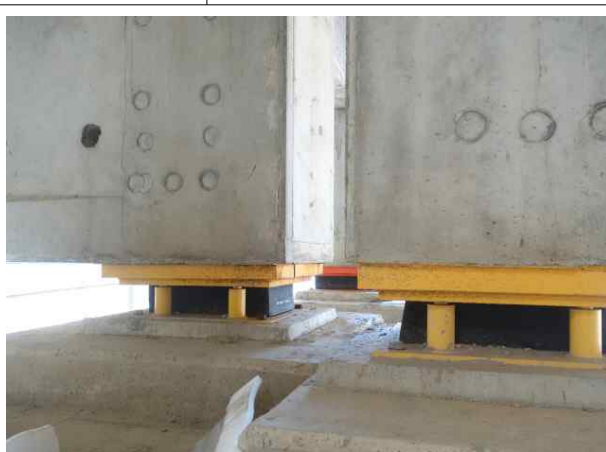
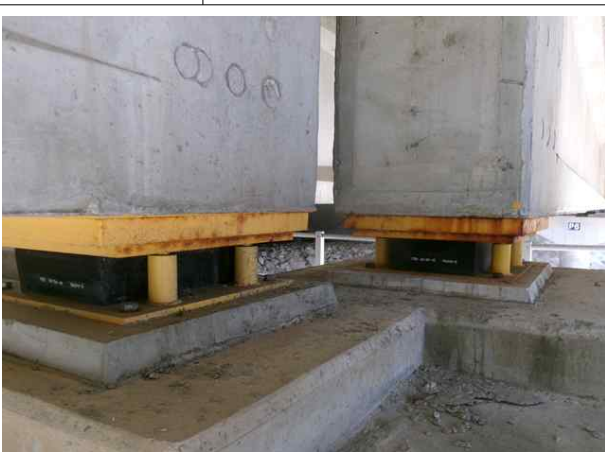
| 06<br>(25년 하반기) | 교량받침(P5) 본체 부식 | 06<br>(26년 상반기) | 교량받침(P5) 본체 부식 |

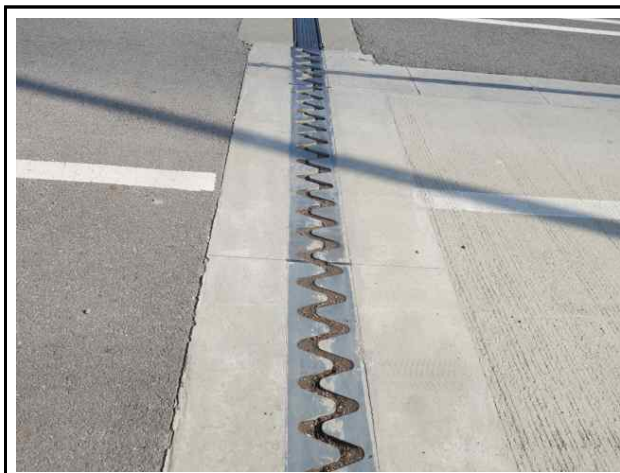
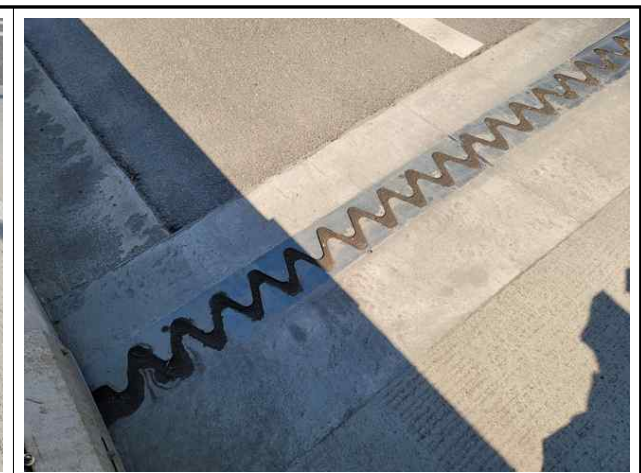
| 07<br>(25년 하반기) | 07<br>(26년 상반기) |

| 신축이음(A1) 유간 토사퇴적 | 신축이음(A1) 유간 토사퇴적 |

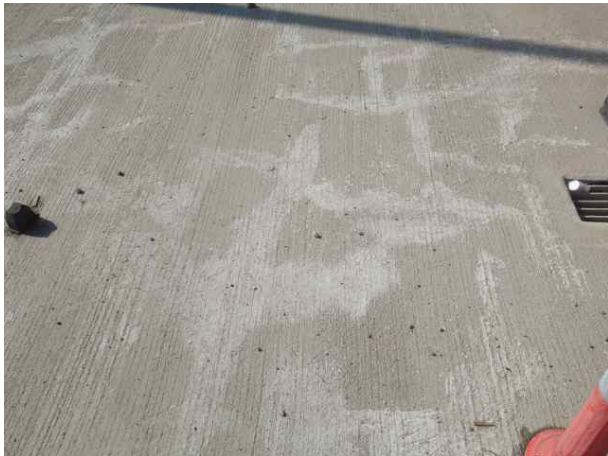
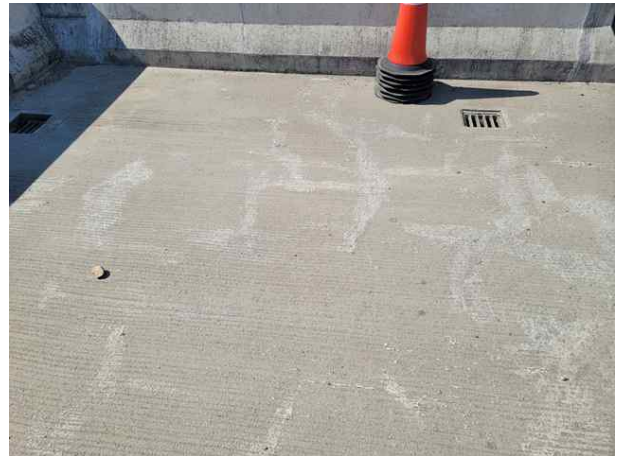
| 10<br>(25년 하반기) | 교면포장(S2) 망상균열 | 10<br>(26년 상반기) | 교면포장(S2) 망상균열 |

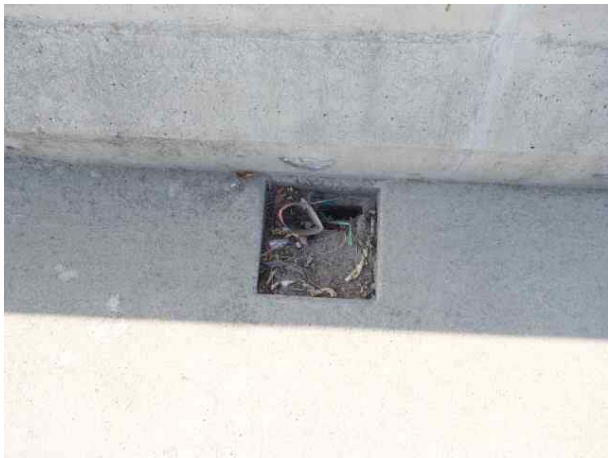
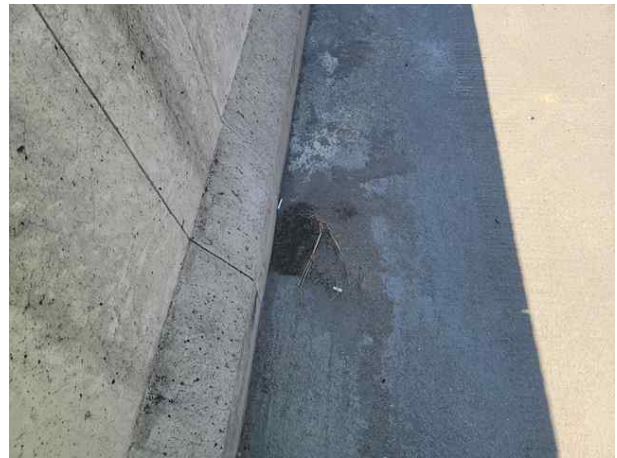
| 11<br>(25년 하반기) | 배수구(S1) 막힘 | 11<br>(26년 상반기) | 배수구(S1) 막힘 |

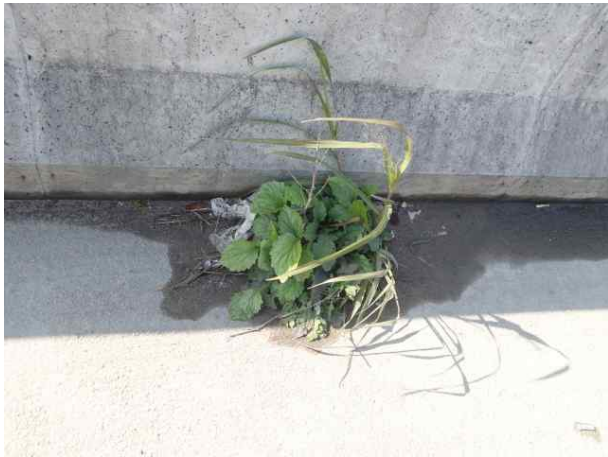
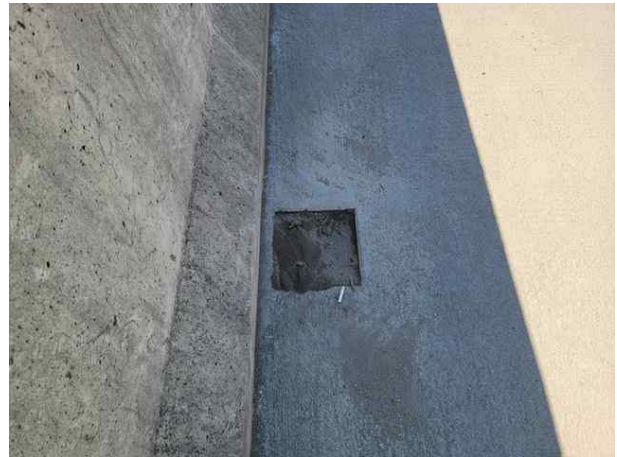
| 12<br>(25년 하반기) | 배수구(S6) 막힘 | 12<br>(26년 상반기) | 배수구(S6) 막힘 |

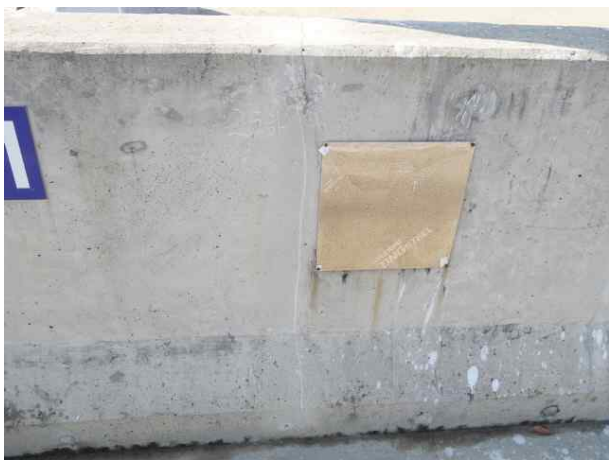
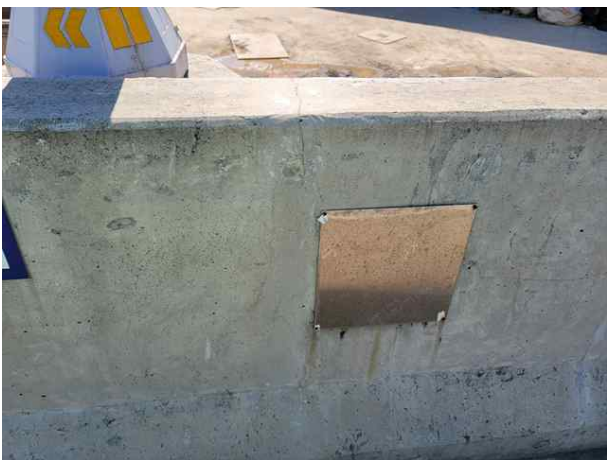
| 13<br>(25년 하반기) | 방호벽(S1) 균열(0.3mm이상) | 13<br>(26년 상반기) | 방호벽(S1) 균열(0.3mm이상) |

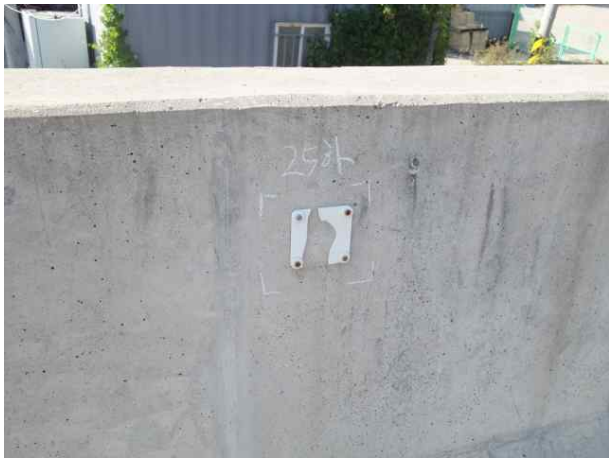
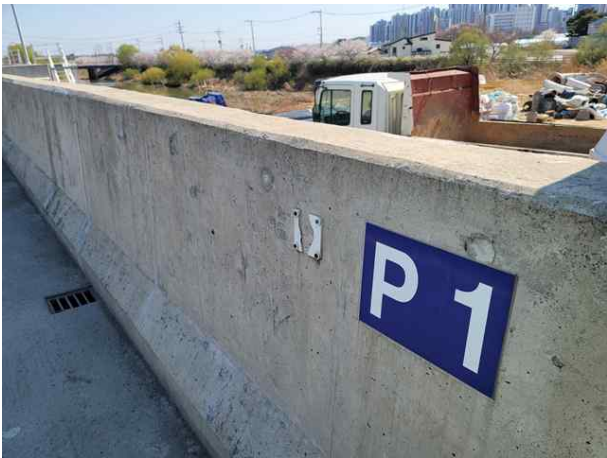
| 14<br>(25년 하반기) | 방호벽(S1) 델리네이터 파손 | 14<br>(26년 상반기) | 방호벽(S1) 델리네이터 파손 |

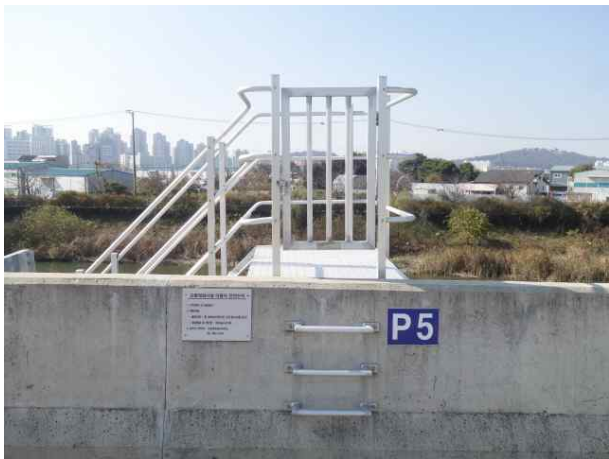
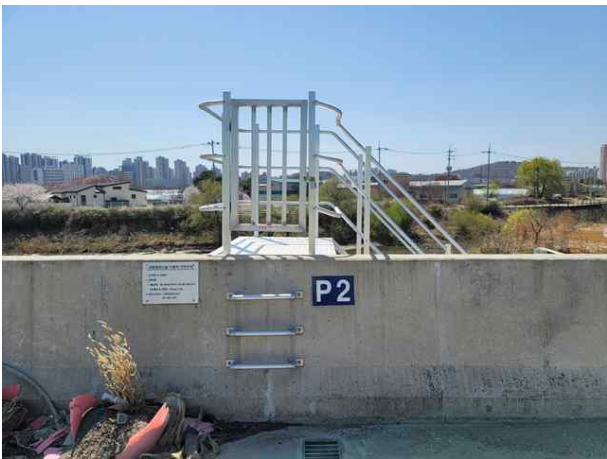
| 15<br>(25년 하반기) | 점검시설(P5) 점검사다리 상태양호 | 15<br>(26년 상반기) | 점검시설(P2) 점검사다리 상태양호 |

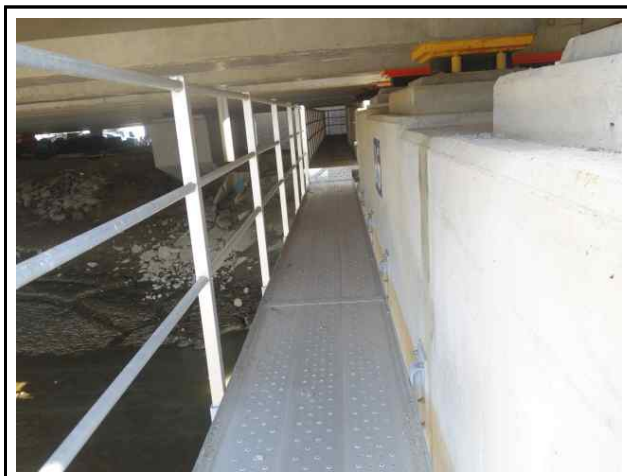
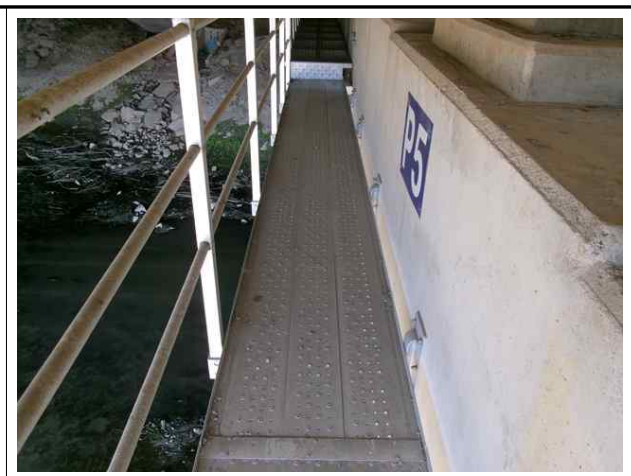
| <p>16<br/>(25년 하반기)</p> | <p>16<br/>(26년 상반기)</p> |

| <p>점검시설(P5) 점검로 상태양호</p> | <p>점검시설(P5) 점검로 상태양호</p> |

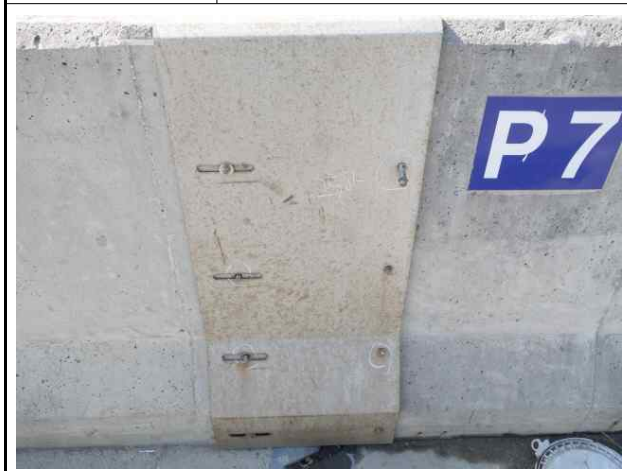
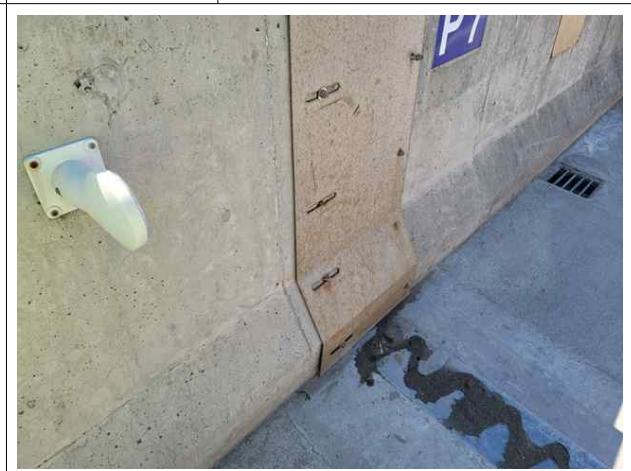
| <p>17<br/>(25년 하반기)</p> | <p>17<br/>(26년 상반기)</p> |

| <p>신축이음(P7) 덮개 볼트탈락(4ea)</p> | <p>신축이음(P7) 덮개 볼트탈락(4ea)</p> |

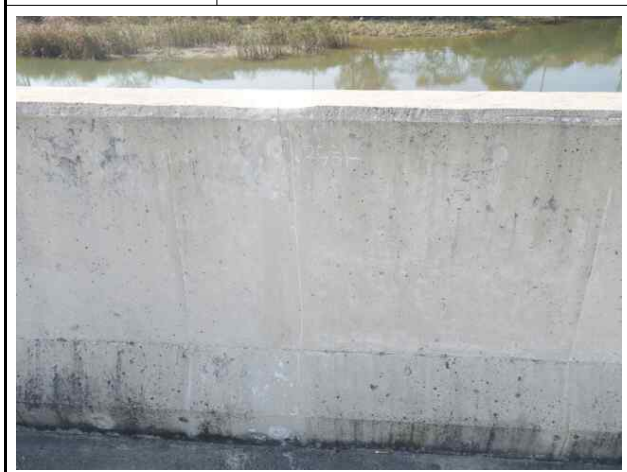
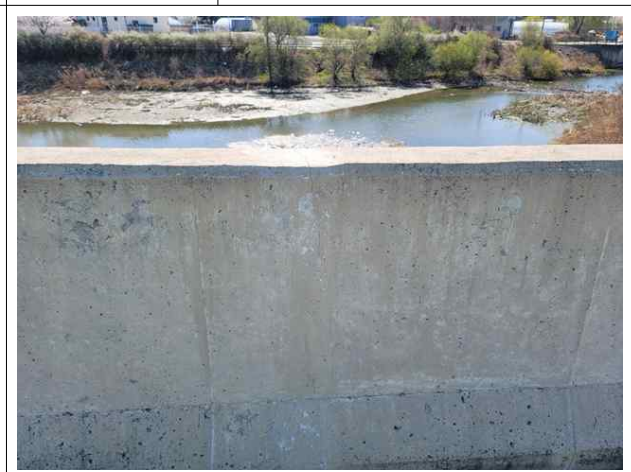
| <p>18<br/>(25년 하반기)</p> | <p>18<br/>(26년 상반기)</p> |

| <p>방호벽(S3) 균열(0.3mm미만)</p> | <p>방호벽(S3) 균열(0.3mm미만)</p> |
