## 8. 군하교

## 손상현황

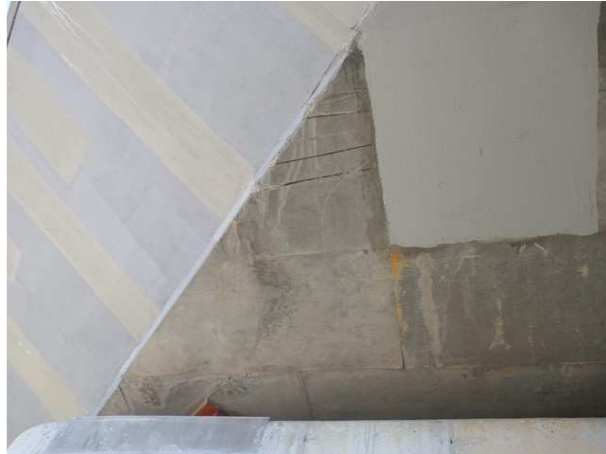
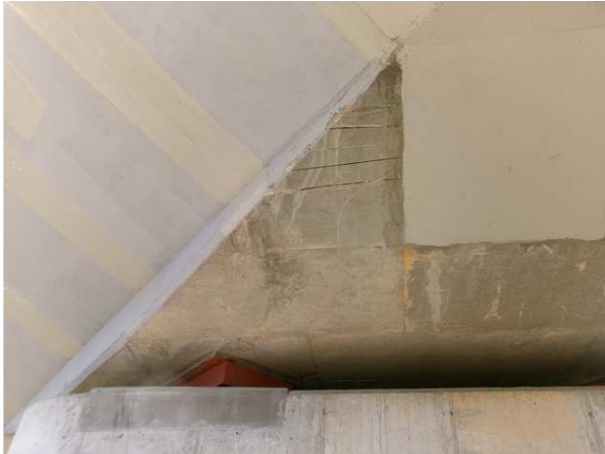
| 01<br>(25년 하반기) | 바닥판하면(S1)<br>균열(0.3mm미만) | 01<br>(26년 상반기) | 바닥판하면(S1)<br>균열(0.3mm미만) |

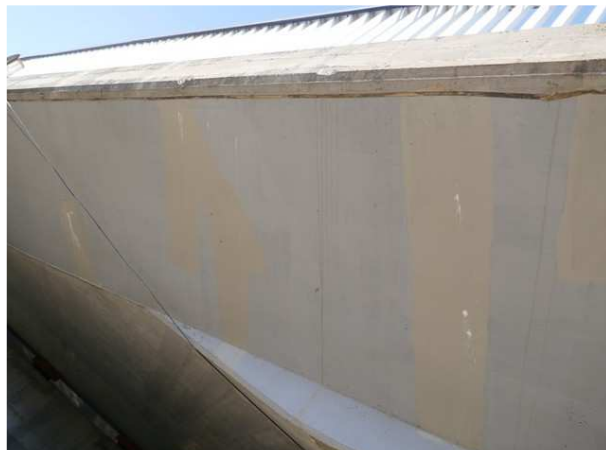
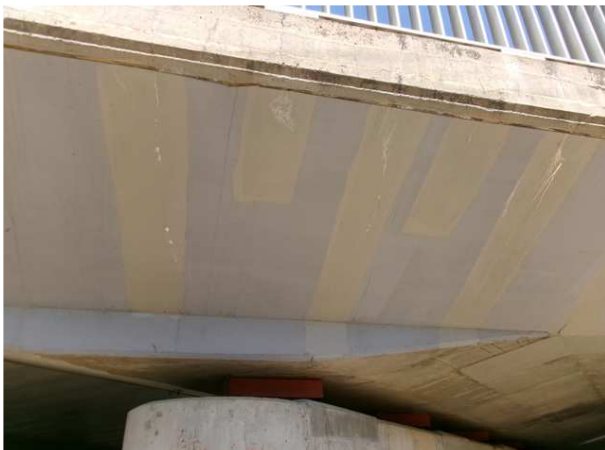
| 02<br>(25년 하반기) | 바닥판하면(S1) 보수부 백태 | 02<br>(26년 상반기) | 바닥판하면(S1) 보수부 백태 |

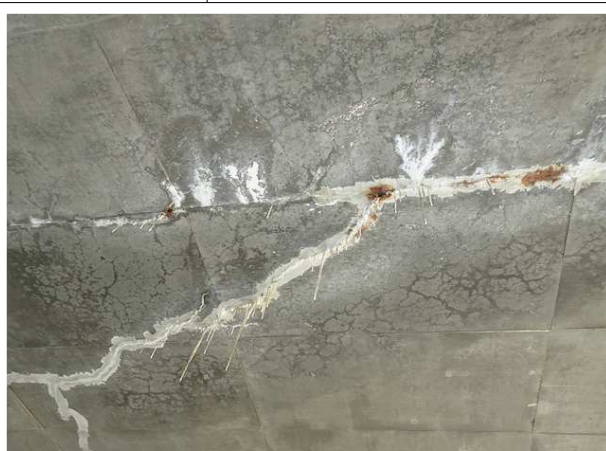
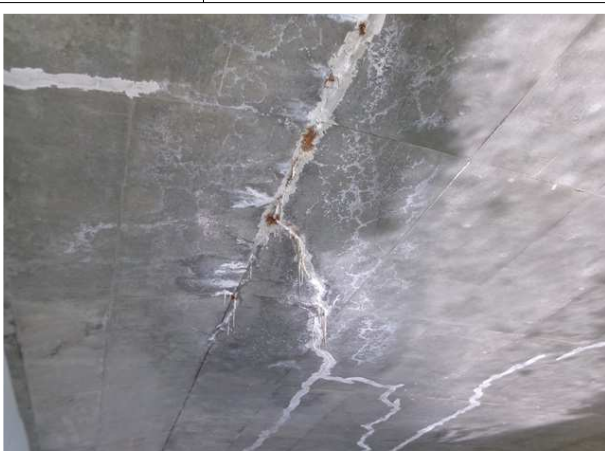
| 03<br>(25년 하반기) | 바닥판하면(S5) 녹물 및 백태 | 03<br>(26년 상반기) | 바닥판하면(S5) 녹물 및 백태 |

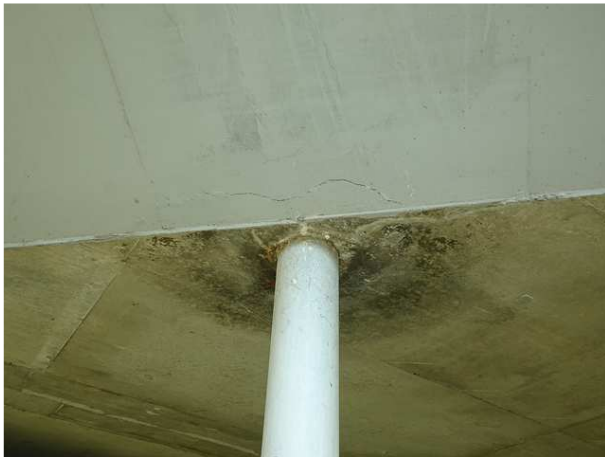
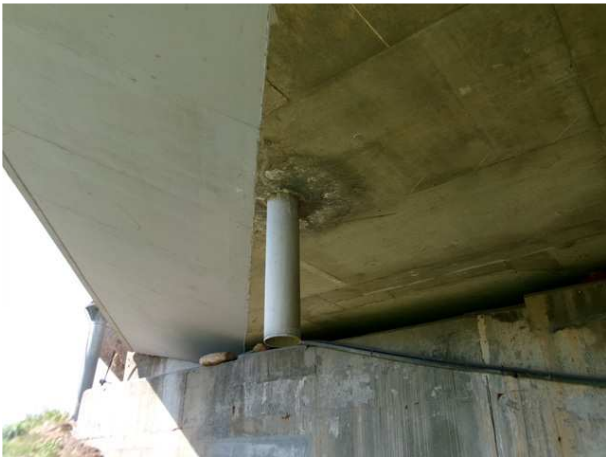
| 04<br>(25년 하반기) | 배수관(S6) 주변 박락 | 04<br>(26년 상반기) | 배수관(S6) 주변 박락 |

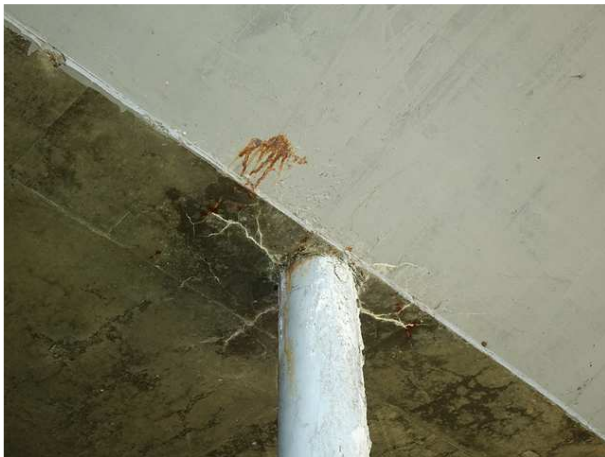
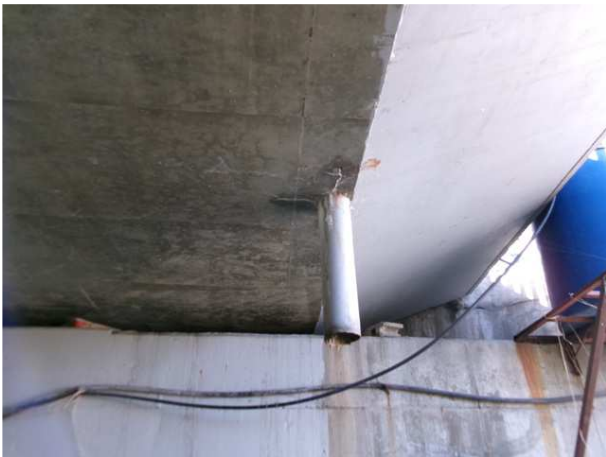
| 05<br>(25년 하반기) | 배수관(S6) 주변 백태 | 05<br>(26년 상반기) | 배수관(S6) 주변 백태 |

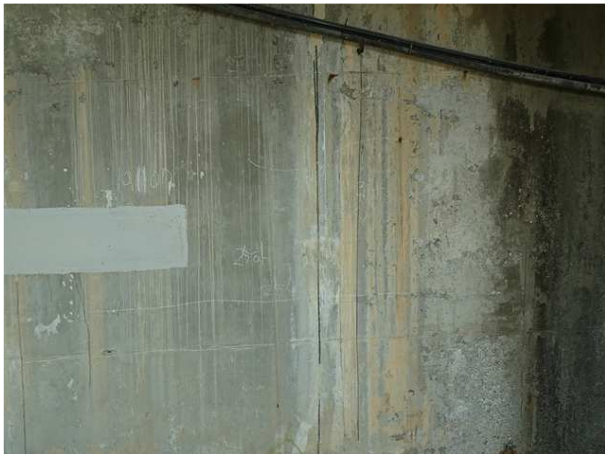
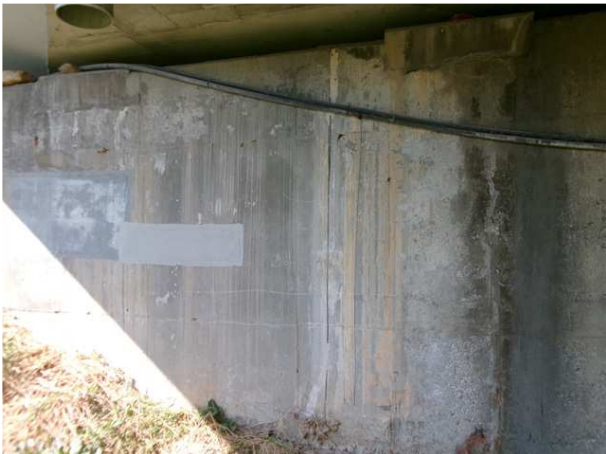
| 06<br>(25년 하반기) | 교대(A2) 벽체<br>전면 보수부 균열(0.3mm미만) | 06<br>(26년 상반기) | 교대(A2) 벽체<br>전면 보수부 균열(0.3mm미만) |

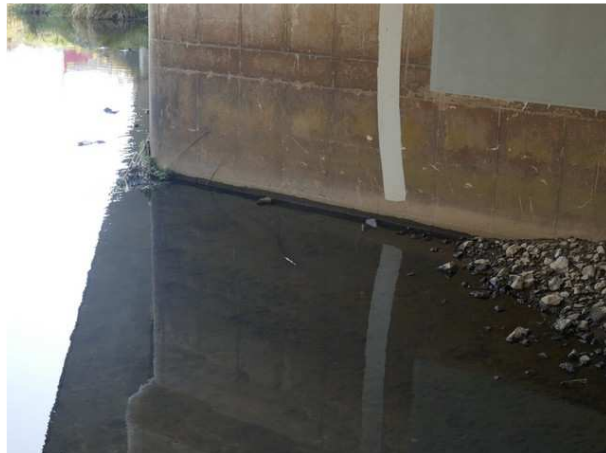
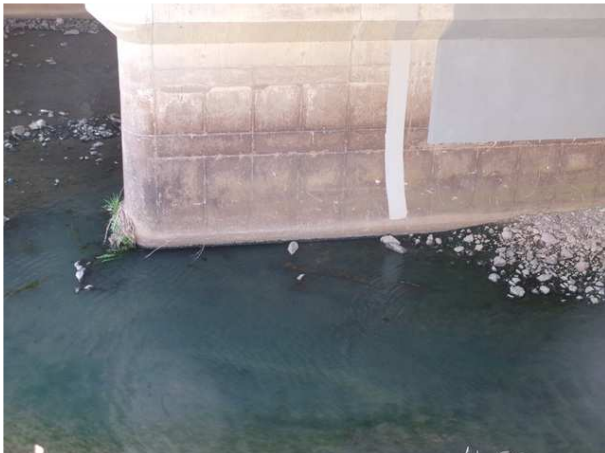
| 07<br>(25년 하반기) | 교각(P4)<br>일부 침식-토포 확보 | 07<br>(26년 상반기) | 교각(P4)<br>일부 침식-토포 확보 |

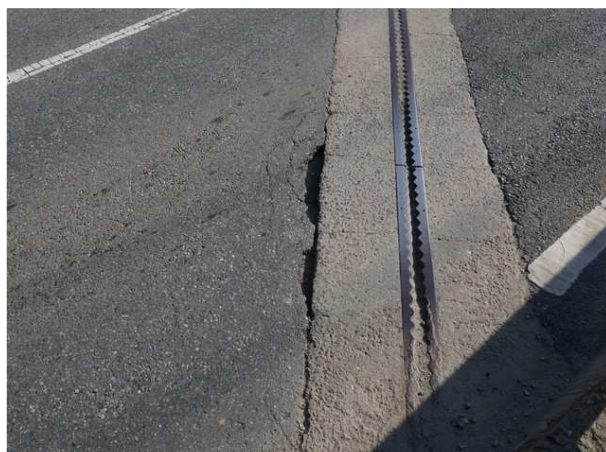
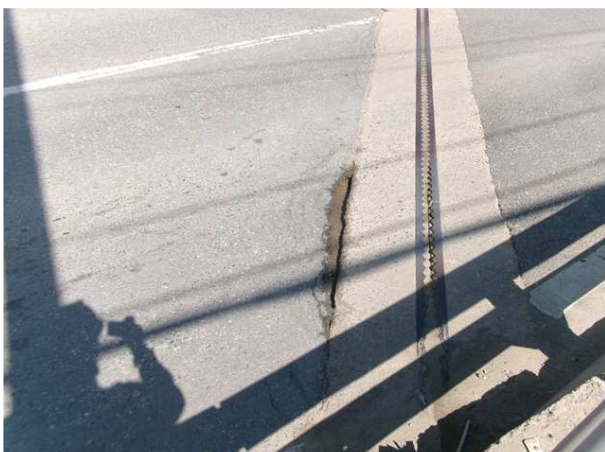
| 08<br>(25년 하반기) | 교면포장(A2) 서울방향<br>접속부 포장 파손 | 08<br>(26년 상반기) | 교면포장(A2) 서울방향<br>접속부 포장 파손 |

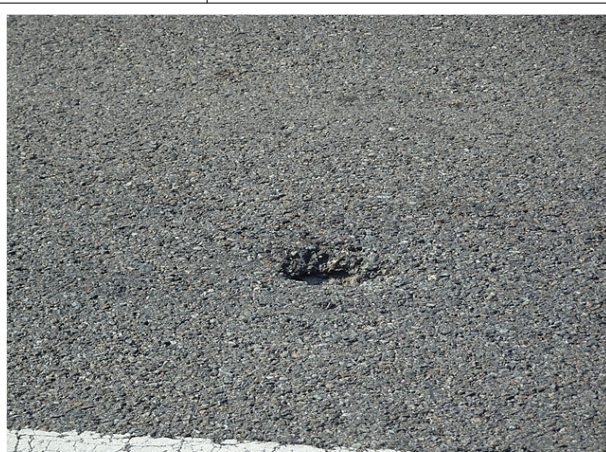
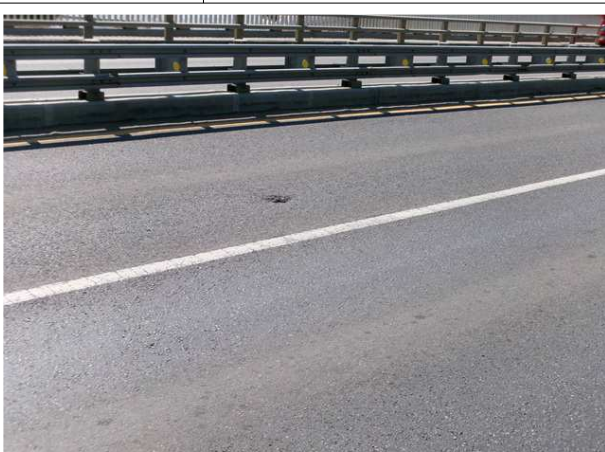
| 09<br>(25년 하반기) | 교면포장(S2) 강화방향 패임 | 09<br>(26년 상반기) | 교면포장(S2) 강화방향 패임 |

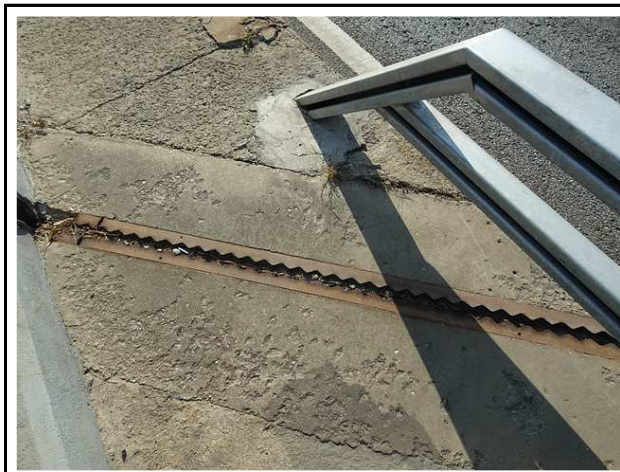
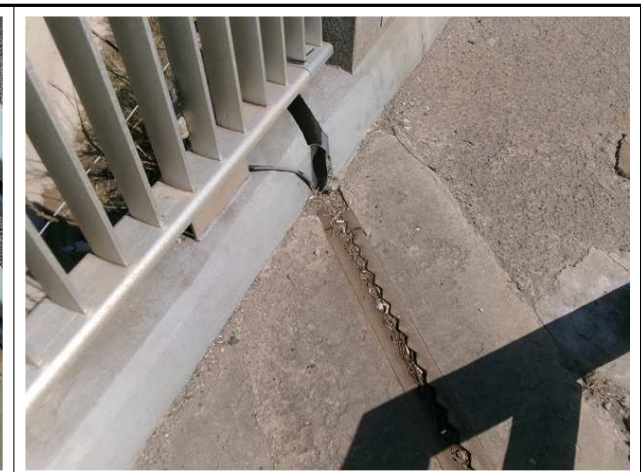
| <p>10<br/>(25년 하반기)</p> | <p>10<br/>(26년 상반기)</p> |

신축이음(A1) 표면열화

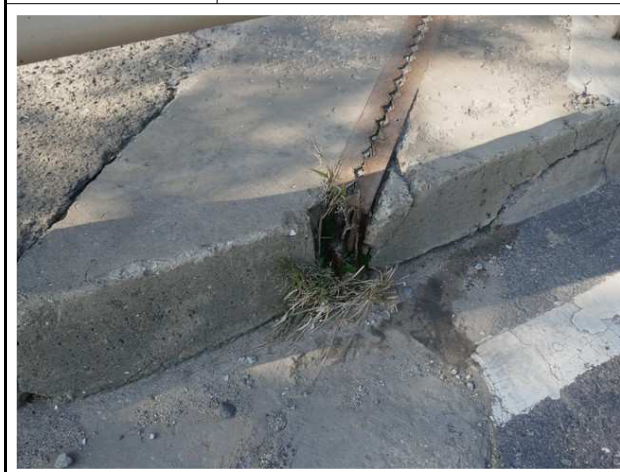
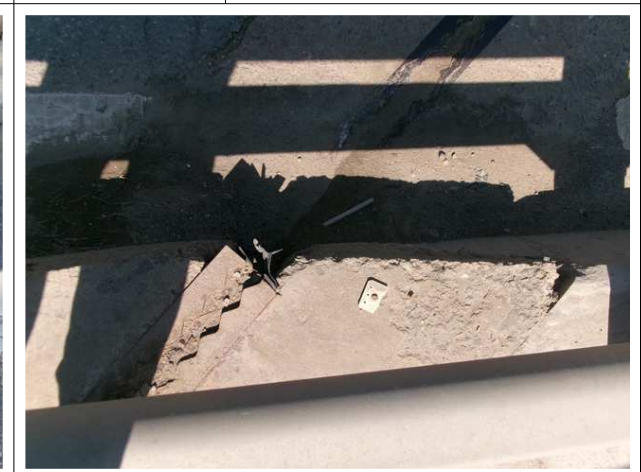
| <p>11<br/>(25년 하반기)</p> | <p>11<br/>(26년 상반기)</p> |

신축이음(A1) 차수판 미설치

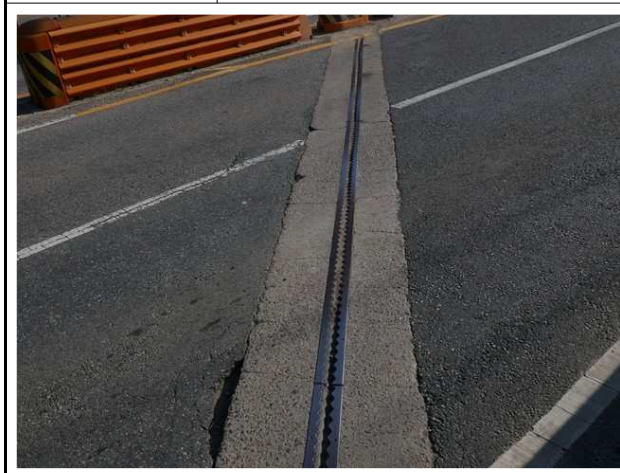
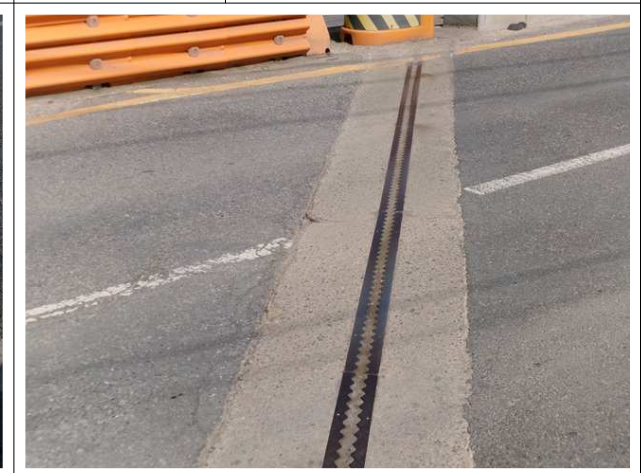
| <p>12<br/>(25년 하반기)</p> | <p>12<br/>(26년 상반기)</p> |

신축이음(A2)  
토사퇴적, 균열, 파손

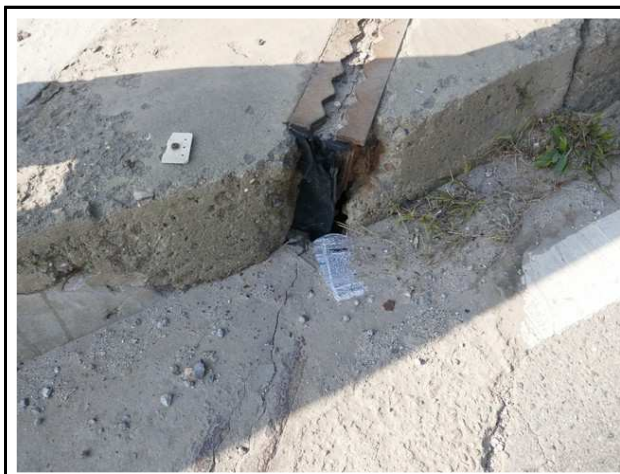
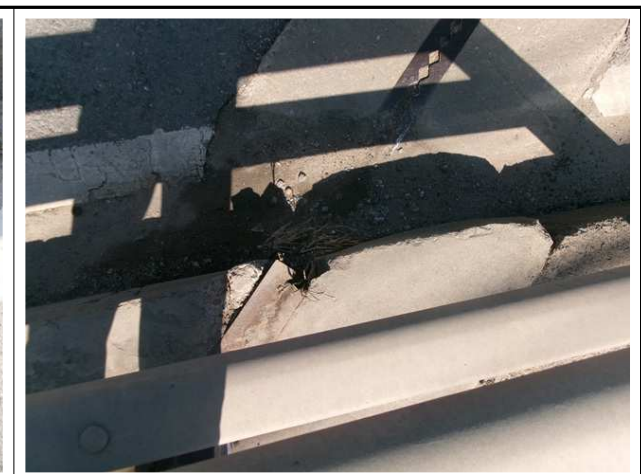
| <div>13</div> <div>(25년 하반기)</div> | <div>13</div> <div>(26년 상반기)</div> |

| 신축이음(A2) 고무재 탈락 | 신축이음(A2) 고무재 탈락 |

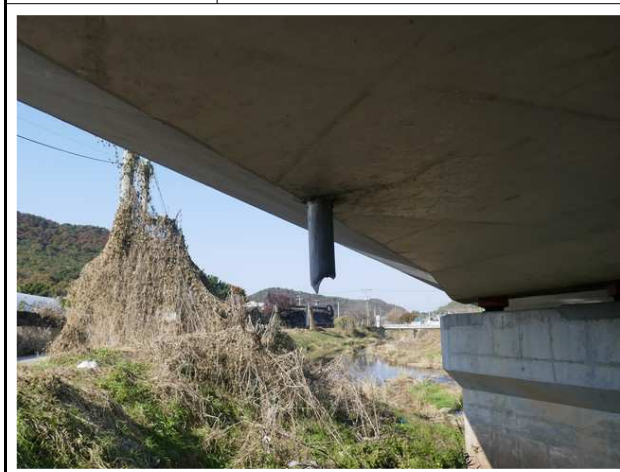
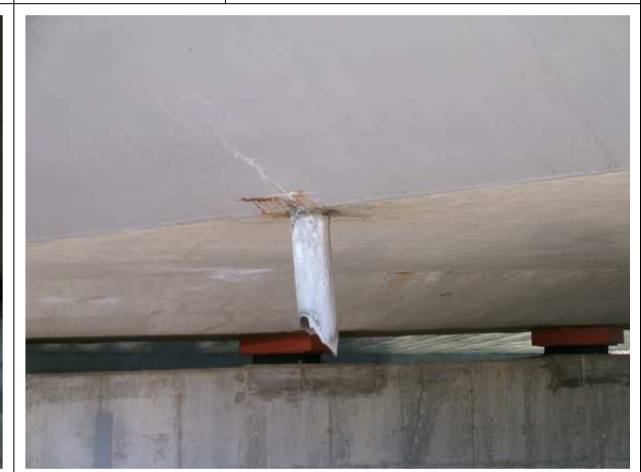
| <div>14</div> <div>(25년 하반기)</div> | <div>14</div> <div>(26년 상반기)</div> |

| 배수시설(S2) 배수관 파손 | 배수시설(S2) 배수관 파손 |

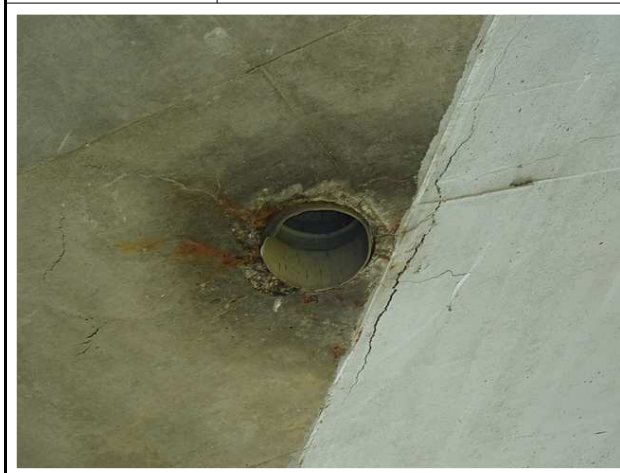
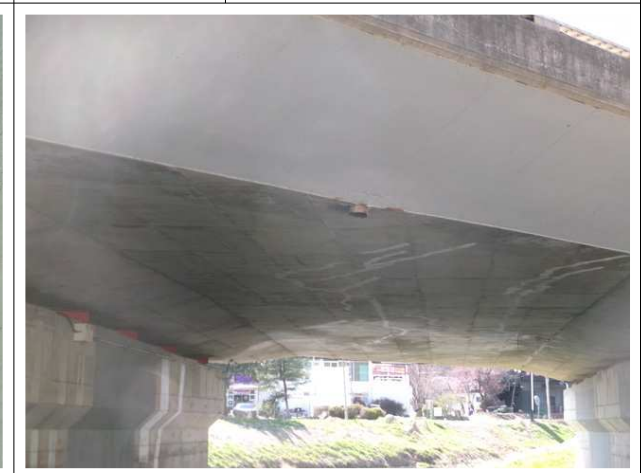
| <div>15</div> <div>(25년 하반기)</div> | <div>15</div> <div>(26년 상반기)</div> |

| 배수시설(S5) 배수관 탈락 | 배수시설(S5) 배수관 탈락 |

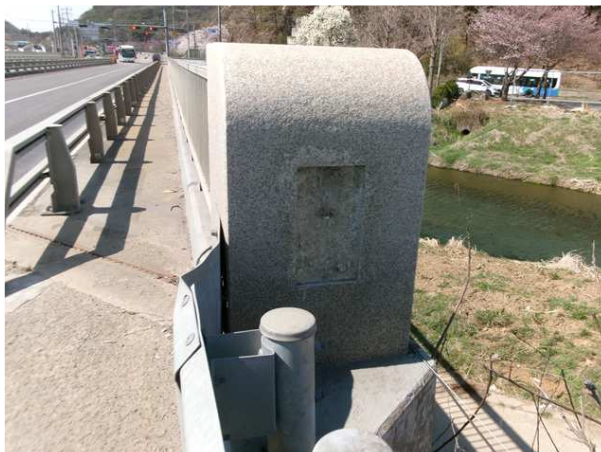
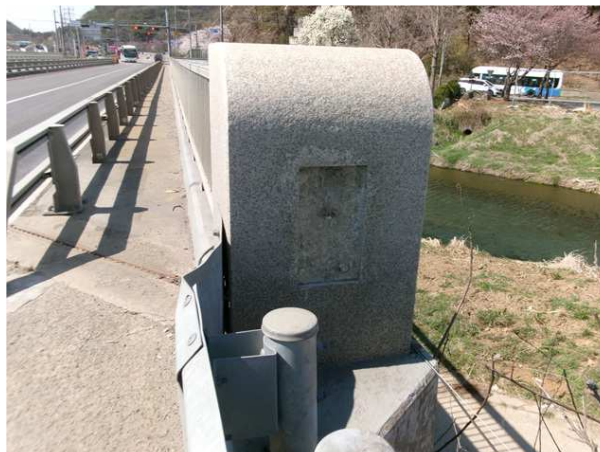
| 16<br>(25년 하반기) | 교명관(S1) 탈락 | 16<br>(26년 상반기) | 교명관(S1) 탈락 |

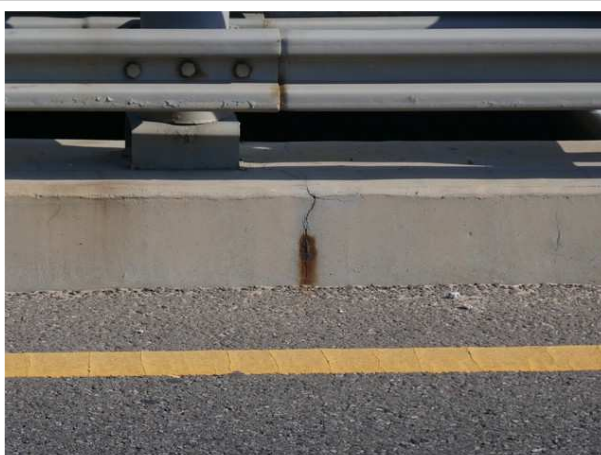
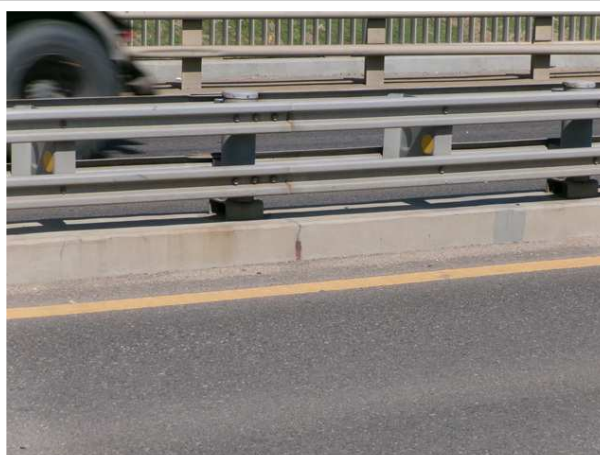
| 17<br>(25년 하반기) | 중양분리대(S1)<br>균열(0.3mm이상) | 17<br>(26년 상반기) | 중양분리대(S1)<br>균열(0.3mm이상) |

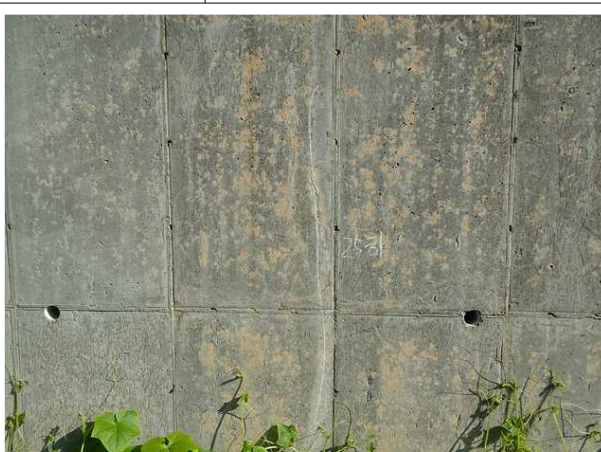
| 18<br>(25년 하반기) | 옹벽 (A2) 우측<br>보수부 균열(0.3mm미만) | 18<br>(26년 상반기) | 옹벽 (A2) 우측<br>보수부 균열(0.3mm미만) |

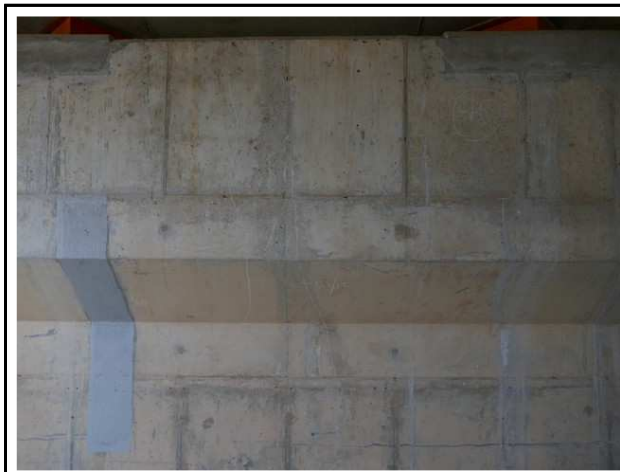
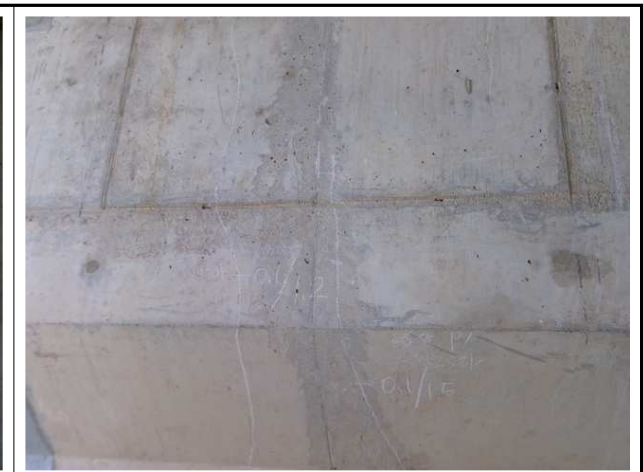
| <div>25</div> <div>(25년 하반기)</div> | <div>25</div> <div>(26년 상반기)</div> |

| <div>교각(P1) 균열 (0.3mm미만)</div> | <div>교각(P1) 균열 (0.3mm미만)</div> |

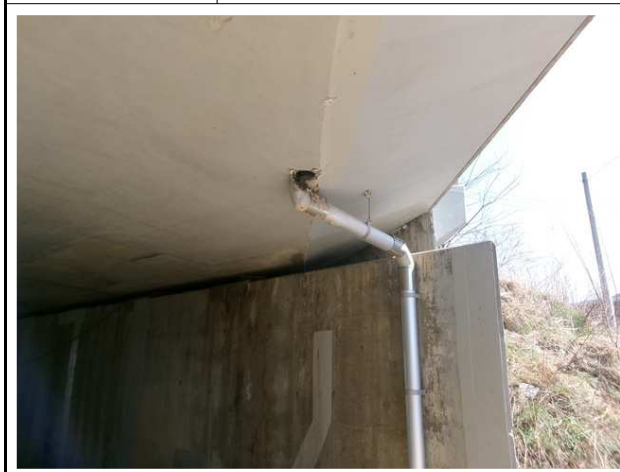
| <div>배수시설(S1) 배수관 파손</div> | <div>교명판(A2) 탈락</div> |
