## 10. 마송IC교

## 손상현황

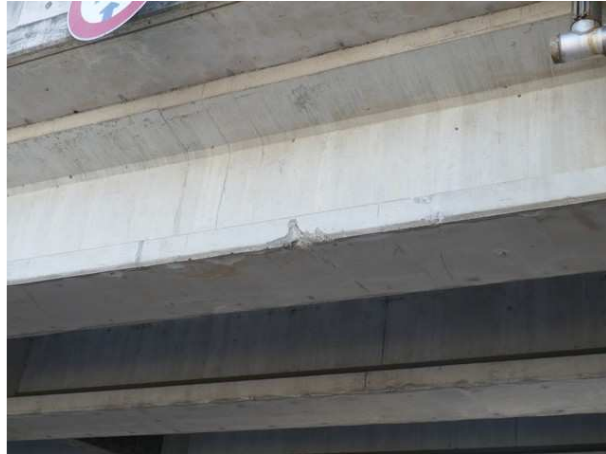
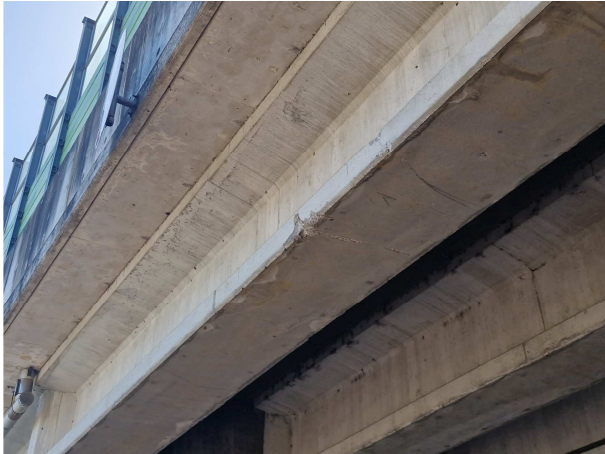
| 01<br>(25년 하반기) | 거더(A1G1, 마송)<br>파손 | 01<br>(26년 상반기) | 거더(A1G1, 마송)<br>파손 |

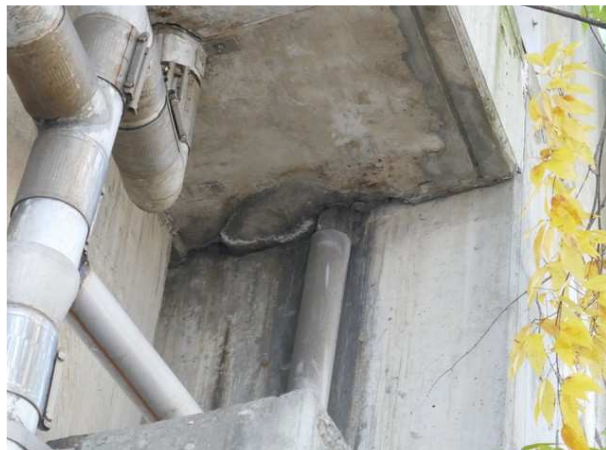
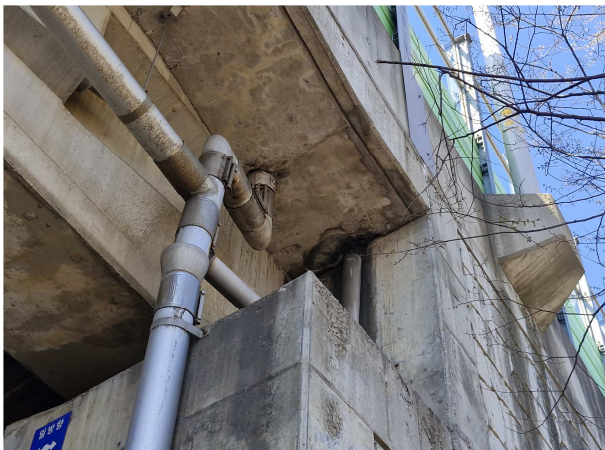
| 02<br>(25년 하반기) | 거더(A1G1, 마송)<br>파손 | 02<br>(26년 상반기) | 거더(A1G1, 마송)<br>파손 |

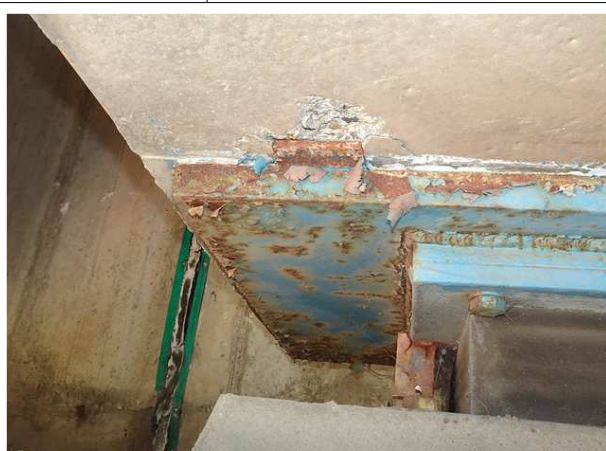
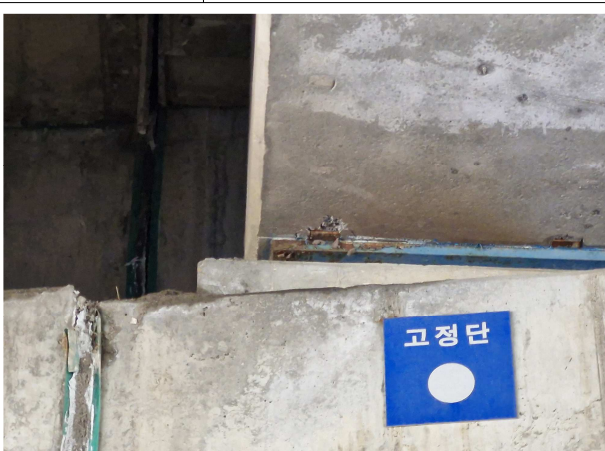
| 03<br>(25년 하반기) | 교량받침(A1-Sh5, 마송)<br>플레이트 부식 | 03<br>(26년 상반기) | 교량받침(A1-Sh5, 마송)<br>플레이트 부식 |

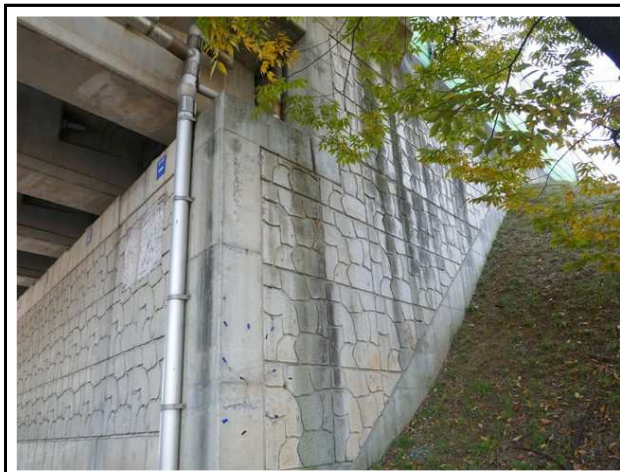
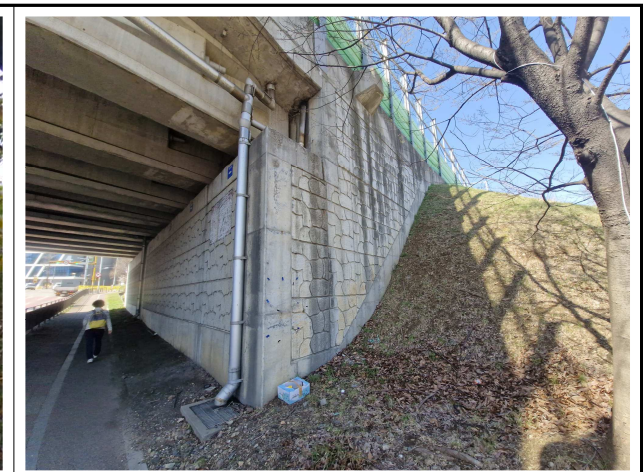
| <p>04<br/>(25년 하반기)</p> | <p>교대(A1, 마송)<br/>날개벽 표면오염</p> |

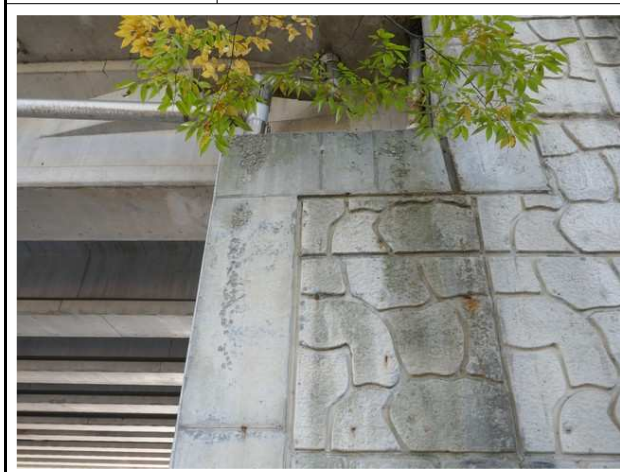
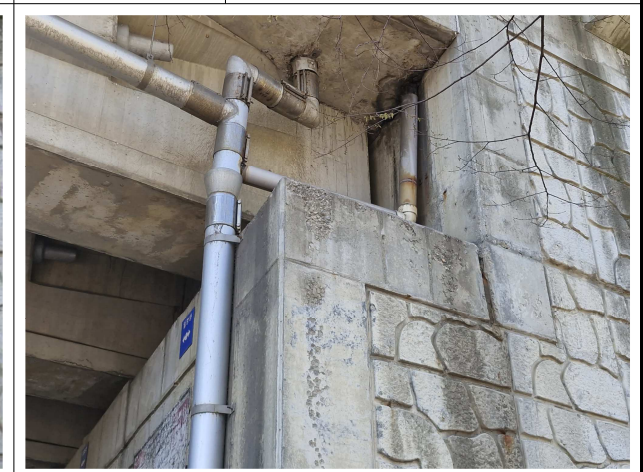
| <p>05<br/>(25년 하반기)</p> | <p>교대(A1, 마송) 벽체<br/>박리</p> |

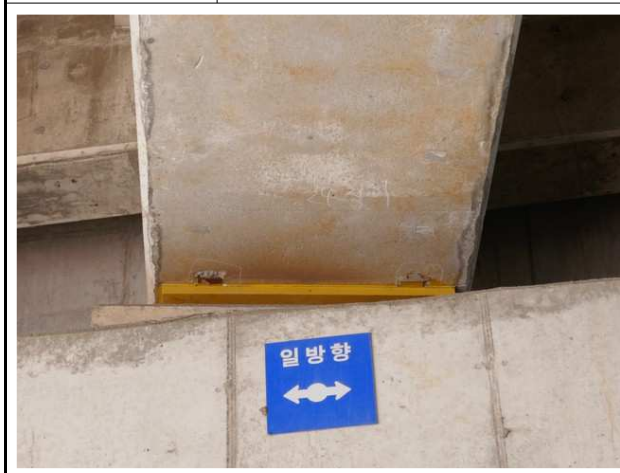
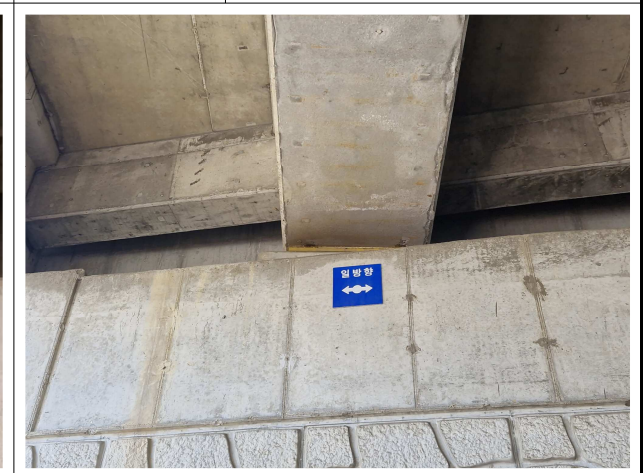
| <p>06<br/>(25년 하반기)</p> | <p>거더(A1G2, 누산)<br/>박락</p> |
| | <p>06<br/>(26년 상반기)</p> |
| | <p>거더(A1G2, 누산)<br/>박락</p> |

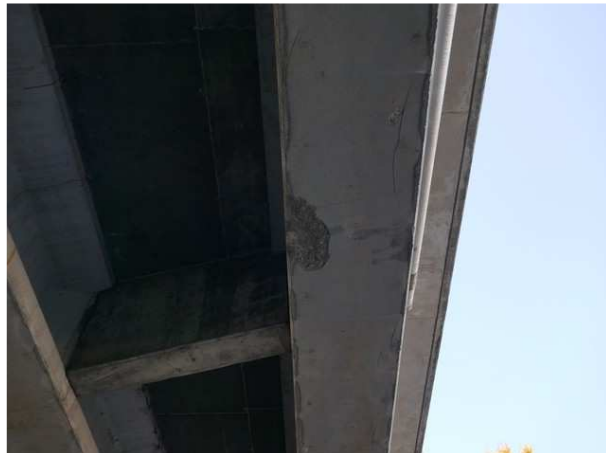
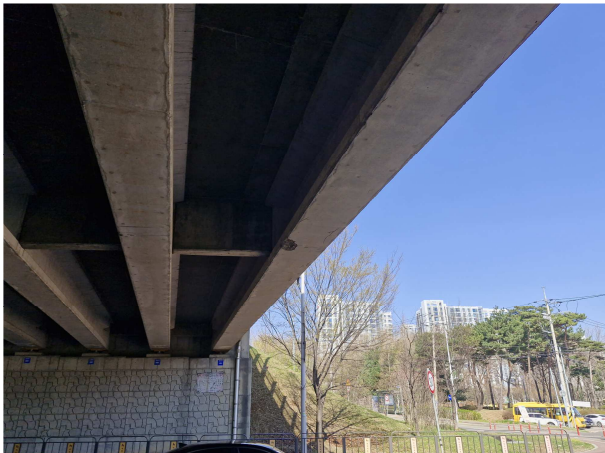
| 07<br>(25년 하반기) | 거더(A2G1, 마송)<br>파손 | 07<br>(26년 상반기) | 거더(A2G1, 마송)<br>파손 |

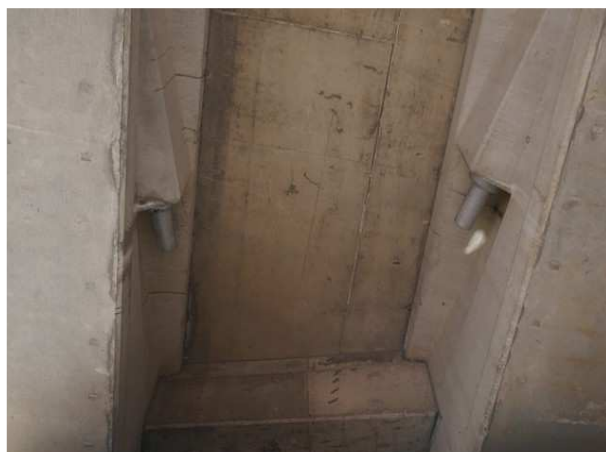
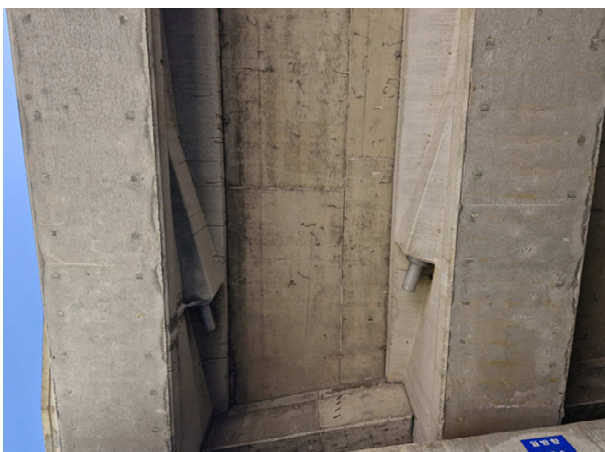
| 08<br>(25년 하반기) | 바닥판 하면(S1, 누산)<br>균열(0.3mm미만) | 08<br>(26년 상반기) | 바닥판 하면(S1, 누산)<br>균열(0.3mm미만) |

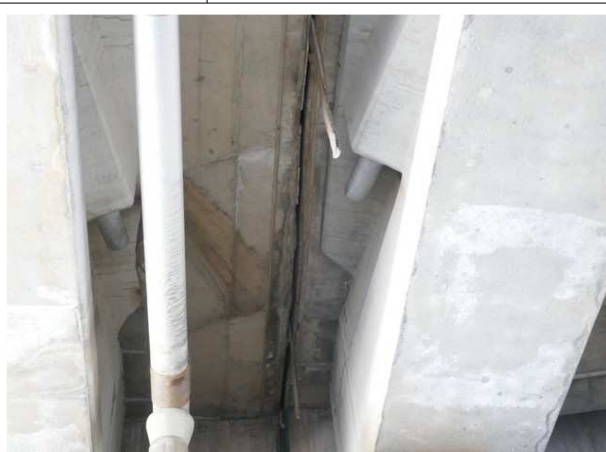
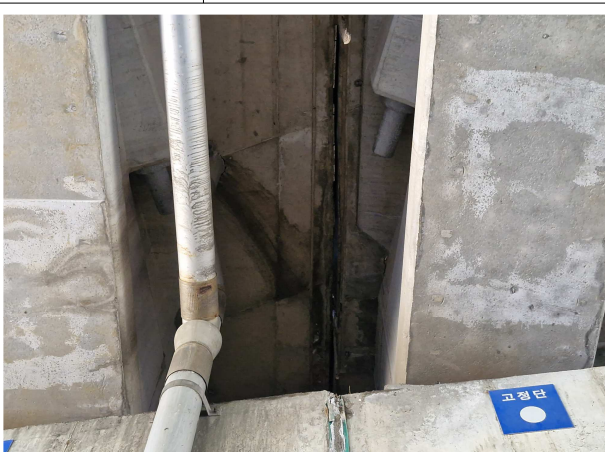
| 09<br>(25년 하반기) | 바닥판 하면(S1, 접속부)<br>실란트 열화 | 09<br>(26년 상반기) | 바닥판 하면(S1, 접속부)<br>실란트 열화 |

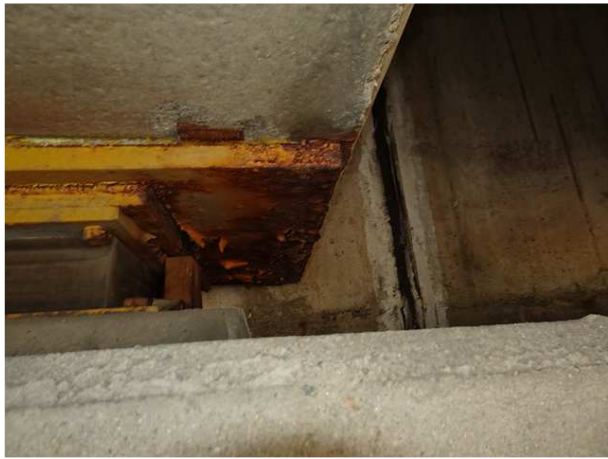
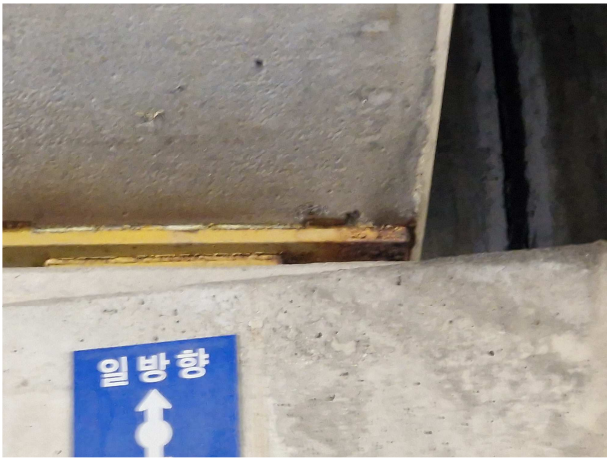
| <p>10<br/>(25년 하반기)</p> | <p>10<br/>(26년 상반기)</p> |

| <p>교량받침 (A2-Sh5, 마송)<br/>플레이트 부식</p> | <p>교량받침 (A2-Sh5, 마송)<br/>플레이트 부식</p> |

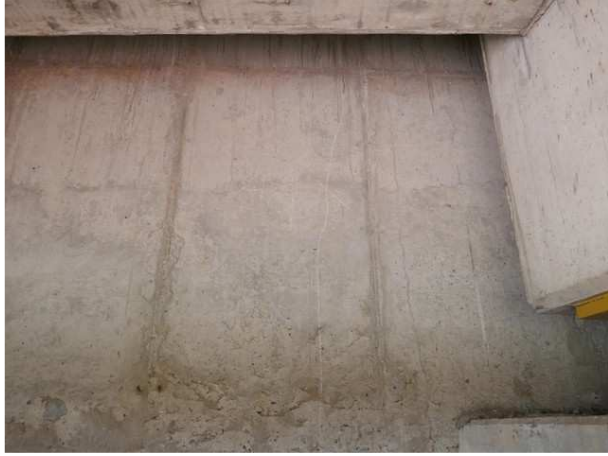
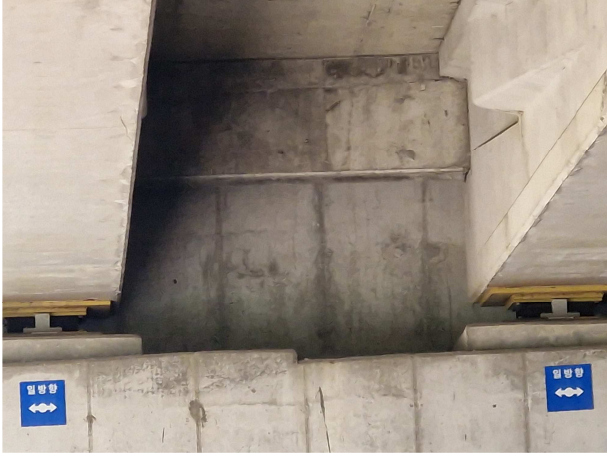
| <p>11<br/>(25년 하반기)</p> | <p>11<br/>(26년 상반기)</p> |

| <p>교대(A1, 누산) 흥벽<br/>균열(0.3mm미만)</p> | <p>교대(A1, 누산) 흥벽<br/>균열(0.3mm미만)</p> |

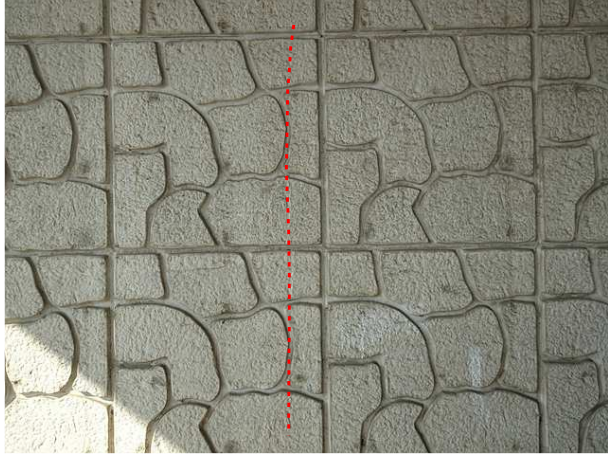
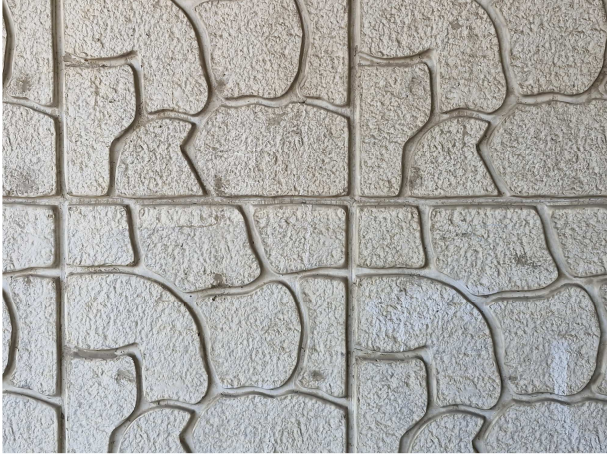
| <p>12<br/>(25년 하반기)</p> | <p>12<br/>(26년 상반기)</p> |

| <p>교대(A1, 누산) 벽체<br/>균열(0.3mm미만)</p> | <p>교대(A1, 누산) 벽체<br/>균열(0.3mm미만)</p> |

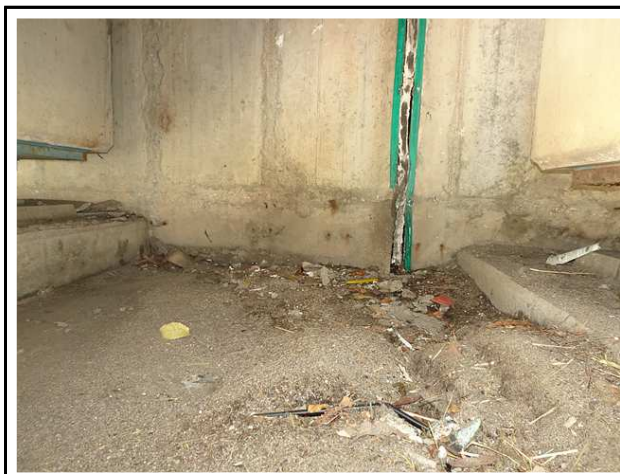
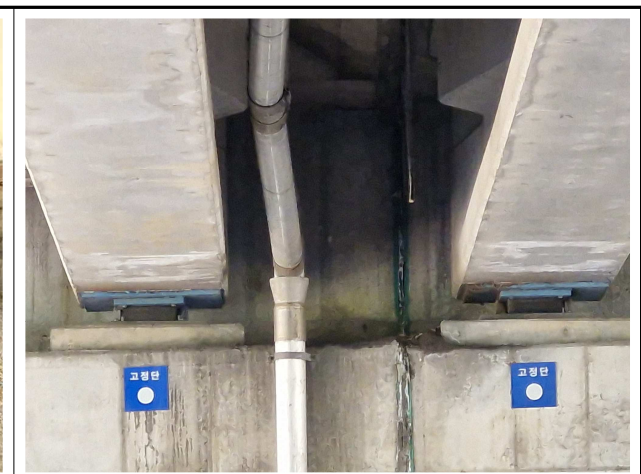
| <p>13<br/>(25년 하반기)</p> | <p>교대(A1, 누산) 교좌면<br/>토사퇴적</p> |

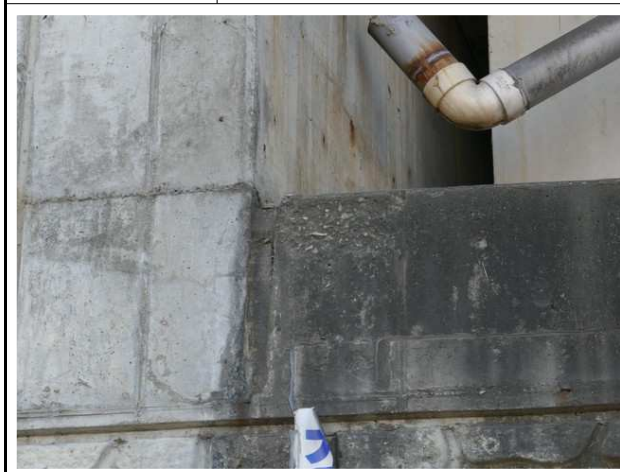
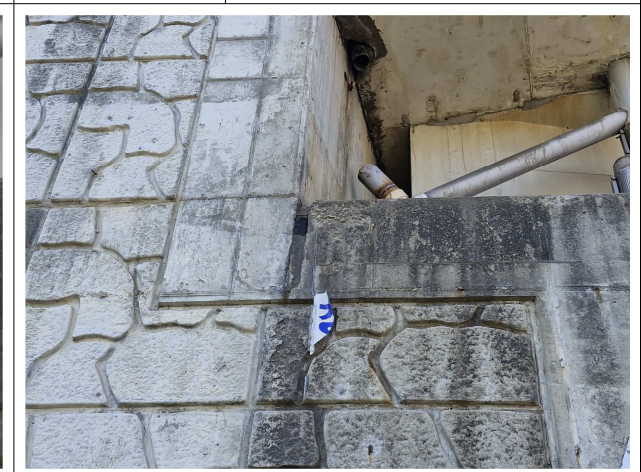
| <p>14<br/>(25년 하반기)</p> | <p>교대(A2, 마송) 벽체<br/>박리</p> |

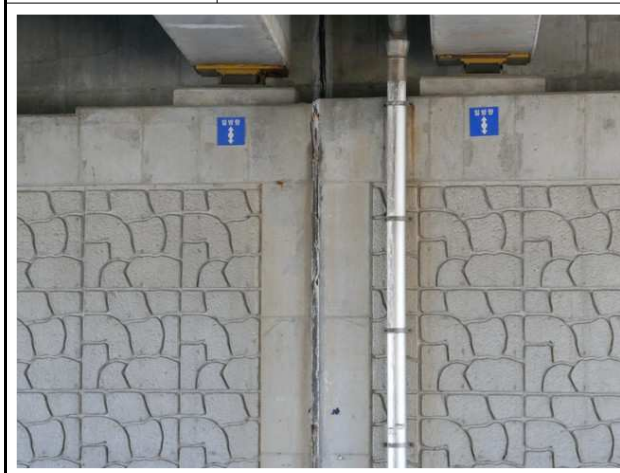
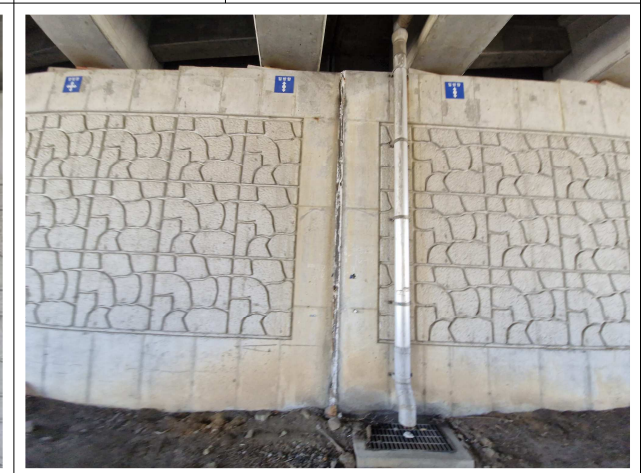
| <p>15<br/>(25년 하반기)</p> | <p>교대(A2, 접속부) 벽체<br/>실란트 열화</p> |

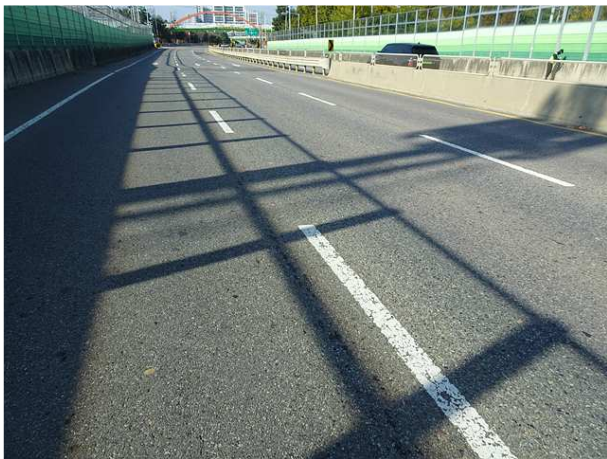
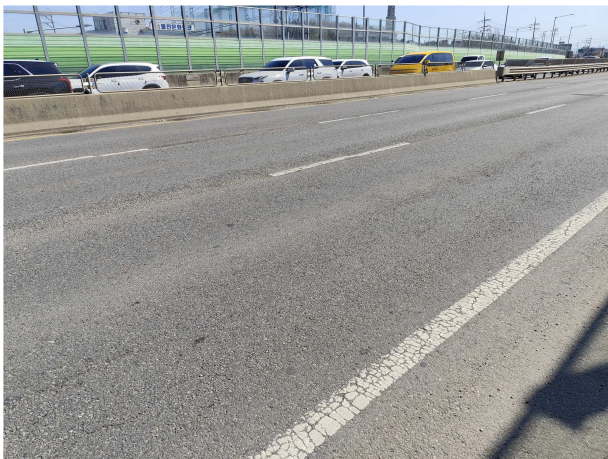
| 16<br>(25년 하반기) | 교면포장(S1, 누산)<br>마모 | 16<br>(26년 상반기) | 교면포장(S1, 누산)<br>마모 |

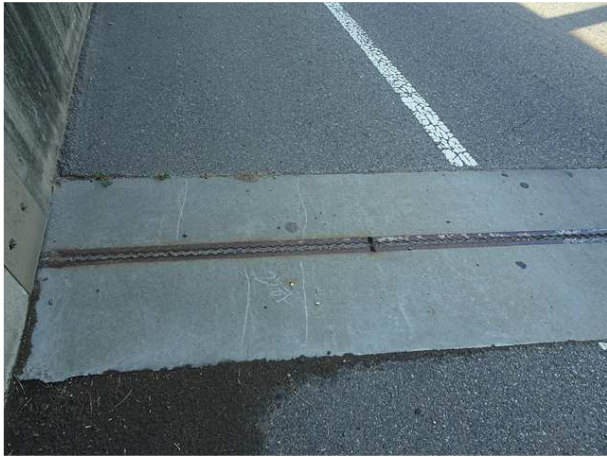
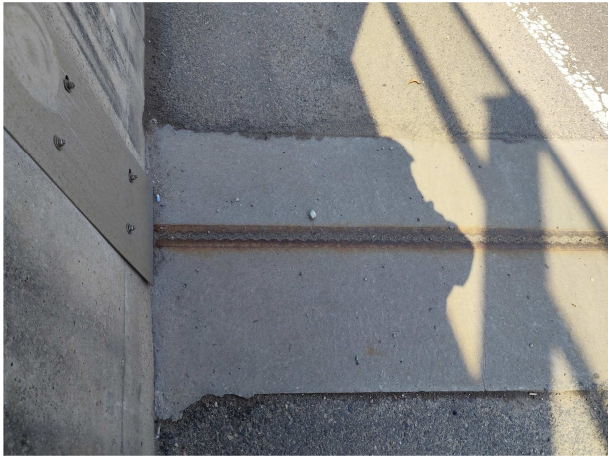
| 17<br>(25년 하반기) | 신축이음(A1, 누산)<br>본체 부식 | 17<br>(26년 상반기) | 신축이음(A1, 누산)<br>본체 부식 |

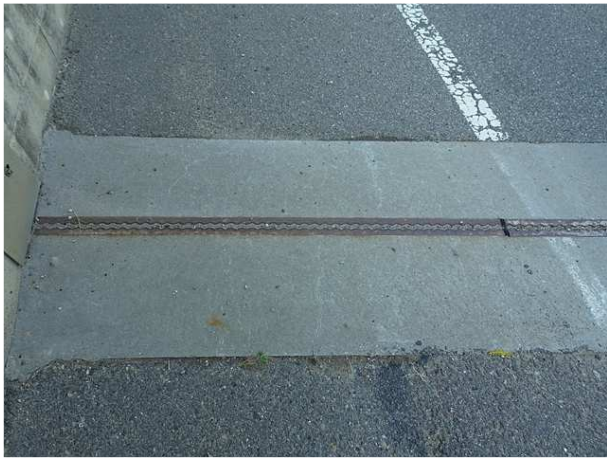
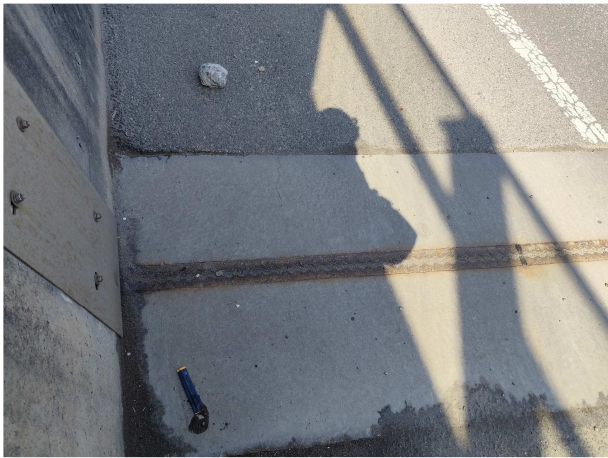
| 18<br>(25년 하반기) | 신축이음(A2, 누산)<br>본체 부식 | 18<br>(26년 상반기) | 신축이음(A2, 누산)<br>본체 부식 |

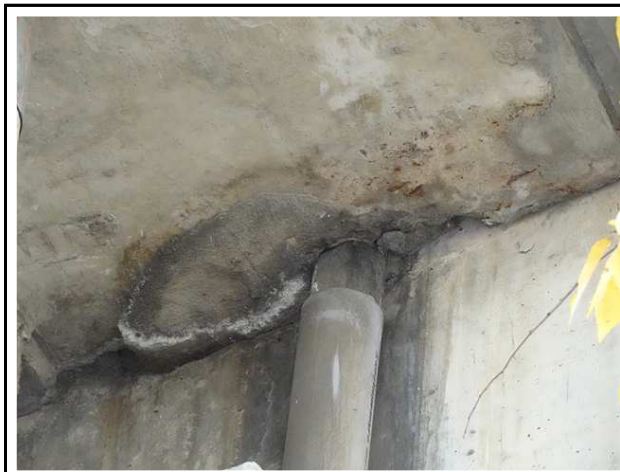
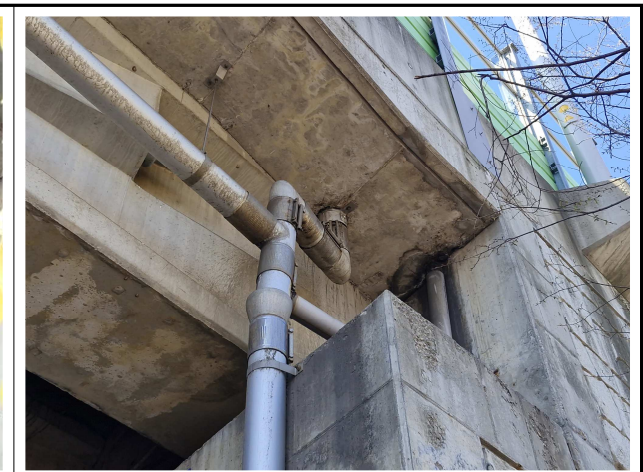
| 19<br>(25년 하반기) | 19<br>(26년 상반기) |

| 배수시설(S1, 마송)<br>누수 | 배수시설(S1, 마송)<br>누수 |

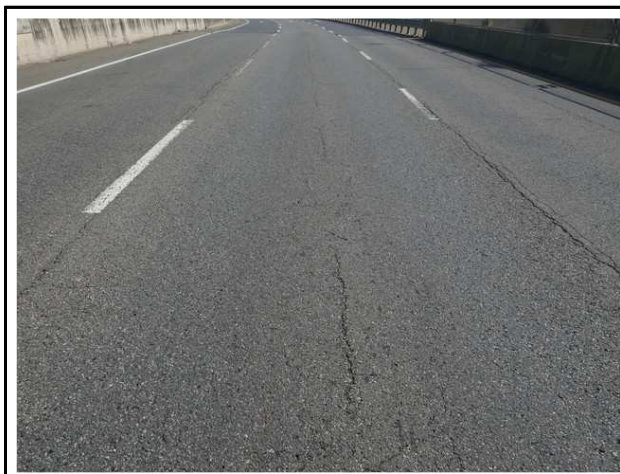
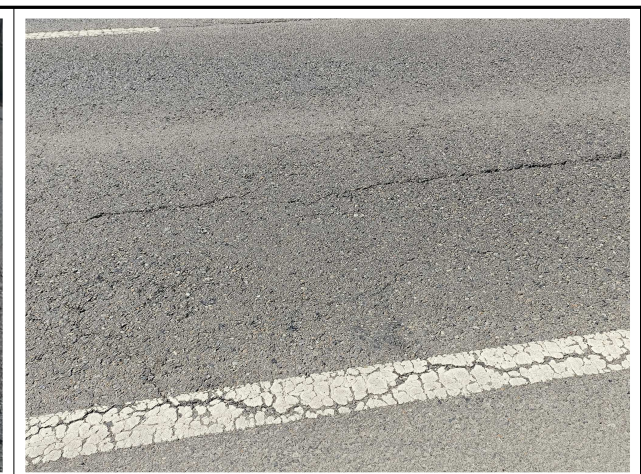
| 22<br>(25년 하반기) | 22<br>(26년 상반기) |

| 교면포장(S1, 마송)<br>아스콘 균열 | 교면포장(S1, 마송)<br>아스콘 균열 |

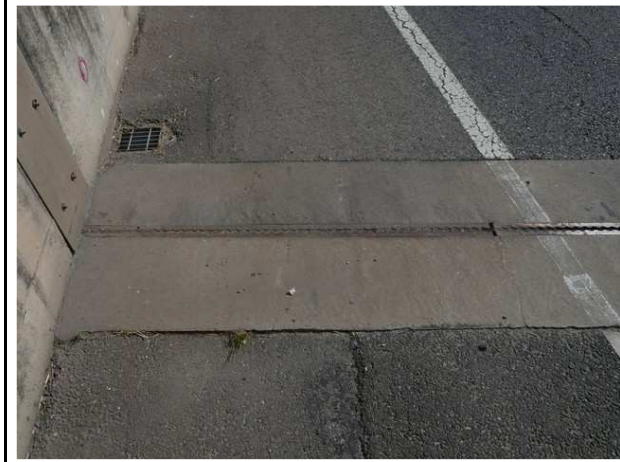
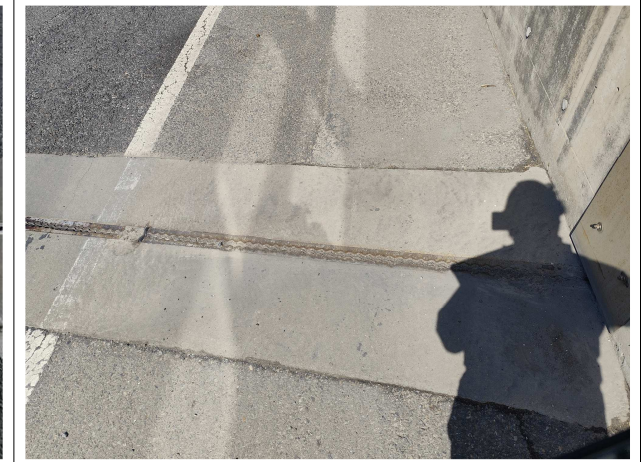
| 24<br>(25년 상반기) | 24<br>(26년 상반기) |

| 신축이음(A1, 마송)<br>본체 부식 | 신축이음(A1, 마송)<br>본체 부식 |

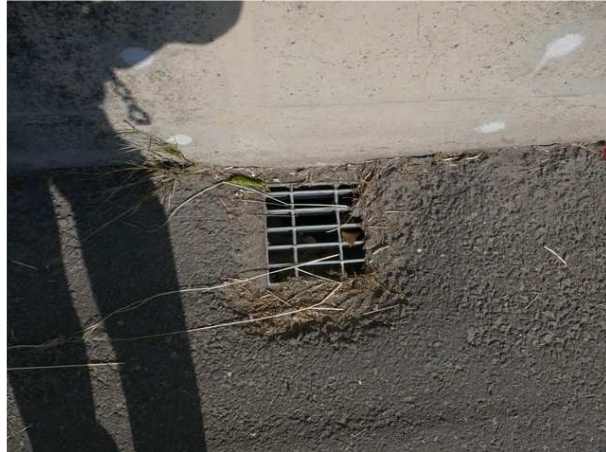
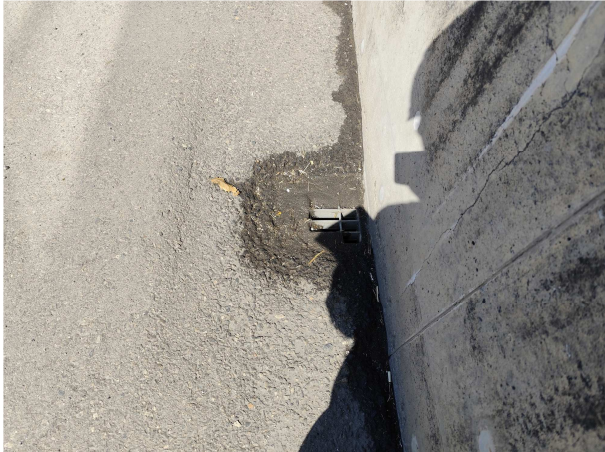
| 28<br>(25년 하반기) | 배수시설(S1, 마송)<br>배수구 이물질 퇴적 보수완료 | 28<br>(26년 상반기) | 배수시설(S1, 마송)<br>배수구 이물질 퇴적 보수완료 |

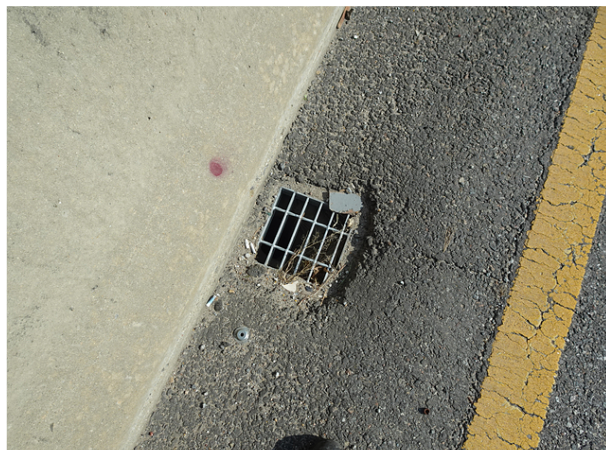
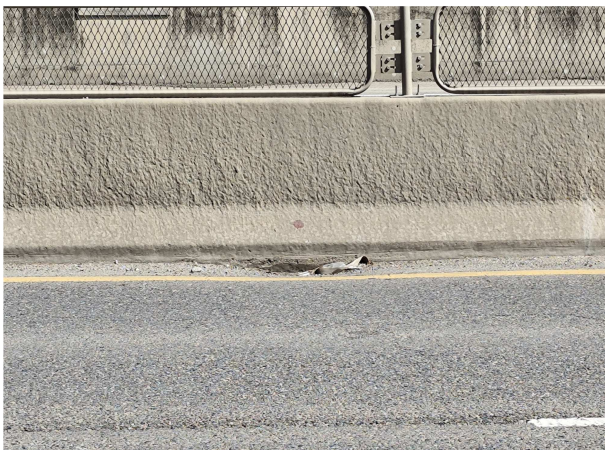
| 29<br>(25년 하반기) | 배수시설(S1, 누산)<br>배수구 막힘 보수 | 29<br>(26년 상반기) | 배수시설(S1, 누산)<br>배수구 막힘 보수 상태양호 |

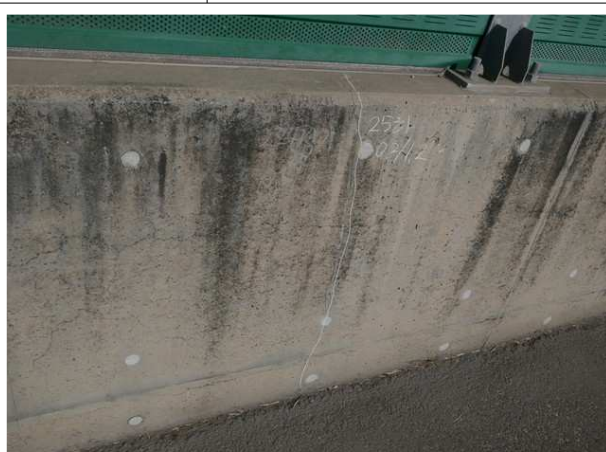
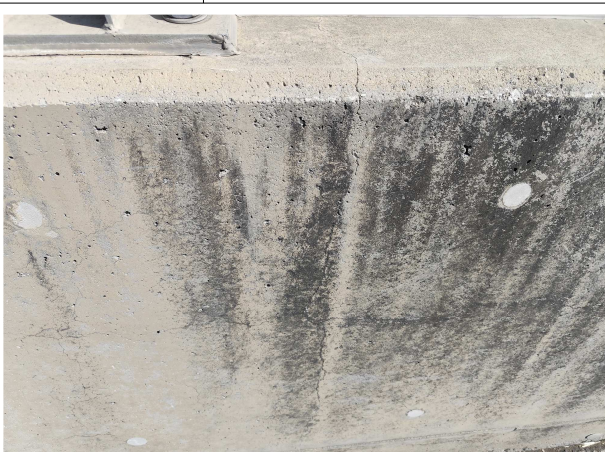
| 30<br>(25년 상반기) | 방호울타리(S1, 마송)<br>균열(0.3mm미만) | 30<br>(26년 상반기) | 방호울타리(S1, 마송)<br>균열(0.3mm미만) |

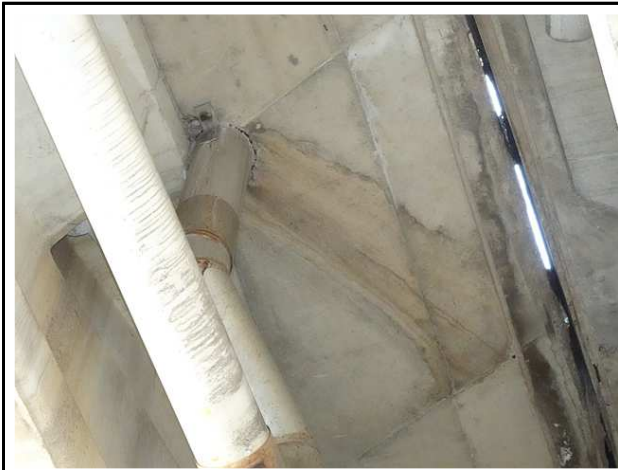
31  
(25년 하반기)

배수시설(S1, 누산)  
배수관 누수

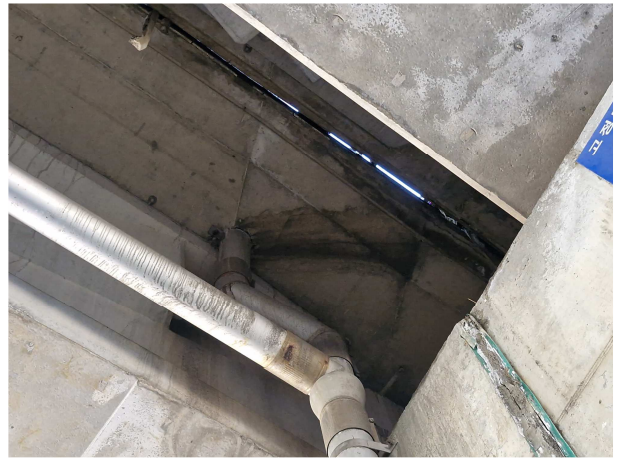
31  
(26년 상반기)

배수시설(S1, 누산)  
배수관 누수

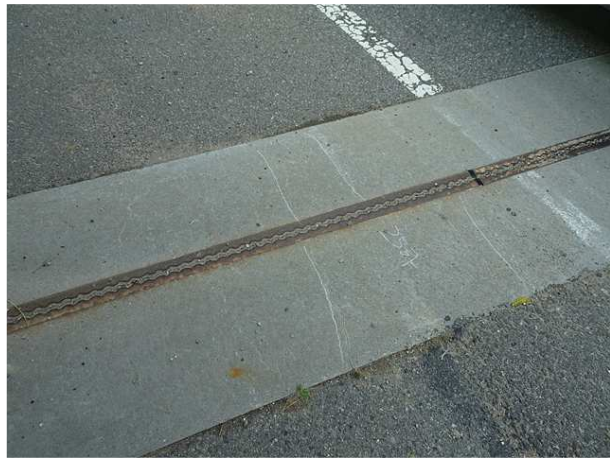
32  
(25년 하반기)

신축이음(A2, 누산)  
후타재 균열(0.3mm미만)

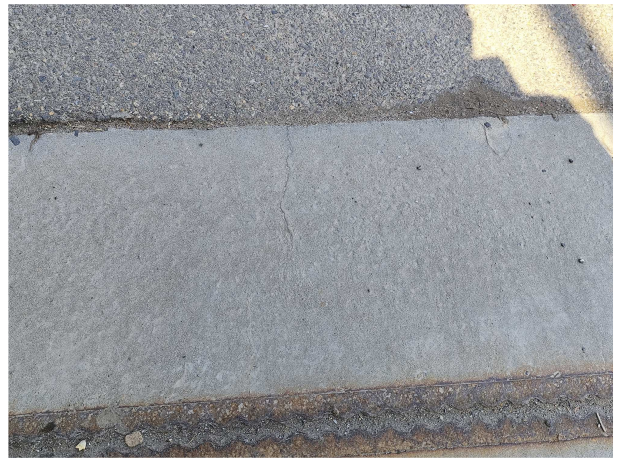
32  
(26년 상반기)

신축이음(A2, 누산)  
후타재 균열(0.3mm미만)

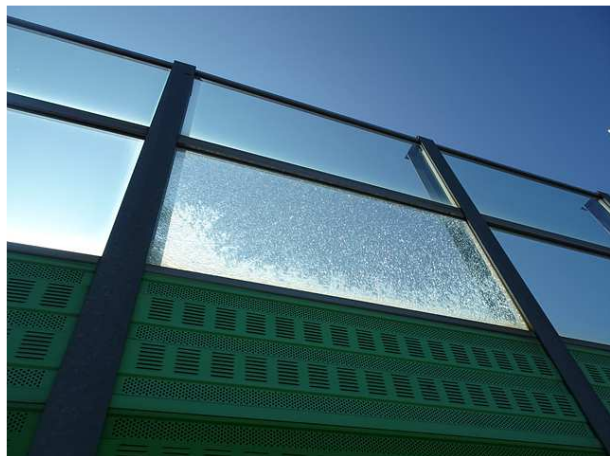
33  
(25년 상반기)

방음벽(S1, 누산)  
방음벽 유리 파손

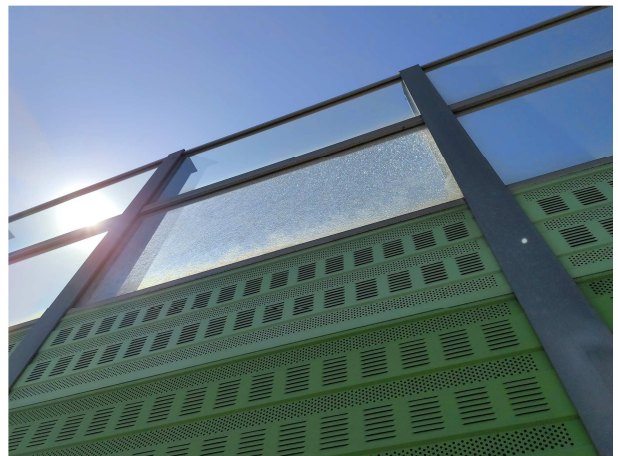
33  
(26년 상반기)

방음벽(S1, 누산)  
방음벽 유리 파손

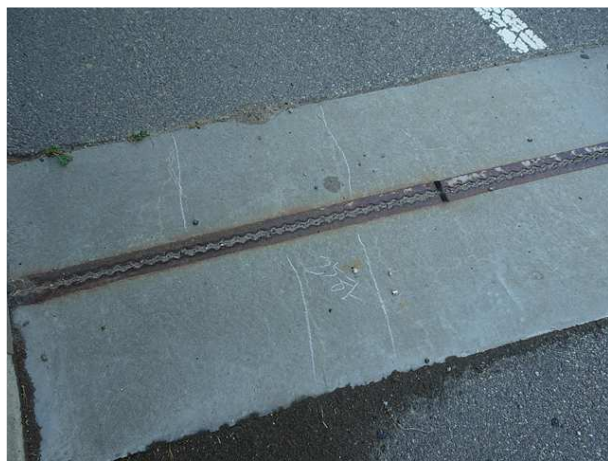
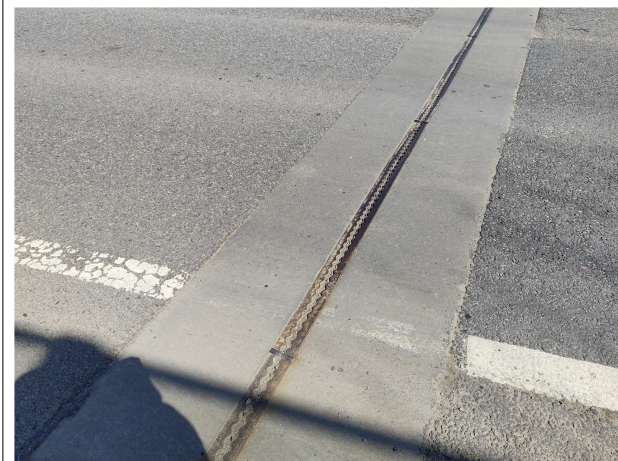
| 34<br>(25년 하반기) | 신축이음 (A1, 누산)<br>후타재 균열 (0.3mm미만) | 34<br>(26년 상반기) | 신축이음 (A1, 누산)<br>후타재 균열 (0.3mm미만) |

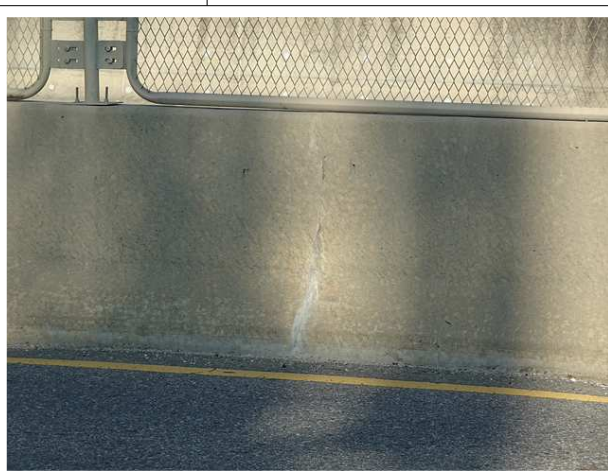
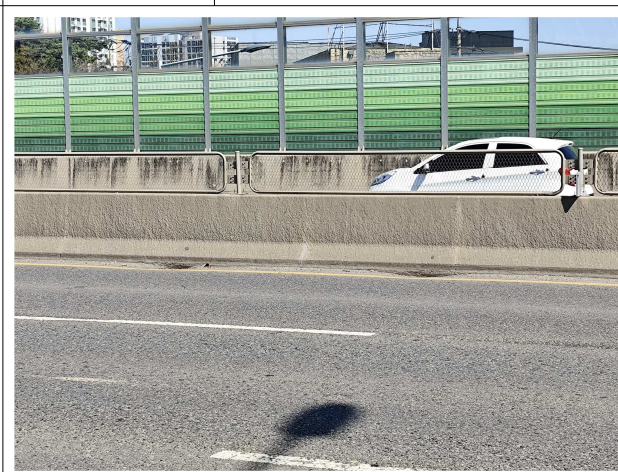
| 35<br>(25년 하반기) | 중양분리대 (누산)<br>균열부백태 (0.3mm미만) | 35<br>(26년 상반기) | 중양분리대 (누산)<br>균열부백태 (0.3mm미만) |
