## 15. 태리IC램프A교

손상현황

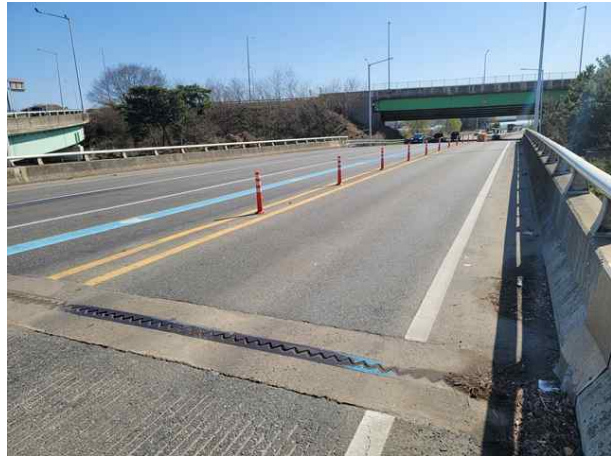
교면포장 전경

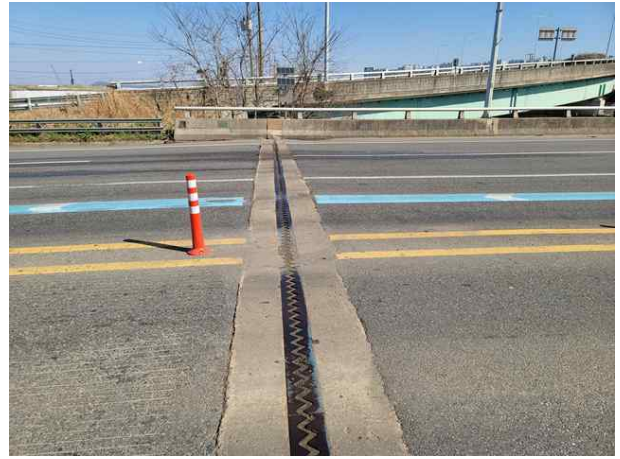
신축이음장치 전경

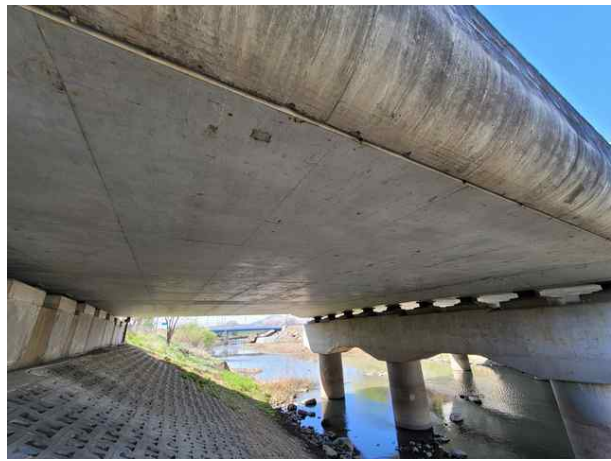
바닥판하면 전경

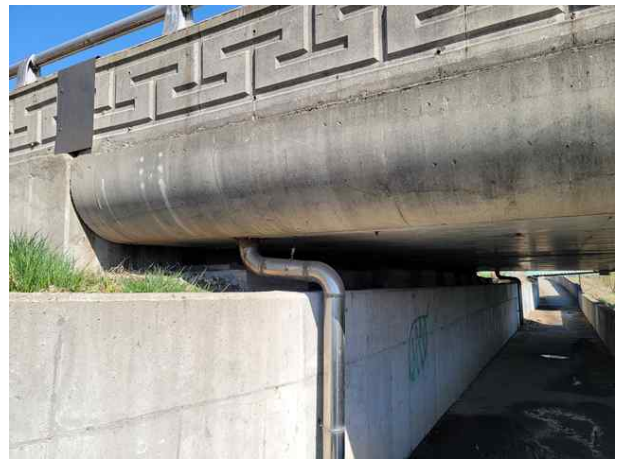
교대 전경

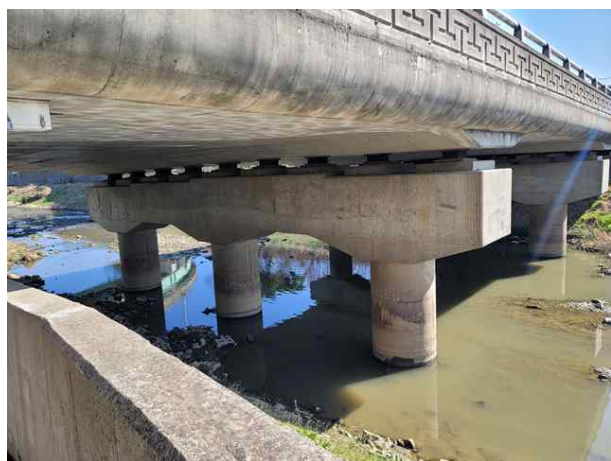
교각 전경

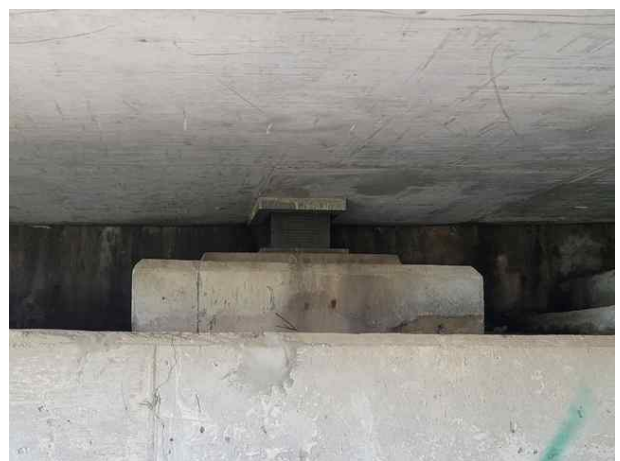
교량받침 전경

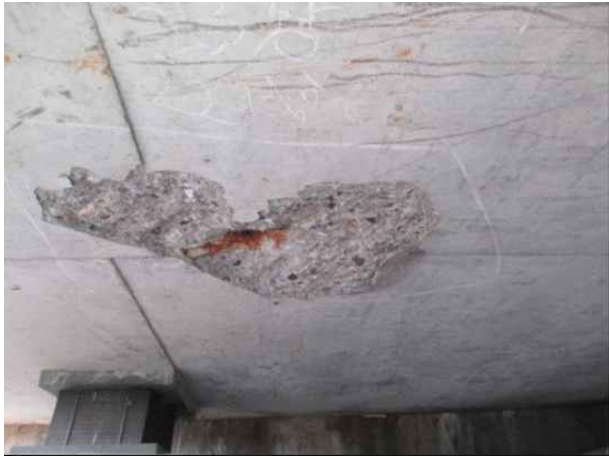
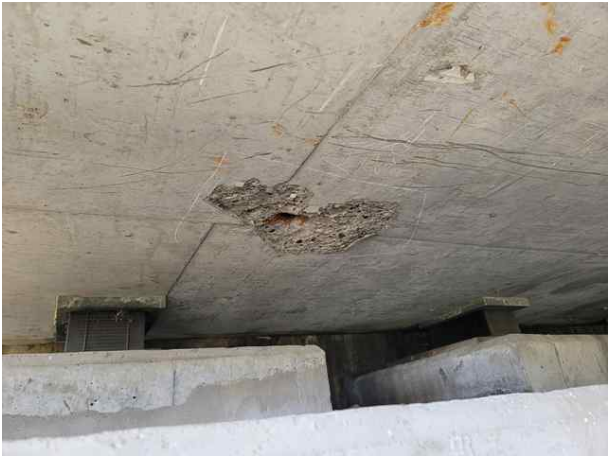
| 01<br>(25년 하반기) | 바닥판(S1) 잡철근 노출 및 박락 | 01<br>(26년 상반기) | 바닥판(S1) 잡철근 노출 및 박락 |

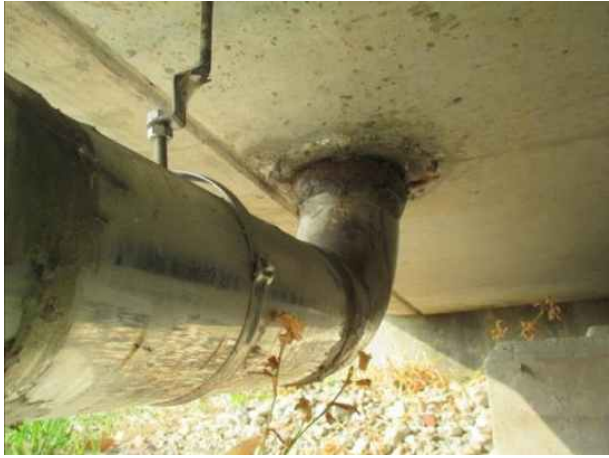
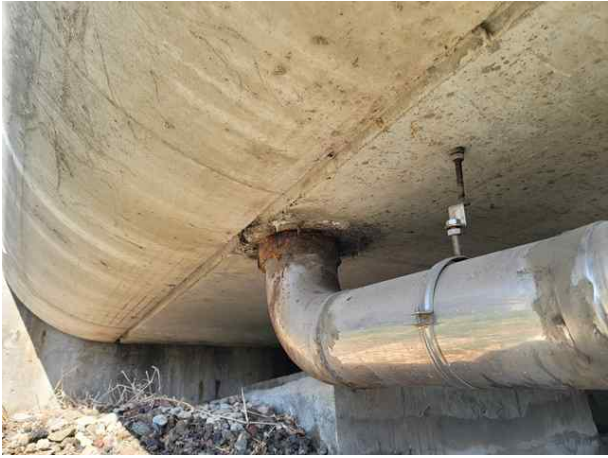
| 02<br>(25년 하반기) | 바닥판(S1) 배수관 주변 백태 | 02<br>(26년 상반기) | 바닥판(S1) 배수관 주변 백태 |

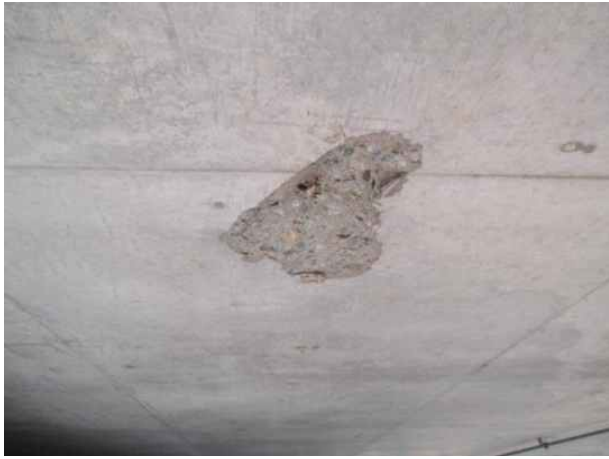
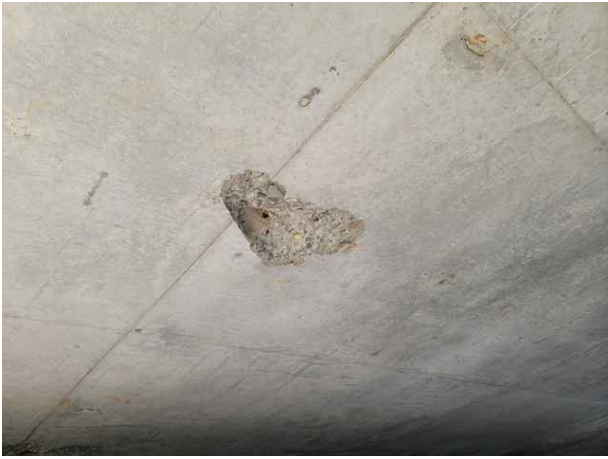
| 03<br>(25년 하반기) | 바닥판(S1) 파손 | 03<br>(26년 상반기) | 바닥판(S1) 파손 |

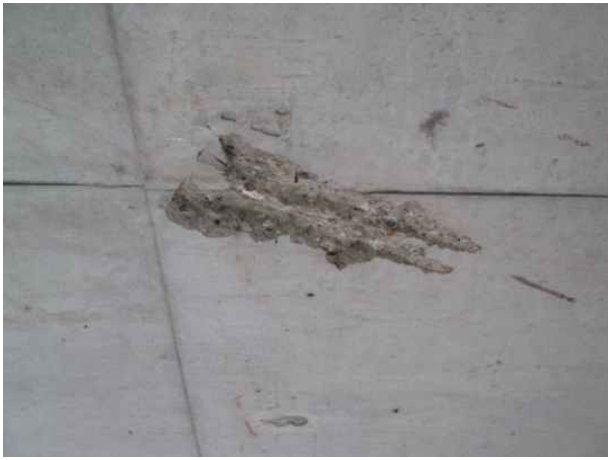
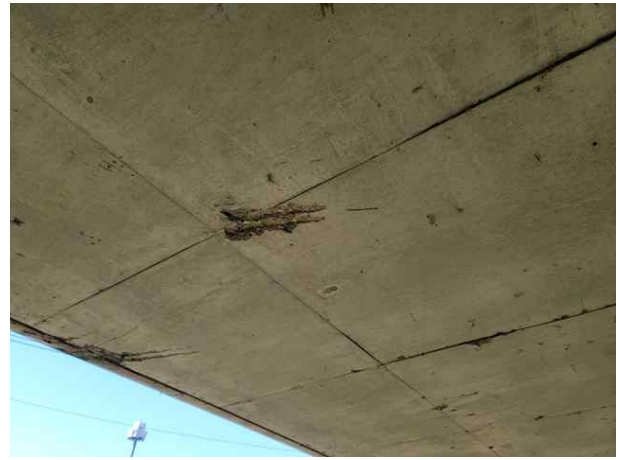
| 04<br>(25년 하반기) | 바닥판(S2) 파손 | 04<br>(26년 상반기) | 바닥판(S2) 파손 |

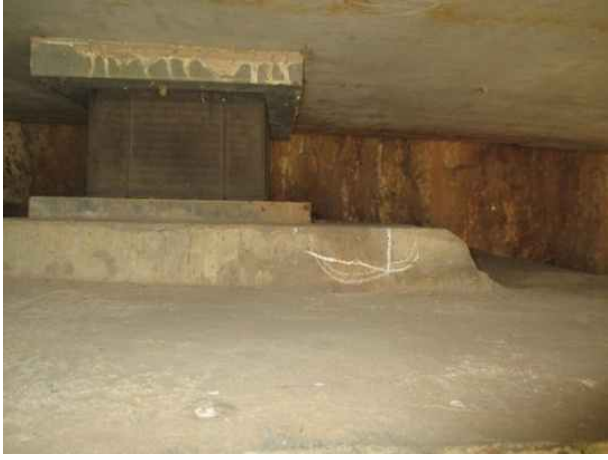
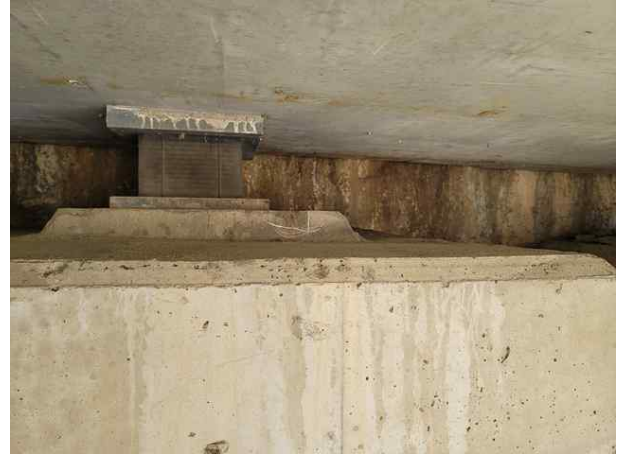
| 05<br>(25년 하반기) | 교량받침(A2-Sh8) 몰탈 파손/경미 | 05<br>(26년 상반기) | 교량받침(A2-Sh8) 몰탈 파손/경미 |

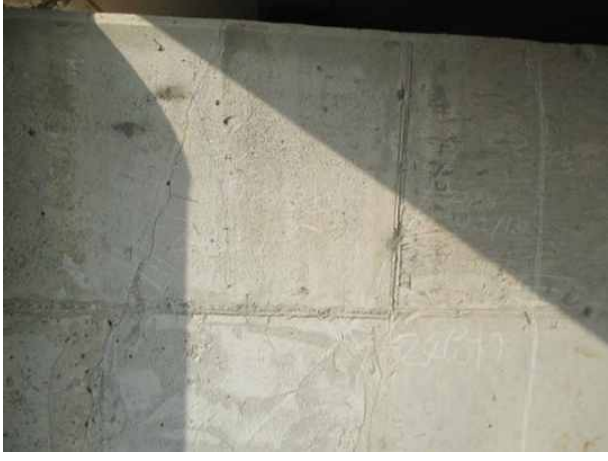
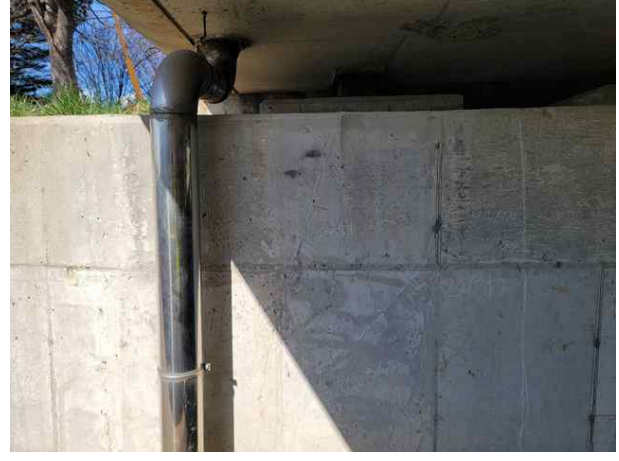
| 06<br>(25년 하반기) | 교대(A1) 벽체→산책로<br>균열(cw=0.2mm, 0.3mm) | 06<br>(26년 상반기) | 교대(A1) 벽체→산책로<br>균열(cw=0.2mm, 0.3mm) |

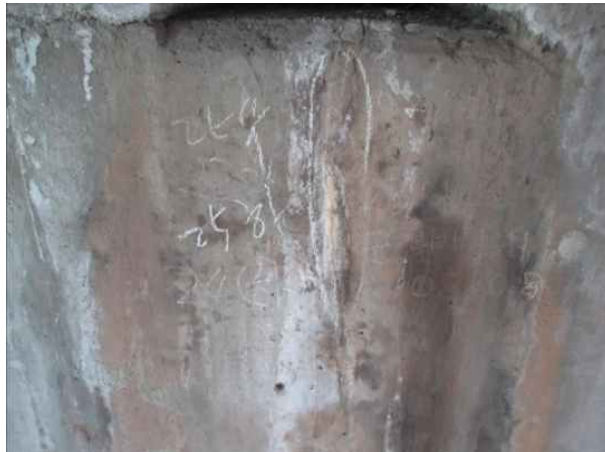
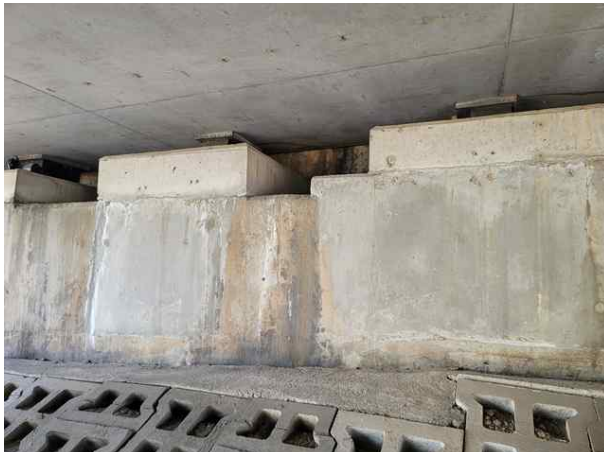
| 07<br>(25년 하반기) | 교대(A2) 균열부백태 | 07<br>(26년 상반기) | 교대(A2) 균열부백태 |

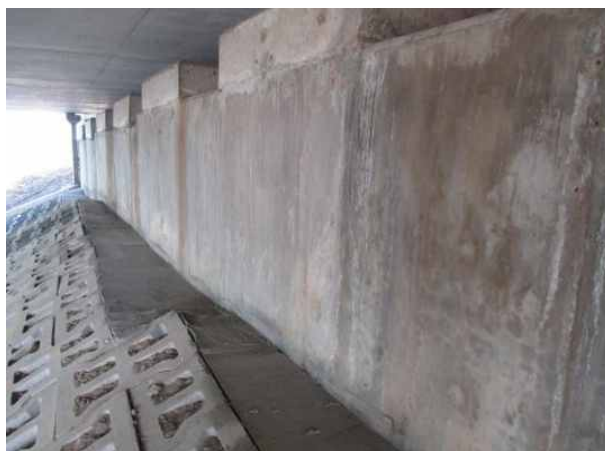
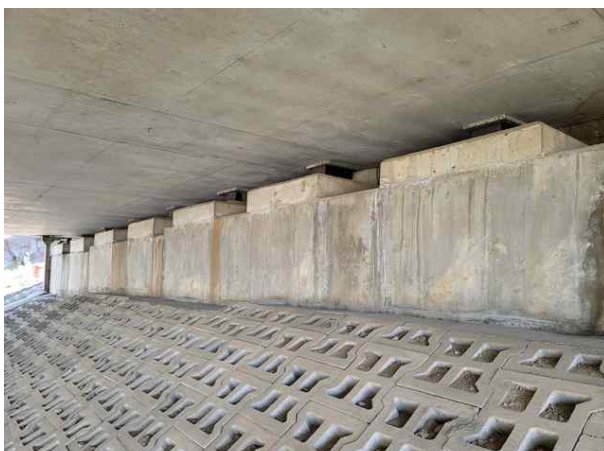
| 08<br>(25년 하반기) | 교대(A2) 균열부백태 | 08<br>(26년 상반기) | 교대(A2) 균열부백태 |

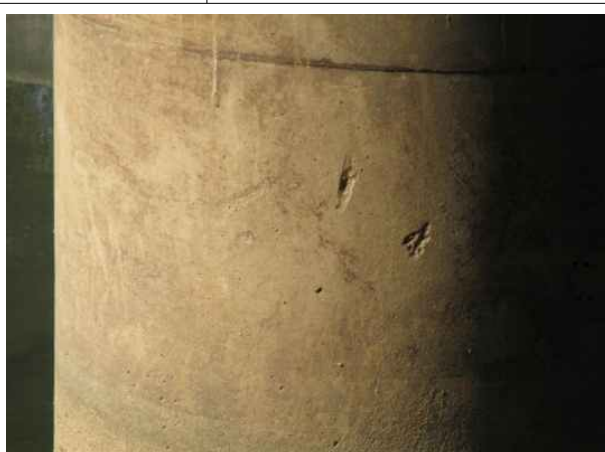
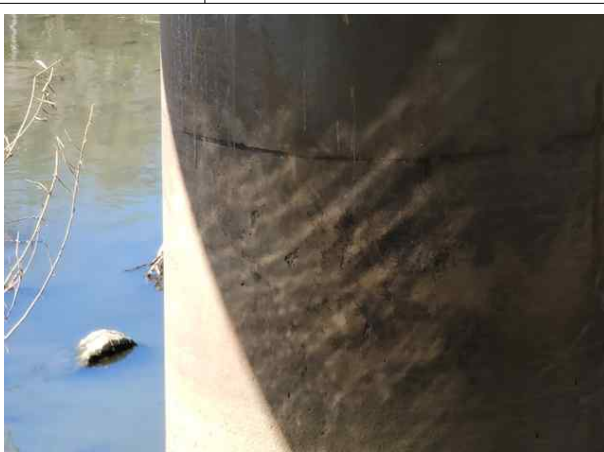
| 09<br>(25년 하반기) | 교각(P2) 기둥 파손/경미 | 09<br>(26년 상반기) | 교각(P2) 기둥 파손/경미 |

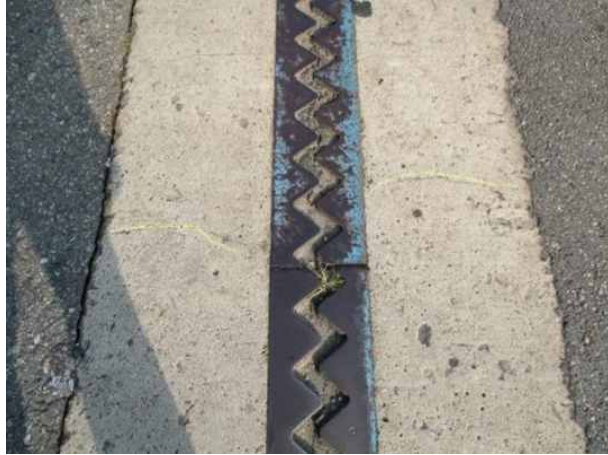
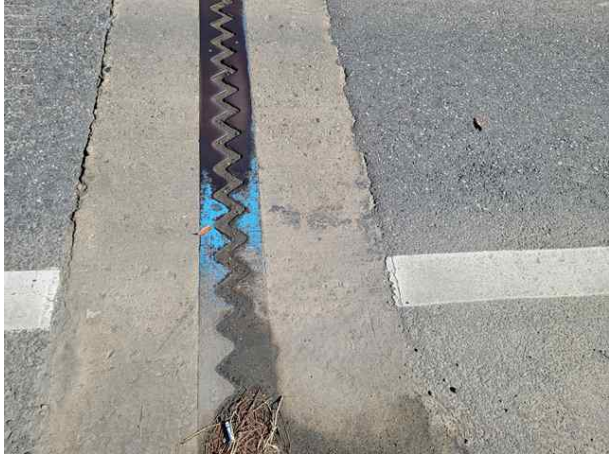
| 10<br>(25년 하반기) | 신축이음(A1)<br>후타재 균열(0.3mm미만) | 10<br>(26년 상반기) | 신축이음(A1)<br>후타재 균열(0.3mm미만) |

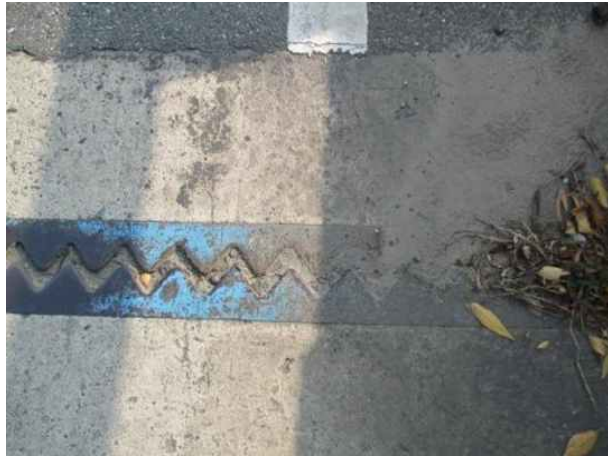
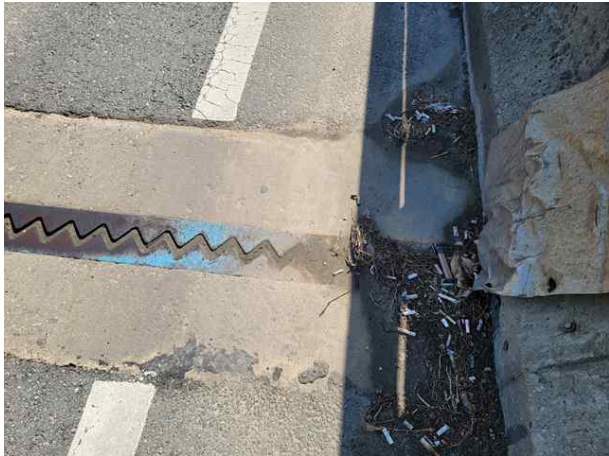
| 11<br>(25년 하반기) | 신축이음장치(A2)<br>유간 이물질퇴적 | 11<br>(26년 상반기) | 신축이음장치(A2)<br>유간 이물질퇴적 |

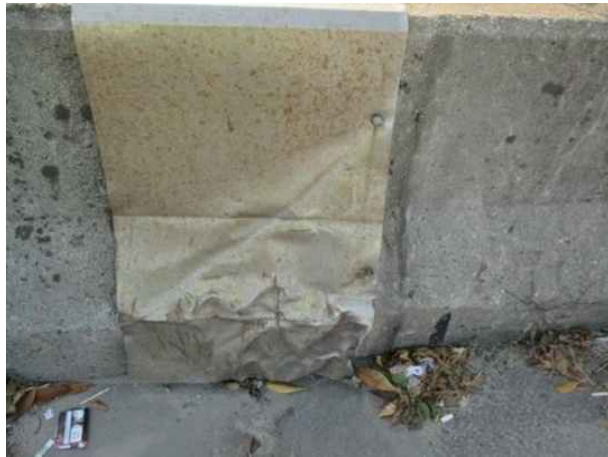
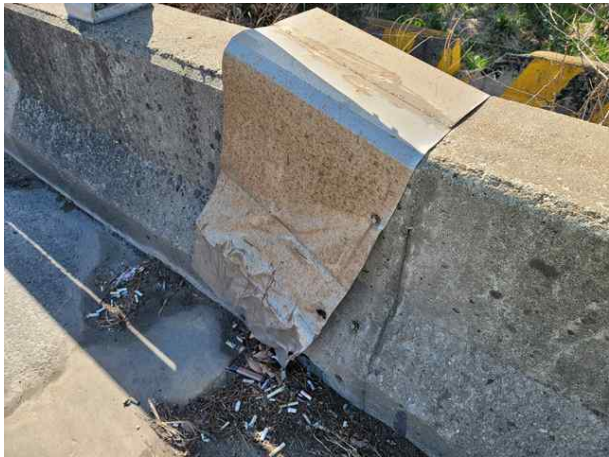
| 12<br>(25년 하반기) | 신축이음(A2) 차수판 변형 | 12<br>(26년 상반기) | 신축이음(A2) 차수판 변형 |

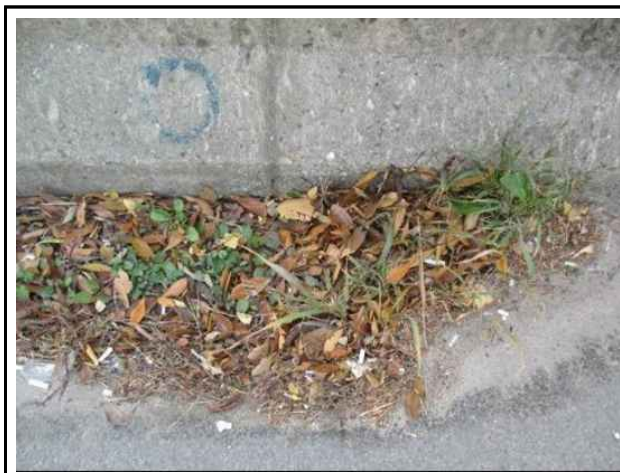
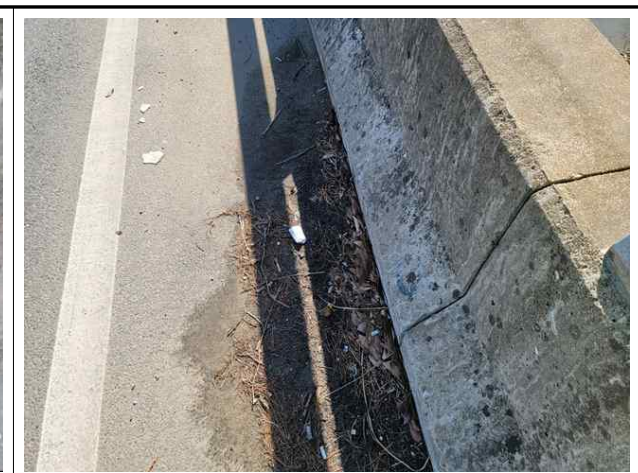
| 배수구(S1~S3) 막힘 | 배수구(S1~S3) 막힘 |

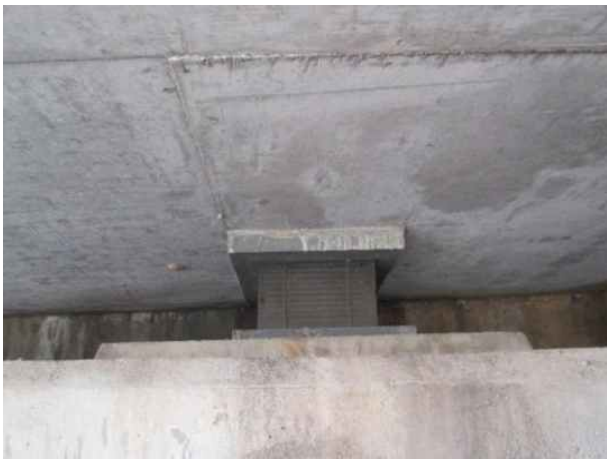
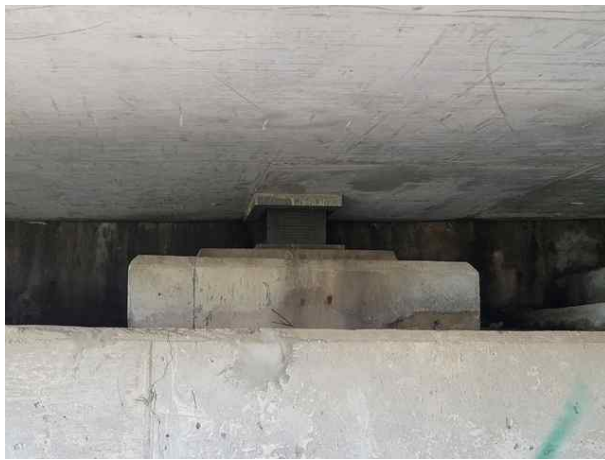
| <p>16<br/>(25년 하반기)</p> | <p>교량받침 상태양호</p> | <p>16<br/>(26년 상반기)</p> | <p>교량받침 상태양호</p> |

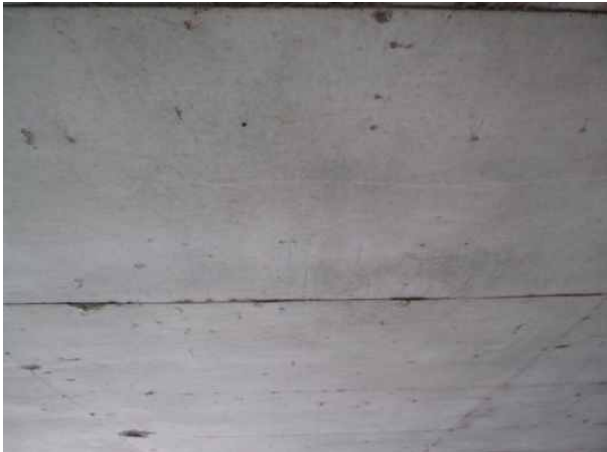
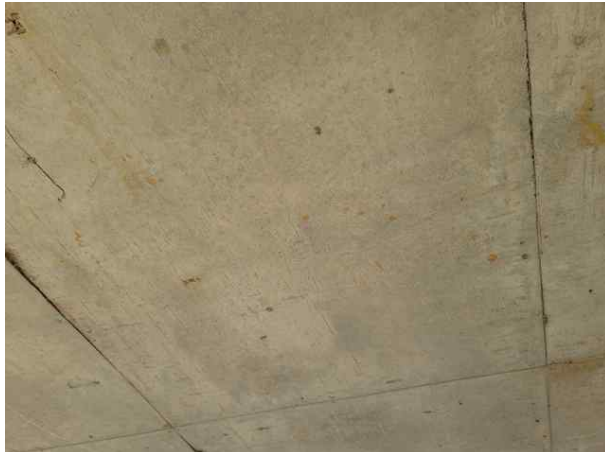
| <p>17<br/>(25년 하반기)</p> | <p>바닥판 미세균열(S3)</p> | <p>17<br/>(26년 상반기)</p> | <p>바닥판 미세균열(S3)</p> |

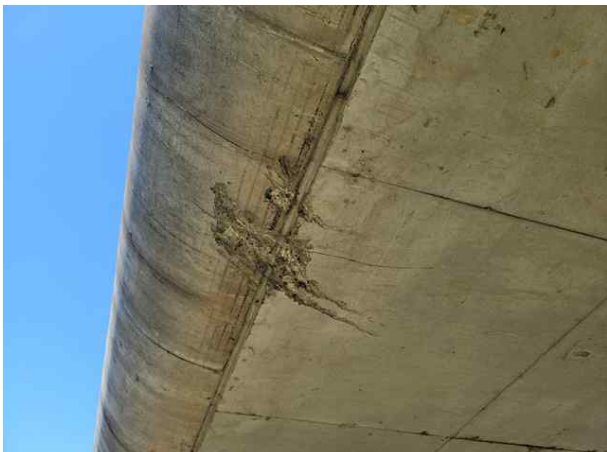
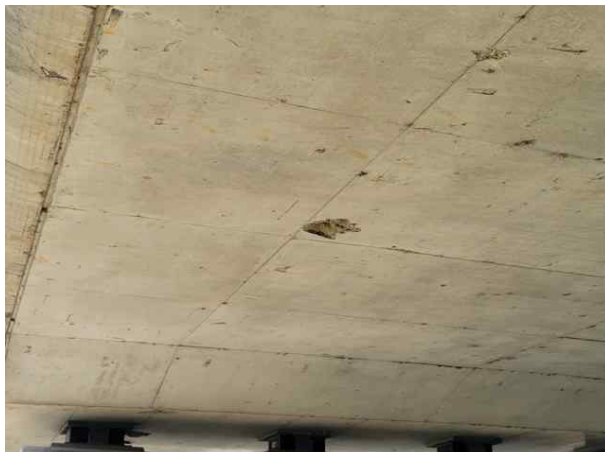
| <p>18<br/>(26년 상반기)</p> | <p>바닥판하면(S3) 파손</p> | <p>19<br/>(26년 상반기)</p> | <p>바닥판하면(S3) 파손</p> |
