## 17. 태리IC육교(상)

## 손상현황

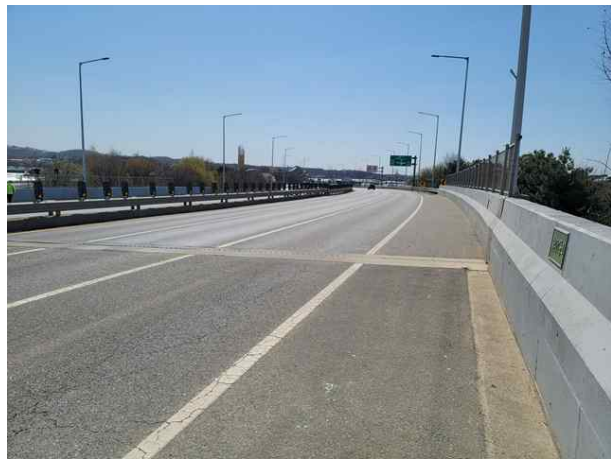
전경

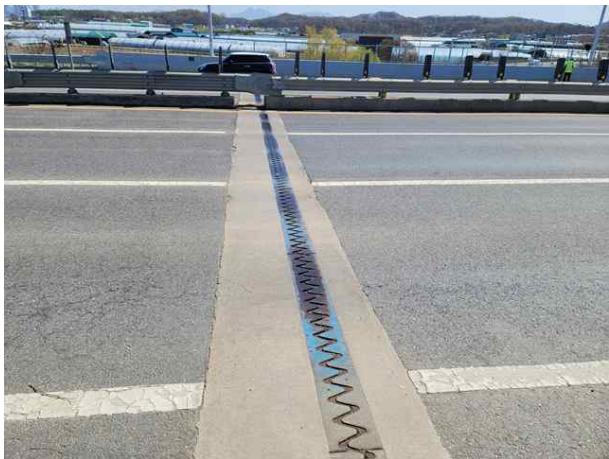
교면포장 전경

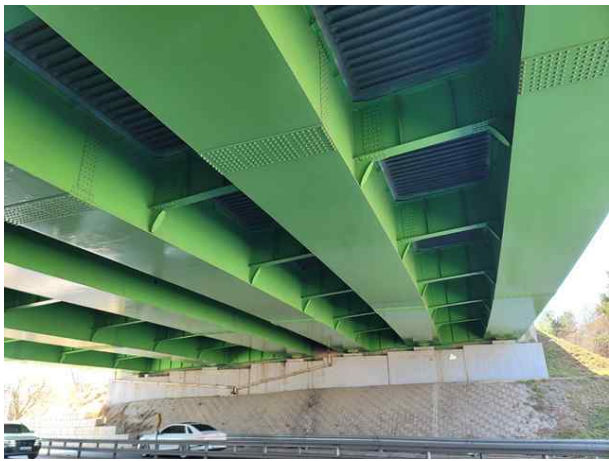
바닥판하면 전경

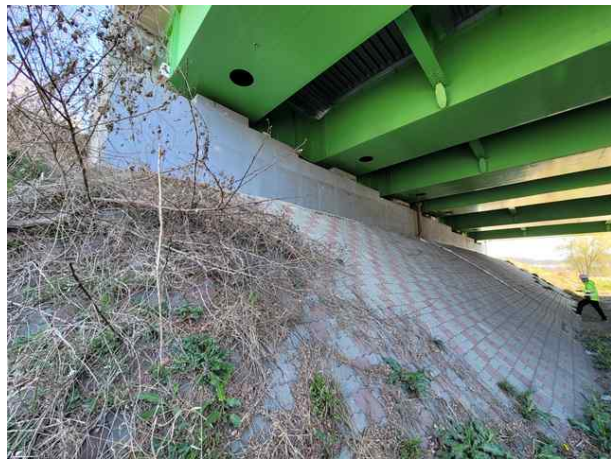
거더외부 전경

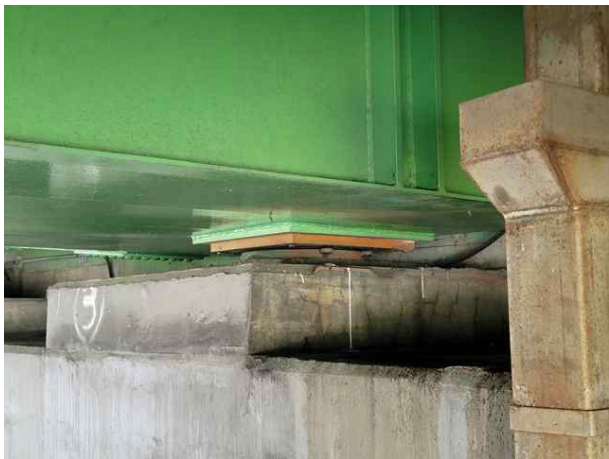
교대 전경

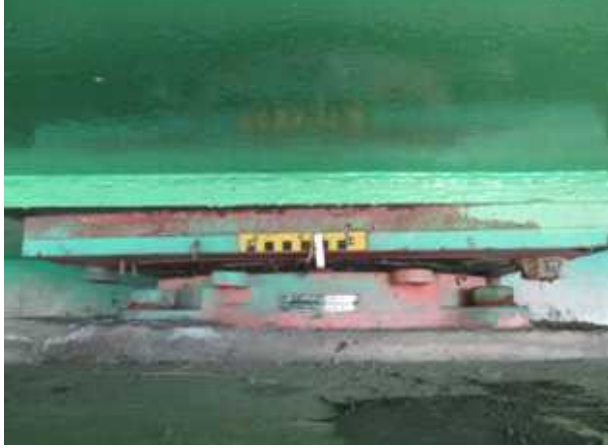
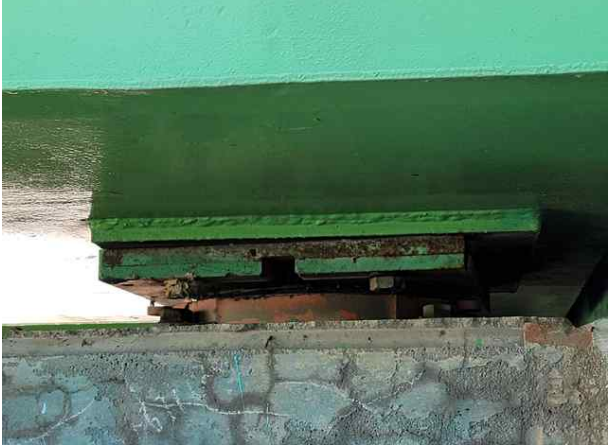
| 03<br>(25년 하반기) | 03<br>(26년 상반기) |

| 받침 (A2-Sh3) 부식 | 받침 (A2-Sh3) 부식 |

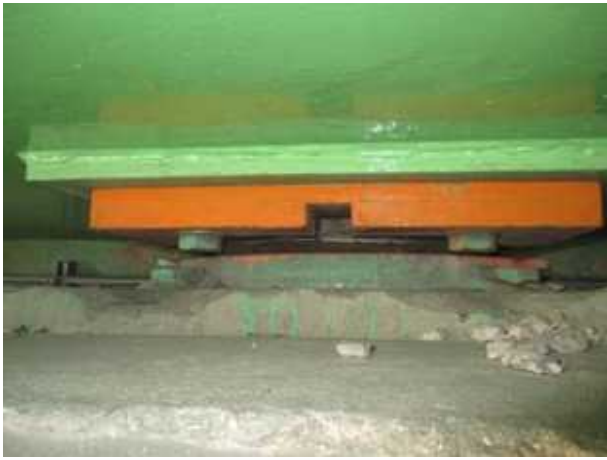
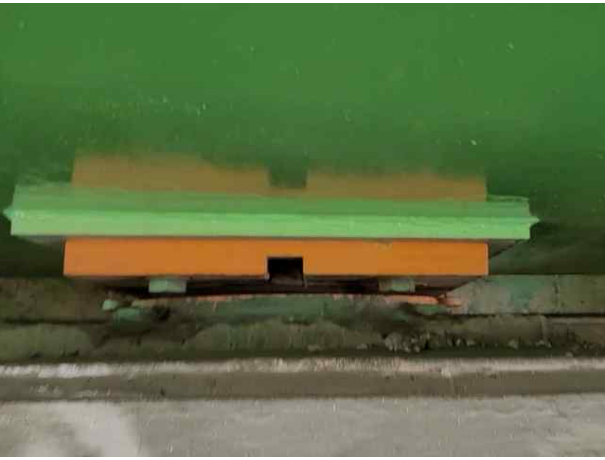
| 04<br>(25년 하반기) | 받침 (A1-Sh2) 물탈 파손 | 04<br>(26년 상반기) | 받침 (A1-Sh2) 물탈 파손 |

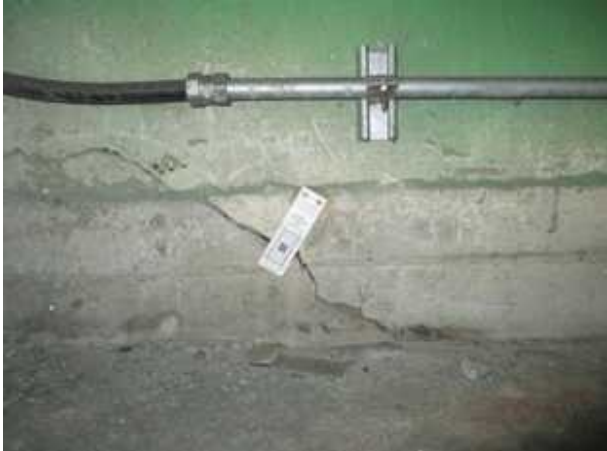
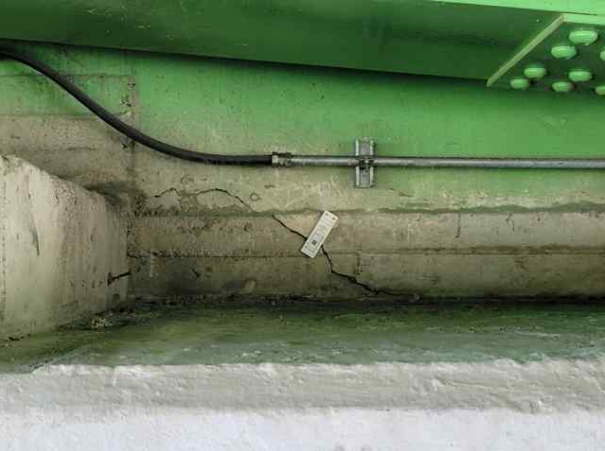
| 05<br>(25년 하반기) | 교대 (A1) 균열 (0.5mm이상) | 05<br>(26년 상반기) | 교대 (A1) 균열 (0.5mm이상) |

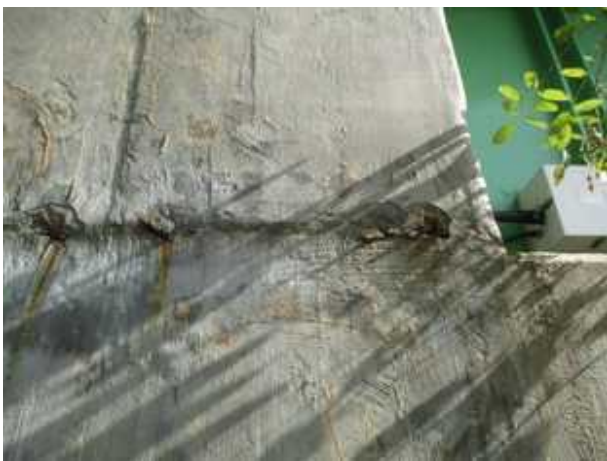
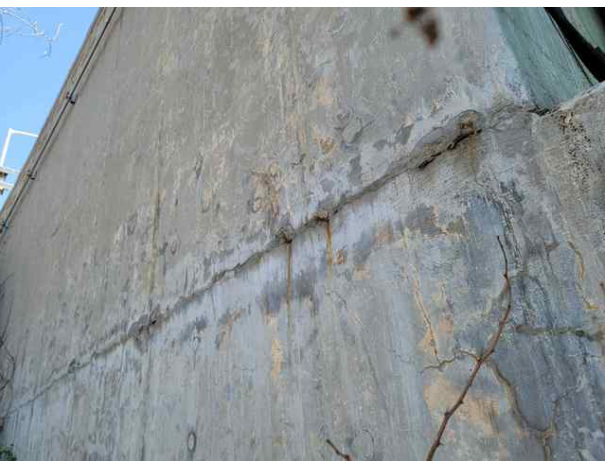
| 06<br>(25년 하반기) | 교대 (A1) 잡철물 노출 | 06<br>(26년 상반기) | 교대 (A1) 잡철물 노출 |

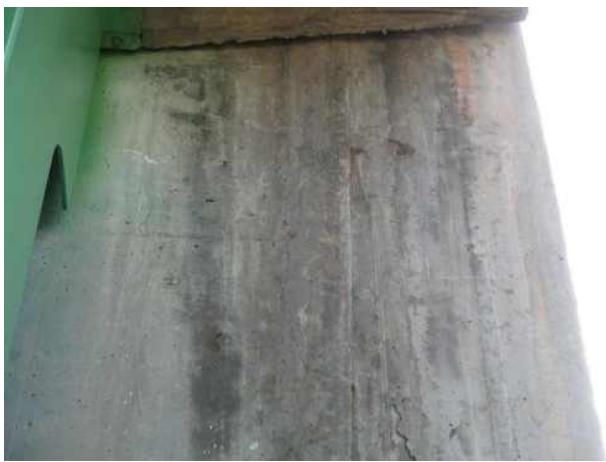
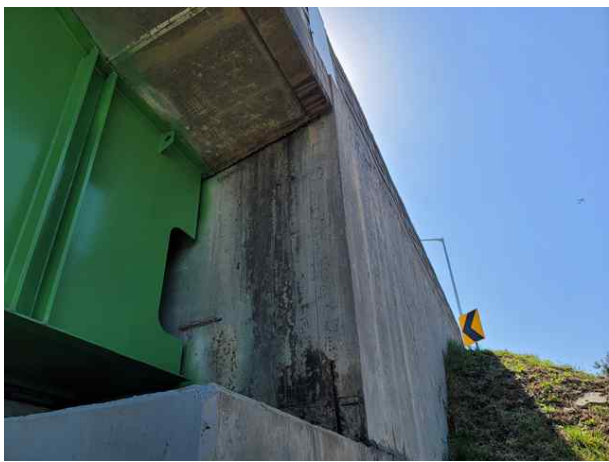
| 10<br>(25년 하반기) | 교대(A2) 누수흔적 | 10<br>(26년 상반기) | 교대(A2) 누수흔적 |

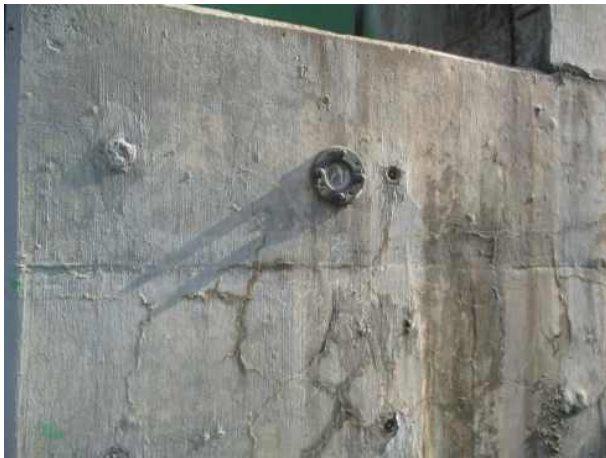
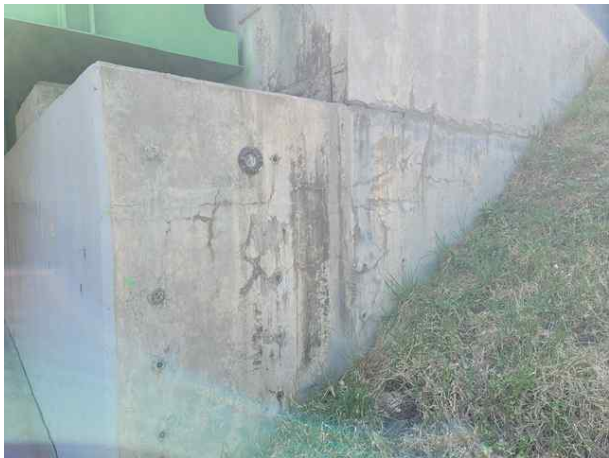
| 11<br>(25년 하반기) | 교대(A2) 망상균열 | 11<br>(26년 상반기) | 교대(A2) 망상균열 |

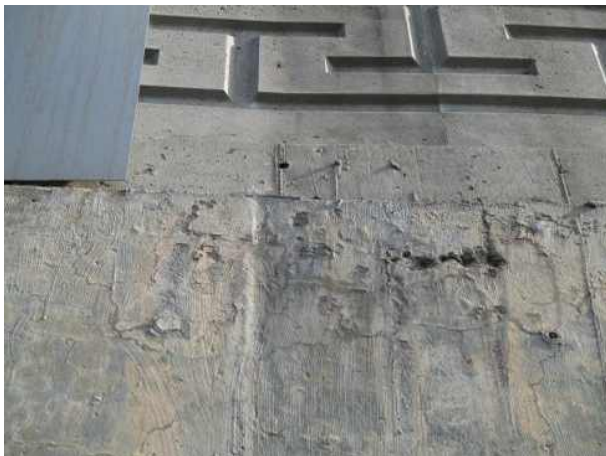
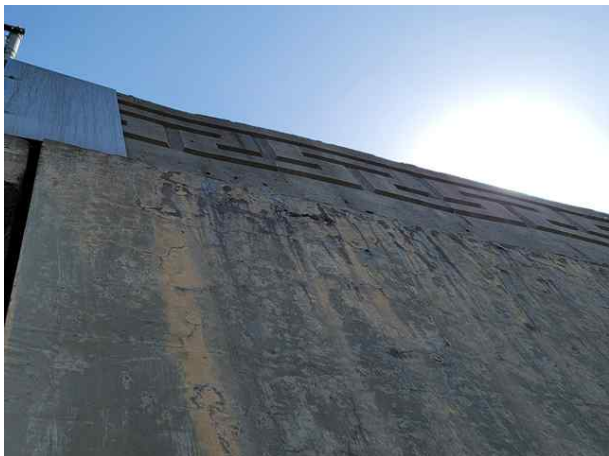
| 12<br>(25년 하반기) | 교대(A2) 날개벽 파손/경미 | 12<br>(26년 상반기) | 교대(A2) 날개벽 파손/경미 |

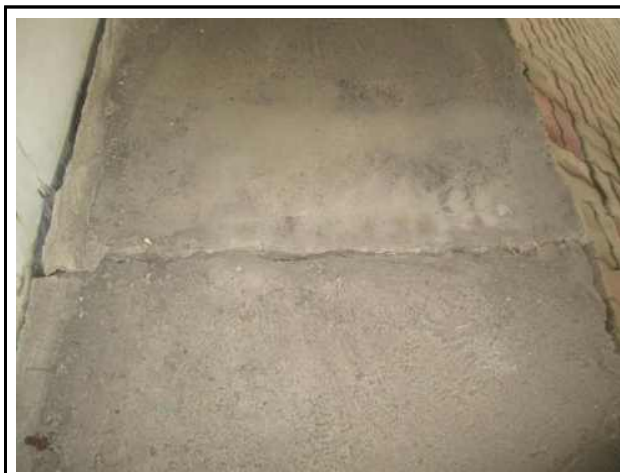
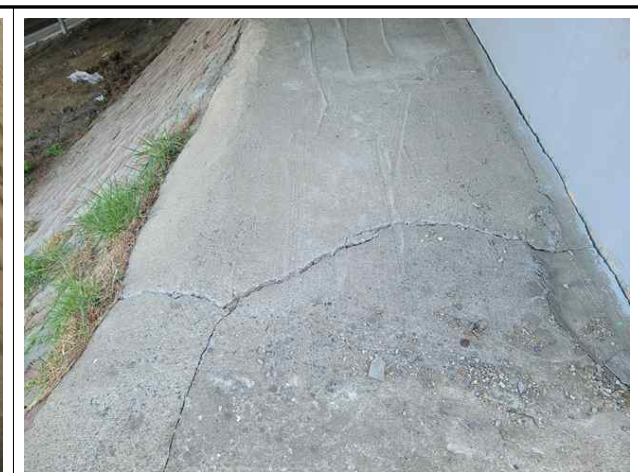
| 13<br>(25년 하반기) | 13<br>(26년 상반기) |

| 교대(A2) 법면 상부 몰탈 파손 | 교대(A2) 법면 상부 몰탈 파손 |

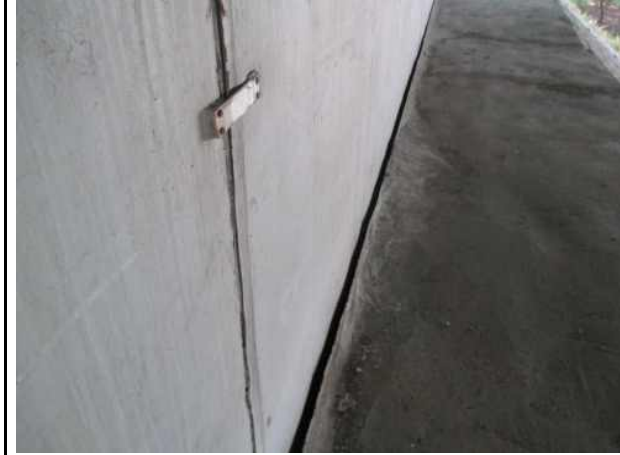
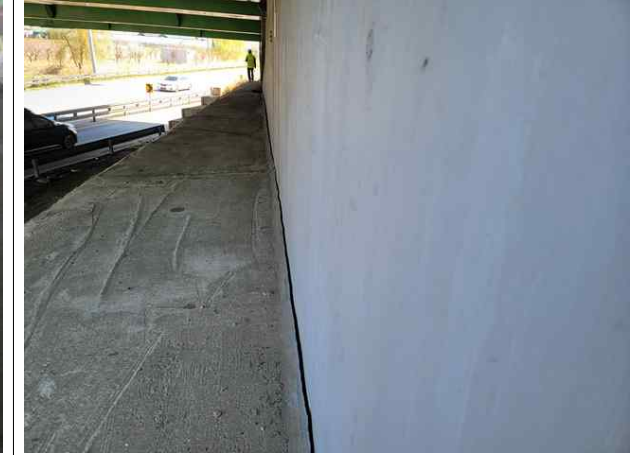
| 14<br>(25년 하반기) | 14<br>(26년 상반기) |

| 교대(A2) 법면 이격(30mm) | 교대(A2) 법면 이격(30mm) |

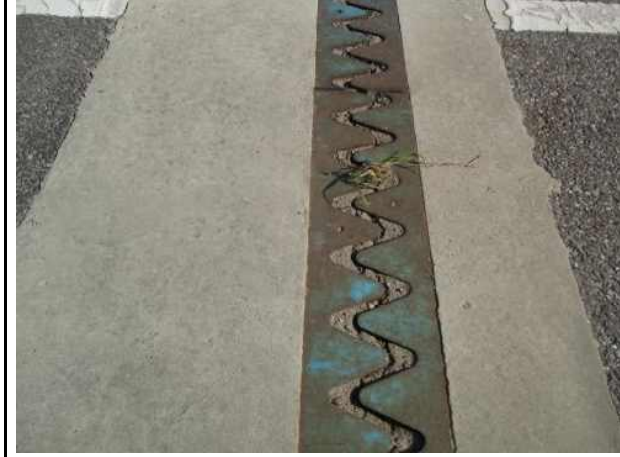
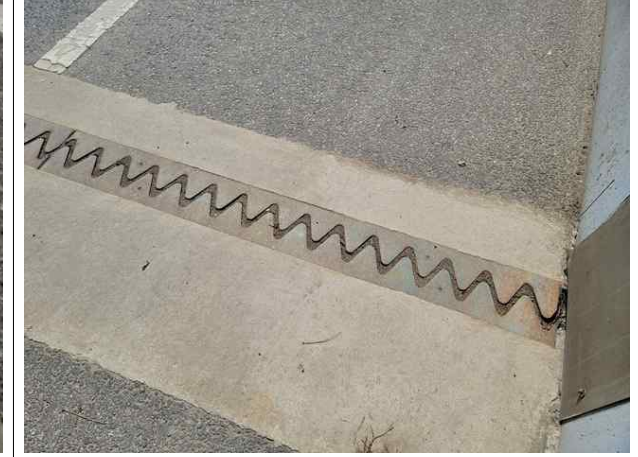
| 15<br>(25년 하반기) | 15<br>(26년 상반기) |

| 신축이음(A1) 유간 토사퇴적 | 신축이음(A1) 유간 토사퇴적 |

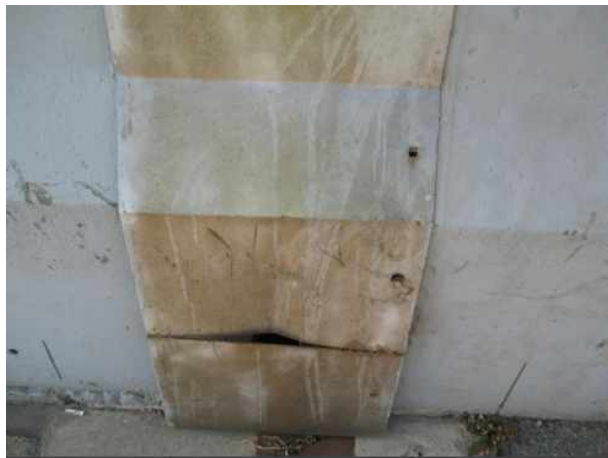
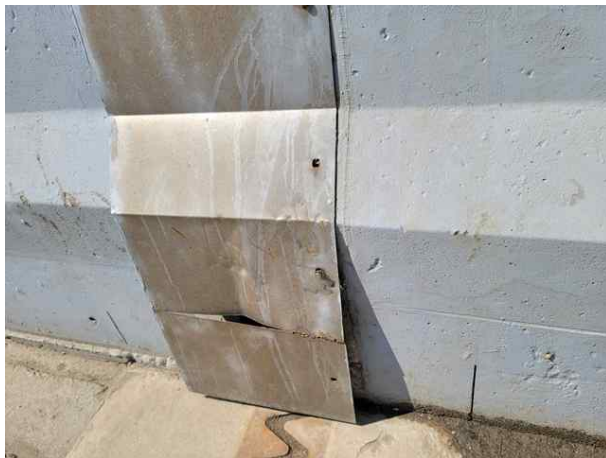
| 16<br>(25년 하반기) | 차수관(A2) 볼트 탈락 | 16<br>(26년 상반기) | 차수관(A2) 볼트 탈락 |

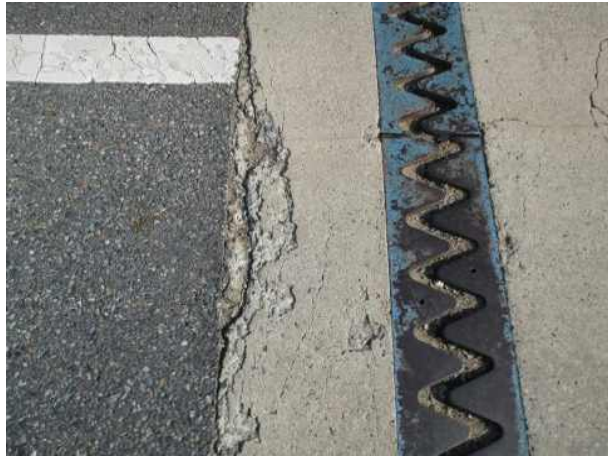
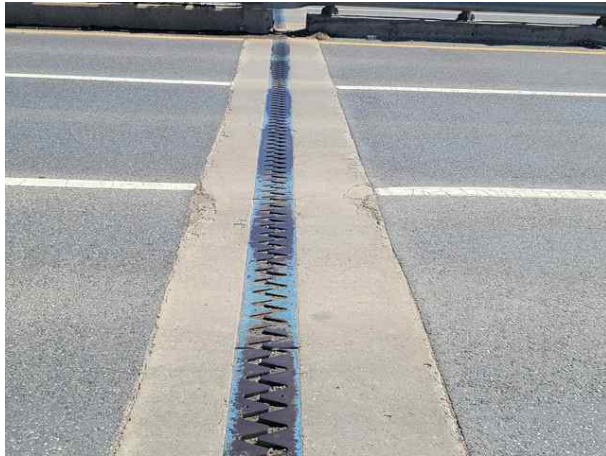
| 17<br>(25년 하반기) | 신축이음(A2) 후타재 파손 | 17<br>(26년 상반기) | 신축이음(A2) 후타재 파손 |

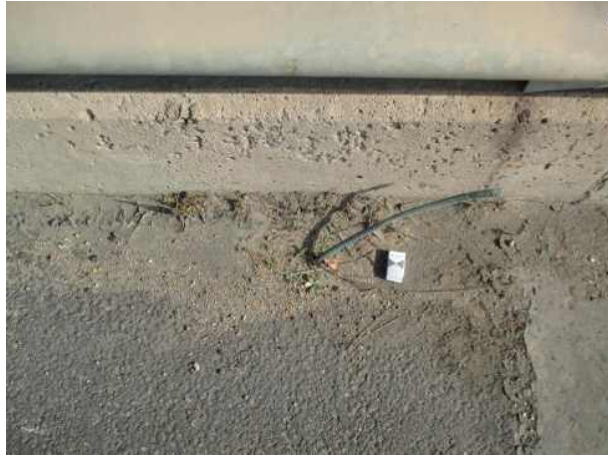
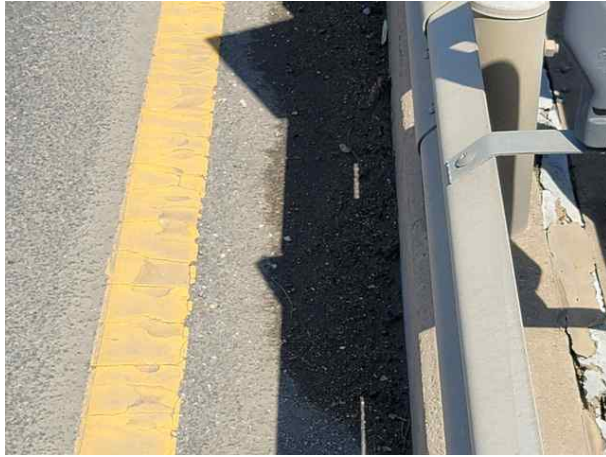
| 18<br>(25년 하반기) | 배수구 막힘 | 18<br>(26년 상반기) | 배수구 막힘 |

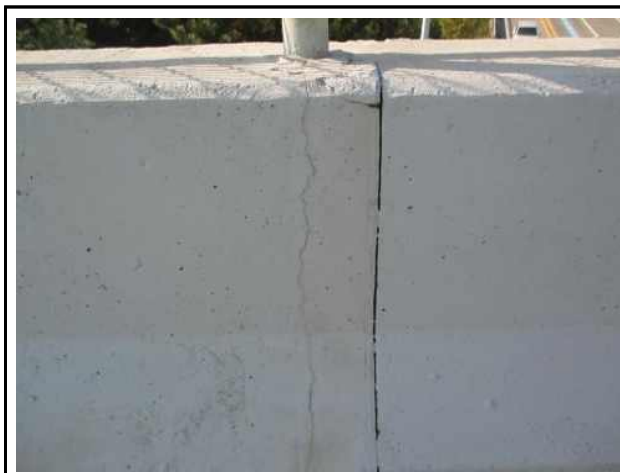
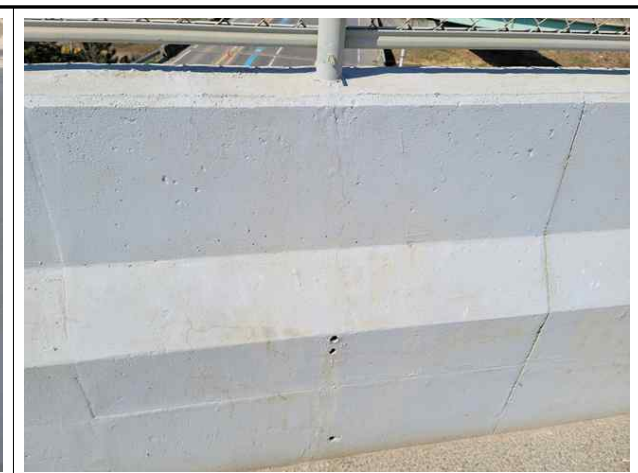
| 19<br>(25년 하반기) | 19<br>(26년 상반기) |

방호벽 균열(0.3mm미만)

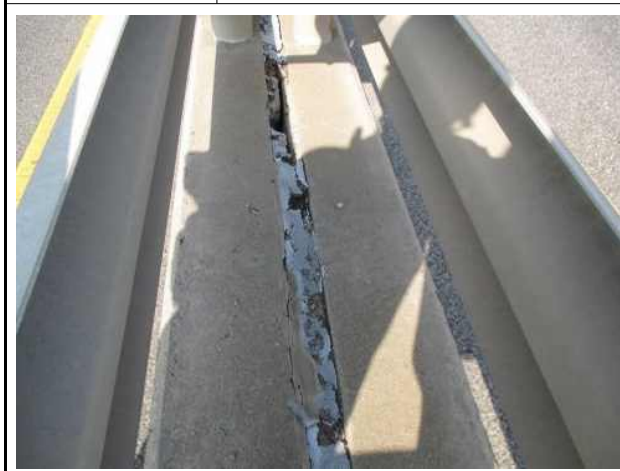
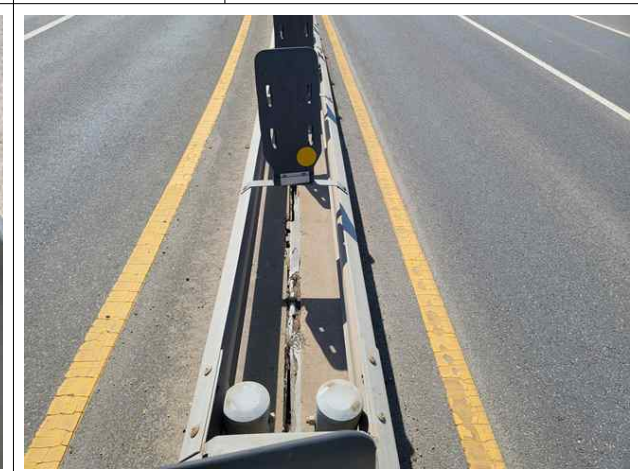
| 20<br>(25년 하반기) | 20<br>(26년 상반기) |

중분대(S1) 실란트 파손

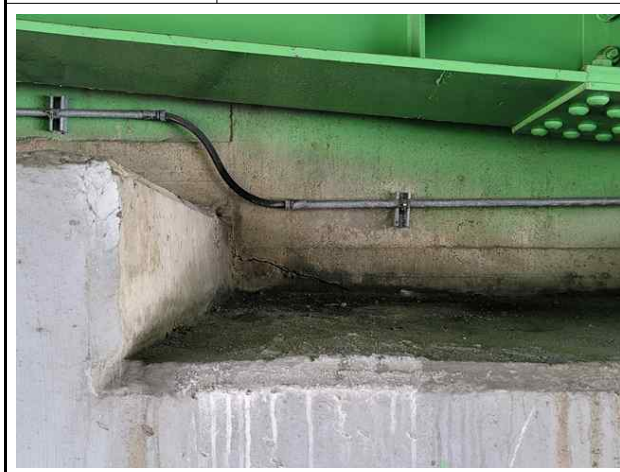
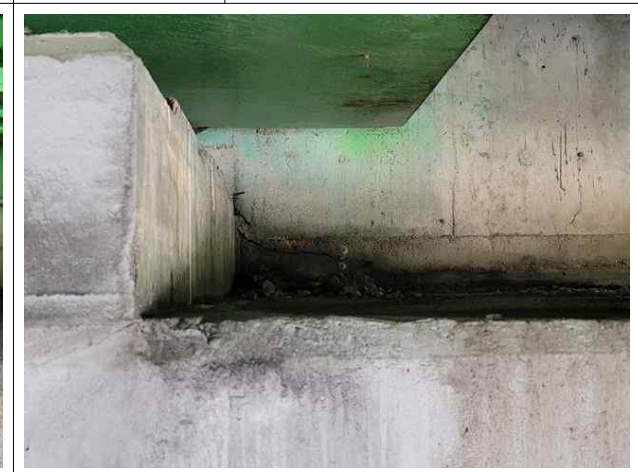
| 21<br>(26년 상반기) | 22<br>(26년 상반기) |

교대(A1) 균열(0.5mm이상)
