## 18. 태리IC육교(하)

## 손상현황

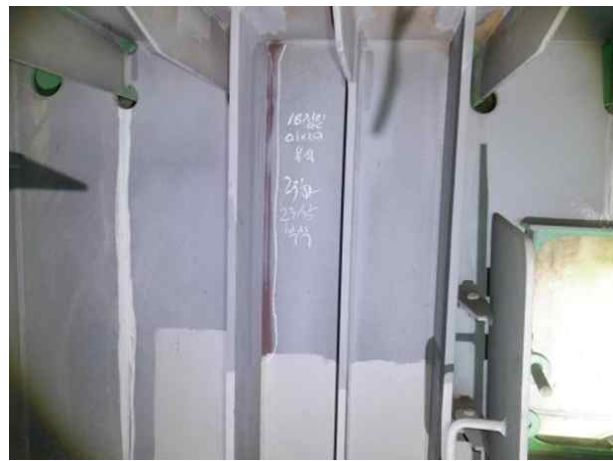
01  
(25년 하반기)

거더(G1) 내부 부식

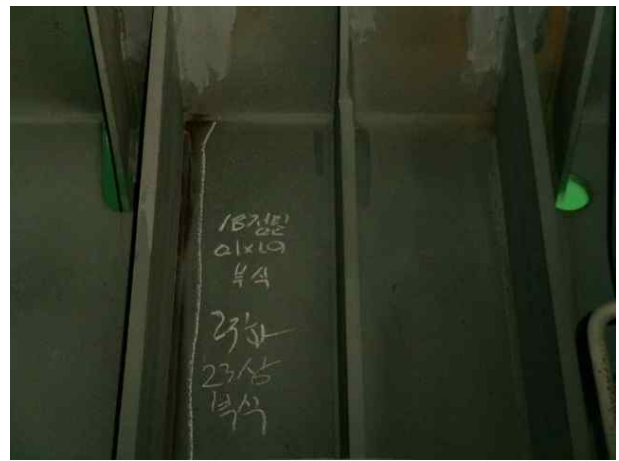
01  
(26년 상반기)

거더(G1) 내부 부식

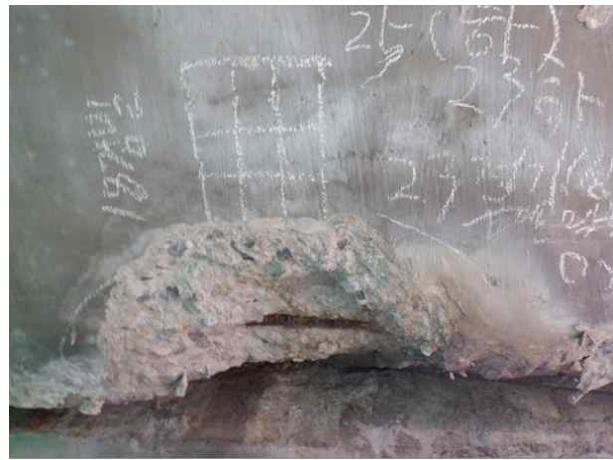
02  
(25년 하반기)

바닥판(S1) 단부 파손 및 철근노출

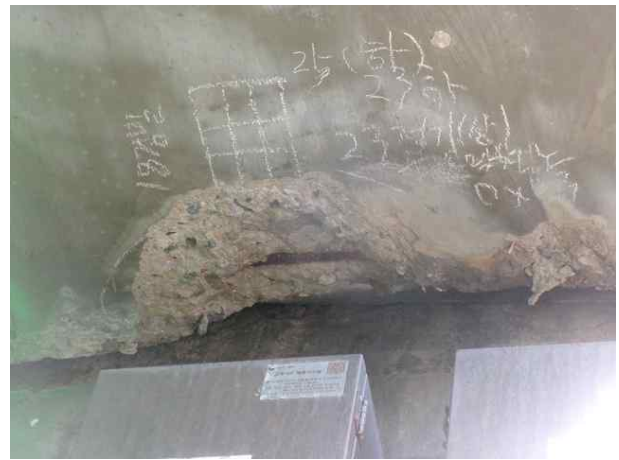
02  
(26년 상반기)

바닥판(S1) 단부 파손 및 철근노출

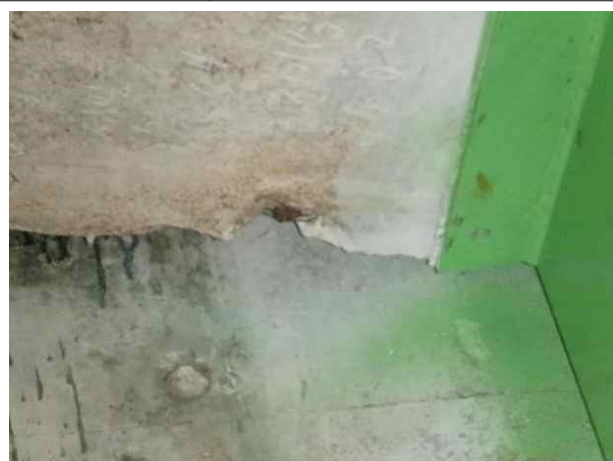
03  
(25년 하반기)

바닥판(S1) 하면 파손

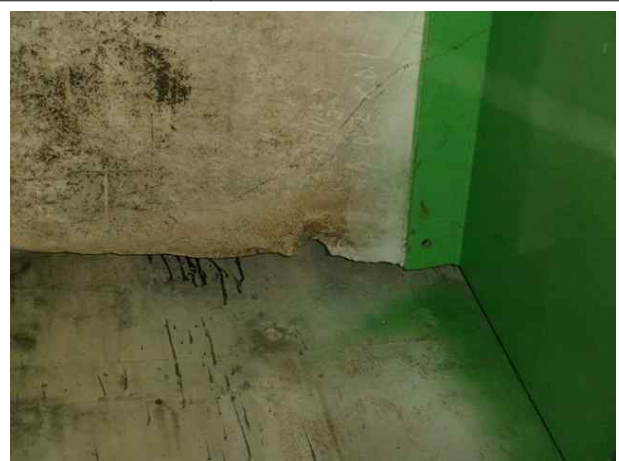
03  
(26년 상반기)

바닥판(S1) 하면 파손

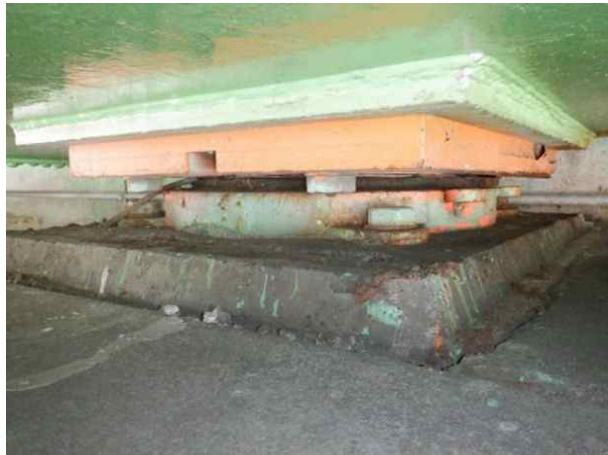
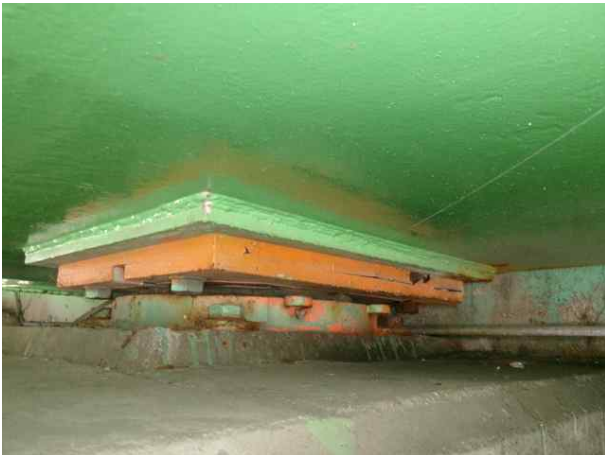
| 04<br>(25년 하반기) | 받침 (A1-Sh2) 부식/경미 | 04<br>(26년 상반기) | 받침 (A1-Sh2) 부식/경미 |

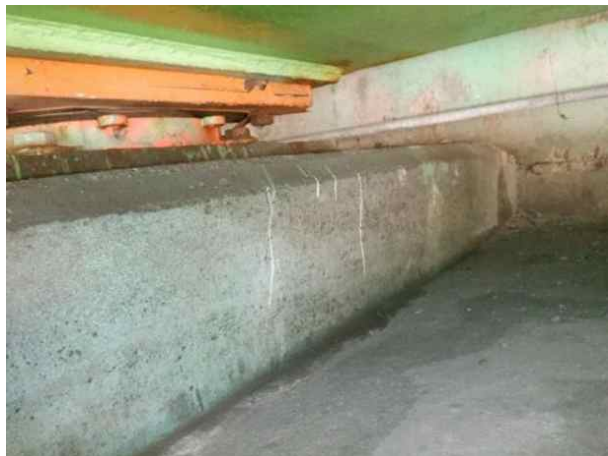
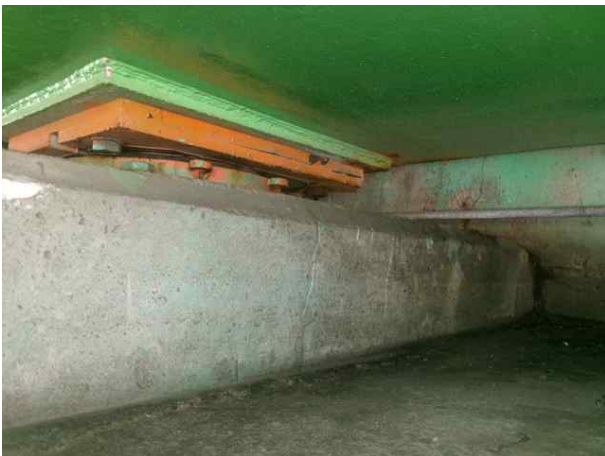
| 05<br>(25년 하반기) | 받침 콘크리트 (A1-Sh2)<br>균열 (0.3mm미만) | 05<br>(26년 상반기) | 받침 콘크리트 (A1-Sh2)<br>균열 (0.3mm미만) |

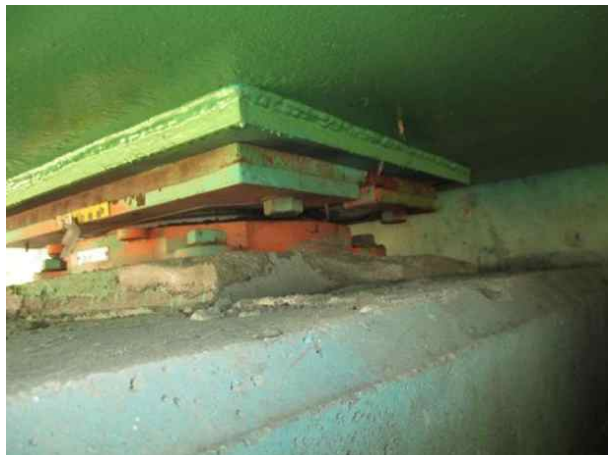
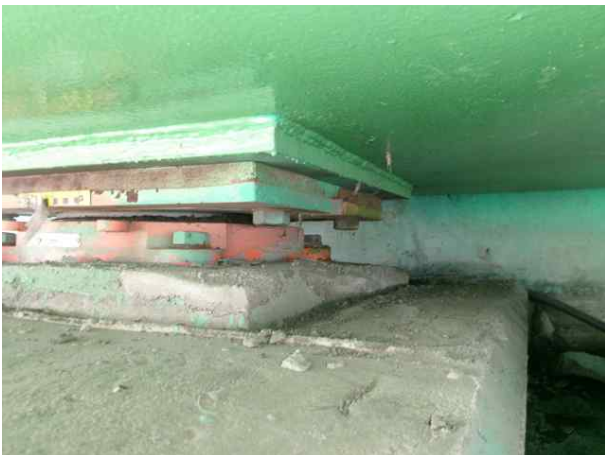
| 06<br>(25년 하반기) | 받침 (A2-Sh1) 몰탈 파손 | 06<br>(26년 상반기) | 받침 (A2-Sh1) 몰탈 파손 |

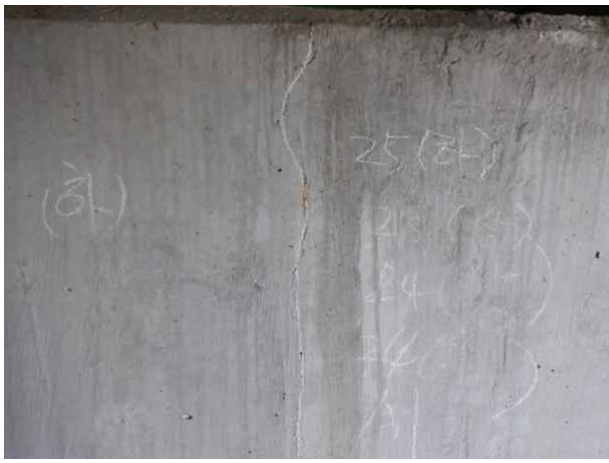
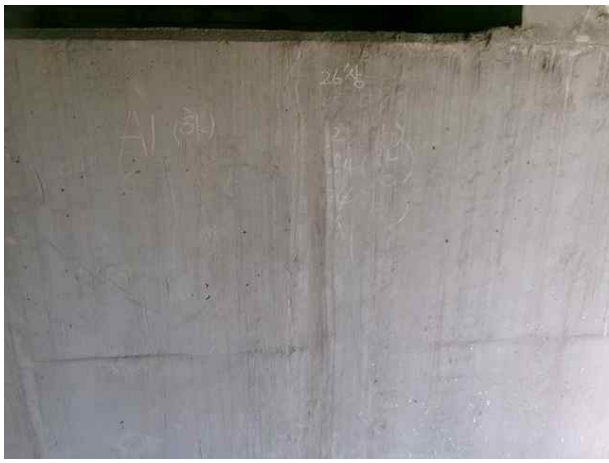
| 10<br>(25년 하반기) | 교대(A1) 균열(0.3mm미만) | 10<br>(26년 상반기) | 교대(A1) 균열(0.3mm미만) |

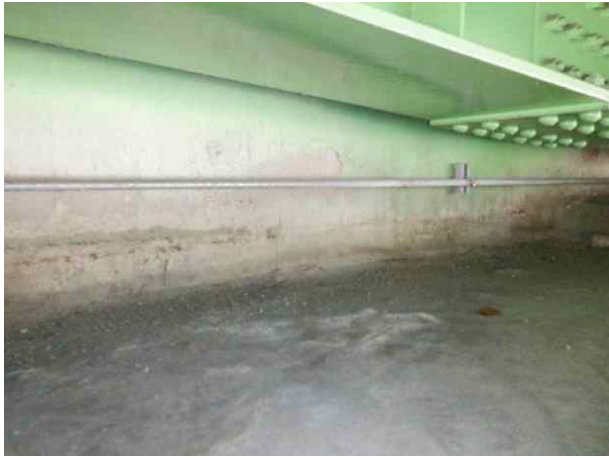
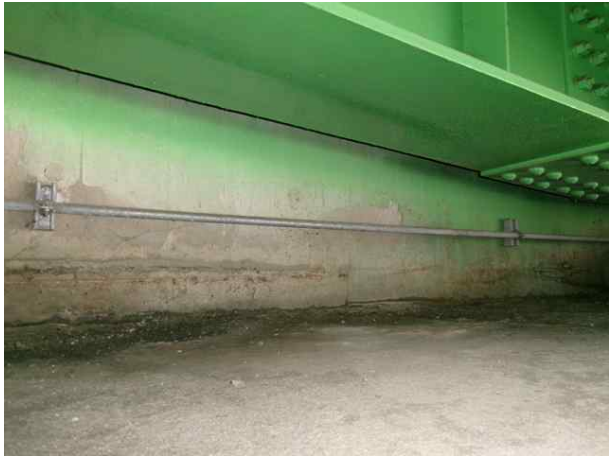
| 11<br>(25년 하반기) | 교대(A1) 흠벽 균열(0.3mm이상) | 11<br>(26년 상반기) | 교대(A1) 흠벽 균열(0.3mm이상) |

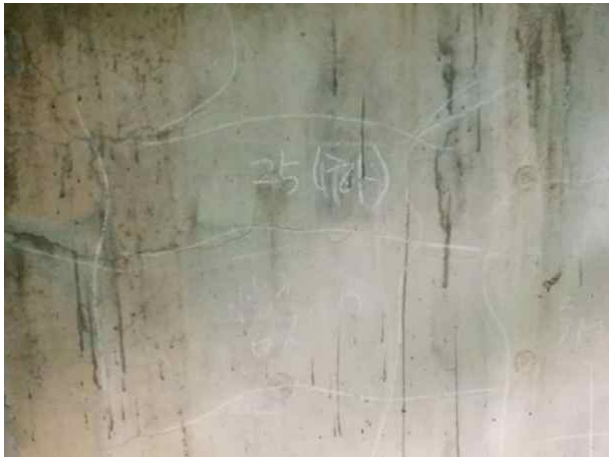
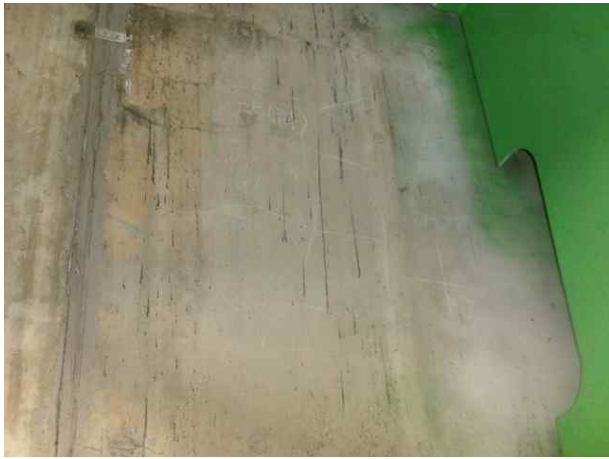
| 12<br>(25년 하반기) | 교대(A1) 망상균열 | 12<br>(26년 상반기) | 교대(A1) 망상균열 |

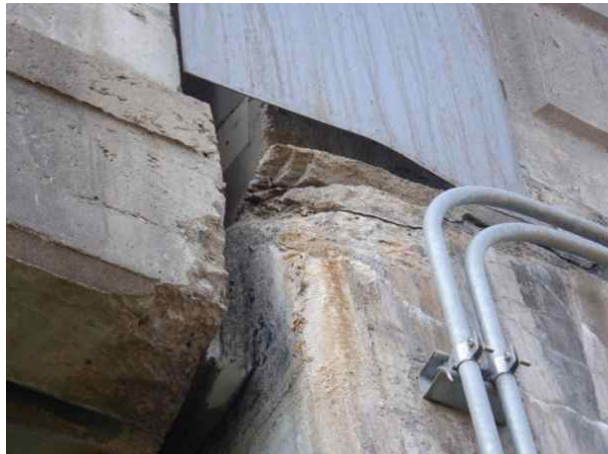
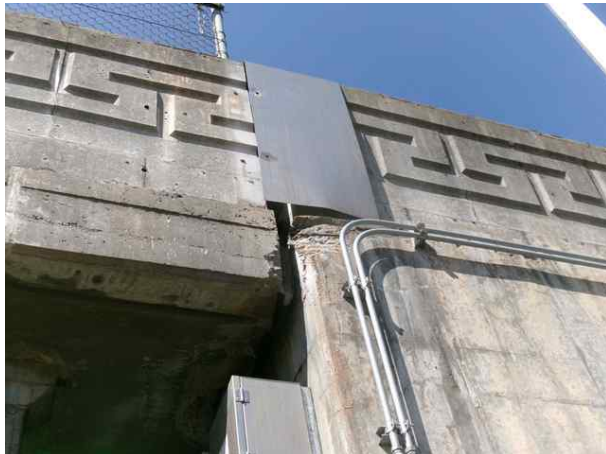
| 13<br>(25년 하반기) | 교대(A1) 홍벽 파손 | 13<br>(26년 상반기) | 교대(A1) 홍벽 파손 |

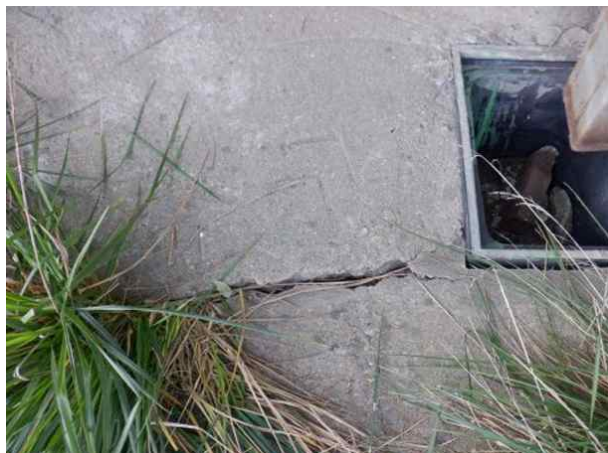
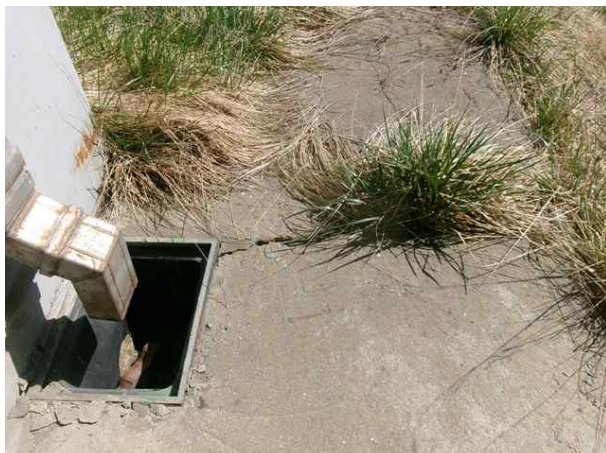
| 14<br>(25년 하반기) | 교대(A1) 범면 상부 몰탈 파손 | 14<br>(26년 상반기) | 교대(A1) 범면 상부 몰탈 파손 |

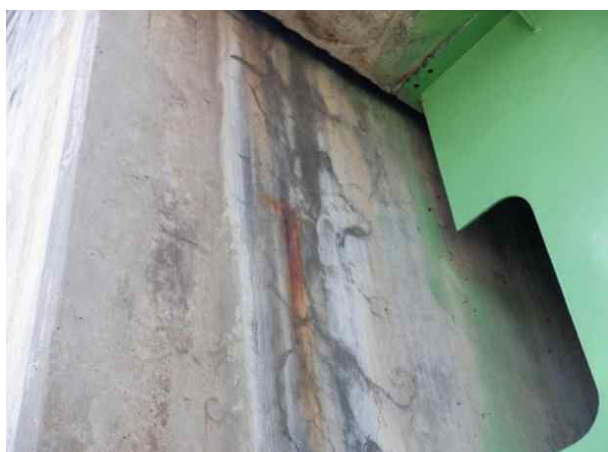
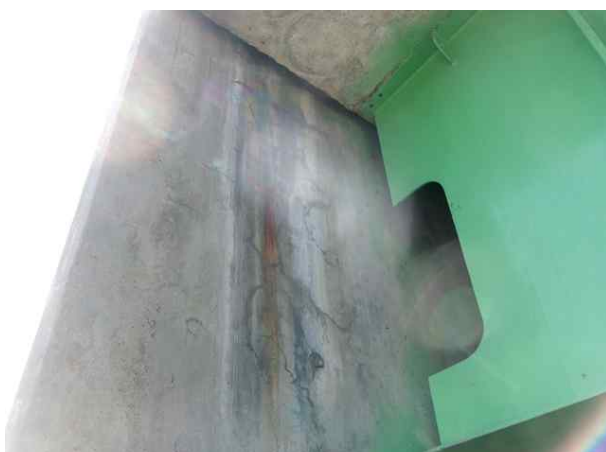
| 15<br>(25년 하반기) | 교대(A2) 홍벽 누수흔적 및 망상균열 | 15<br>(26년 상반기) | 교대(A2) 홍벽 누수흔적 및 망상균열 |

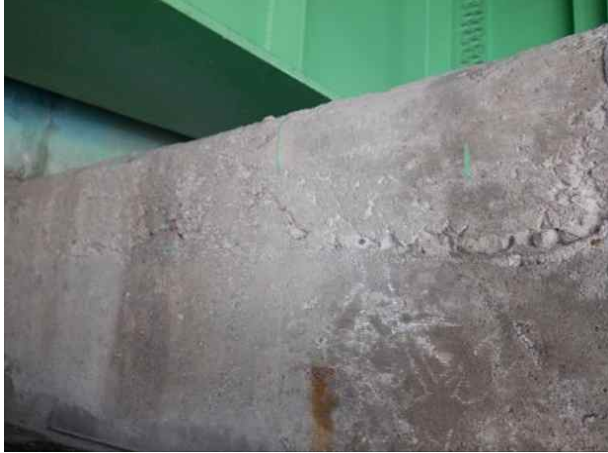
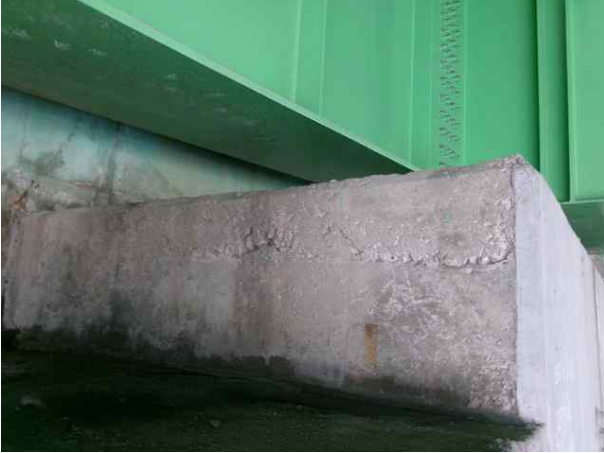
| 16<br>(25년 하반기) | 16<br>(26년 상반기) |

| 교대(A2) 재료분리 | 교대(A2) 재료분리 |

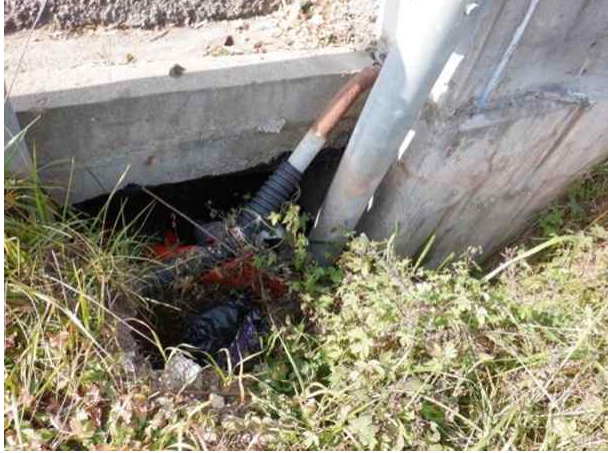
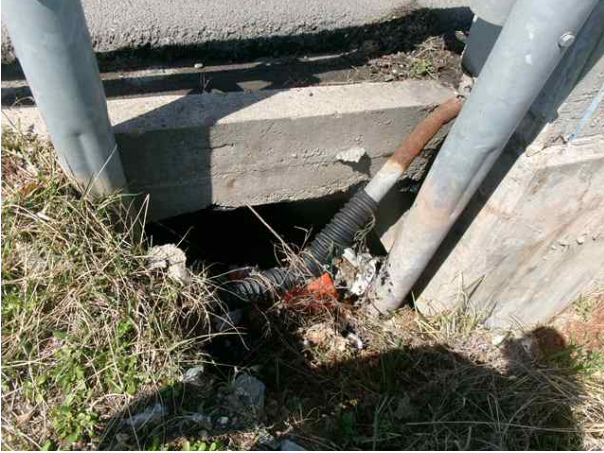
| 17<br>(25년 하반기) | 17<br>(26년 상반기) |

| 교대(A2) 토사유실(t=1.0m) | 교대(A2) 토사유실(t=1.0m) |

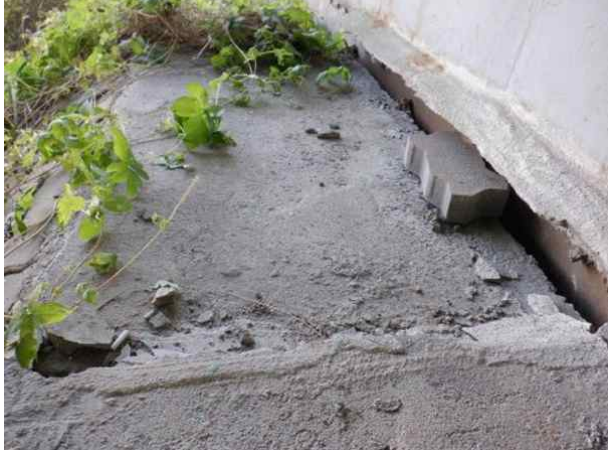
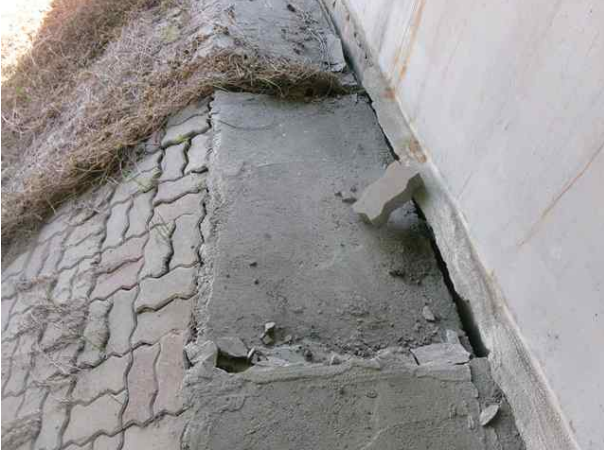
| 18<br>(25년 하반기) | 18<br>(26년 상반기) |

| 교대(A2) 법면 상부 몰탈 파손 | 교대(A2) 법면 상부 몰탈 파손 |

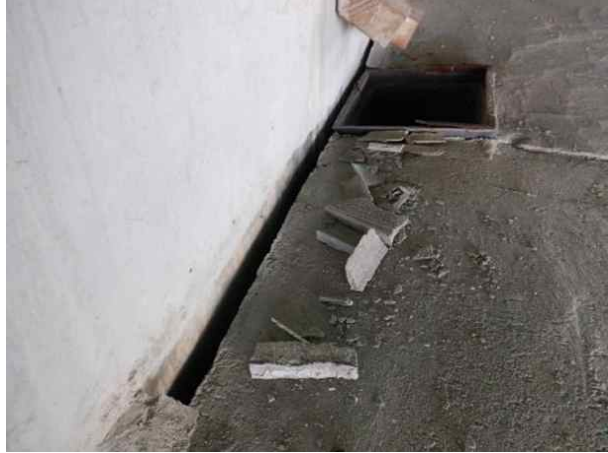
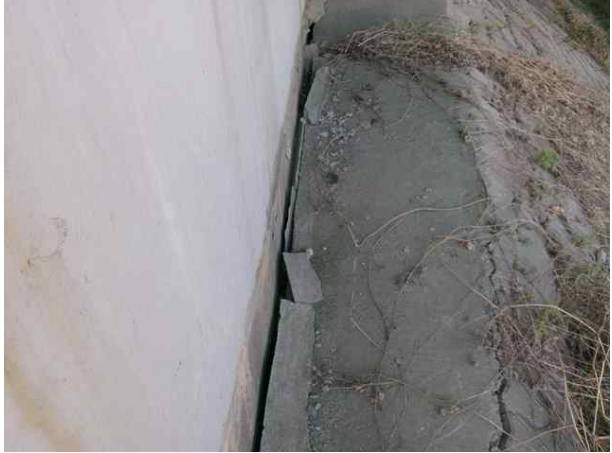
| 19<br>(25년 하반기) | 교대(A2) 법면 이격 | 19<br>(26년 상반기) | 교대(A2) 법면 이격 |

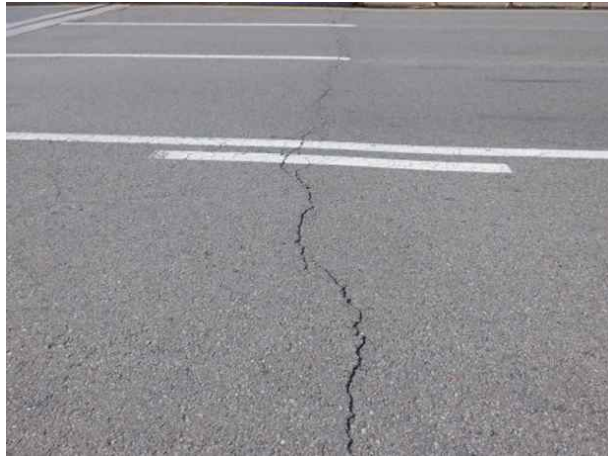
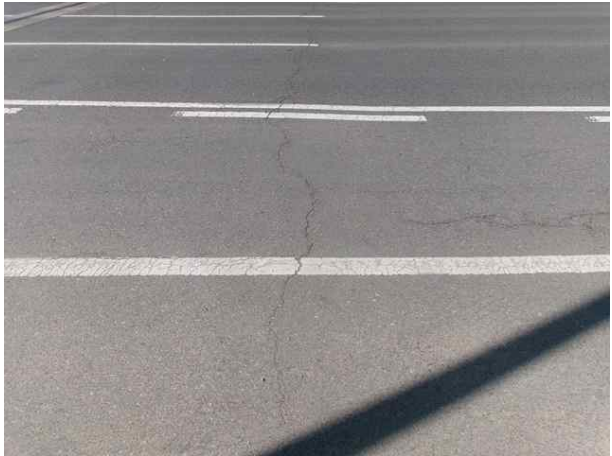
| 20<br>(25년 하반기) | 교면포장(A1) 접속부 균열 | 20<br>(26년 상반기) | 교면포장(A1) 접속부 균열 |

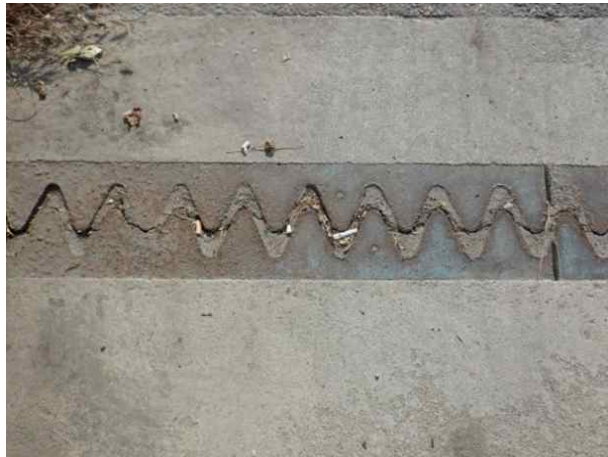
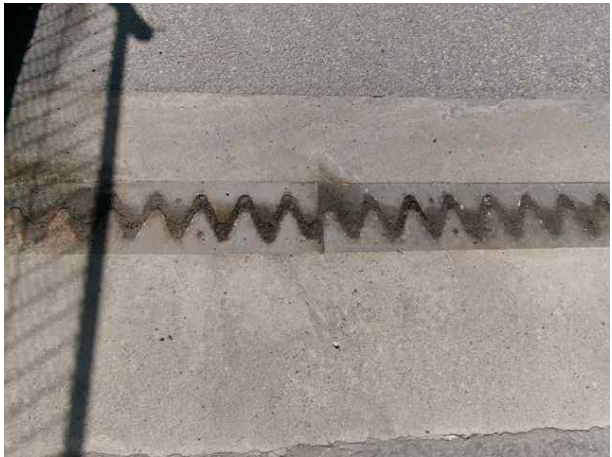
| 21<br>(25년 하반기) | 신축이음(A1) 유간 토사퇴적 | 21<br>(26년 상반기) | 신축이음(A1) 유간 토사퇴적 |

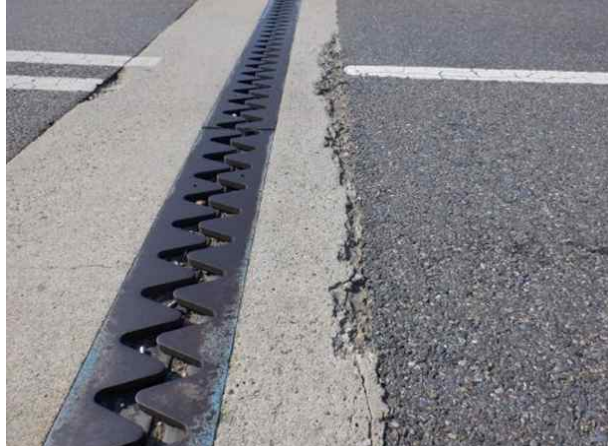
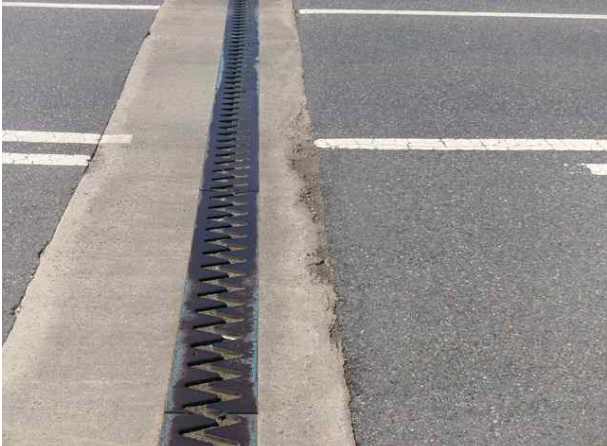
| <div>22</div> <div>(25년 하반기)</div> | <div>신축이음(A2) 후타재 파손</div> | <div>22</div> <div>(26년 상반기)</div> | <div>신축이음(A2) 후타재 파손</div> |

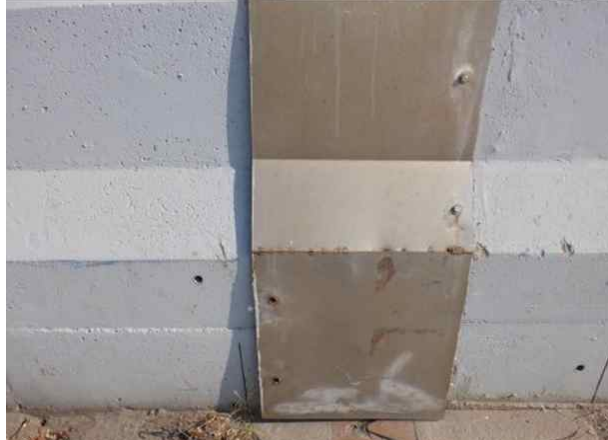
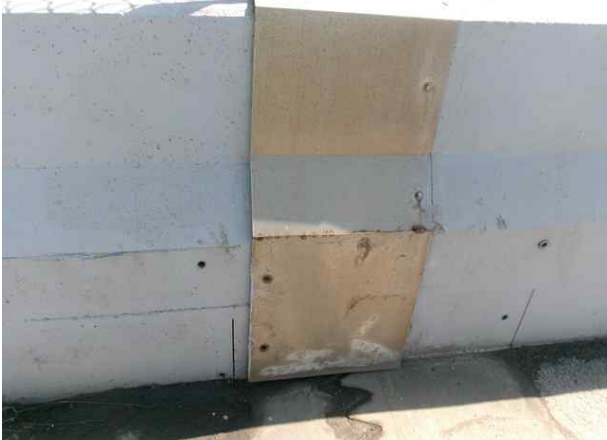
| <div>23</div> <div>(25년 하반기)</div> | <div>차수관(A2) 볼트 탈락</div> | <div>23</div> <div>(26년 상반기)</div> | <div>차수관(A2) 볼트 탈락</div> |

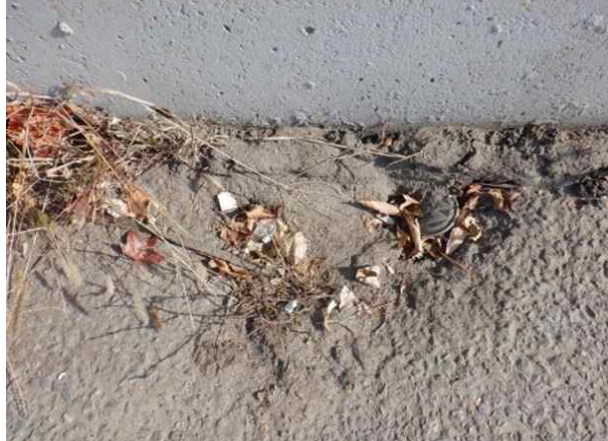
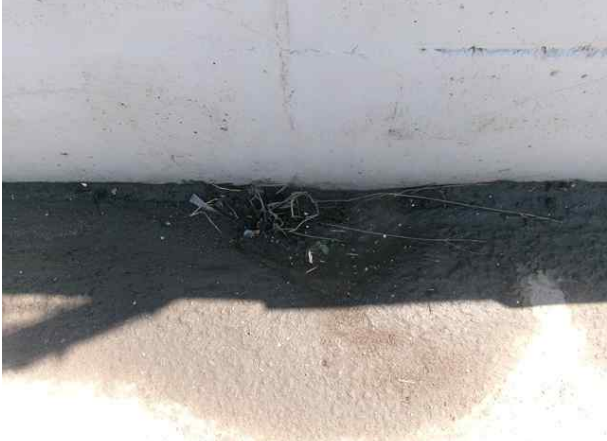
| <div>24</div> <div>(25년 하반기)</div> | <div>배수구 퇴적물(막힘)</div> | <div>24</div> <div>(26년 상반기)</div> | <div>배수구 퇴적물(막힘)</div> |

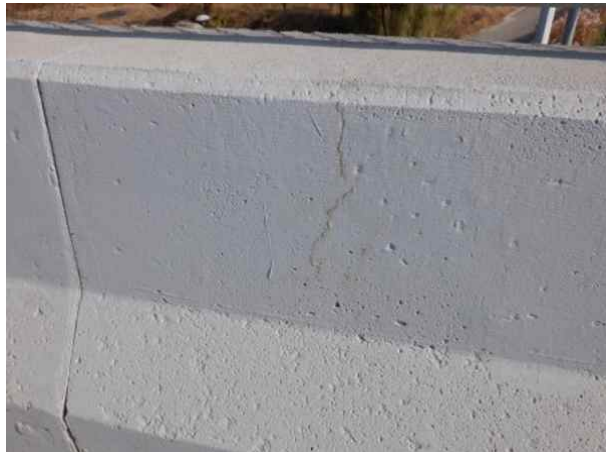
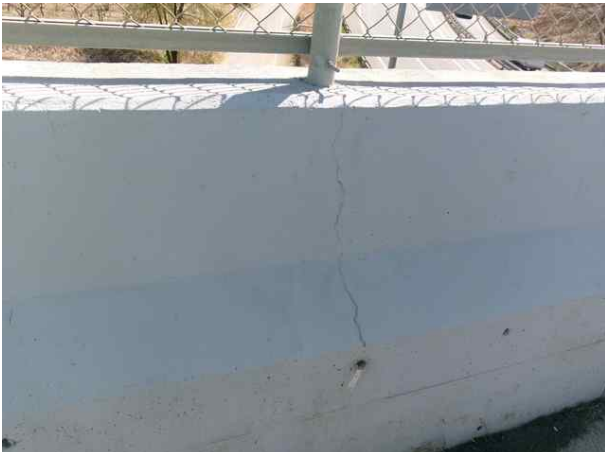
| 25<br>(25년 하반기) | 방호벽 균열(0.3mm미만) | 25<br>(26년 상반기) | 방호벽 균열(0.3mm미만) |

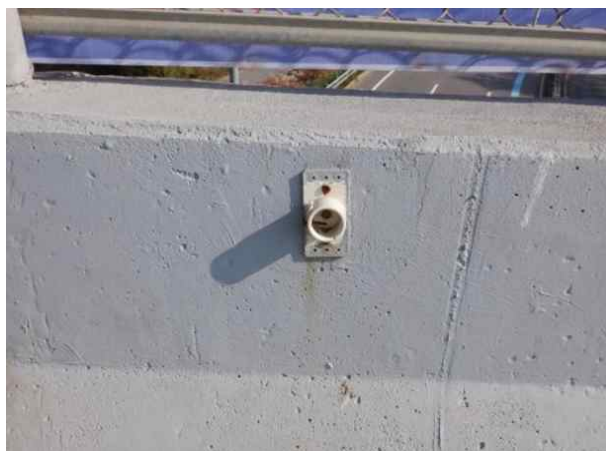
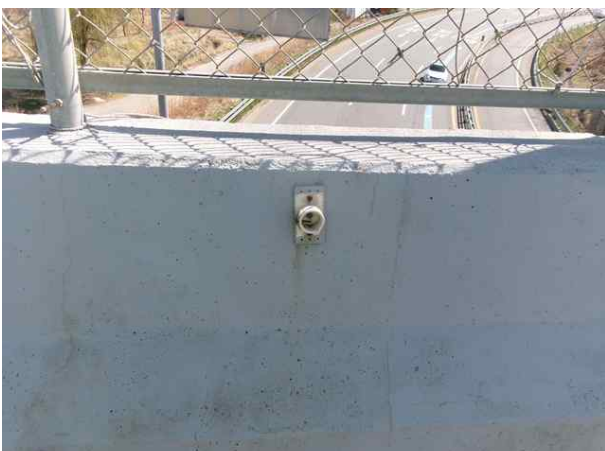
| 26<br>(25년 하반기) | 텔리네이터 파손 | 26<br>(26년 상반기) | 텔리네이터 파손 |
