## 28. 옥림2교

손상현황

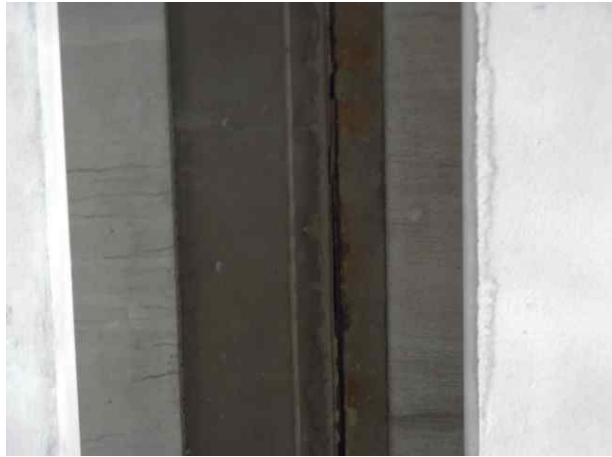
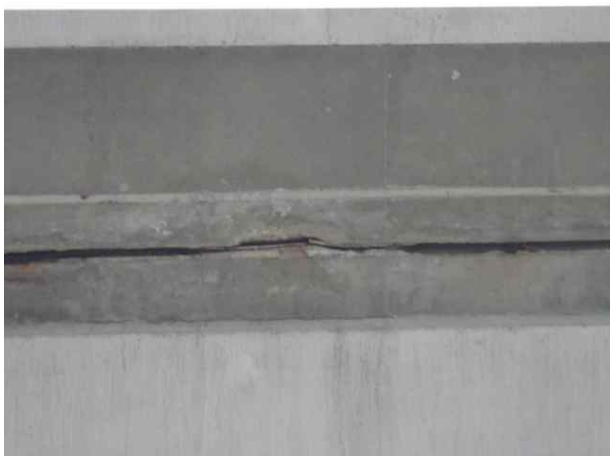
| 01<br>(25년 하반기) | 바닥판하면 누수, 박리, 박락 | 01<br>(26년 상반기) | 바닥판하면 누수, 박리, 박락 |

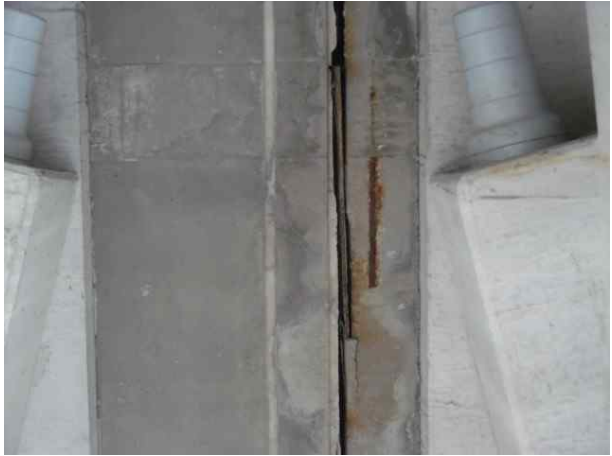
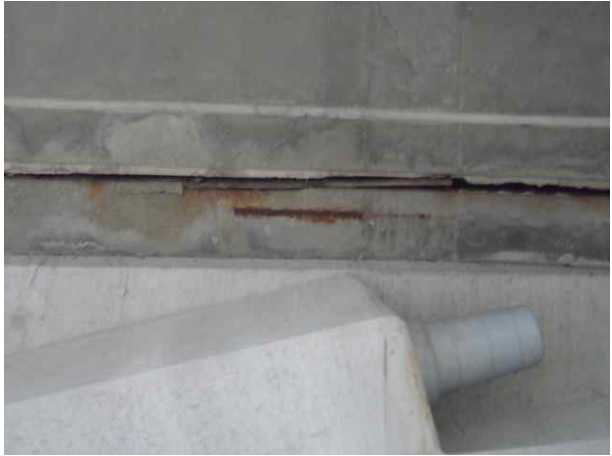
| 02<br>(25년 하반기) | 바닥판하면 철근노출 | 02<br>(26년 상반기) | 바닥판하면 철근노출 |

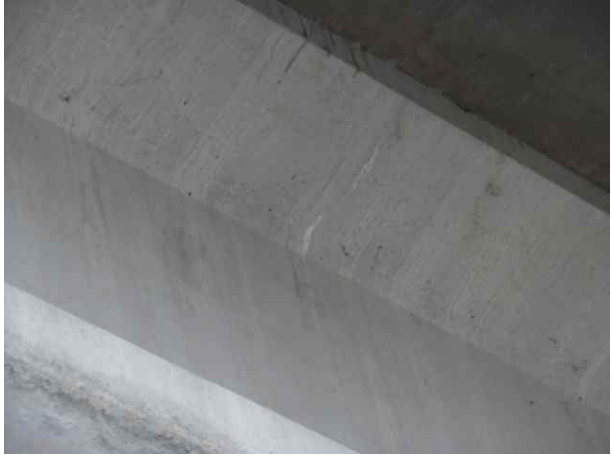
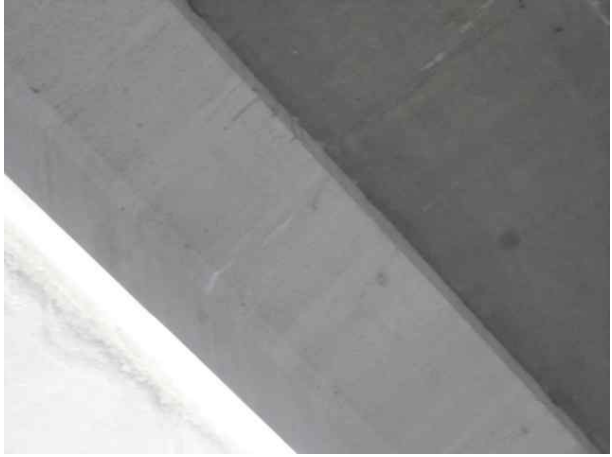
| 03<br>(25년 하반기) | 거더 균열부 백태(0.3mm미만) | 03<br>(26년 상반기) | 거더 균열부 백태(0.3mm미만) |

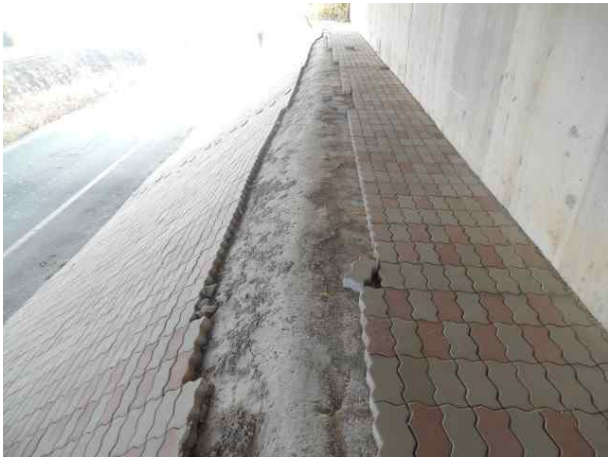
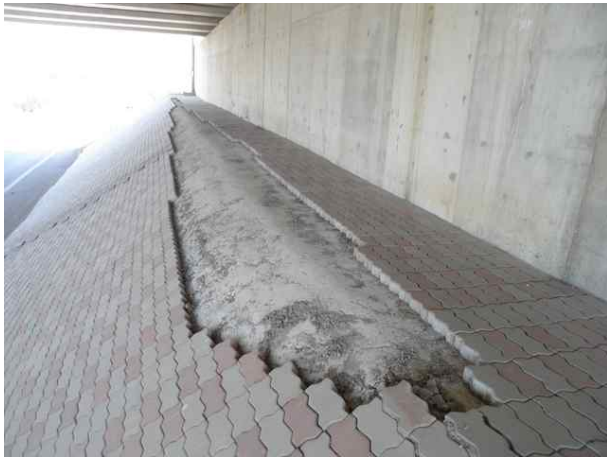
| 04<br>(25년 하반기) | 교대 법면 블록 유실 | 04<br>(26년 상반기) | 교대 법면 블록 유실 |

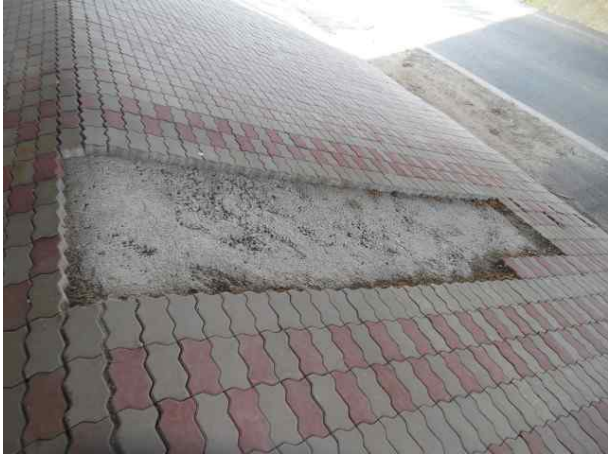
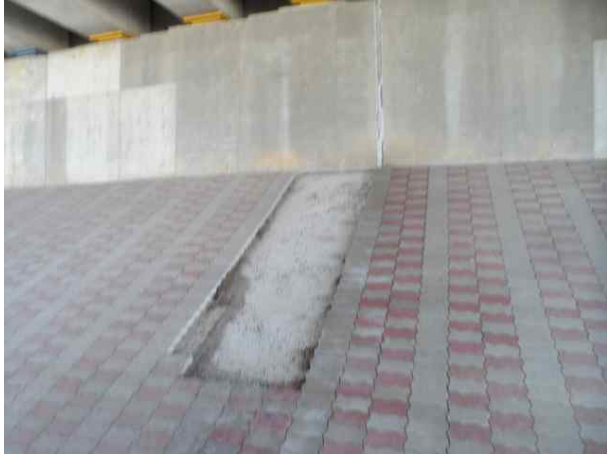
| 05<br>(25년 하반기) | 교대 법면 블록 유실 | 05<br>(26년 상반기) | 교대 법면 블록 유실 |

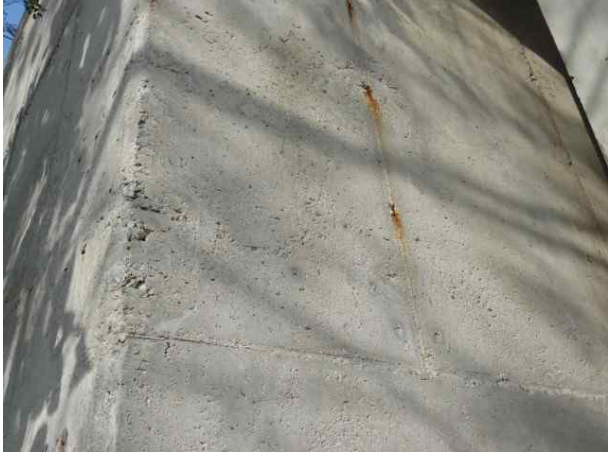
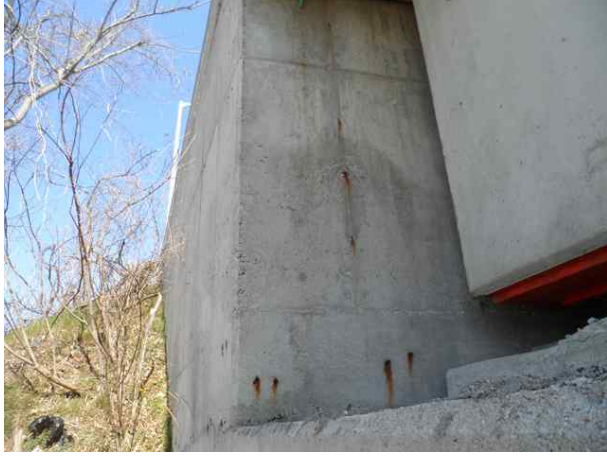
| 06<br>(25년 하반기) | 교대 홍벽 재료분리 | 06<br>(26년 상반기) | 교대 홍벽 재료분리 |

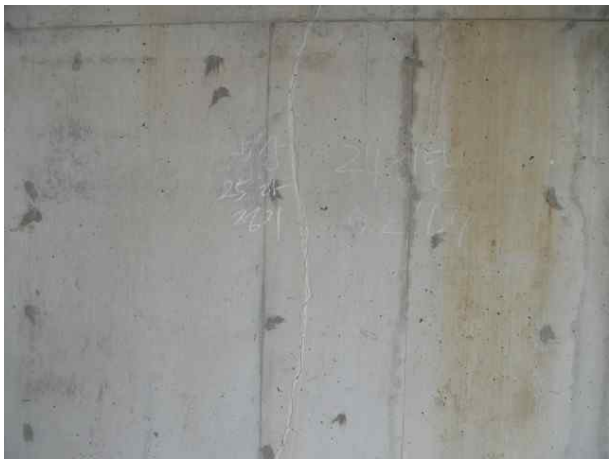
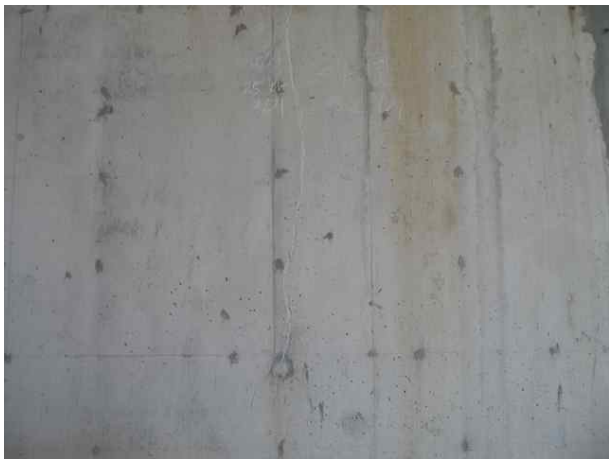
| 07<br>(25년 하반기) | 교대 균열(0.3mm미만) | 07<br>(26년 상반기) | 교대 균열(0.3mm미만) |

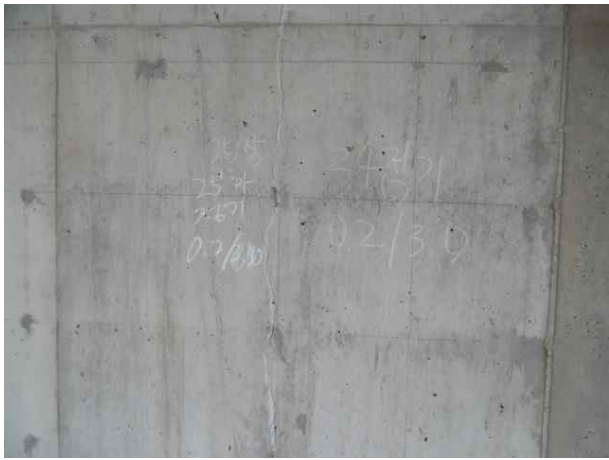
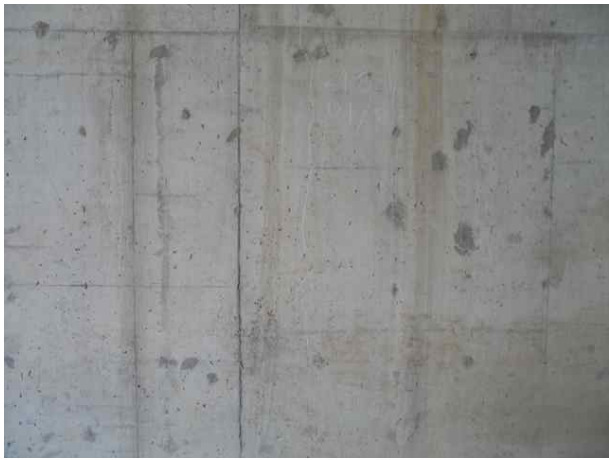
| 08<br>(25년 하반기) | 교대 균열(0.3mm미만) | 08<br>(26년 상반기) | 교대 균열(0.3mm미만) |

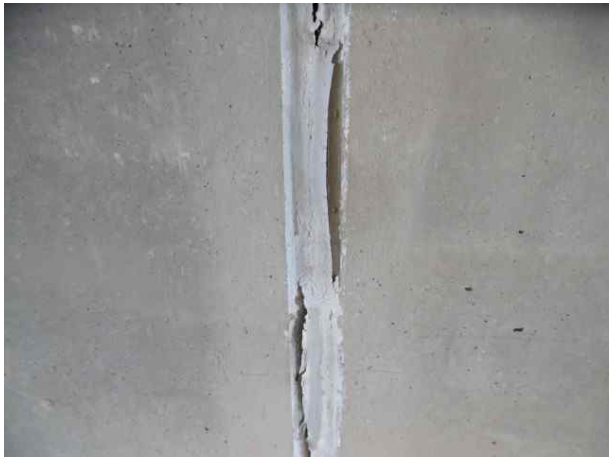
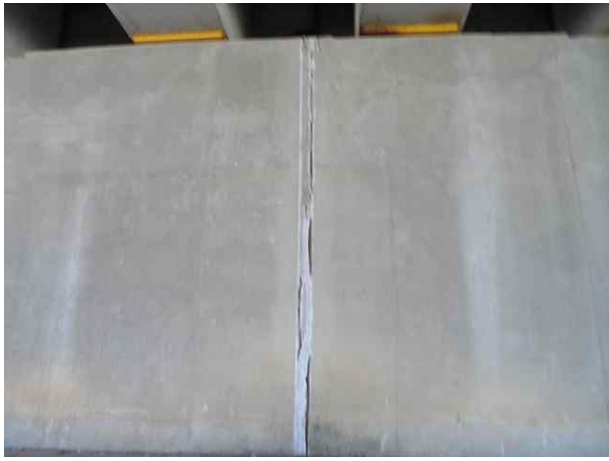
| 09<br>(25년 하반기) | 교대 실란트 파손 | 09<br>(26년 상반기) | 교대 실란트 파손 |

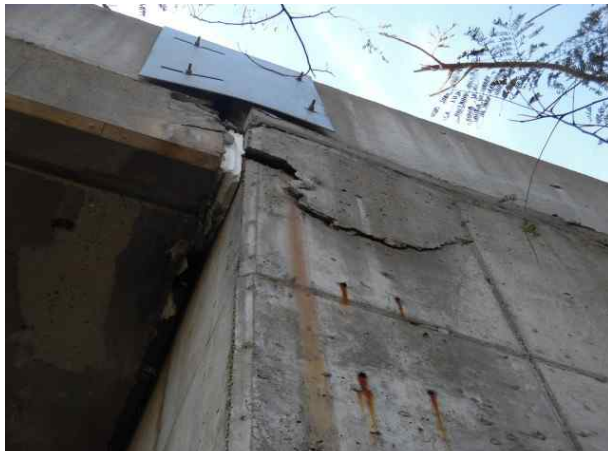
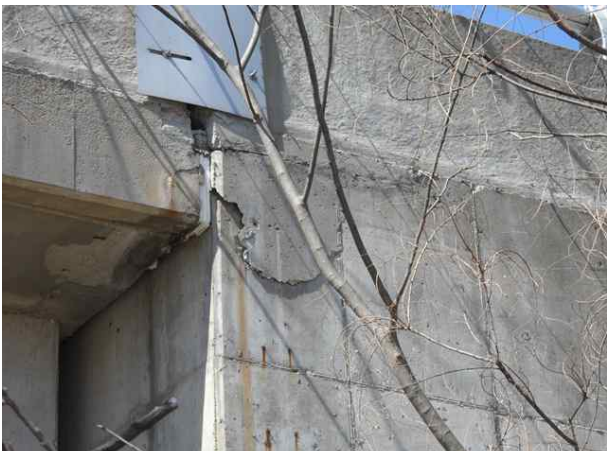
| 10<br>(25년 하반기) | 교대 박락 | 10<br>(26년 상반기) | 교대 박락 |

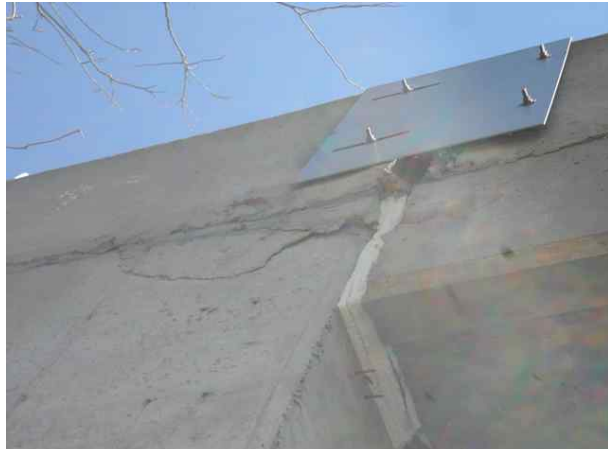
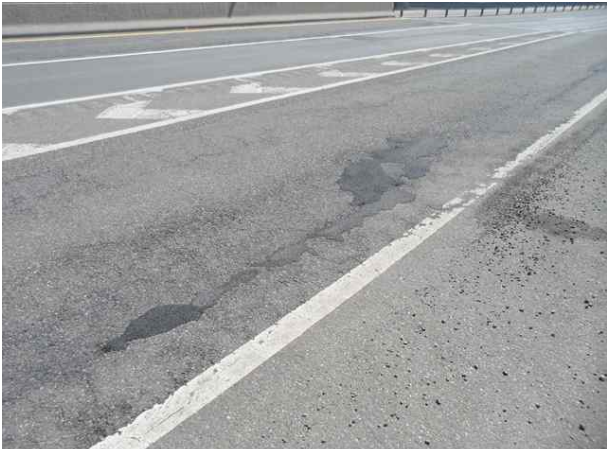
| 11<br>(26년 상반기) | 교대 박락 | 12<br>(26년 상반기) | 교면포장 포장 균열 |

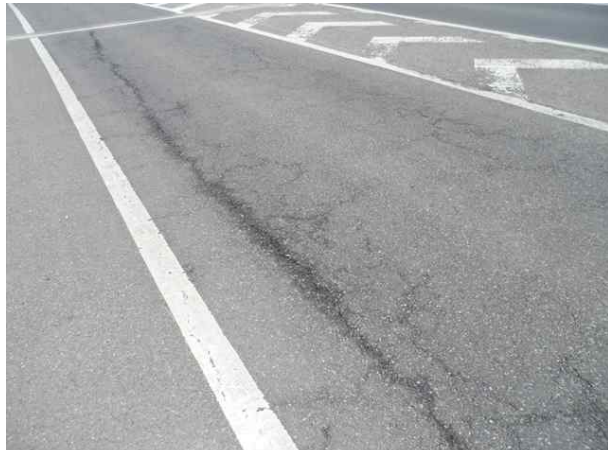
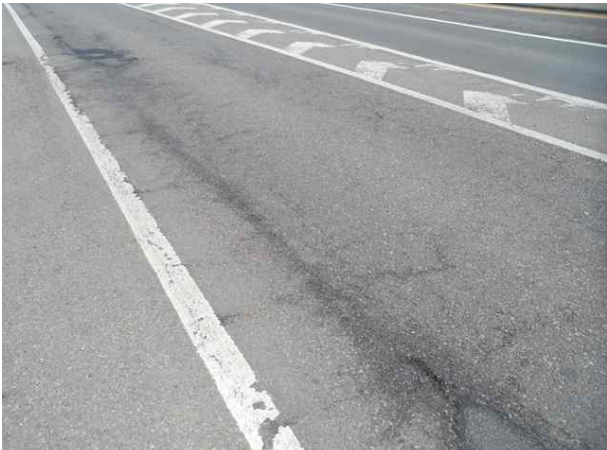
| 13<br>(26년 상반기) | 교면포장 포장 균열/망상균열 | 14<br>(26년 상반기) | 교면포장 포장 마모 |

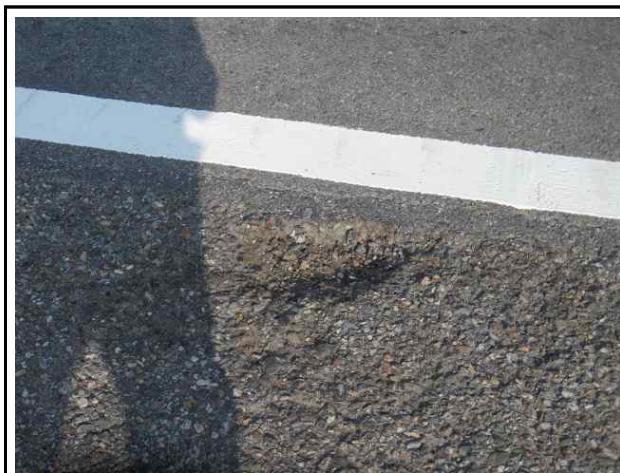
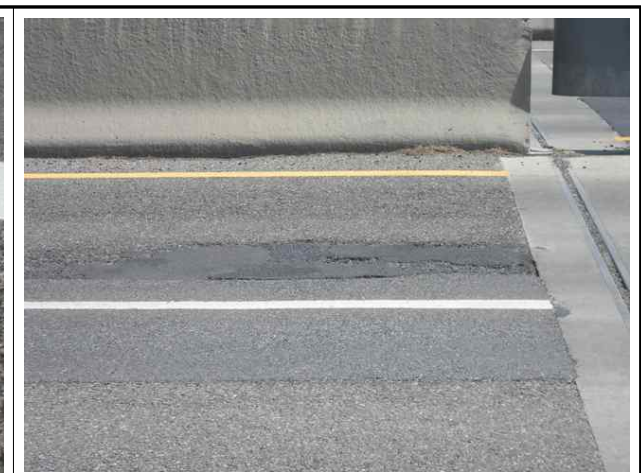
| 15<br>(25년 하반기) | 15<br>(26년 상반기) |

| 교면포장 포트홀 | 교면포장 포트홀 |

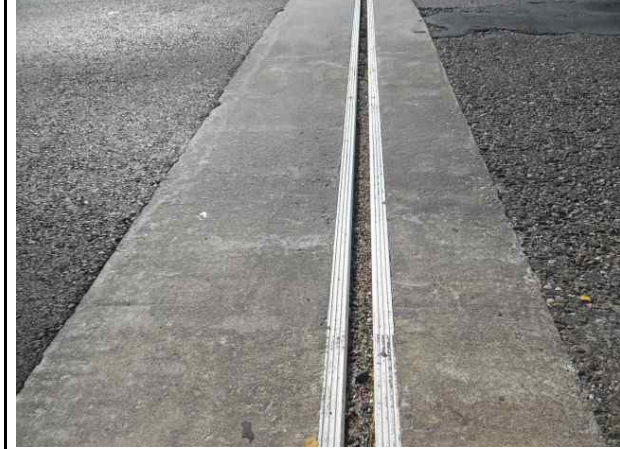
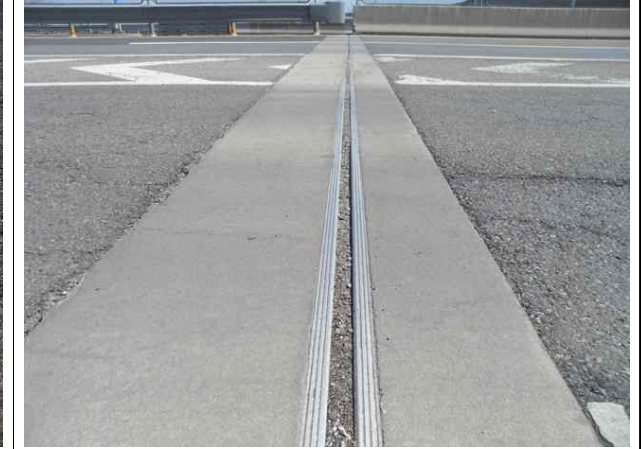
| 16<br>(25년 하반기) | 16<br>(26년 상반기) |

| 신축이음 유간 토사퇴적 | 신축이음 유간 토사퇴적 |

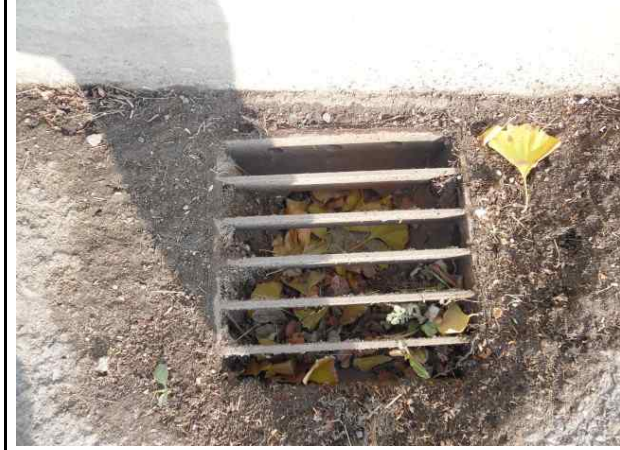
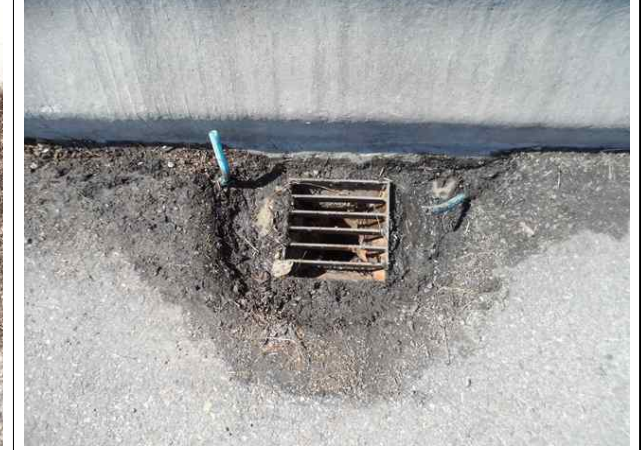
| 17<br>(25년 하반기) | 17<br>(26년 상반기) |

| 배수시설 배수구 막힘 | 배수시설 배수구 막힘 보수 |
