## 30. 용정교

## 손상현황

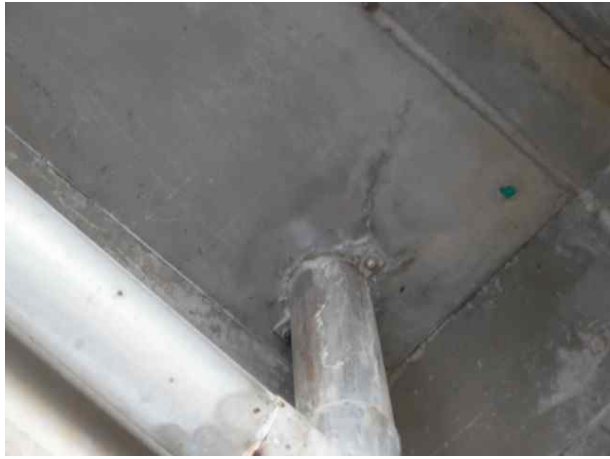
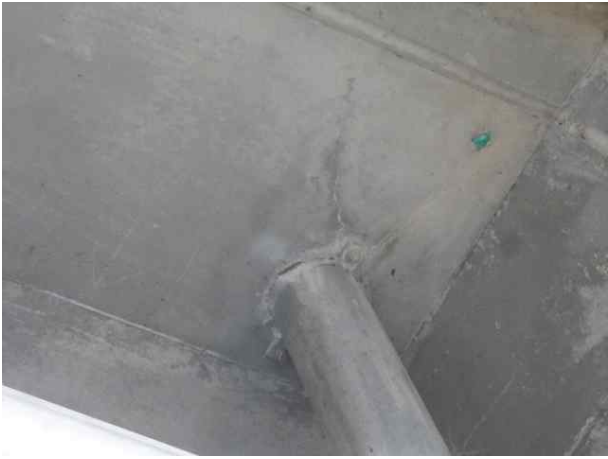
| 01<br>(25년 하반기) | 바닥판하면 균열부 백태(0.3mm미만) | 01<br>(26년 상반기) | 바닥판하면 균열부 백태(0.3mm미만) |

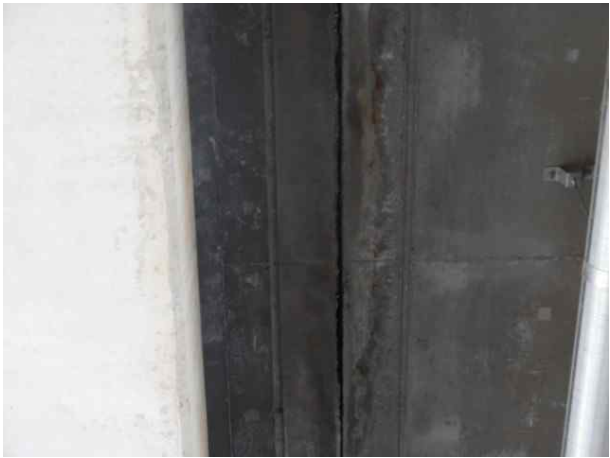
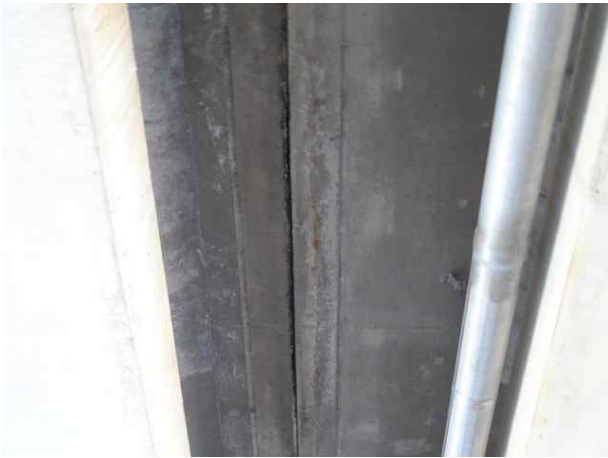
| 02<br>(25년 하반기) | 바닥판하면 층분리 | 02<br>(26년 상반기) | 바닥판하면 층분리 |

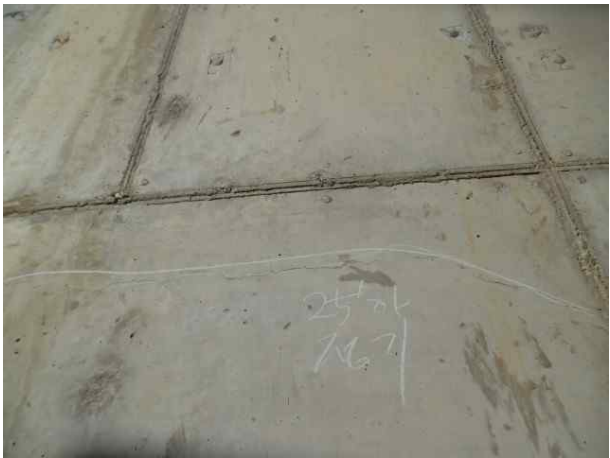
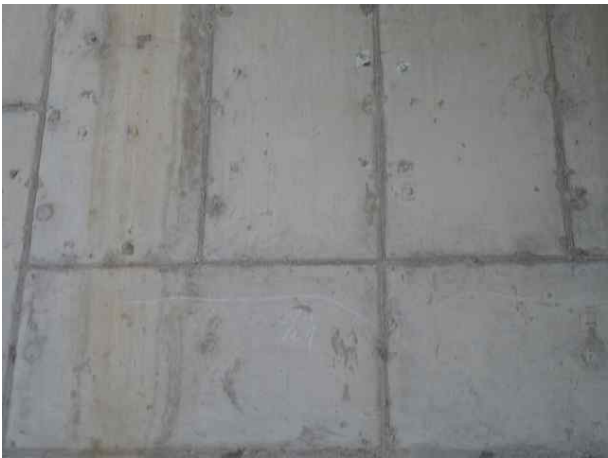
| 03<br>(25년 하반기) | 교대 균열(0.3mm미만) | 03<br>(26년 상반기) | 교대 균열(0.3mm미만) |

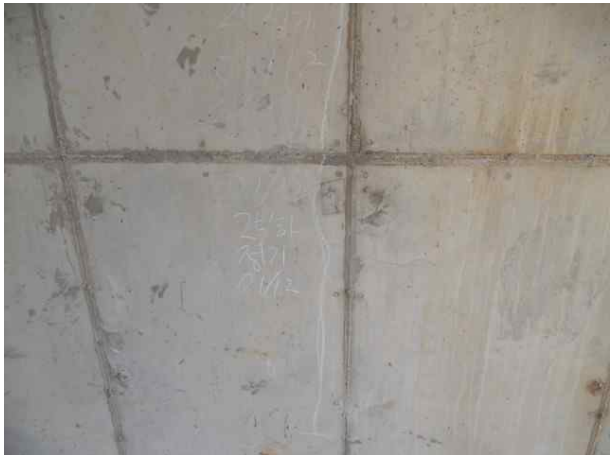
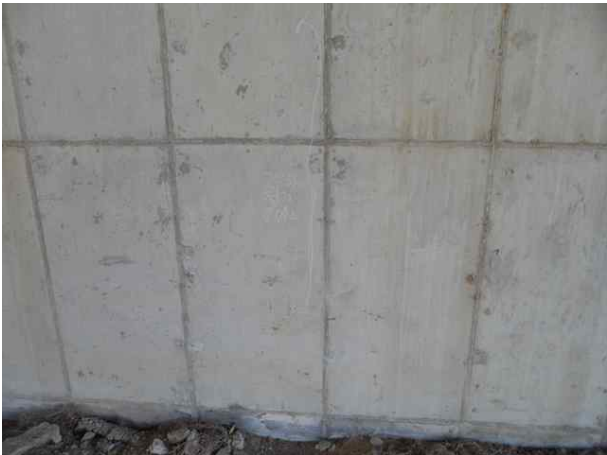
| 04<br>(25년 하반기) | 교대 균열(0.3mm미만) | 04<br>(26년 상반기) | 교대 균열(0.3mm미만) |

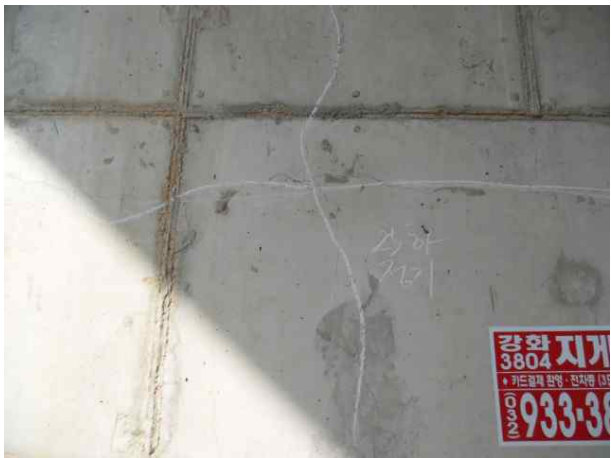
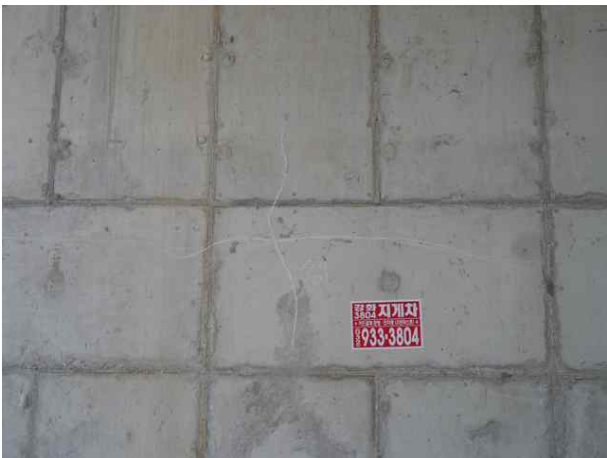
| 05<br>(25년 하반기) | 교대 균열(0.3mm미만) | 05<br>(26년 상반기) | 교대 균열(0.3mm미만) |

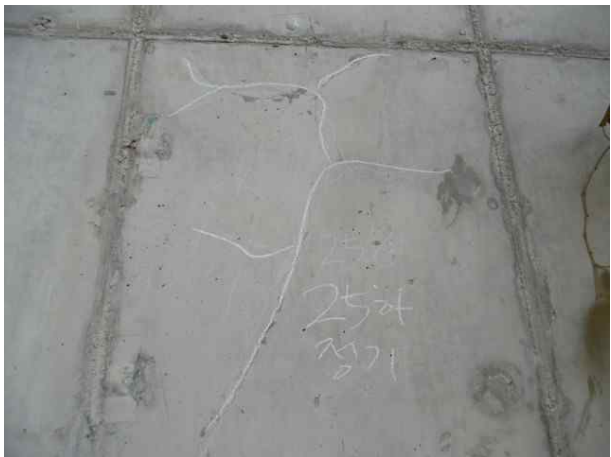
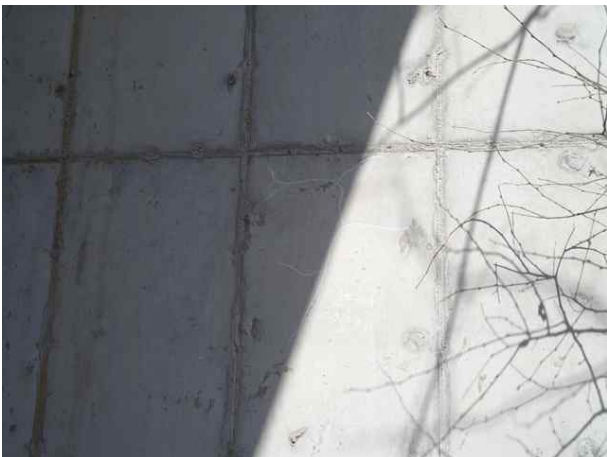
| 06<br>(25년 하반기) | 교대 망상균열(0.3mm미만) | 06<br>(26년 상반기) | 교대 망상균열(0.3mm미만) |

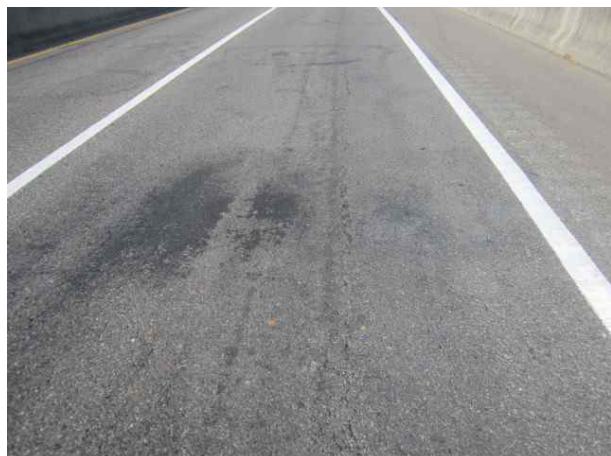
| 10<br>(25년 하반기) | 10<br>(26년 상반기) |

| 교면포장 포장 균열 | 교면포장 포장 망상균열 |

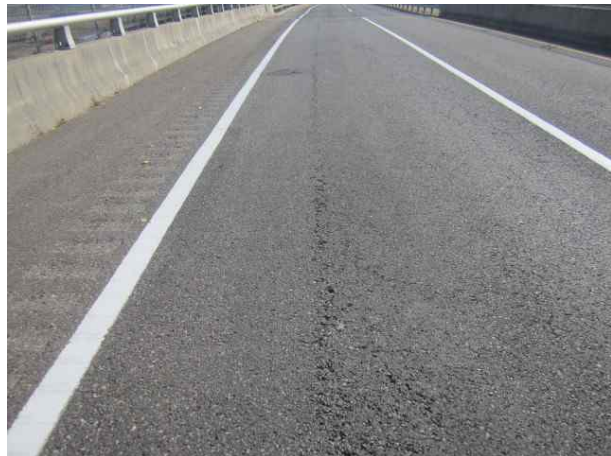
| 11<br>(25년 하반기) | 11<br>(26년 상반기) |

| 교면포장 포장 균열 | 신축이음 본체 부식 |

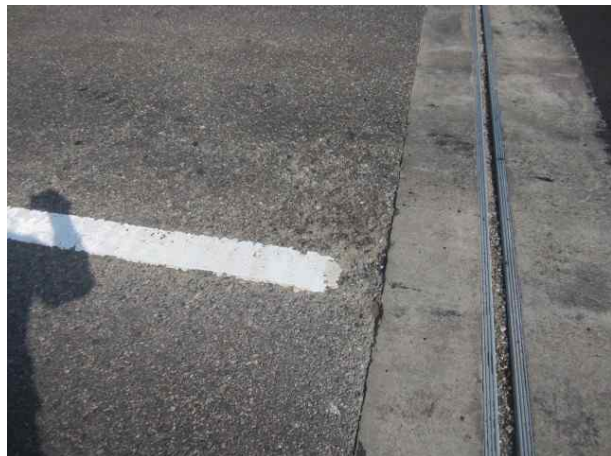
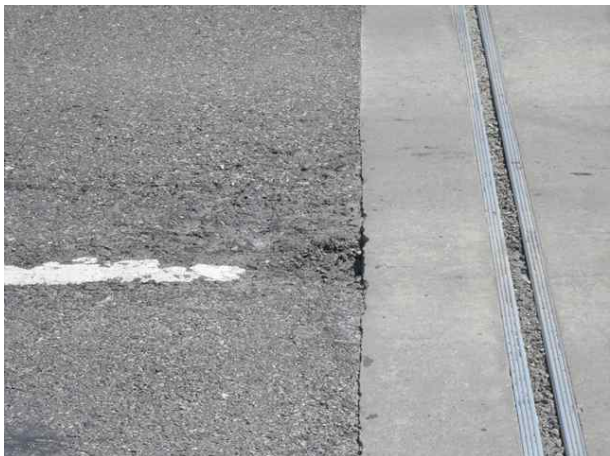
| 12<br>(25년 하반기) | 12<br>(26년 상반기) |

| 교면포장 포장 파손 | 교면포장 포장 파손 |

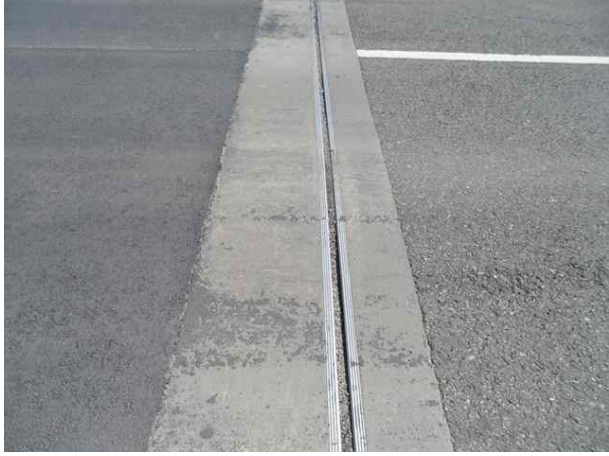
신축이음 후타재 균열(0.3mm미만)

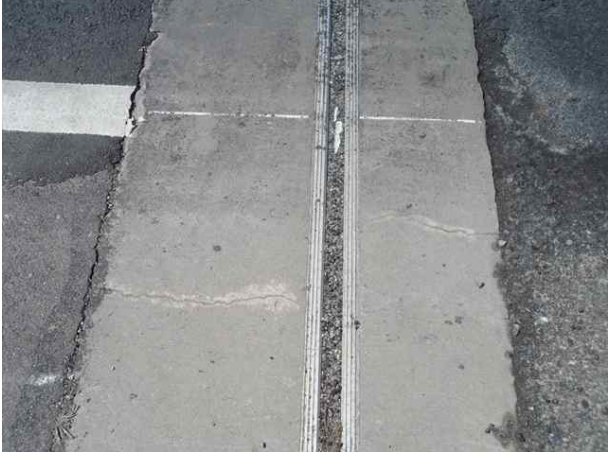
신축이음 후타재 균열(0.3mm미만)

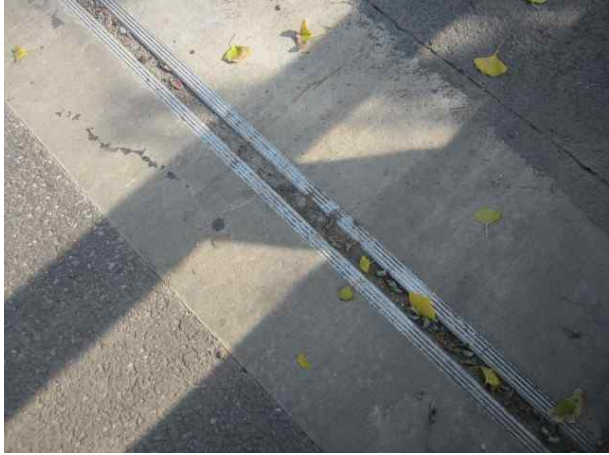
신축이음 유간 토사퇴적

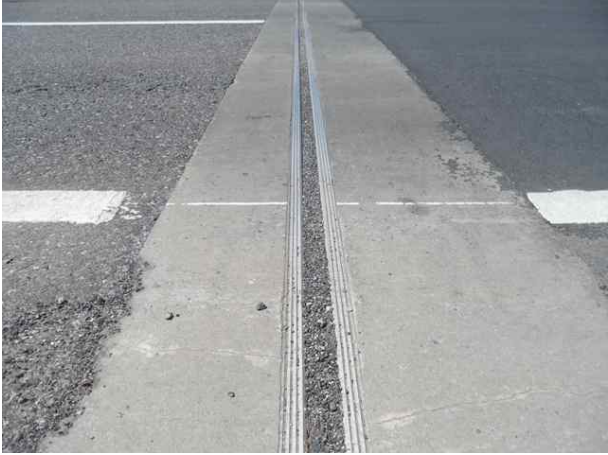
신축이음 유간 토사퇴적

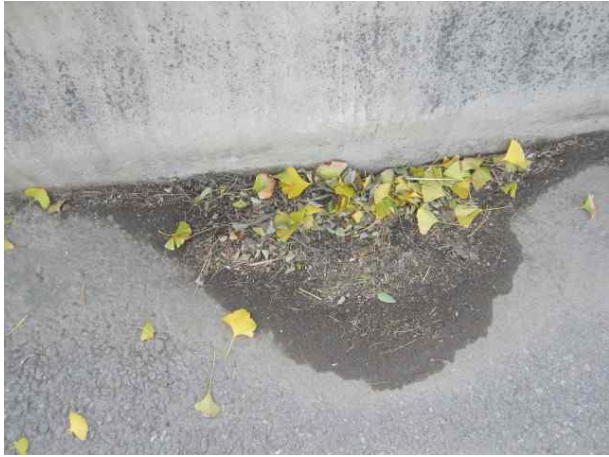
배수시설 배수구 막힘

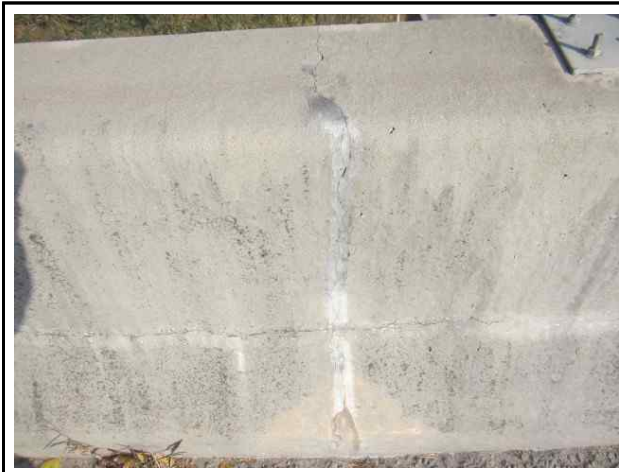
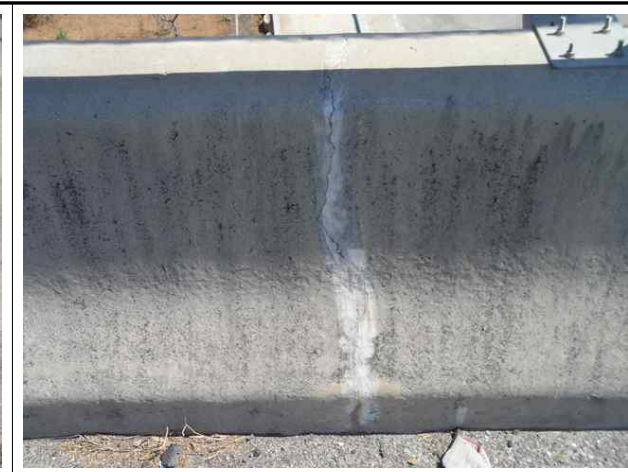
| 17<br>(25년 하반기) | 방호벽 균열(0.3mm미만) | 17<br>(26년 상반기) | 방호벽 균열(0.3mm미만) |

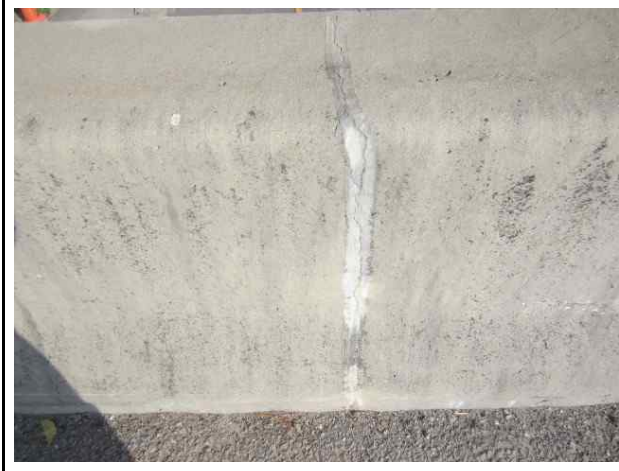
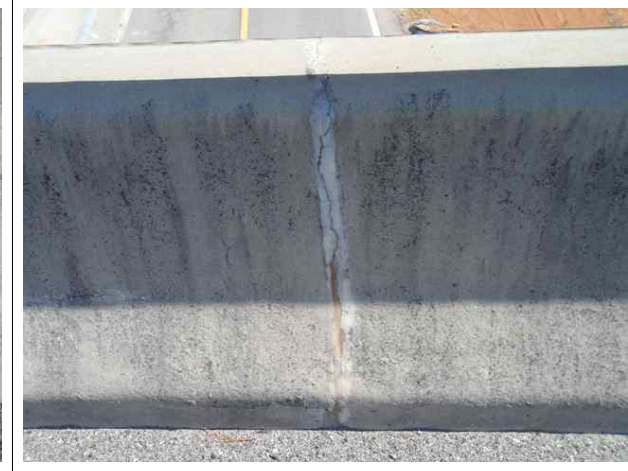
| 18<br>(25년 하반기) | 방호벽 균열(0.3mm미만) | 18<br>(26년 상반기) | 방호벽 균열(0.3mm미만) |
