## 34. 태리

## 손상현황

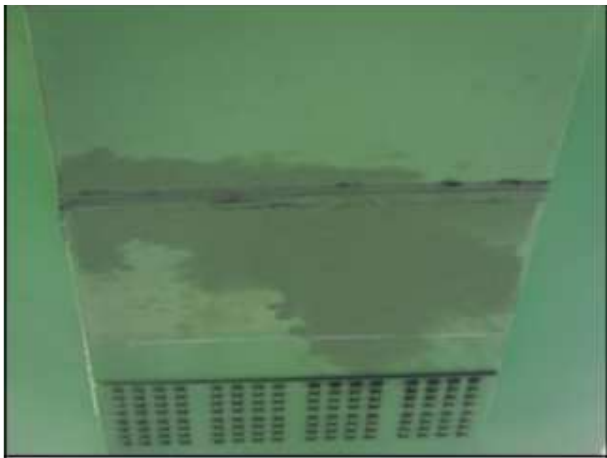
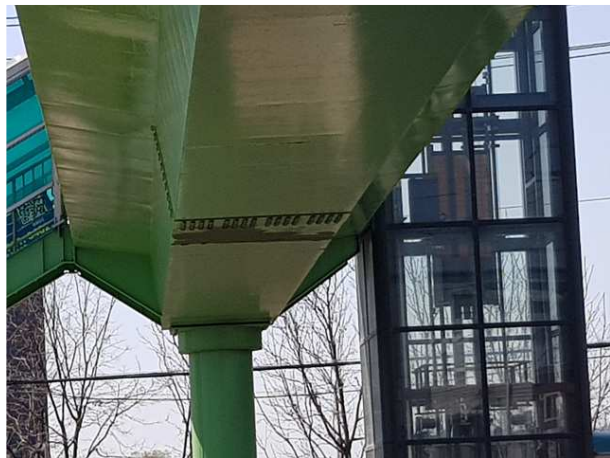
| 01<br>(25년 하반기) | 거더외부 굽힘 | 01<br>(26년 상반기) | 거더외부 굽힘 |

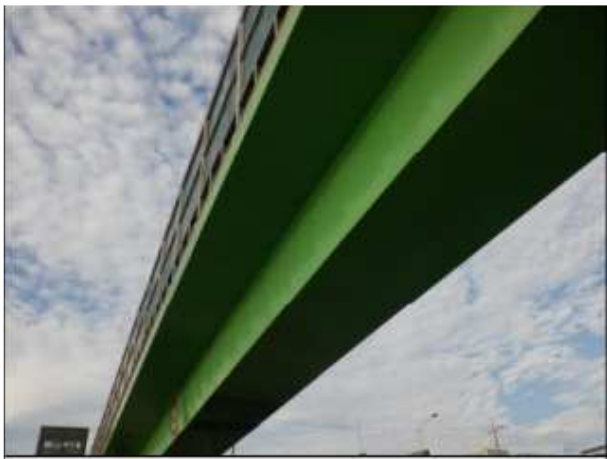
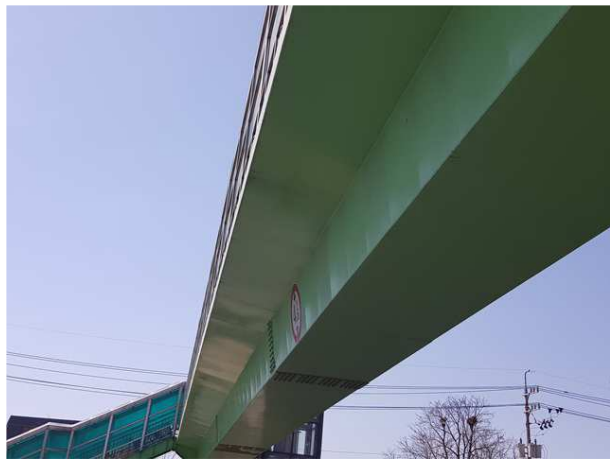
| 02<br>(25년 하반기) | 바닥판 상태양호 | 02<br>(26년 상반기) | 바닥판 상태양호 |

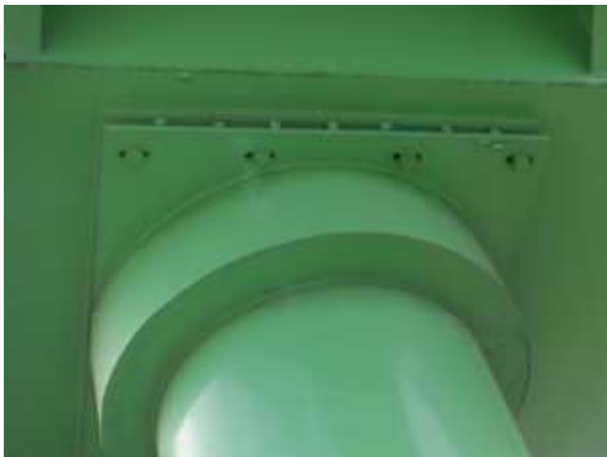
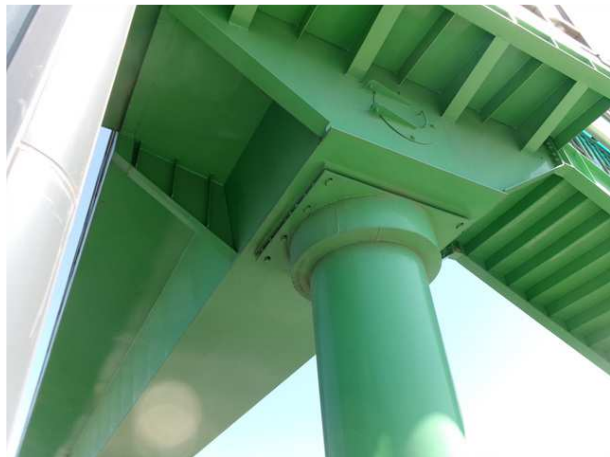
| 03<br>(25년 하반기) | 가동단 상태양호 | 03<br>(26년 상반기) | 가동단 상태양호 |

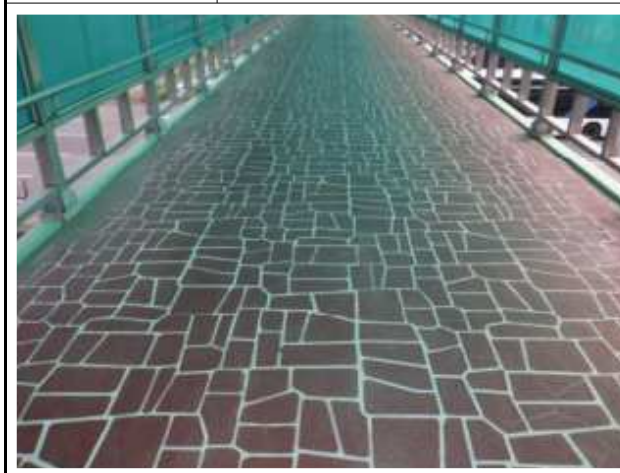
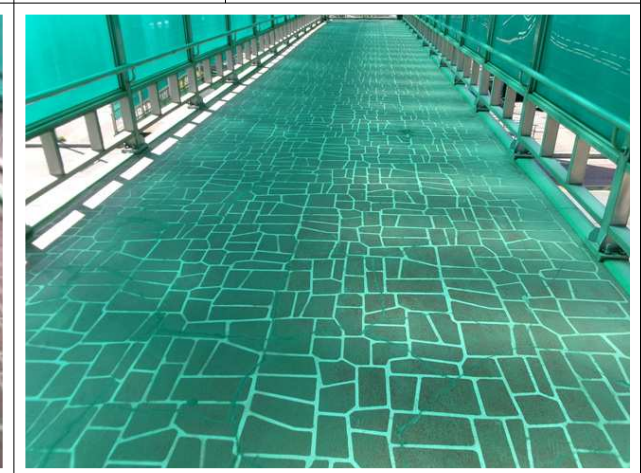
| 06<br>(25년 하반기) | 06<br>(26년 상반기) |

| 상부 포장 상태양호 | 상부 포장 상태양호 |

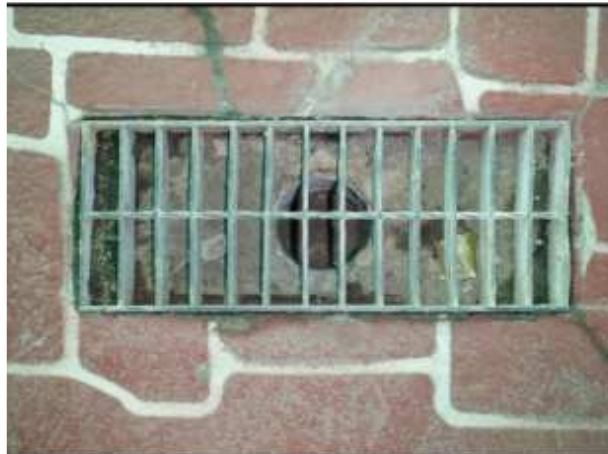
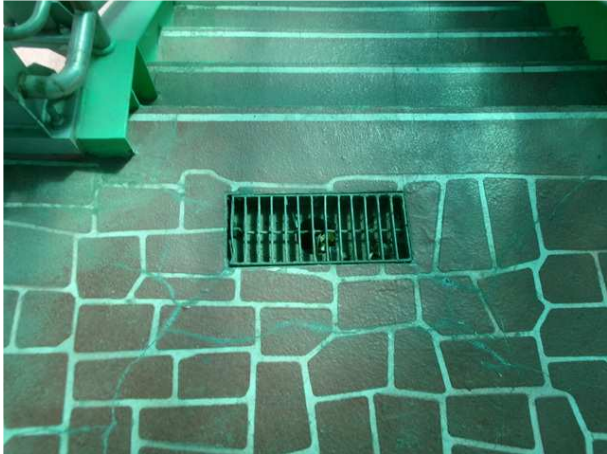
| 07<br>(25년 하반기) | 배수구 양호 | 07<br>(26년 상반기) | 배수구 양호 |

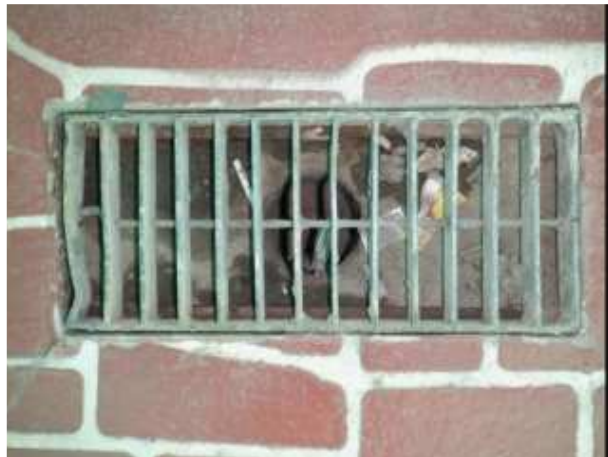
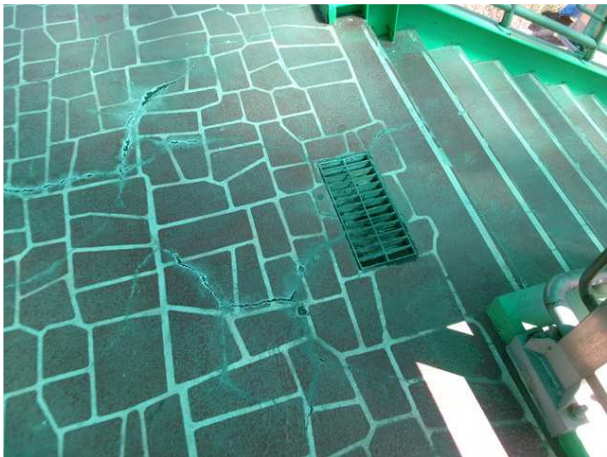
| 08<br>(25년 하반기) | 배수구 양호 | 08<br>(26년 상반기) | 배수구 양호 |

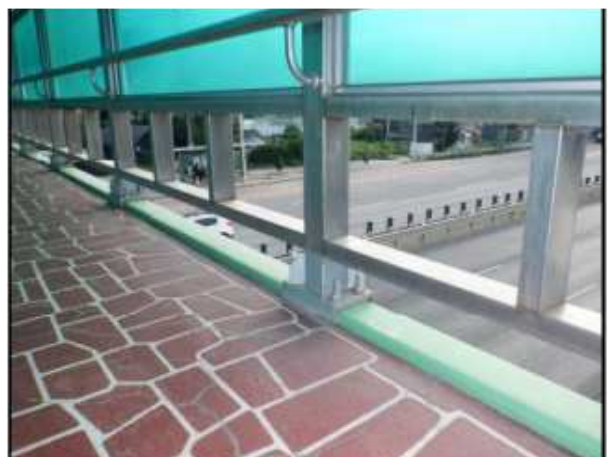
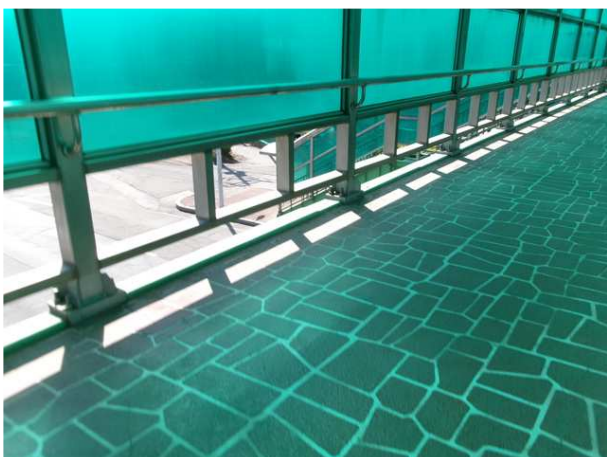
| 09<br>(25년 하반기) | 낙하물방지망 미설치 | 09<br>(26년 상반기) | 낙하물방지망 미설치 |

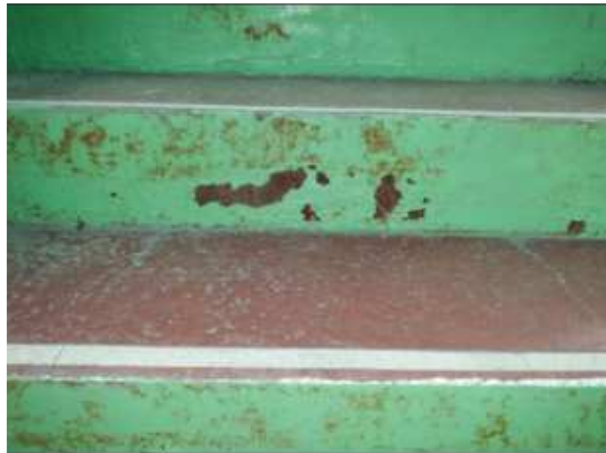
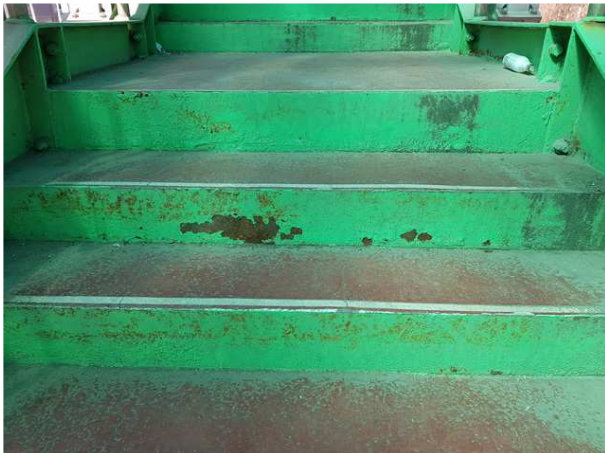
| 10<br>(25년 하반기) | 계단(김포) 부식 | 10<br>(26년 상반기) | 계단(김포) 부식 |

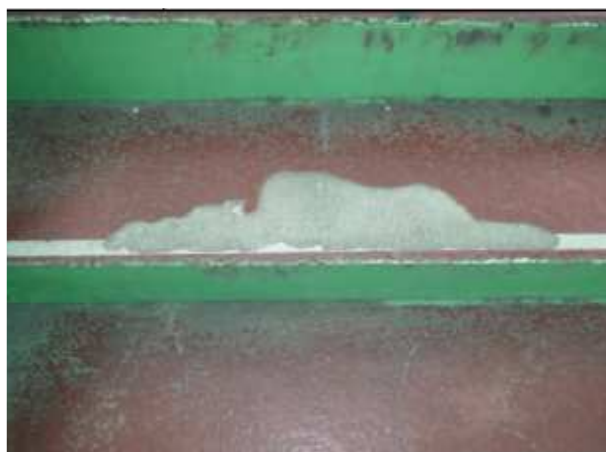
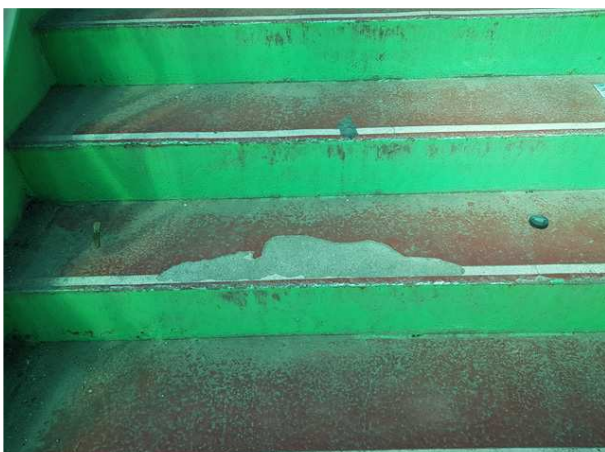
| 11<br>(25년 하반기) | 계단(김포) 도장박락 | 11<br>(26년 상반기) | 계단(김포) 도장박락 |

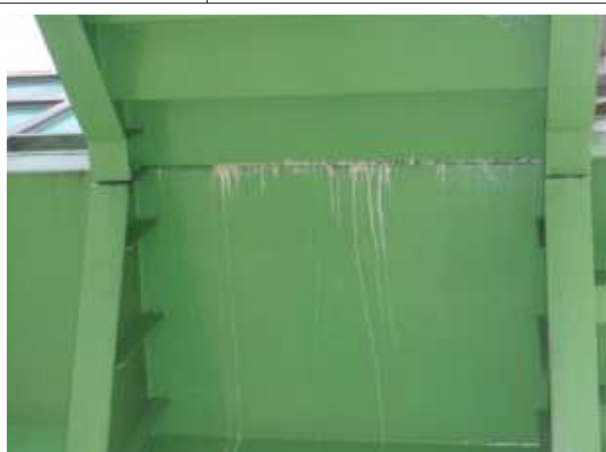
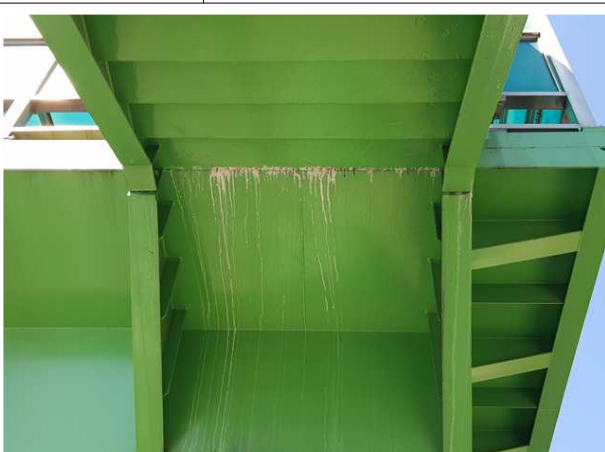
| 12<br>(25년 하반기) | 바닥판 계단 연결부 누수 | 12<br>(26년 상반기) | 바닥판 계단 연결부 누수 |
