# 1. 남 전 교

# 손상현황

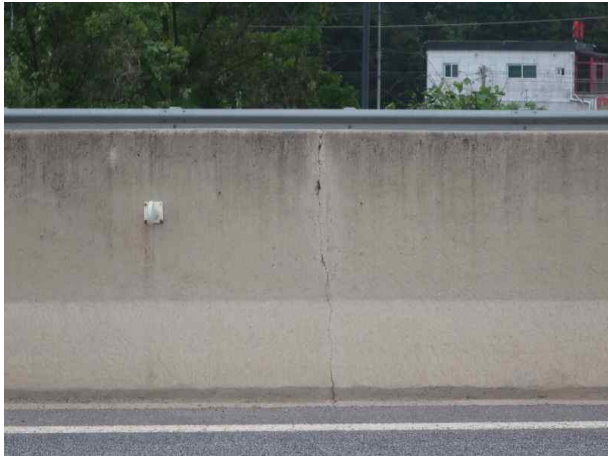
| 01<br>(25년 상반기) | 난간 및 연석(S1) 중분대<br>균열(0.3mm이상) | 01<br>(26년 상반기) | 난간 및 연석(S1) 중분대<br>균열(0.3mm이상) - 보수- |

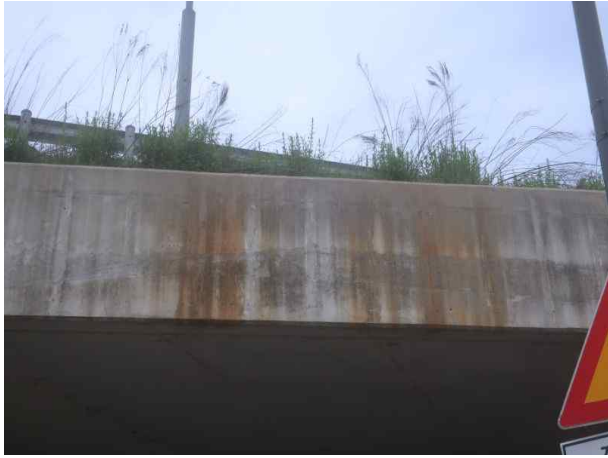
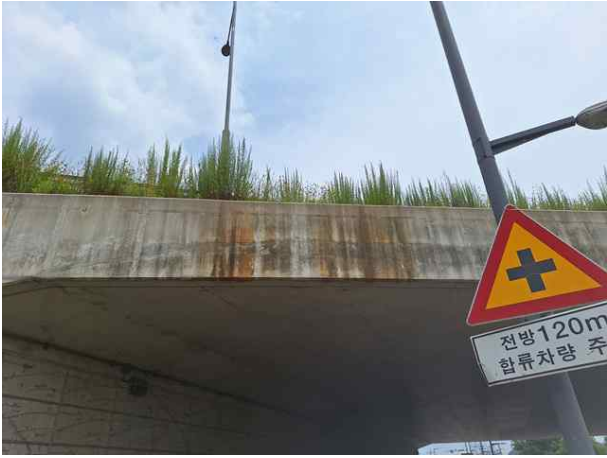
| 02<br>(25년 상반기) | 바닥판하면(S1) 녹발생 | 02<br>(26년 상반기) | 바닥판하면(S1) 녹발생 |

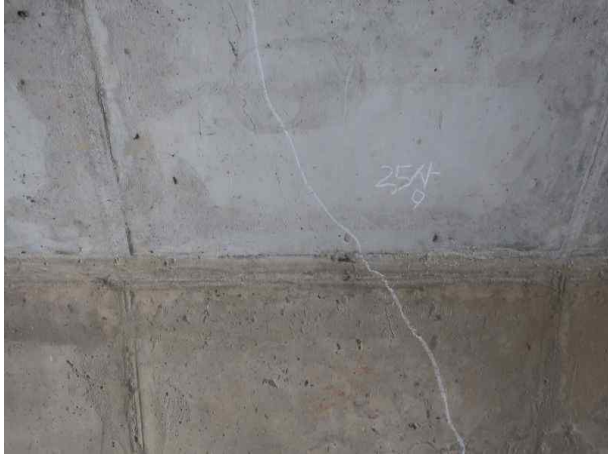
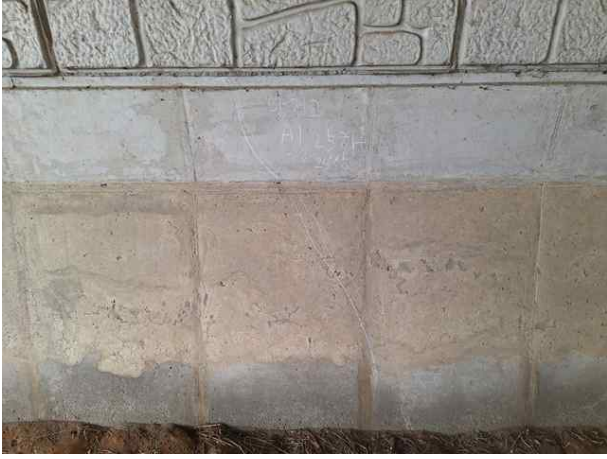
| 03<br>(25년 상반기) | 교대(A1) 균열(0.3mm미만) | 03<br>(26년 상반기) | 교대(A1) 균열(0.3mm미만) |

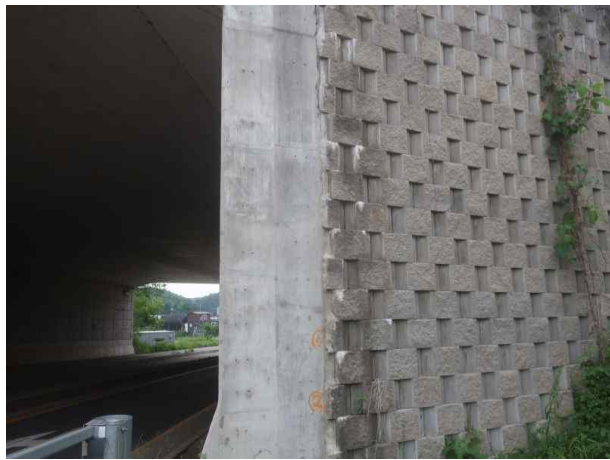
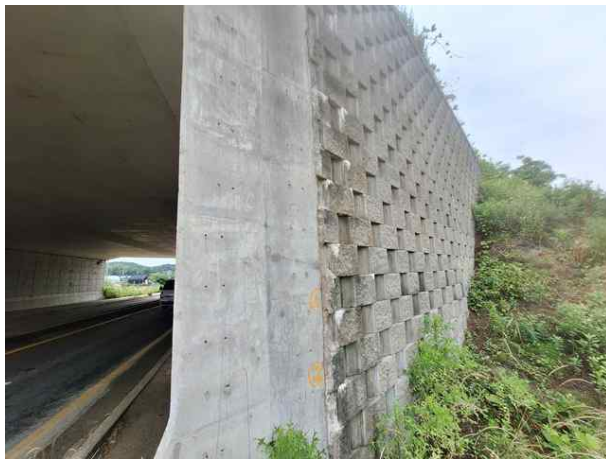
| 04<br>(25년 상반기) | 교대(A1) 날개벽 백태 | 04<br>(26년 상반기) | 교대(A1) 날개벽 백태 |

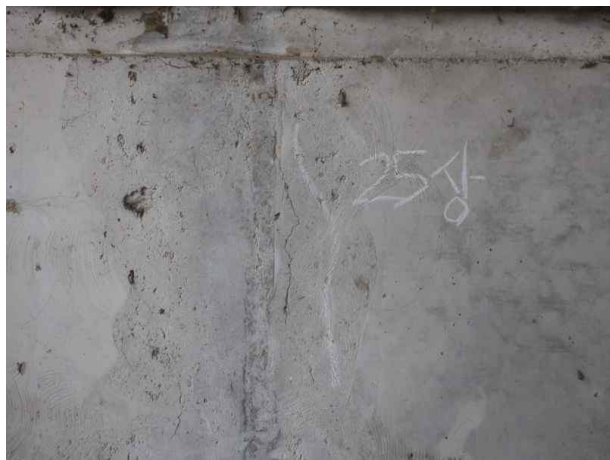
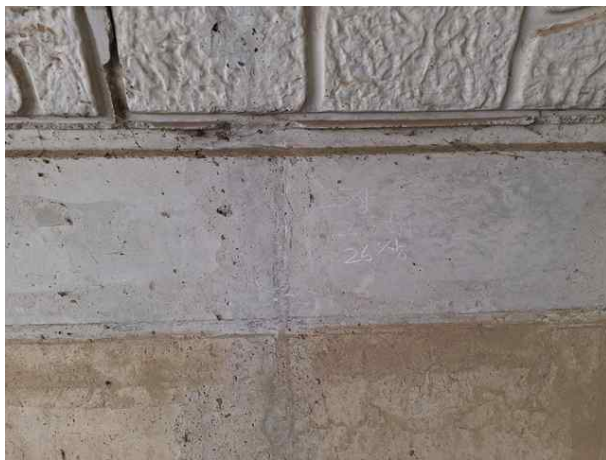
| 05<br>(25년 상반기) | 교대(A2) 균열(0.3mm미만) | 05<br>(26년 상반기) | 교대(A2) 균열(0.3mm미만) |

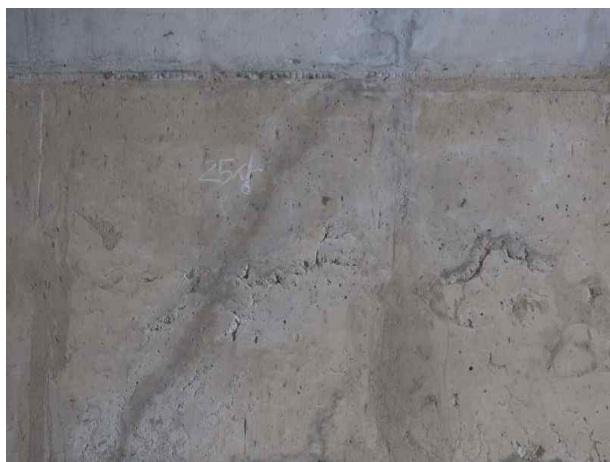
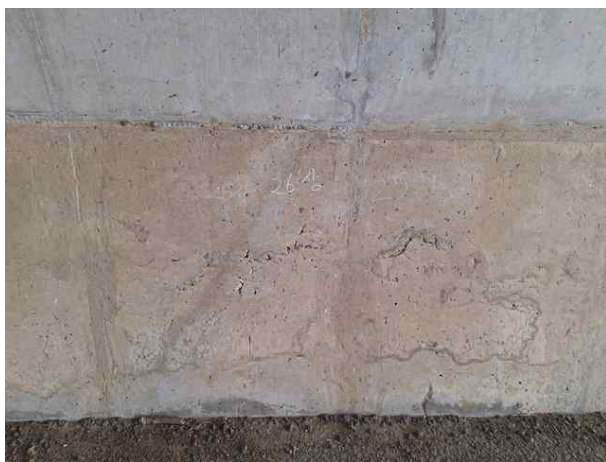
| 06<br>(25년 상반기) | 교대(A2) 재료분리 | 06<br>(26년 상반기) | 교대(A2) 재료분리 |
