## 2. 비 봉 교

# 손상현황

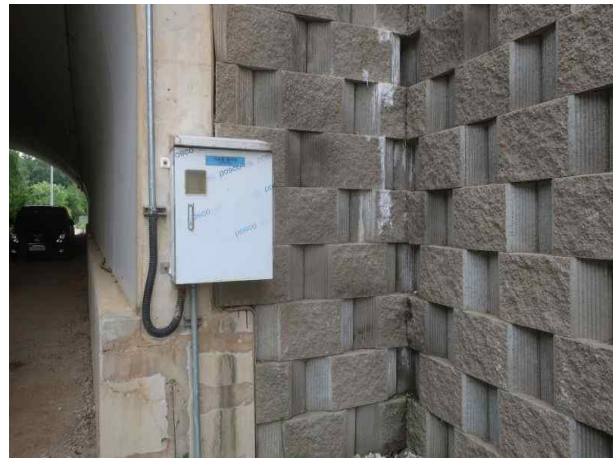
01  
(25년 상반기)

교대(A1) 날개벽 백태

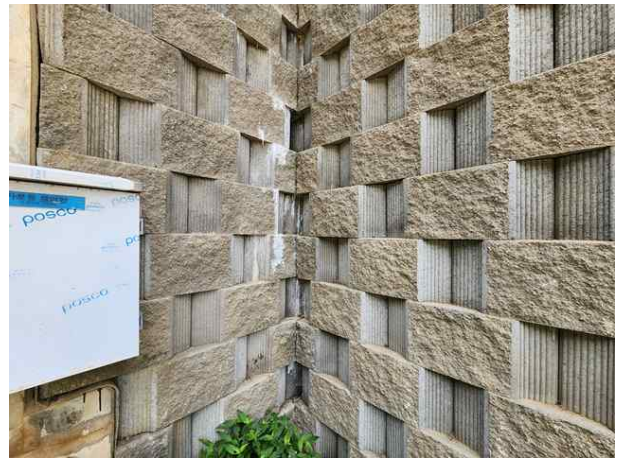
01  
(26년 상반기)

교대(A1) 날개벽 백태

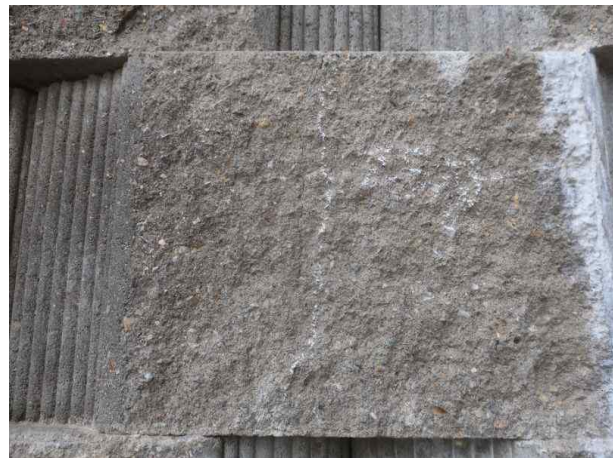
02  
(25년 상반기)

교대(A1) 날개벽 웅벽 파손

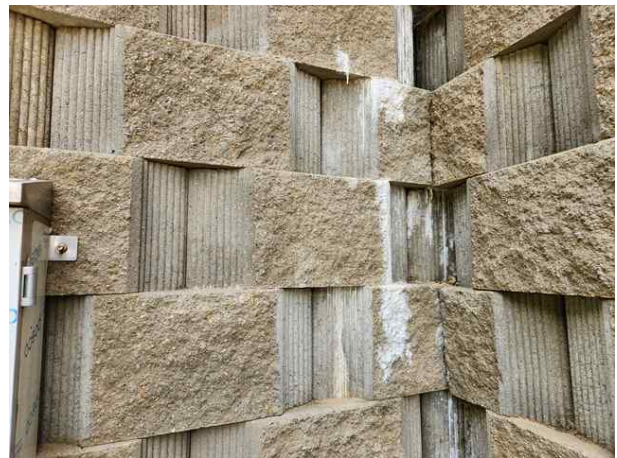
02  
(26년 상반기)

교대(A1) 날개벽 웅벽 파손

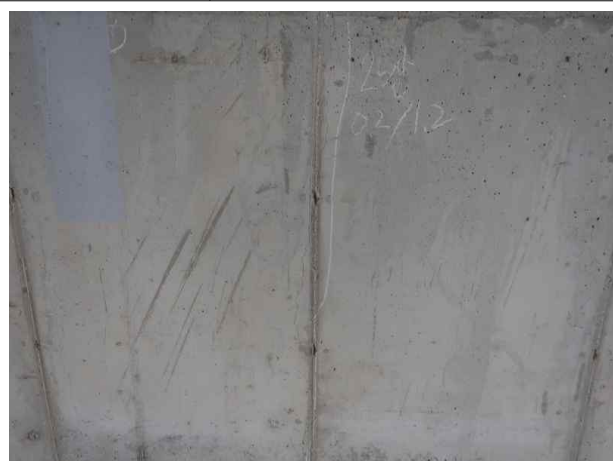
03  
(25년 상반기)

교대(A2) 균열(0.3mm미만)

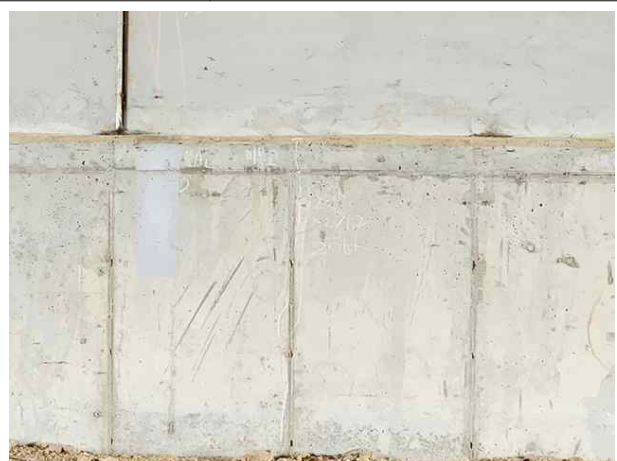
03  
(26년 상반기)

교대(A2) 균열(0.3mm미만)
