## 4. 양 노 4 교

# 손상현황

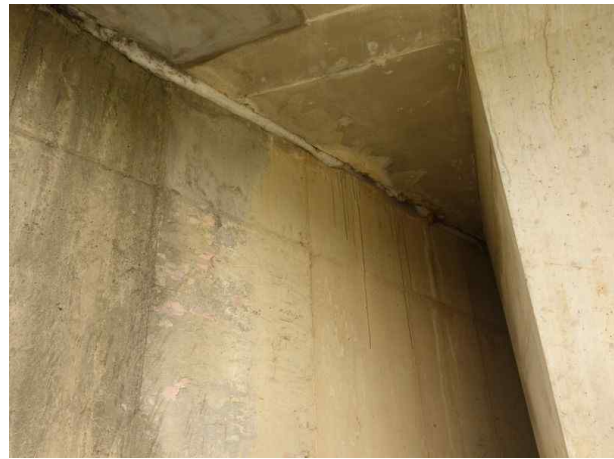
| 01<br>(25년 상반기) | 신축이음(A1) 하부 누수 | 01<br>(26년 상반기) | 신축이음(A1) 하부 누수 |

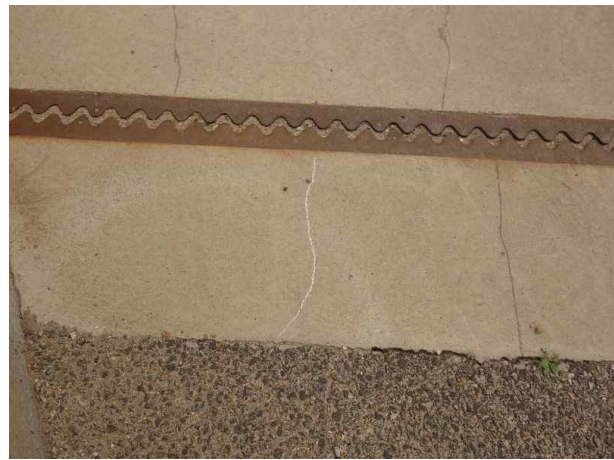
| 02<br>(25년 상반기) | 신축이음(A1) 후타재 균열 | 02<br>(26년 상반기) | 신축이음(A1) 후타재 균열 |

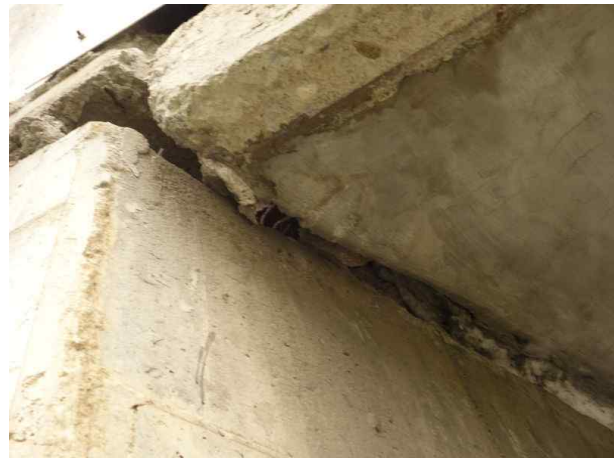
| 03<br>(25년 상반기) | 교대(A1) 마감불량 | 03<br>(26년 상반기) | 교대(A1) 마감불량 |

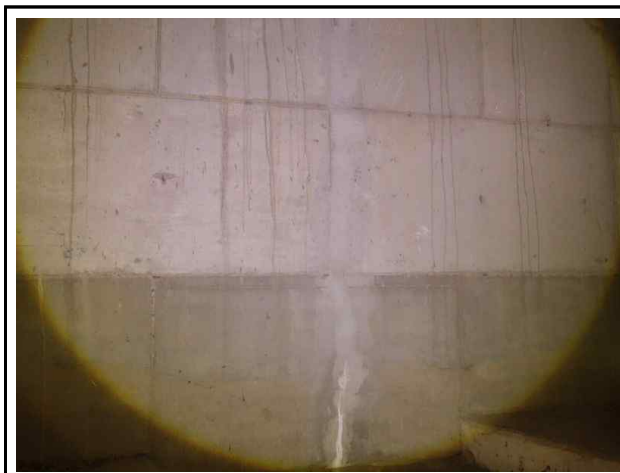
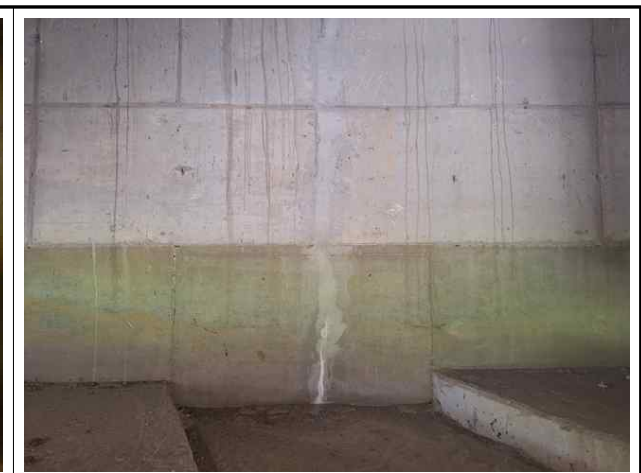
| 04<br>(25년 상반기) | 교대(A2) 백태 |

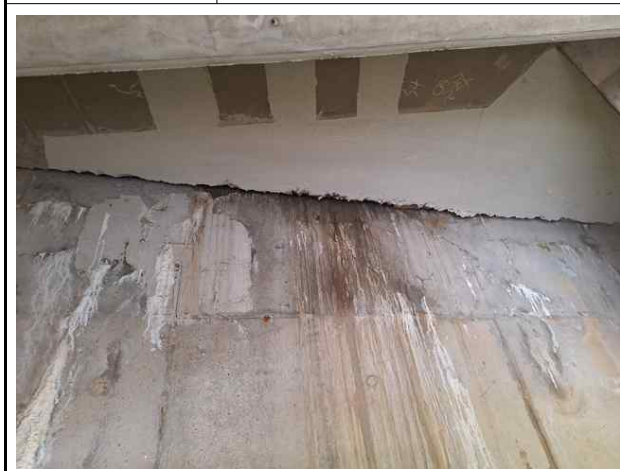
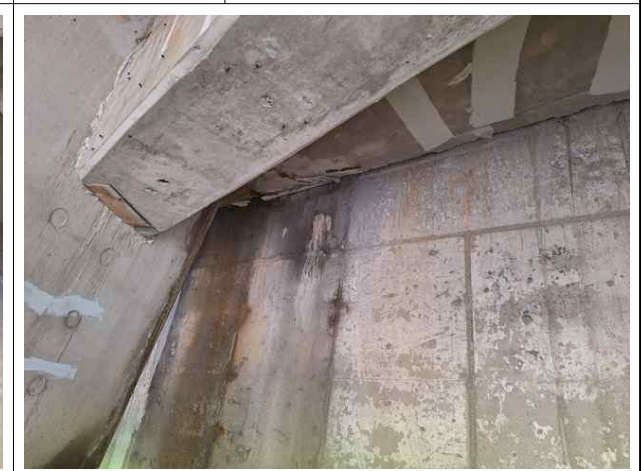
| 05<br>(26년 상반기) | 신축이음(A2) 하부 누수 |

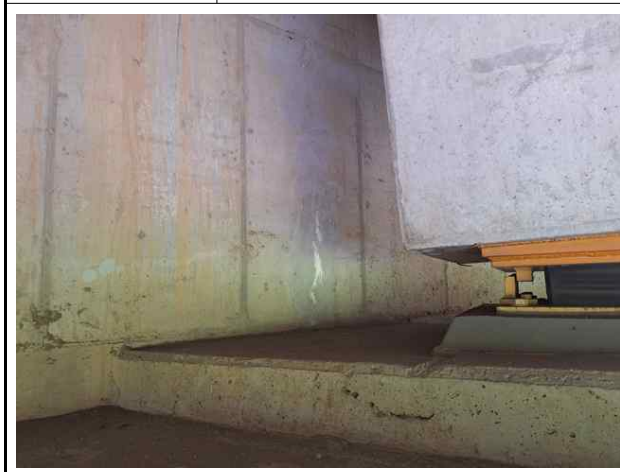
| 07<br>(26년 상반기) | 교대(A2) 백태 |

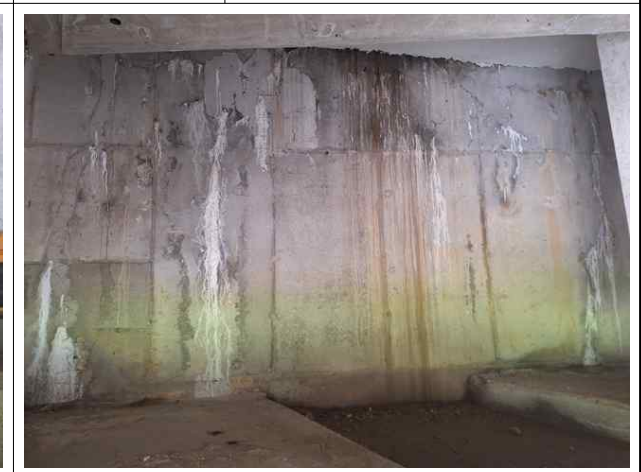
| 08<br>(26년 상반기) | 교대(A2) 백태 |
