## 5. 개 무 교

# 손상현황

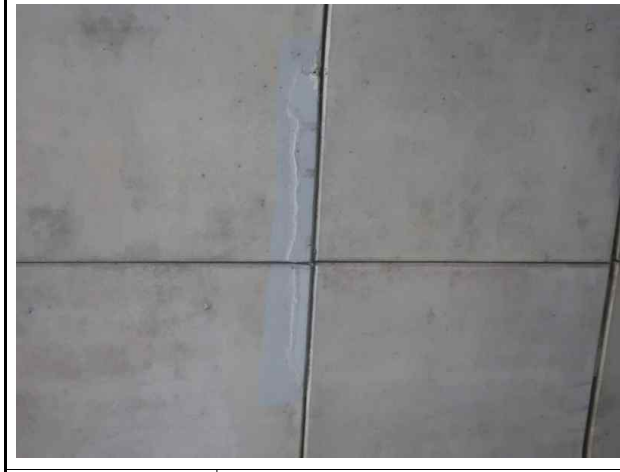
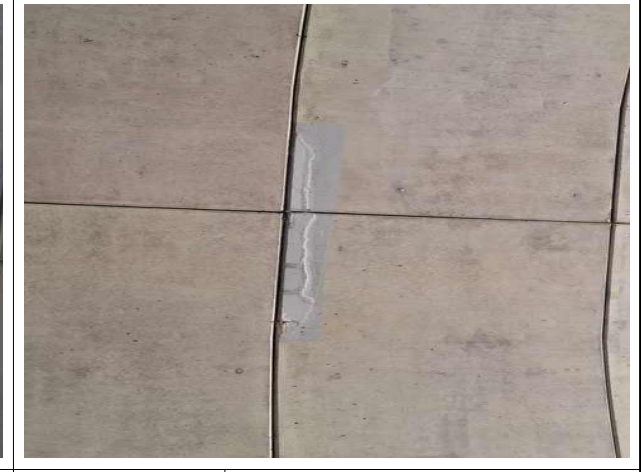
| 03<br>(25년 상반기) | 03<br>(26년 상반기) |

| 바닥판하면(S1) 보수부 재균열 | 바닥판하면(S1) 보수부 재균열 |

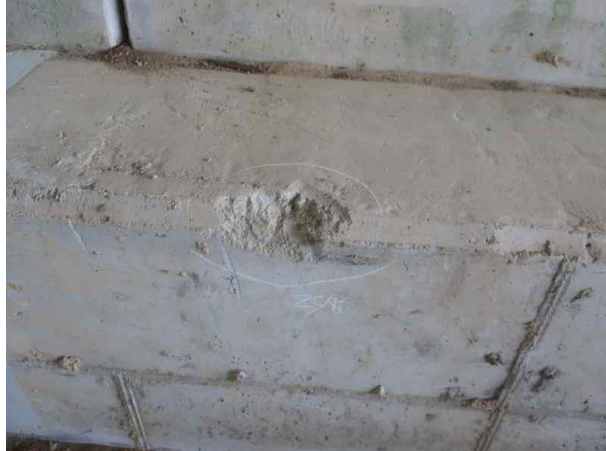
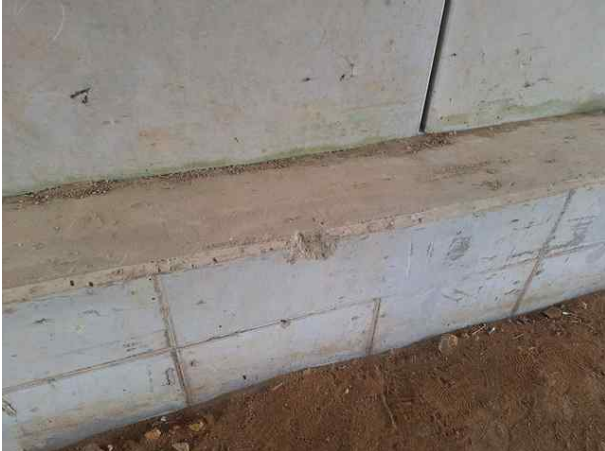
| 04<br>(25년 상반기) | 교대(A1) 파손 | 04<br>(26년 상반기) | 교대(A1) 파손 |

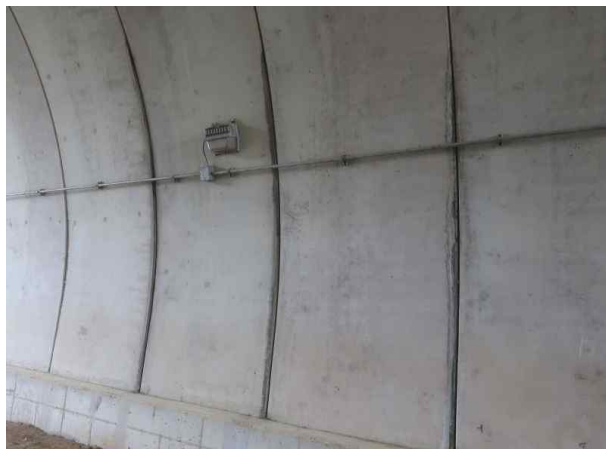
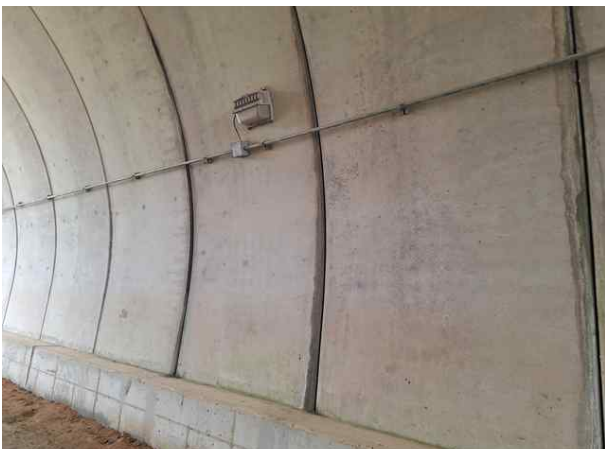
| 05<br>(25년 상반기) | 교대(A1) 누수흔적 | 05<br>(26년 상반기) | 교대(A1) 누수흔적 |

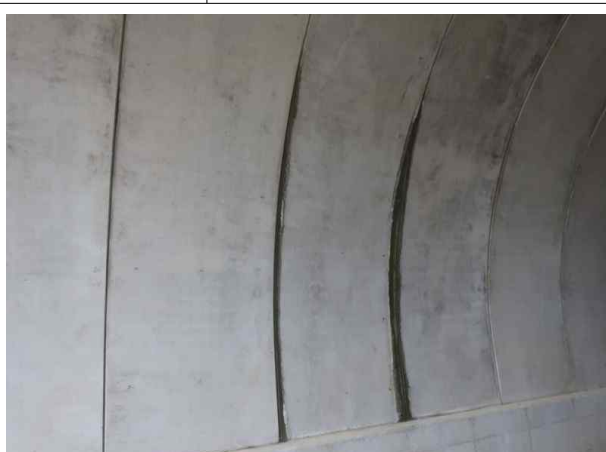
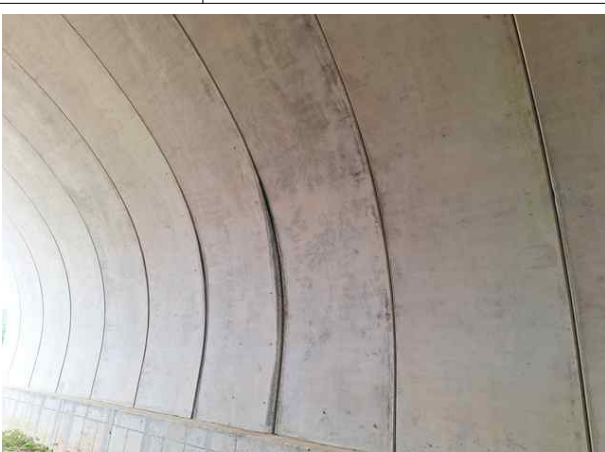
| 06<br>(25년 상반기) | 교대(A2) 누수흔적 | 06<br>(26년 상반기) | 교대(A2) 누수흔적 |
